MONTGOMERY COUNTY HISTORIC PRESERVATION COMMISSION
STAFF REPORT

Address:	2420 Spencerville Rd., Spencerville	Meeting Date:	12/5/2018
Resource:	Individually Listed Master Plan Site <i>Spencer-Carr House</i>	Report Date:	11/28/2018
Applicant:	Cedar Ridge Community Church (Bryan Peterson, Agent)	Public Notice:	11/21/2018
Review:	Historic Area Work Permit	Tax Credit:	n/a
Case Number:	15/55-18C	Staff:	Dan Bruechert
PROPOSAL:	Partial Demolition and Stabilization

Property Condition Report

Historic Farmhouse

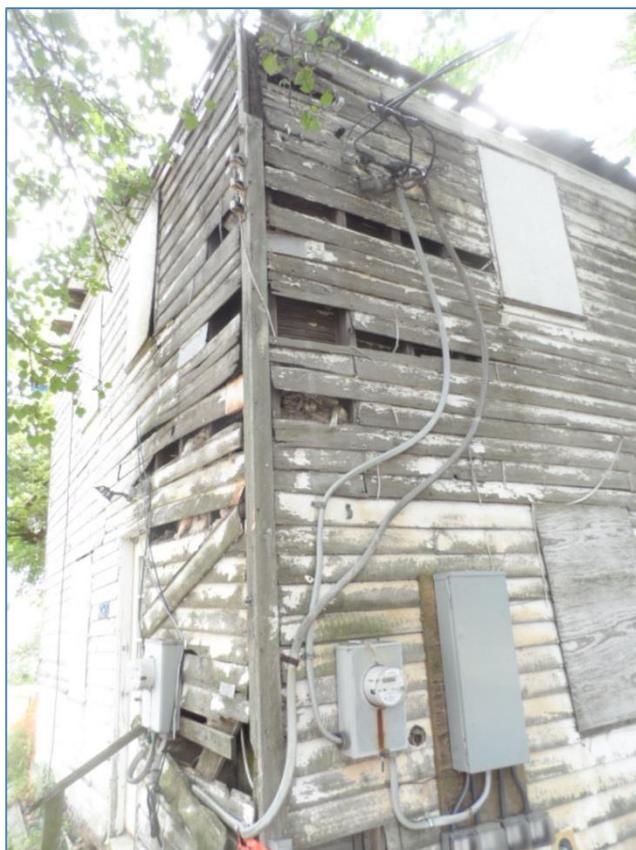
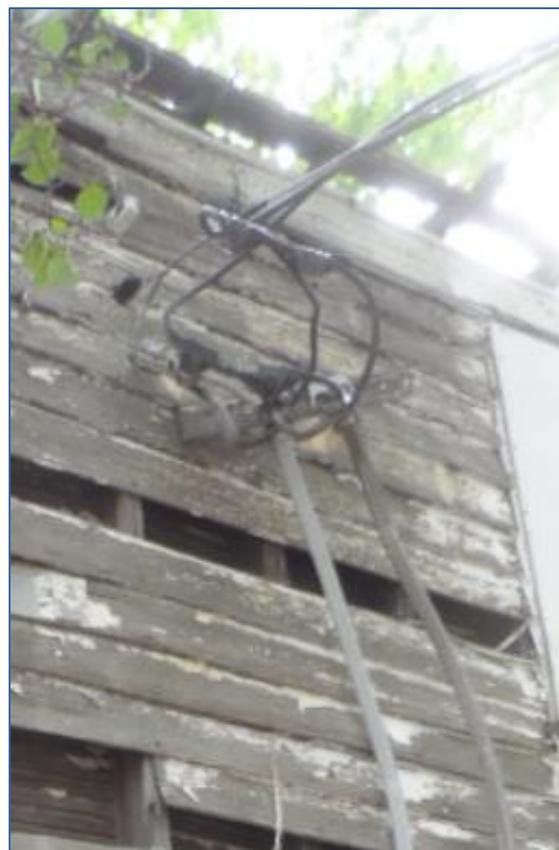
Dangerous Condition: The overhead electrical service drop is connected to an unstable portion of the structure which is at risk of collapsing. If the structure shifts or does collapse, the service entrance cable (“SE cable”) could pull away from the connection at the structure and potentially drop a live wire onto the ground endangering persons nearby until the local utility provider responds.

The electrical panel mounted inside the structure is exposed to weather with evidence of water on the panel (*see inset photo*). The circuit breakers are exposed with no blank plates over empty breaker slots. The panel and breakers are not intended for an exterior application, which is essentially the case given the weather exposure, and poses serious risks and creates a hazardous condition.

Both electrical services do not appear to serve the farmhouse. One is fed underground to outbuildings and does not necessarily have to be mounted to the building.

Immediate steps should be taken to minimize the risk of an electrical fire and the risk of electrocution. See the below recommendations.

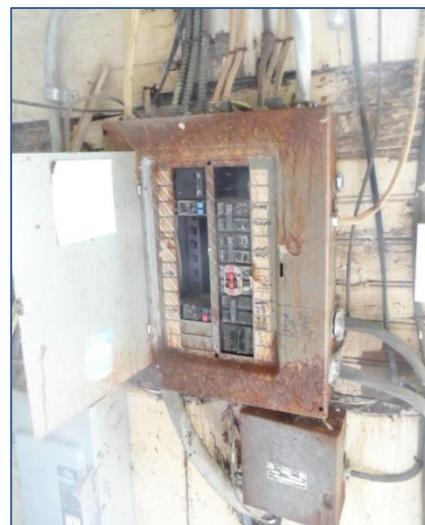
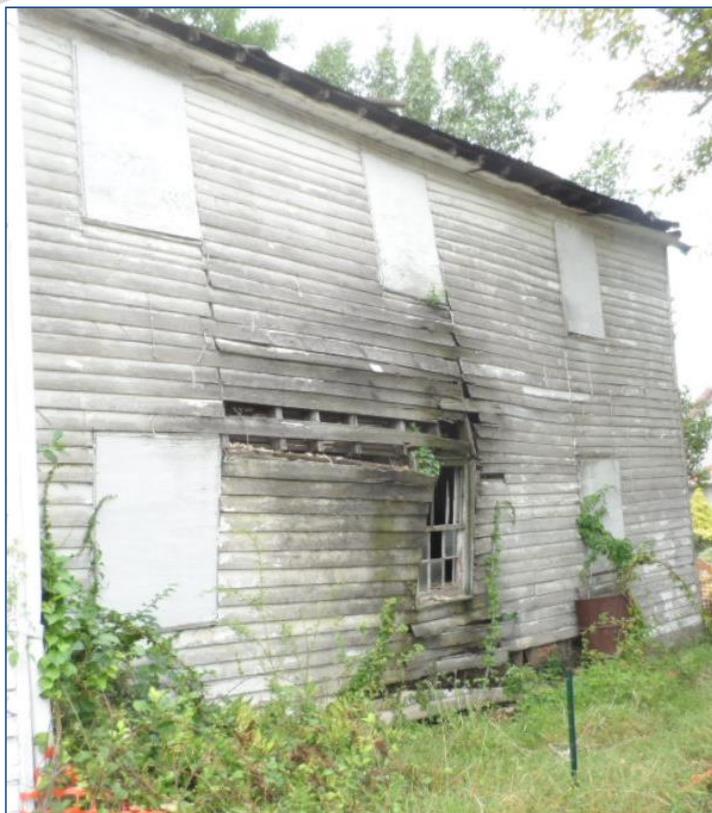
Dangerous Condition: The rear portion of the farmhouse is dilapidated and at risk of collapse. The east

exterior wall (*inset photo left*) is load-bearing and is buckling. Sections of 2nd floor are no longer connected at the wall studs on this wall and are exerting outward pressure on the wall causing it to buckle. Missing portions of the wood lap siding have exposed the structural wood framing to weather and precipitation (*see photo below*). This exposure will advance the deterioration and further undermine the structural integrity increasing the risk of collapse for this portion of the building.

The west exterior wall (opposite to the wall depicted in the left photo) appears be leaning to the east, which is very likely due to the drop of the 2nd floor at the buckled east wall pulling the west wall studs eastward.

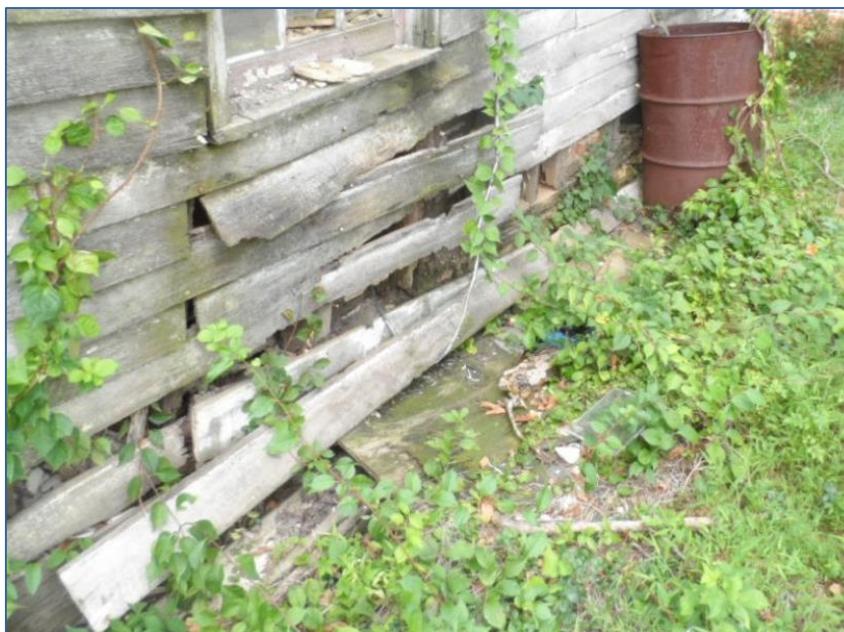
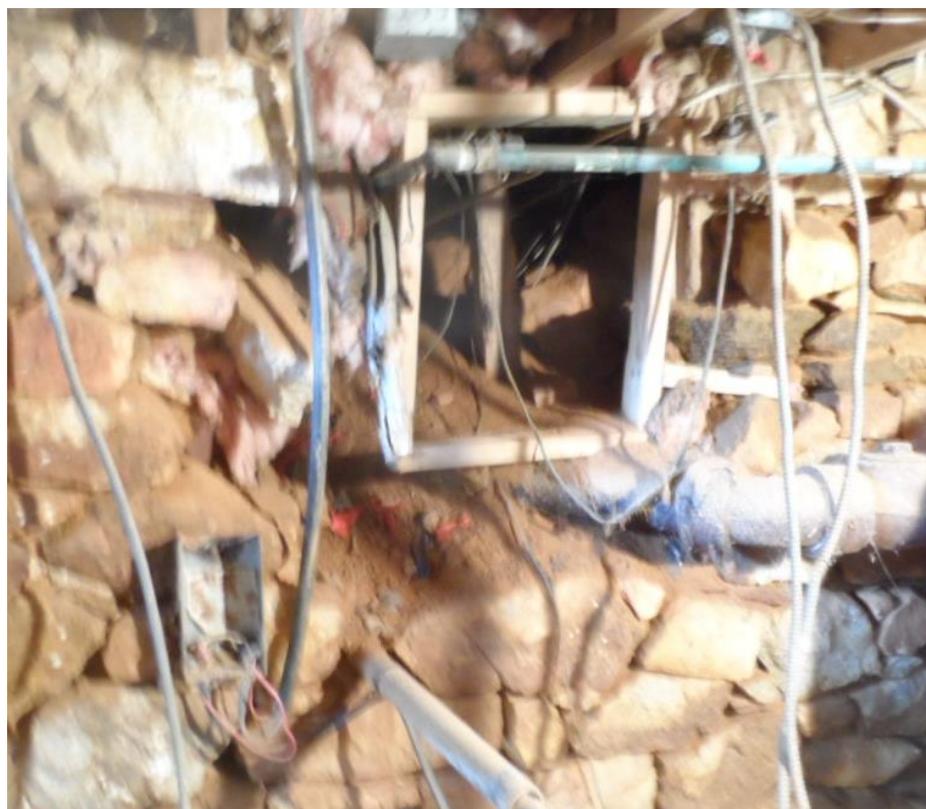
Deferred Maintenance Condition - Foundation and Cellar: The stone foundation along the rear wall of the cellar is crumbling where an access door opening was created at some time after the original construction to enter the crawlspace under the rear portion of the farmhouse, which was a later addition according to information provided by the facilities manager, Mark Hartley. The stonework around the access opening appears to not have been properly re-laid for a fenestration, and has subsequently crumbled. The floor joists and support members bear on this part of the foundation as does the original rear of building and roof structure above (the rafters run perpendicular to this foundation wall).

This area of the foundation is compromising the structural support for the building and should be addressed to prohibit further damage.

The exterior cellar doors over the stairs to the cellar are not watertight. Precipitation entering around the cellar doors further increases the humid and moist conditions of the cellar promoting rot of the structural wood elements of the building from below such as the floor supports and sill beams.

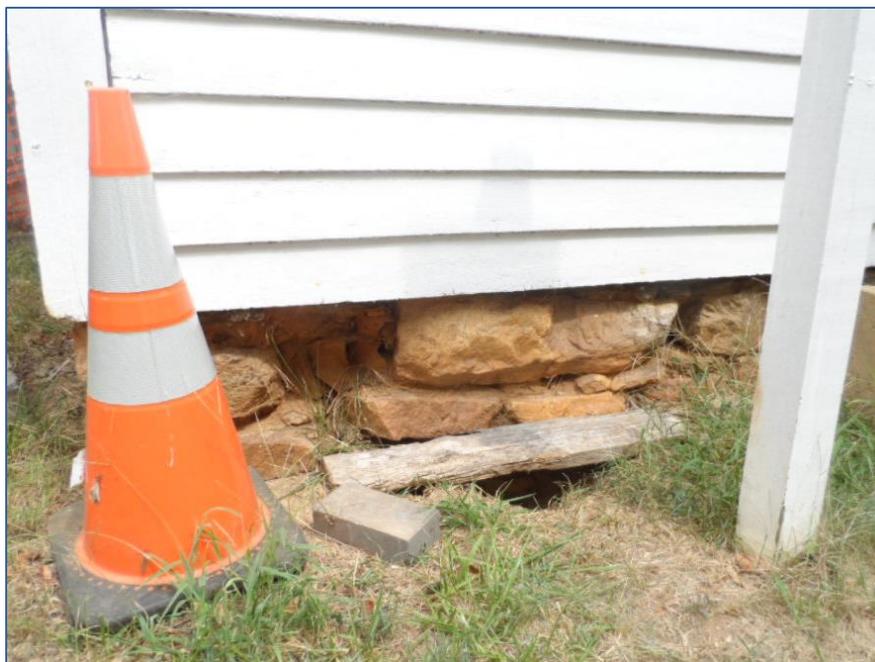
Other small sections of the foundation for the front portion of the farmhouse are in disrepair and are being undermined by rodents (*see the below photo*). Note stonework missing at the southwest corner of the farmhouse behind the safety cone.

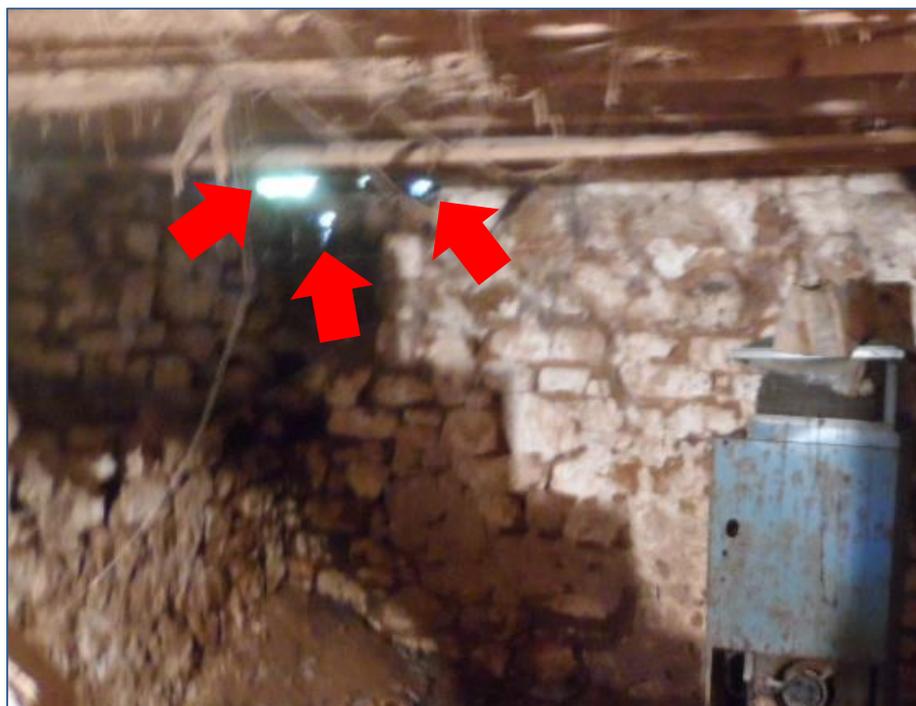
At the northeast corner of the cellar daylight entering between the wood structure and the stone foundation is due to missing stonework which should be repaired for preserving the structure. See recommendations below.

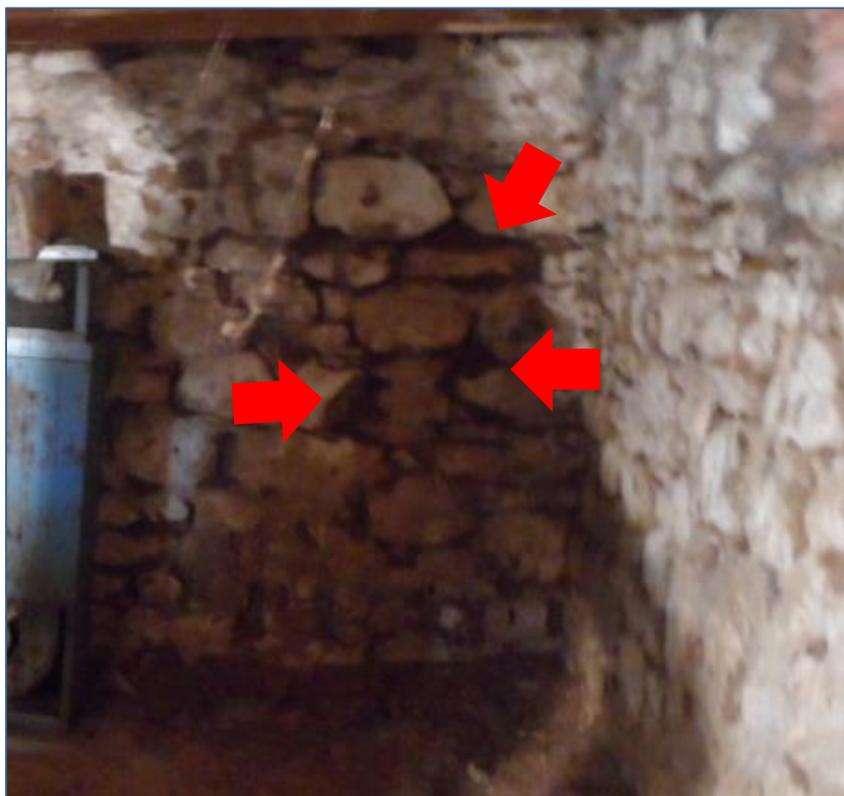
Some repointing work appears to have been performed along the east wall of the foundation in the cellar; however, the appearance of the mortar used for repointing indicates a high content of portland cement which further damages stone foundations, especially below grade.

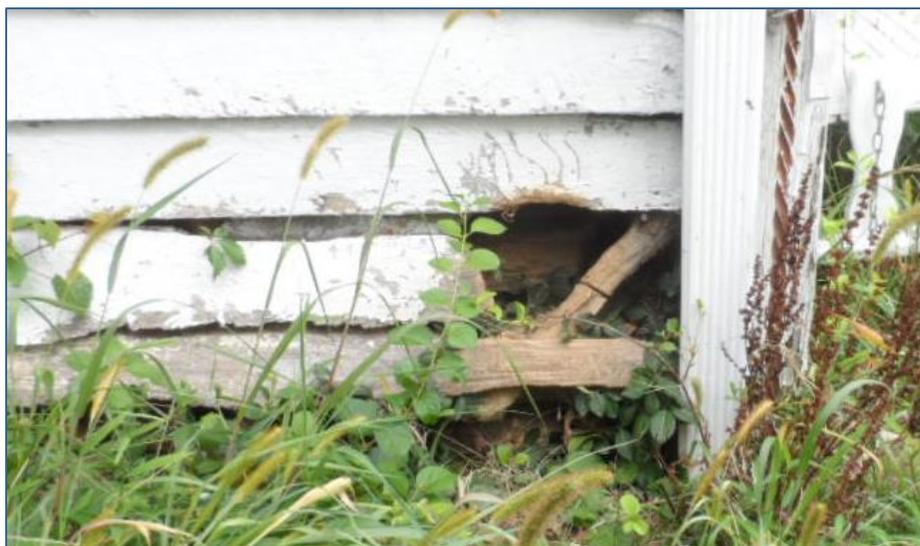
Deferred Maintenance Condition – Wood Lap Siding: Generally the lap siding of the front portion of the farmhouse is in moderate condition with only a few defective areas. On the west gable wall of the building a siding board has twisted out from under the course above and is exposing the building fabric underneath to weather and precipitation. On the southeast corner the first two courses of siding have apparently been removed possibly by rodents as evidenced by the wear on the bottom of the 3rd course and on exposed edges of the lower two courses.

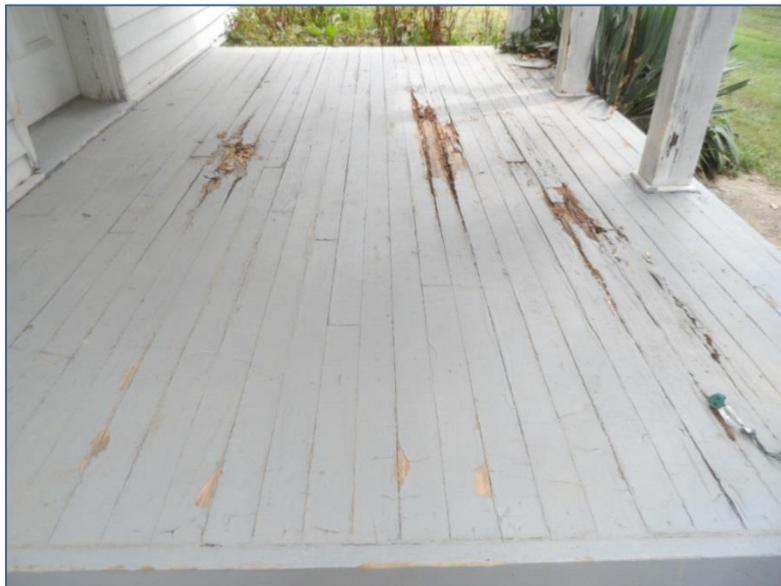
Deferred Maintenance Condition – Front Porch Floor: The front porch floor is showing signs of rot and deterioration. Although the floor boards were painted at some point in time, the wood appears to have been still absorbing and retaining moisture – probably due to their orientation perpendicular to the floor slope. Additionally, if the other three surfaces of each board are not primed or treated to resist absorption, the paint on the top surface will lose its adhesion and peel away due to the high moisture content within the lumber.

Most porch floors are sloped away from the front façade and thus the porch boards are typically oriented parallel with the slope for sheeting rainwater along the length of the boards. The existing boards, however, appear instead to be oriented perpendicular to the slope, which allows water to trap in the joints between the boards, and eventually causes rot as seen in the photo.

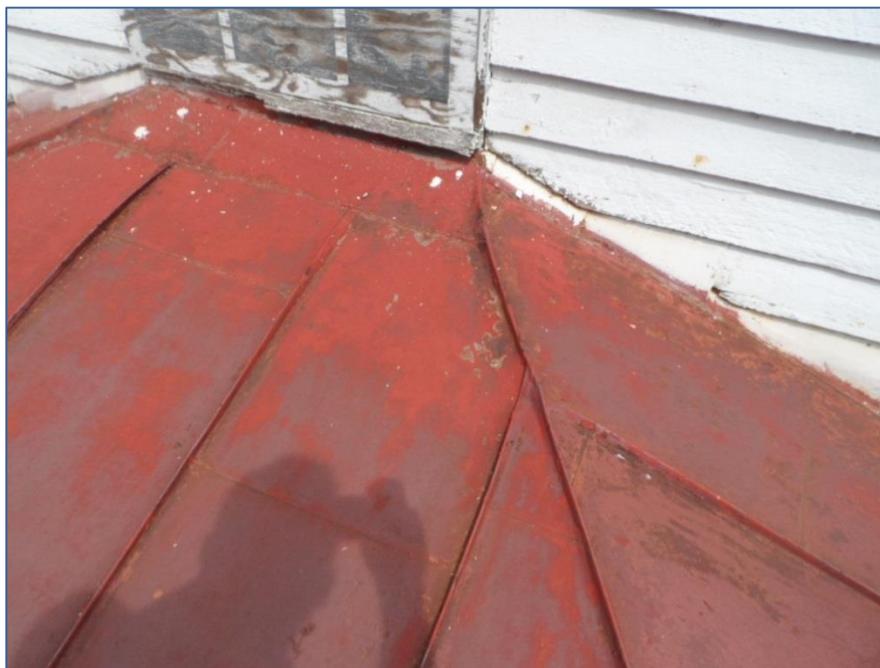
Deferred Maintenance Condition – Standing Seam Roof: Only the front porch was accessible for inspection. Overall the metal and seams were observed to be in moderately good condition; however, the coating has not been maintained and has peeled away with rust forming on the surfaces of the pans.
