Chapter 3

**PHYSICAL DESCRIPTION AND ASSESSMENT
OF EXISTING CONDITIONS**

Farm Women's Market Investigation Conditions Assessment

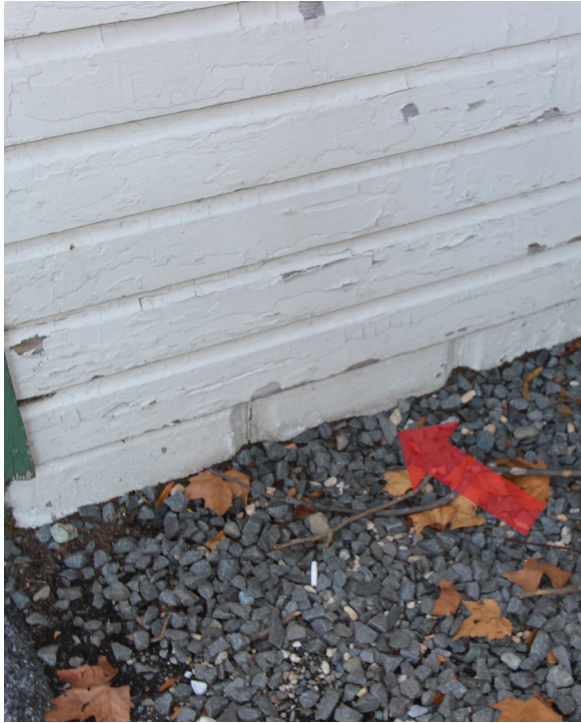
The continuous repair/re-pouring of asphalt paving surrounding the building appears to have damaged the building structure and has also generated drainage issues at the building foundation. As layers of paving have accumulated over the years, in combination with the topography of the site, which slopes down from the northeast to the southwest corner, water is able to collect and pool at the foundation. In addition, the exterior walls appear to undulate, particularly on the east elevation. This undulation is a result of the lateral pressure of the asphalt paving against the wood frame walls. The areas of wood framing indent in towards the building, while the locations of the steel beams on the interior have remained in their original position.

FIGURE 18 Siding and exposed concrete block foundation stem wall (identified with arrow) along the west elevation.

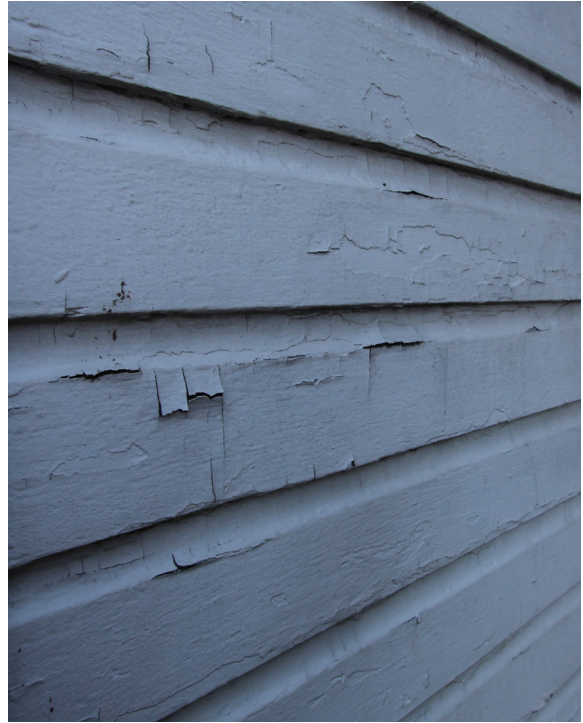
FIGURE 19 Detail of the wood siding and deteriorated paint.

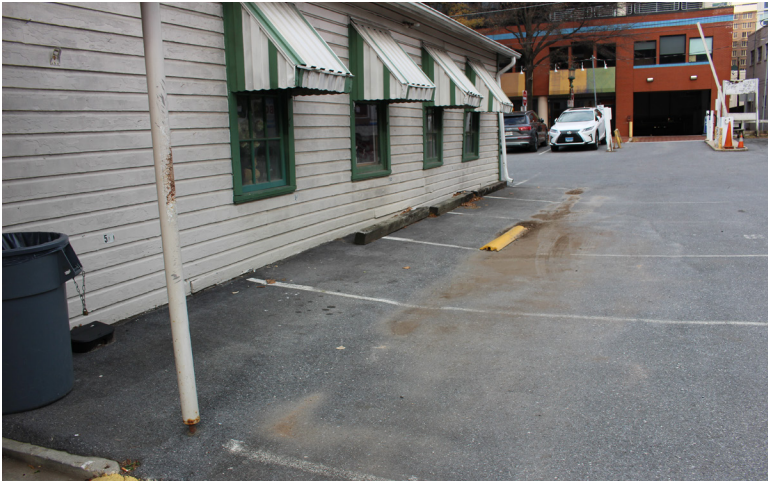
FIGURE 31 Slope of site/ building in hole

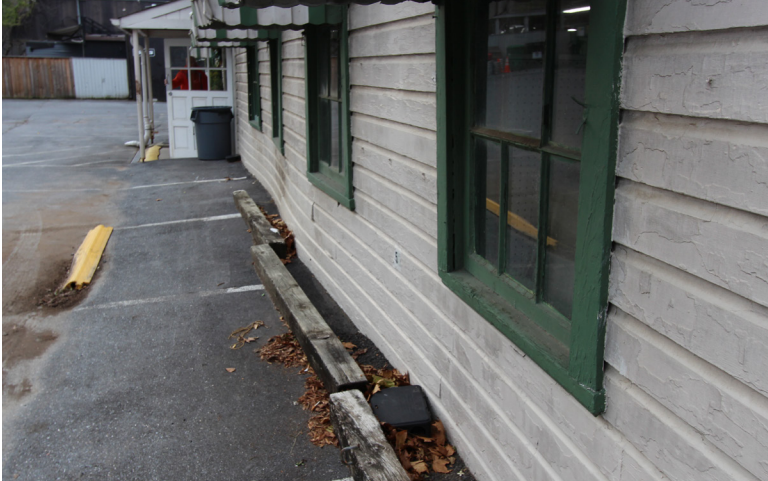
The north side of the elevation, undulates. This undulation is a result of the asphalt paving being poured against the wood frame walls (Figure 32). The areas of wood framing indent into the building, while the locations of the steel frame on the interior have pushed out against the pressure.

FIGURE 32 Undulation of the elevation

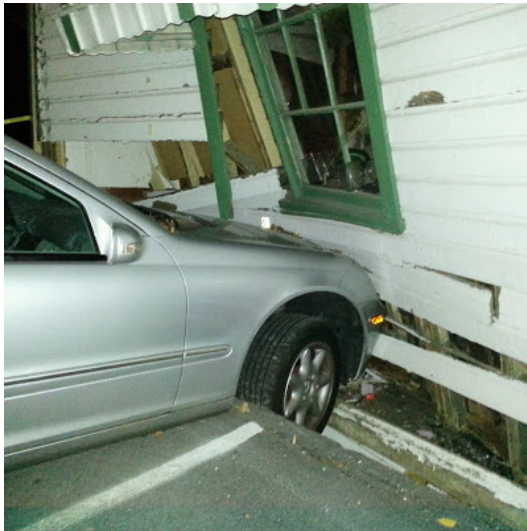
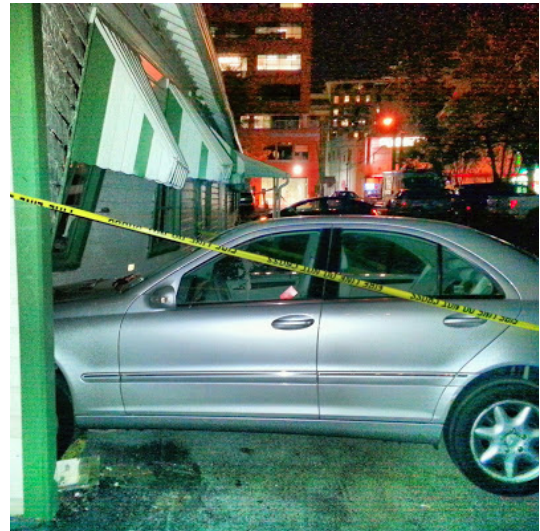
As mentioned, much of the southeast corner has been reassembled or replaced following a car accident in 2013 (Figure 33). Replacement wood cladding is visible as well as at least one replacement window. A small area close to the ground has been patched with vinyl siding. Other windows on this side are missing some munitins and replacement glass has been inserted improperly.

FIGURE 33 Photographs of damage from 2013. Blog, Robert Dyer @ Bethesda Row, <http://robertdyer.blogspot.com>.

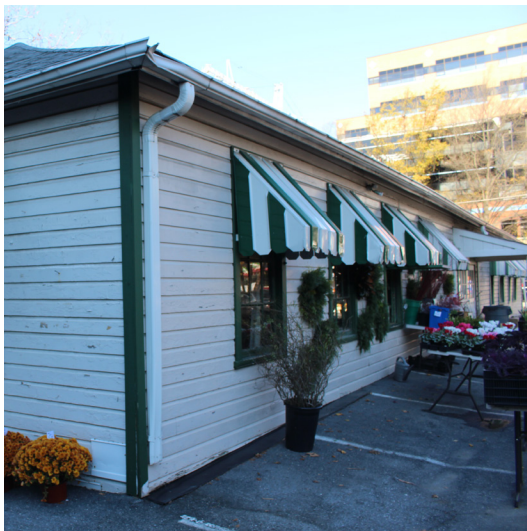
FIGURE 34 Reconstructed southeast corner.

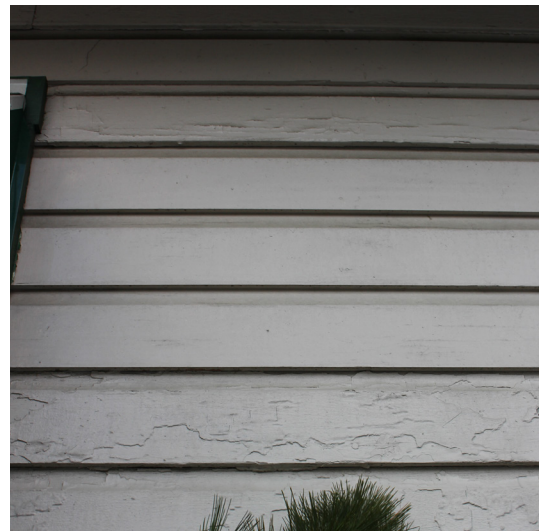
FIGURE 35 Replacement siding visible on east elevation.

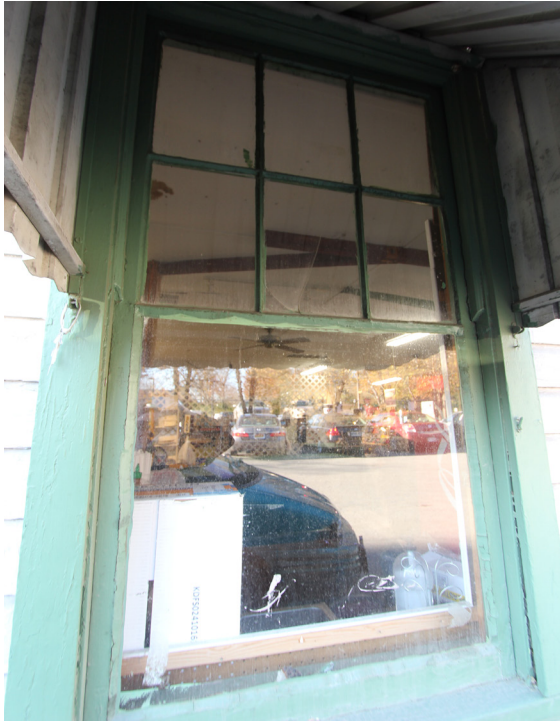
FIGURE 44 Extant window missing lower muntins.

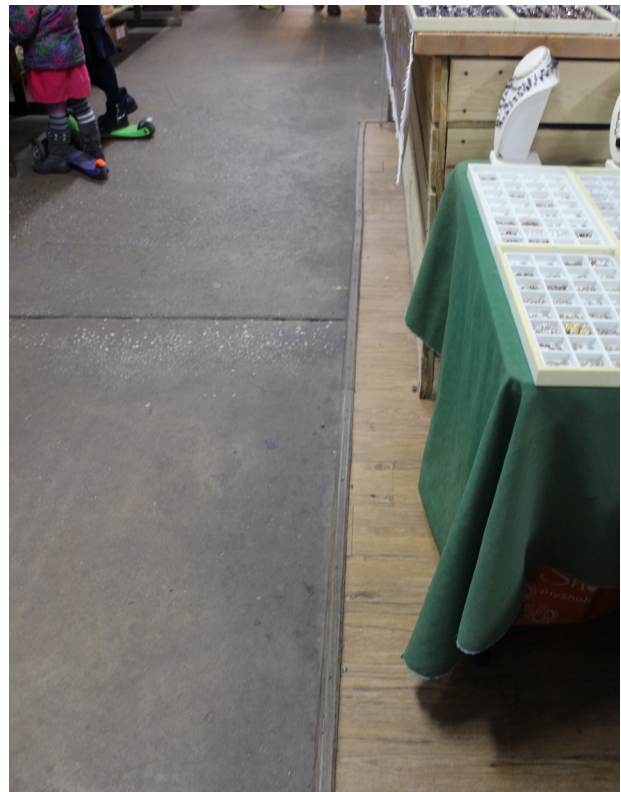
The interior is utilitarian in nature and features little decoration. The historic finishes that remain include the tongue and groove vertical wall paneling, historic doors accessing the restrooms and office, and the structure that is currently concealed by contemporary finishes. In general, the interior is in fair condition. Deterioration is evident at interior wood window surrounds. In addition, areas of termite damage are also evident, particularly in the attic. Concrete floors are stained and cracked in some areas.

FIGURE 65 Detail of concrete flooring with added wood.

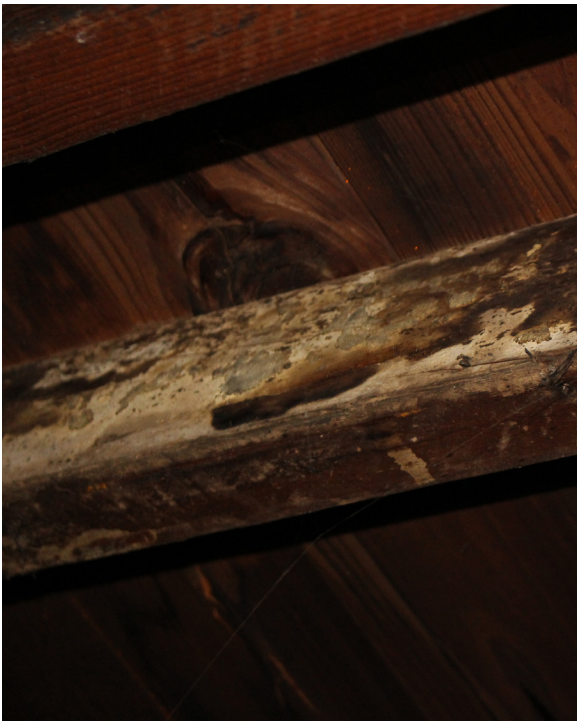
FIGURE 82 Termite damage evident in attic.

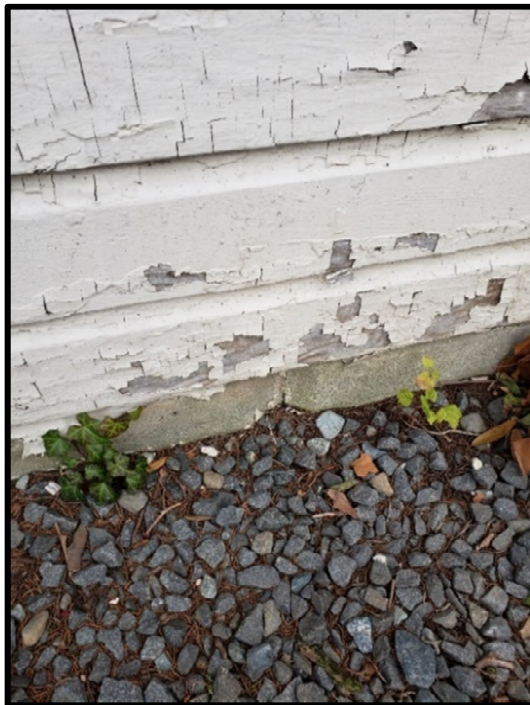
Visible concrete block located at the Southeast corner of the building indicates that a masonry "stem wall" extends up to grade to support the wood framed walls and avoid water exposure. Gravel around the perimeter assures proper drainage in this area. For the other perimeter areas, asphalt pavement has been built up and sand bags have been placed in an attempt to prevent water from entering the building. However, this condition has caused the wall elements to be pushed inward and create a condition where the wood wall framing is in constant contact with moisture from the pavement. Examples of both conditions can be seen in Figure 3 and Figure 4.

Figure 3 - Existing Drainage Conditions Along East Wall

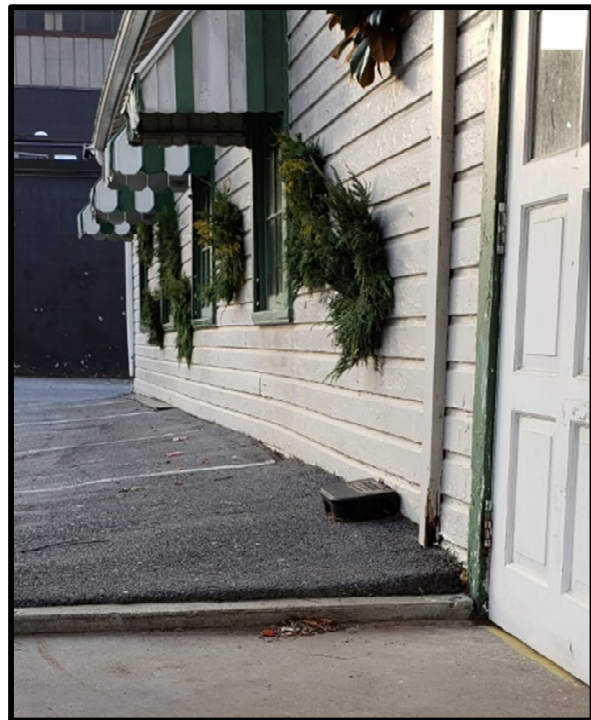
Figure 4 – Built Up Asphalt Against East Wall

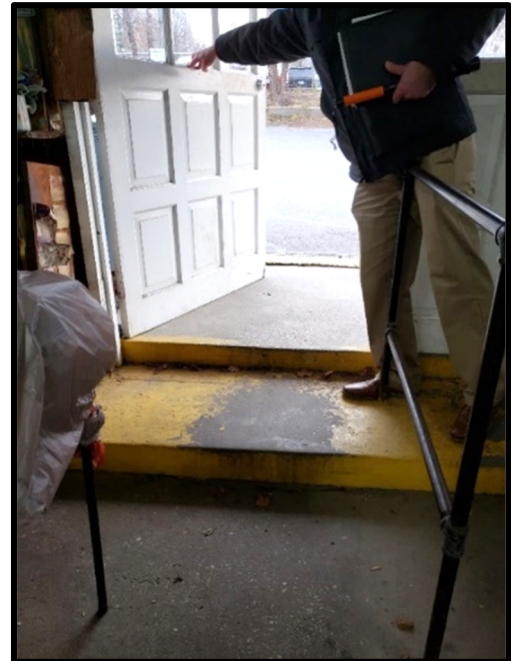
The main floor of the market consists of a concrete slab on grade. The slab is located below the level of the exterior grade, because of the asphalt pavement and is of an unknown thickness. The difference in elevation between the slab and exterior grade can be seen in Figure 5 where door heights were adjusted and steps added.

Figure 5 – East Entrance to Market

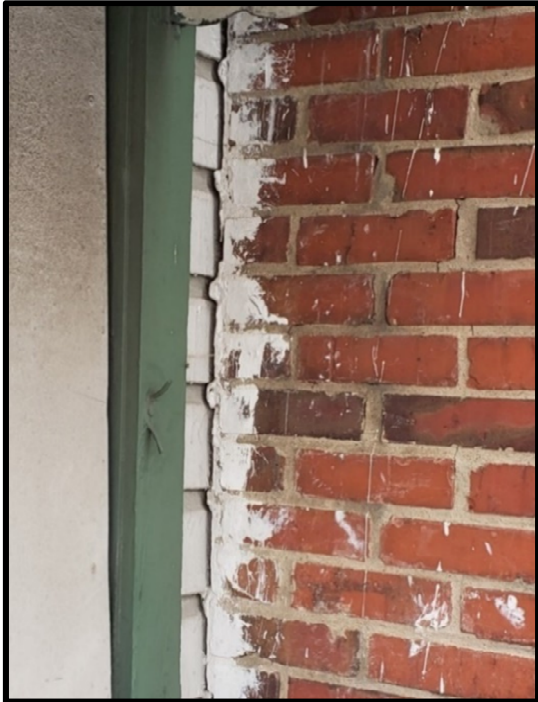
Figure 16 – Visible Gap Between Buildings and Chimney

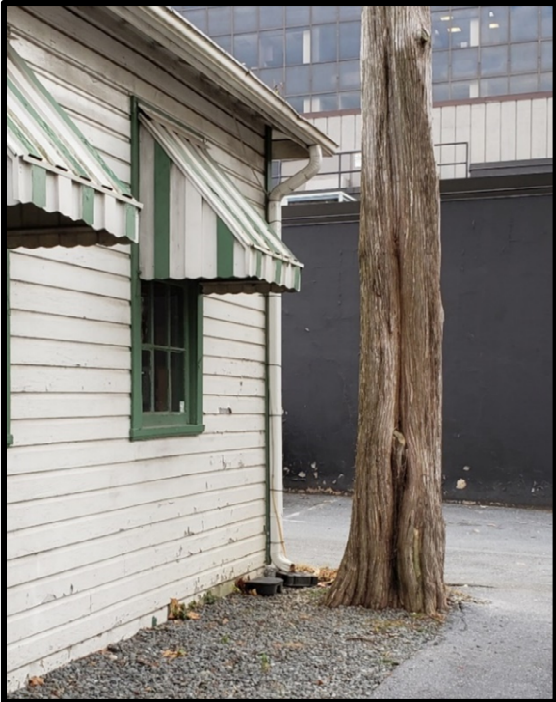
A tree has grown in close proximity to the southeast corner of the building (Figure 17). This is the same corner where termite damage was observed in the attic.

Figure 17 – Southeast Corner of Building
