MONTGOMERY COUNTY HISTORIC PRESERVATION COMMISSION
STAFF REPORT

Address:	5 Columbia Ave., Takoma Park	Meeting Date:	1/23/2019
Resource:	Contributing Resource Takoma Park Historic District	Report Date:	1/16/2019
Applicant:	Annie Kneedler & Sam Bryson	Public Notice:	1/9/2019
Review:	HAWP	Tax Credit:	partial
Case Number:	37/03-19A	Staff:	Dan Bruechert
Proposal:	Building Rehabilitation, New Windows, and Building Additions

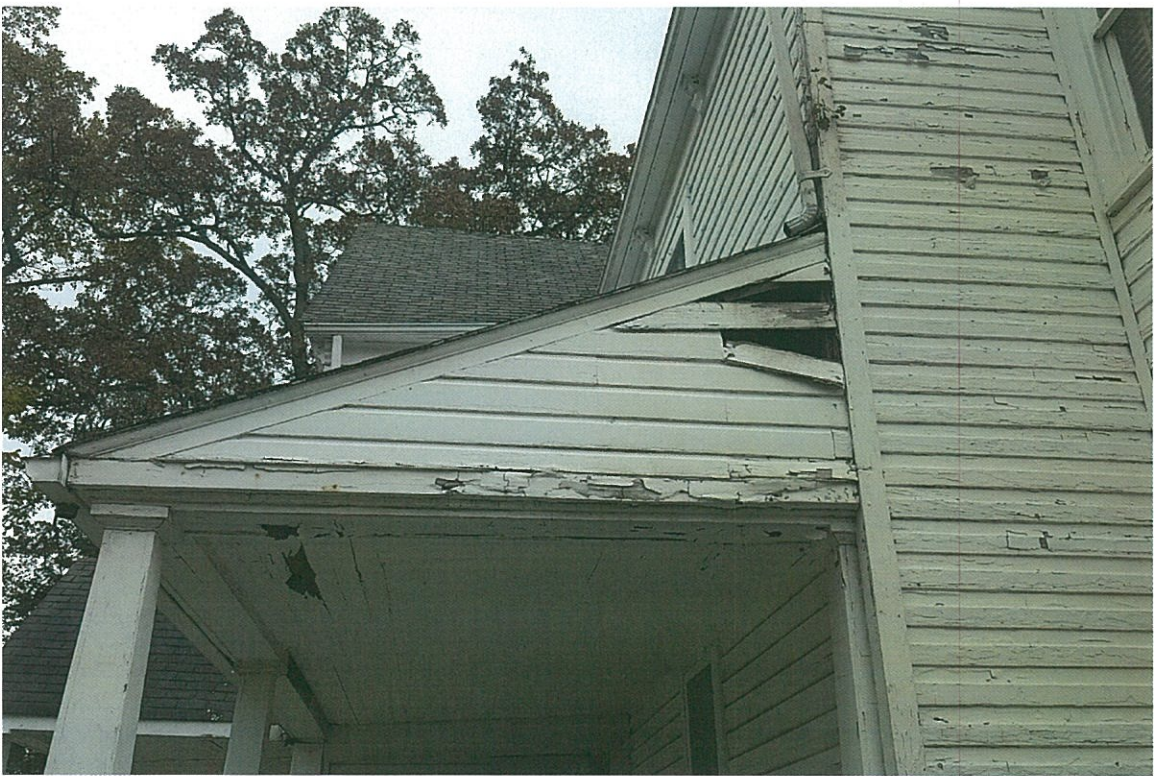
EXAMPLE OF DAMAGED SIDING

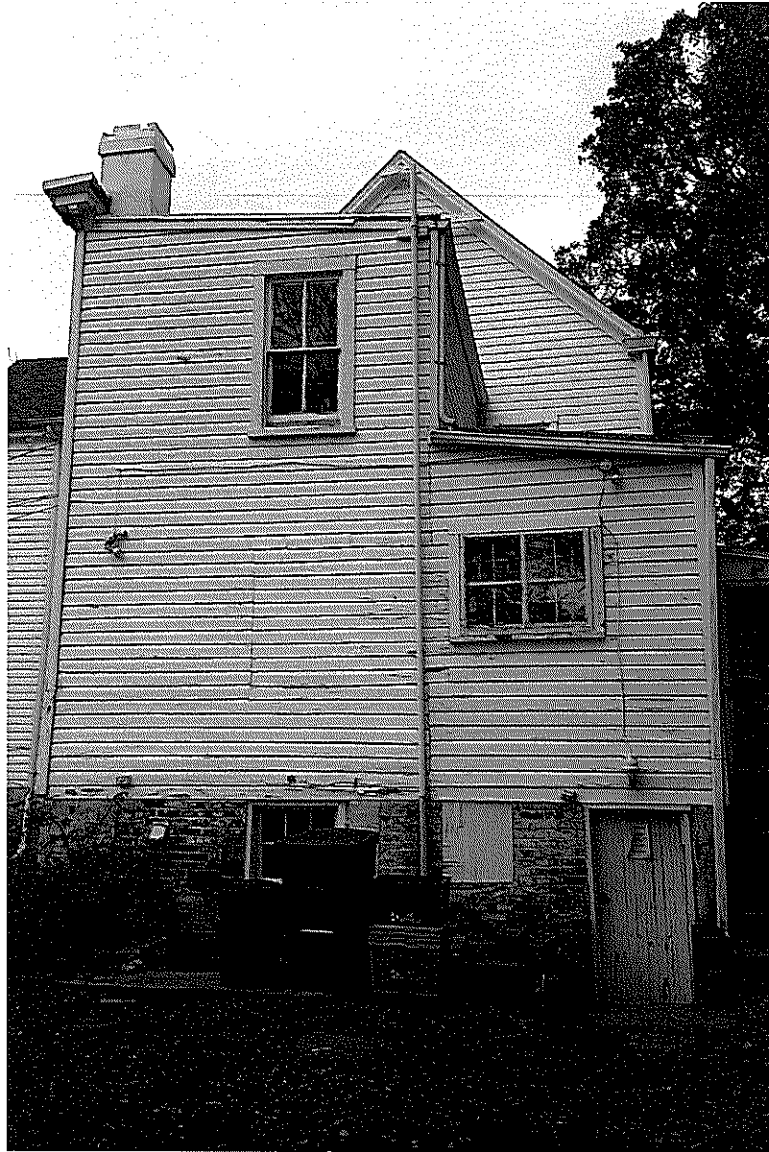
VIEW OF REAR STRUCTURE THAT IS PROPOSED TO BE DEMOLISHED & REPLACED W/ NEW ADDITION

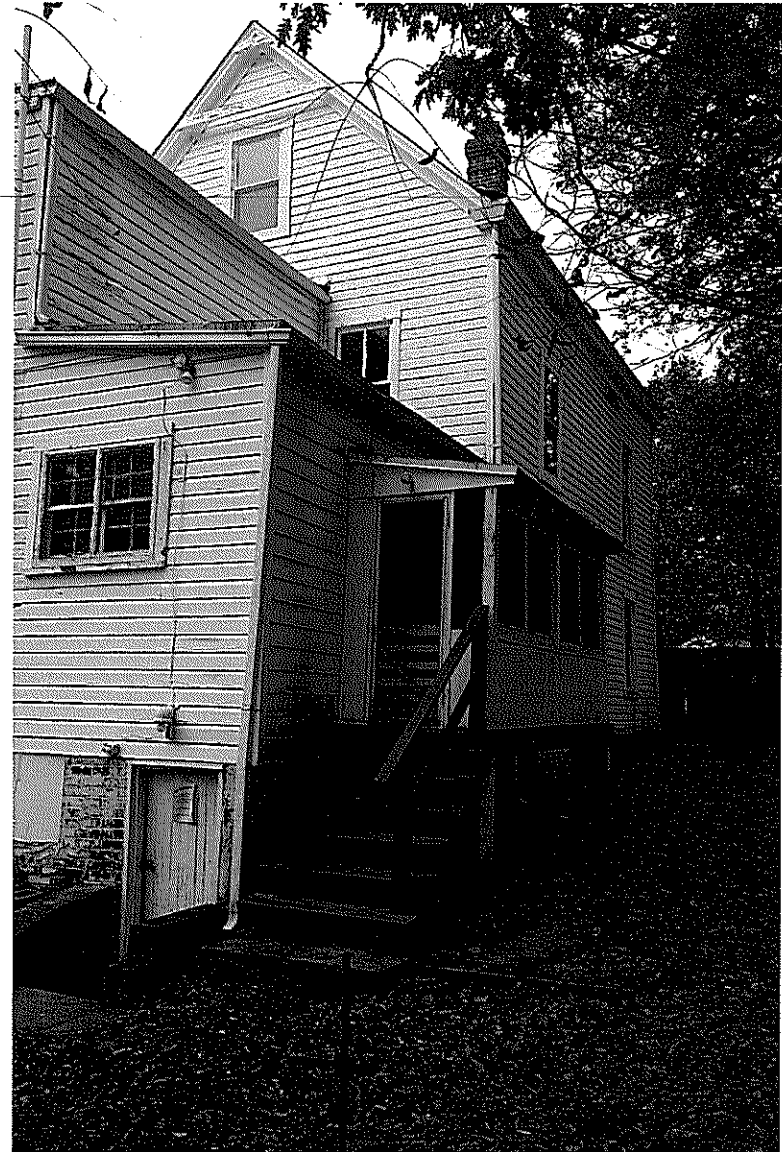
VIEW OF EXIST. SIDE SCREENED PORCH TO BE DEMOLISHED AND REPLACED W/A NEW, LARGER SCREENED PORCH.

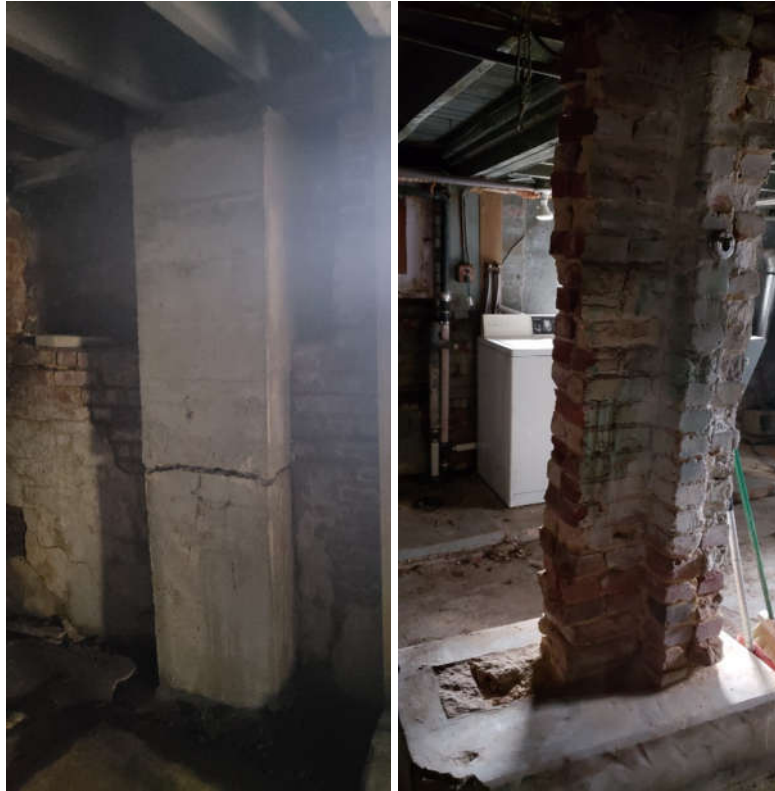
There are major structural concerns in the basement. The masonry basement walls and piers are showing significant signs of deterioration and large cracking.

Based upon the above observation, it is in my profession opinion that the existing addition should be removed and replaced. When demolishing the addition, care should be taken to not damage the original existing structure. Should there be any questions or concerns feel free to contact me.

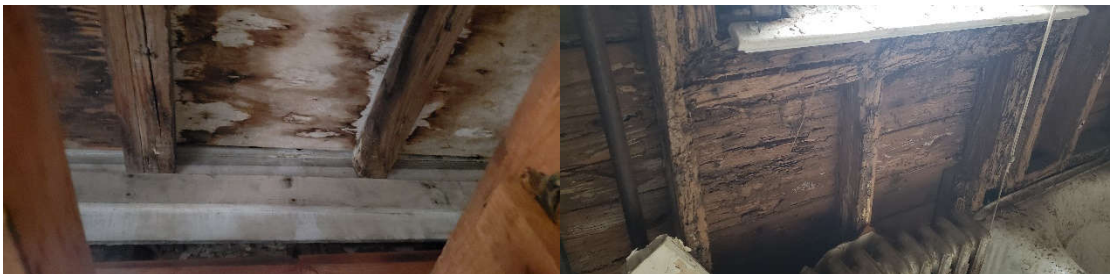
Much of the existing framing is showing significant signs of water damage and deterioration

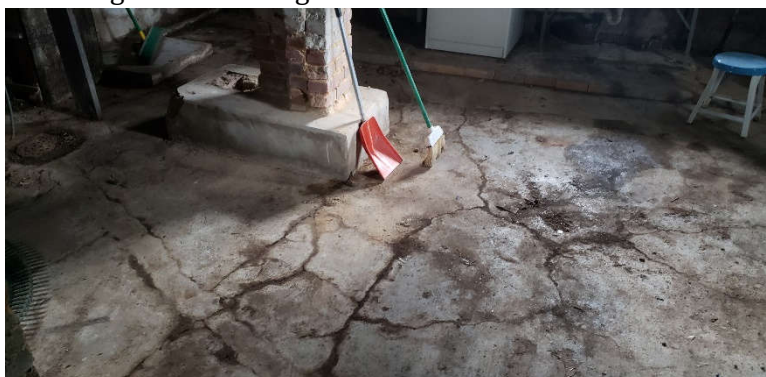
The basement slab on grade shows signs of settlement and extensive cracking.
