MONTGOMERY COUNTY HISTORIC PRESERVATION COMMISSION
STAFF REPORT

Address:	8712 2 nd Avenue, Silver Spring	Meeting Date:	10/11/17
Resource:	Contributing Resource Woodside Locational Atlas District	Report Date:	10/04/17
Applicant:	Wexford Homes, LLC	Public Notice:	09/27/17
Review:	HAWP	Tax Credit:	n/a
Case Number:	36/04-A	Staff:	Dan Bruechert
Proposal:	Building Demolition

ASBESTOS-CONTAINING MATERIALS SURVEY

8712 2nd Avenue
Silver Spring, Maryland 20910

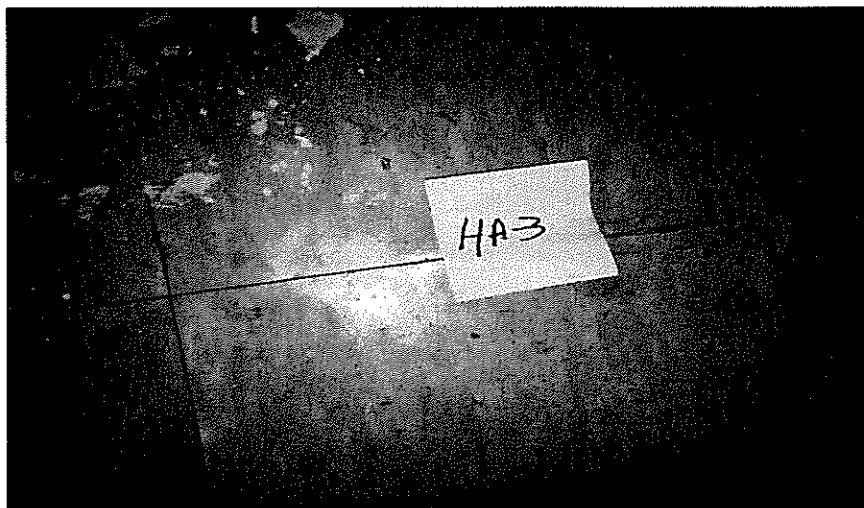
HA #3: 12" x 12" Beige Vinyl Floor Tile

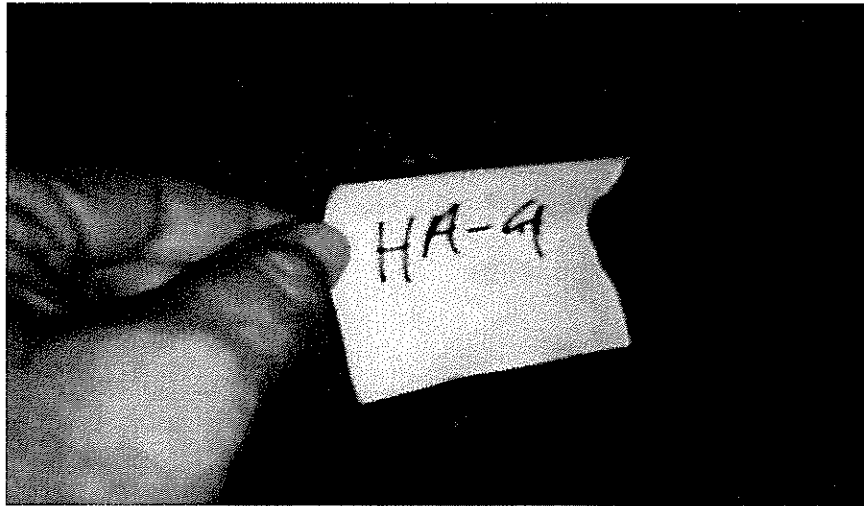
HA #4: Insulation Sleeve on Wood Stove Flue

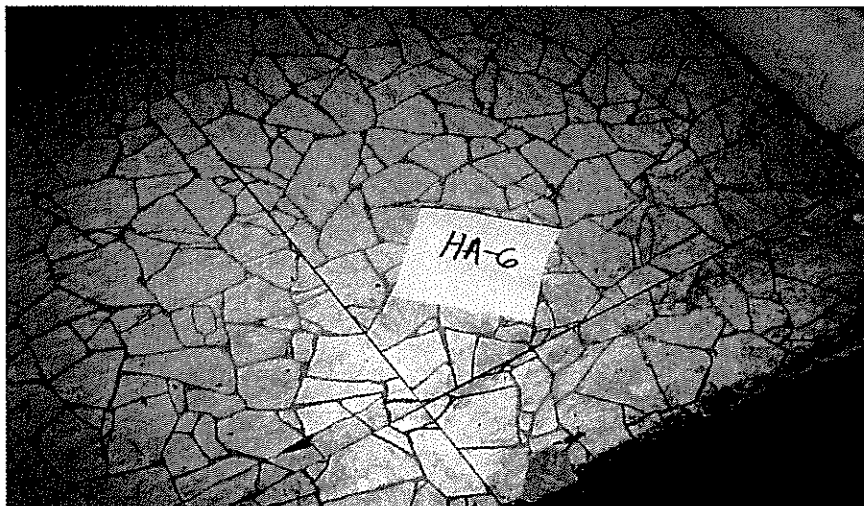
HA #6: 12" x 12" Beige Stone Pattern Vinyl Floor Tile

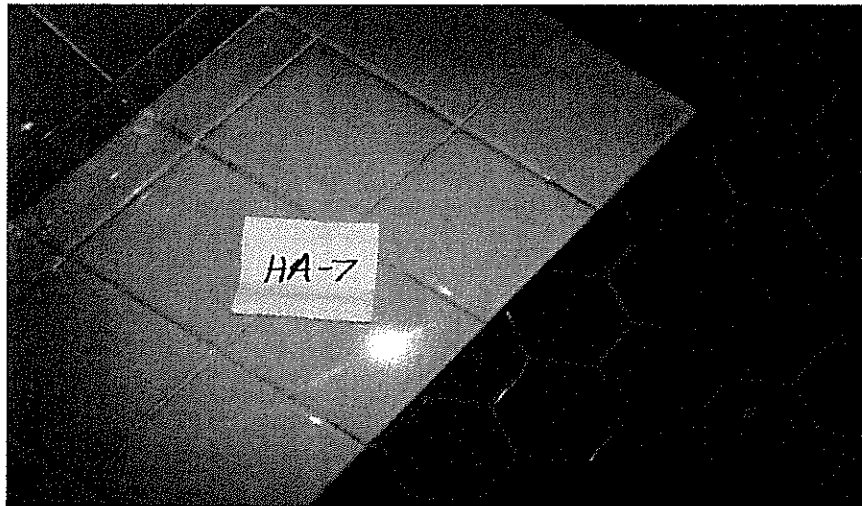
HA #7: Pink Ceramic Floor Tile & Associated Grout

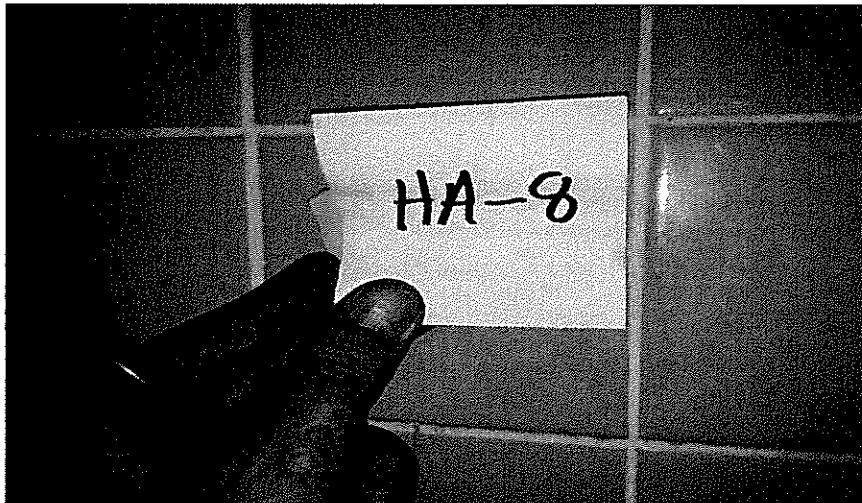
HA #8: 4" x 4" Blue Ceramic Wall Tile & Associated Grout

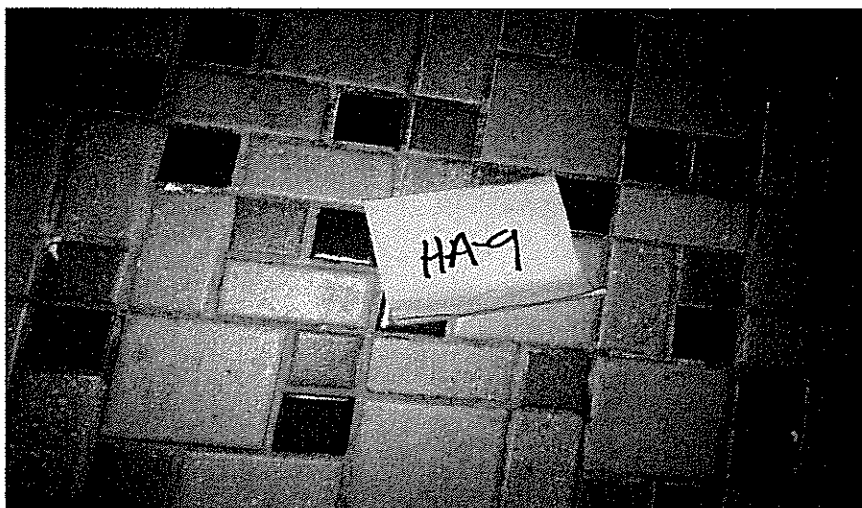
HA #9: 1" x 2" Blue Ceramic Floor Tile & Associated Grout

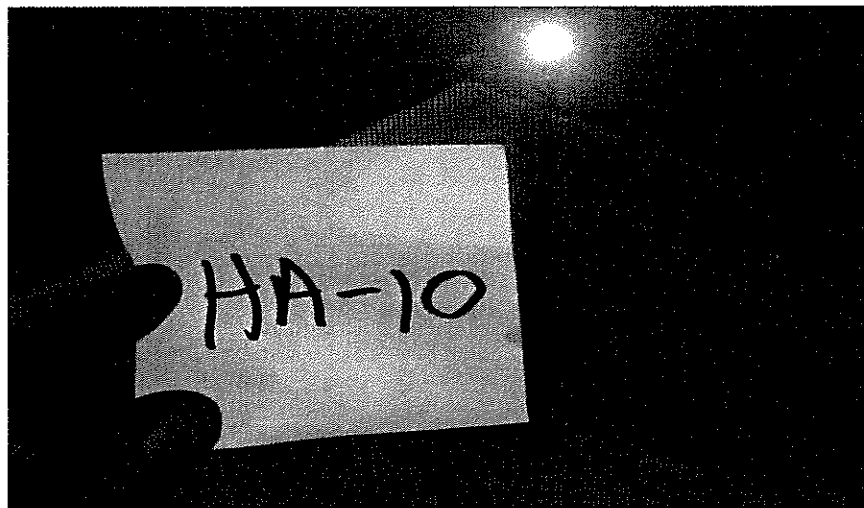
HA #10: Green Asphalt Roof Shingles & Associated Adhesive

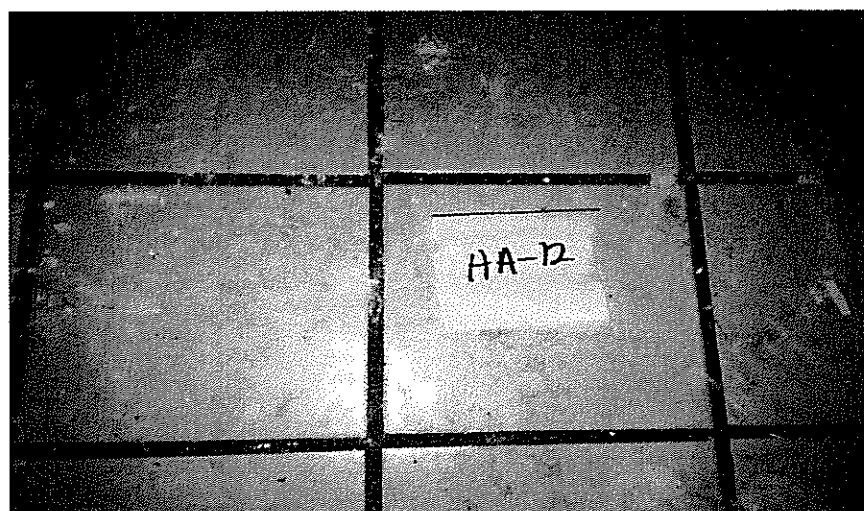
HA #12: 6" x 6" White Ceramic Floor Tile & Associated Grout

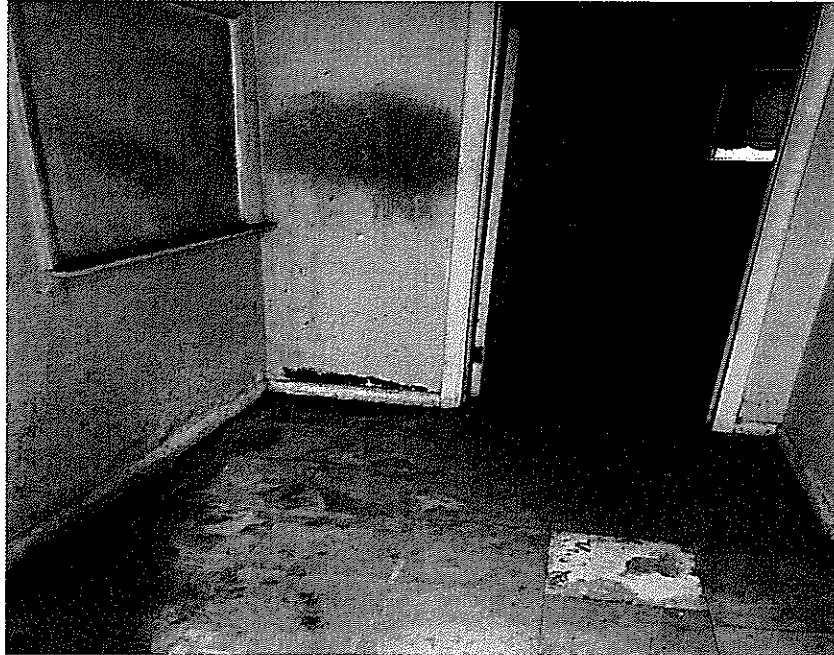
View of visible mold growth on gypsum board sheeting within the basement. In addition, visible water staining and swelling of the vinyl flooring

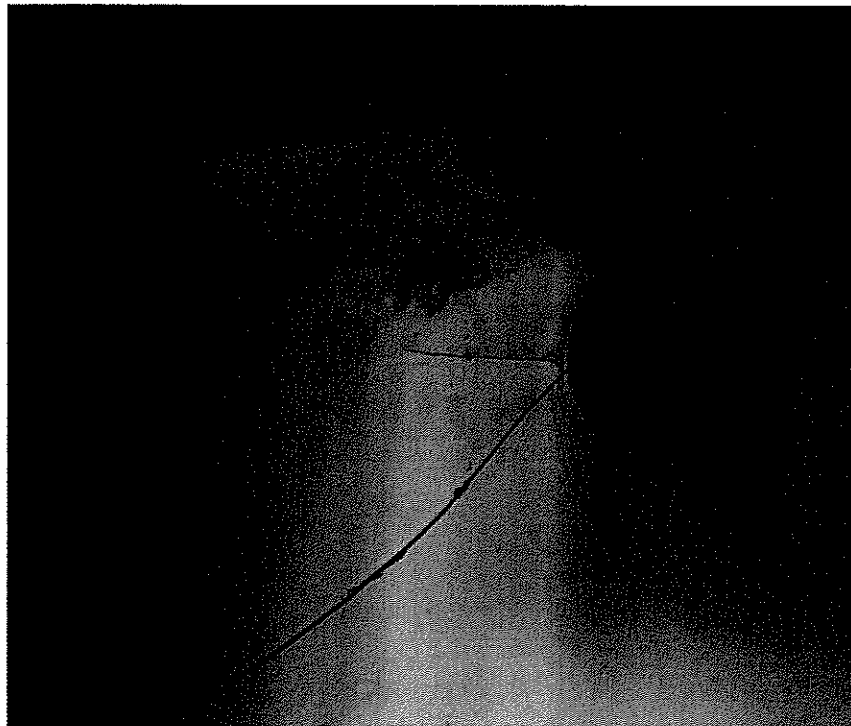
View of visible mold growth on gypsum board sheeting in the basement on the ceiling directly below plumbing on the first floor restroom.

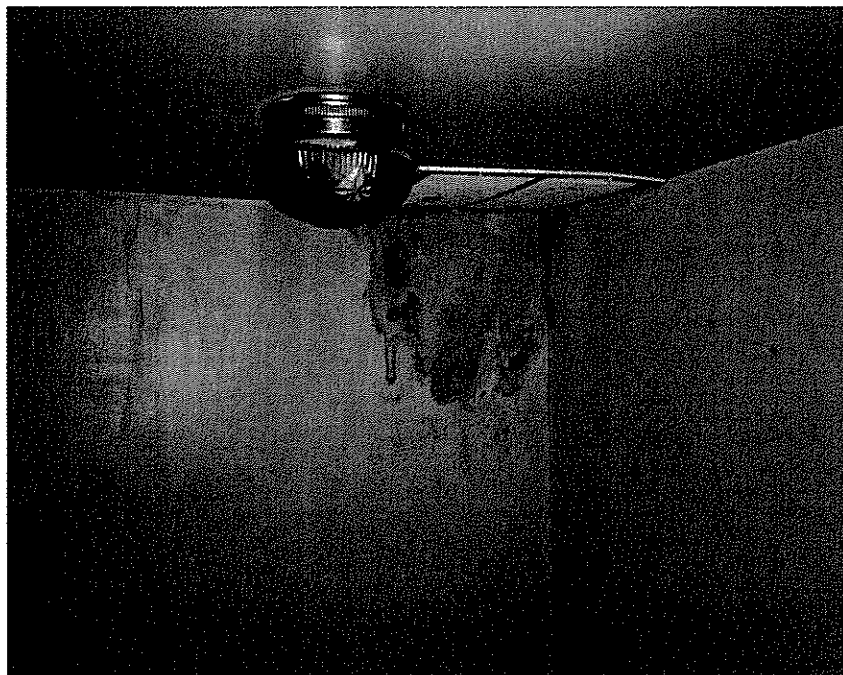
View of surficial mold growth and visible water staining below HVAC return. Based on this condition is can be reasonably assumed conditions promoting microbial growth are present within the HVAC ductwork and enclosed areas.

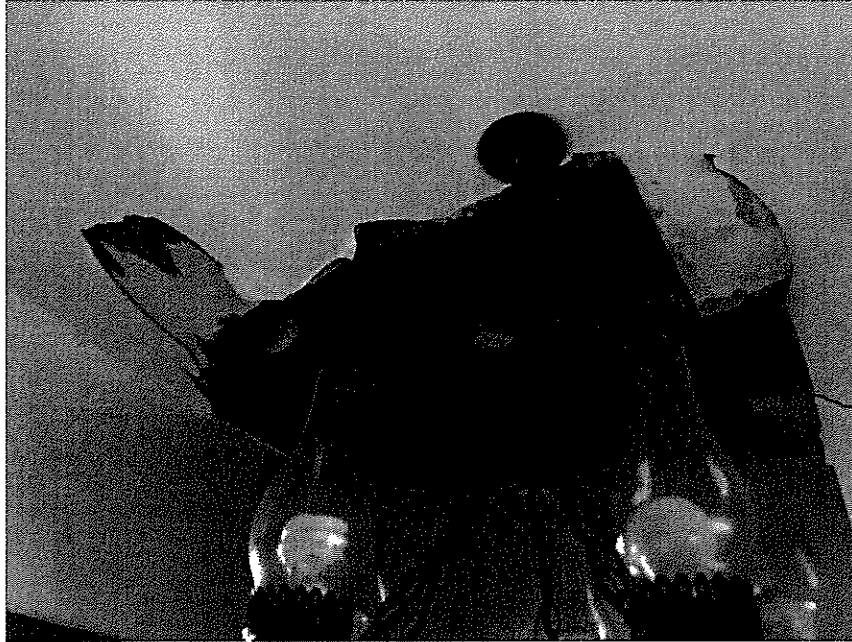
View of visible mold growth directly below second floor bathroom. IT is BEC opinion that the plumbing likely ruptured during the cooler seasons.

1st Floor - Visible mold growth present with kitchen walls & ceiling indicative of water infiltration at second floor bathroom. Mold is present at GBS & framing elements

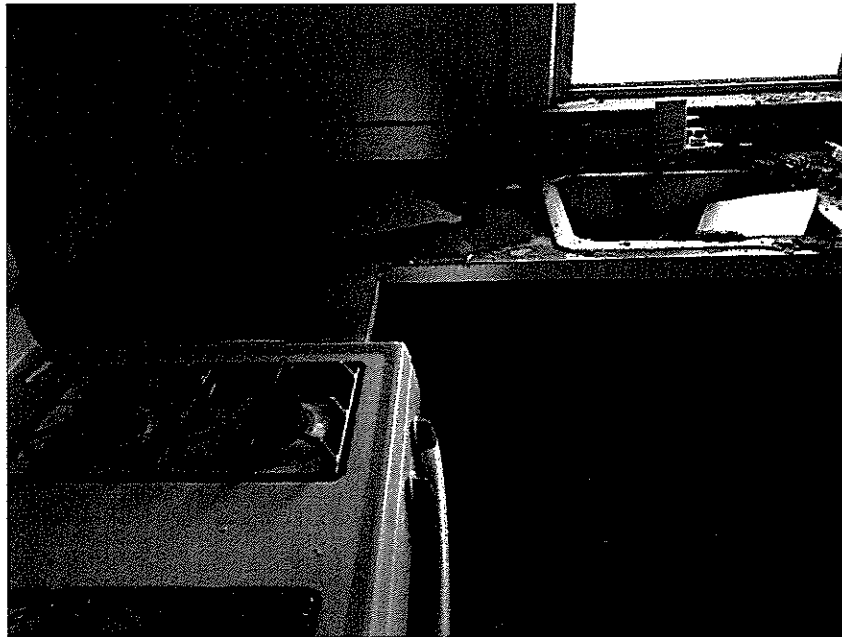
View of water staining and visible mold growth within the kitchen area

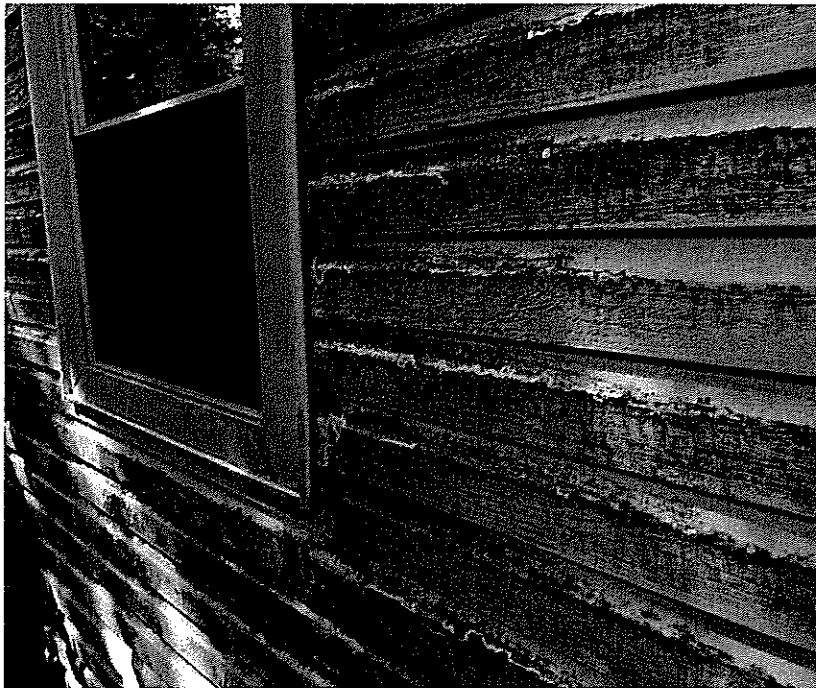
View of visible mold/mildew on the exterior of the subject site

Exterior - Visible mildew & mold growth on vinyl siding, wood is deteriorated where exposed
