EXPEDITED
HISTORIC PRESERVATION COMMISSION STAFF REPORT

Address:	3724 Baltimore St., Takoma Park	Meeting Date:	3/14/18
Resource:	Primary-One Resource Kensington Historic District	Report Date:	3/7/18
Review:	HAWP	Public Notice:	2/28/18
Case Number:	31/06-18C	Tax Credit:	n/a
Applicant:	Adeline Vanderver	Staff:	Dan Bruechert
Proposal:	Accessory Structure Removal

December 15th, 2014

Re: Garage

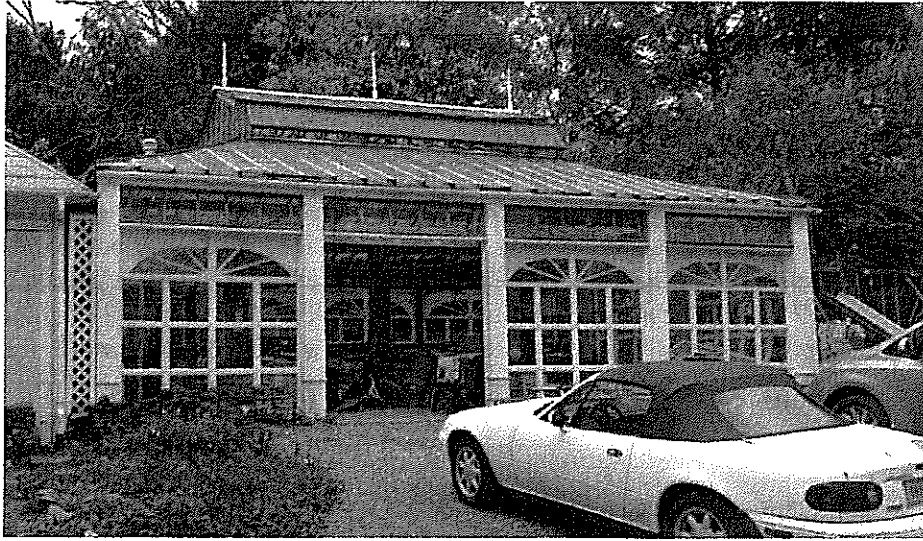
Photo 1
Front of garage

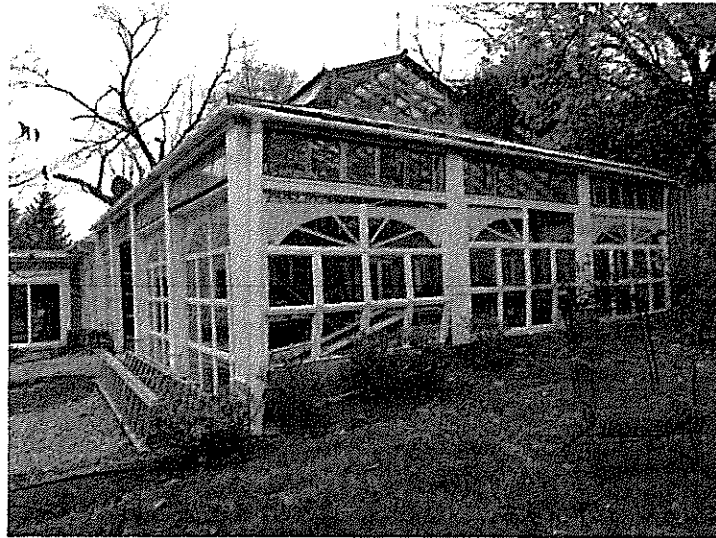
Photo 2
West elevation of garage

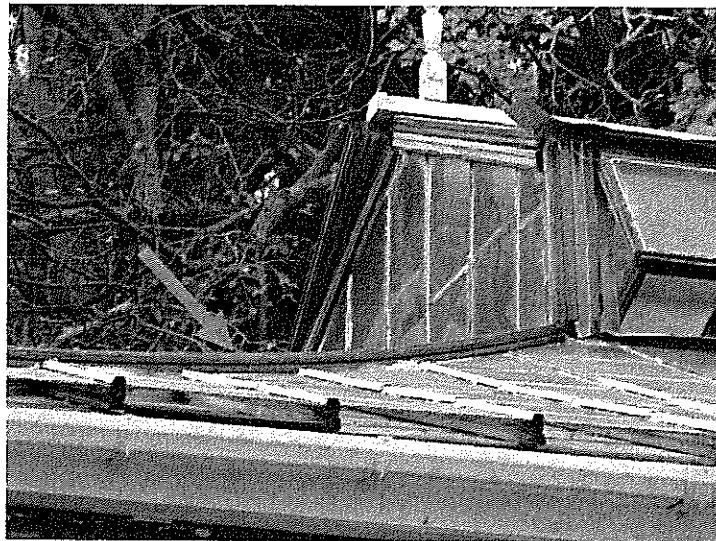
Hip beams are constructed in a similar manner to the rafters except that 3 of the small wood sections are used. All of the hips are exposed to the weather and have sagged significantly and show signs of rot (see photos 4 and 6).

Photo 4
Sagging hip beam

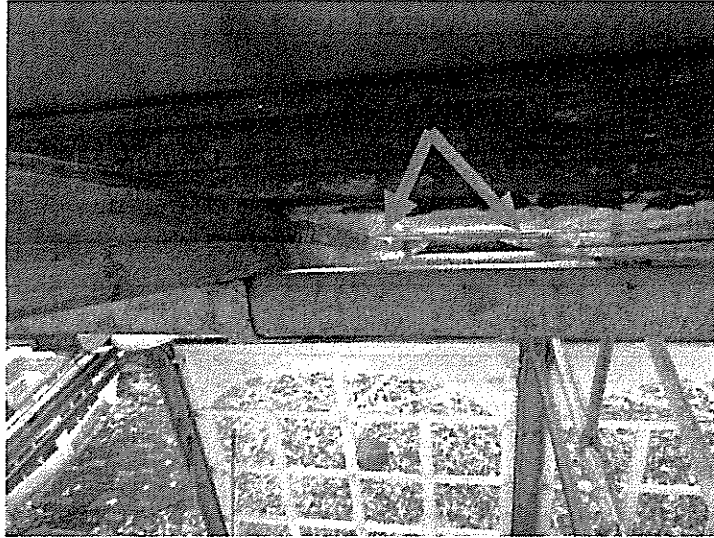
The roof rafters are two 1¾" wide, 2¼" tall wood members set atop one another and spaced 17 inches apart. Each member supports a layer of ¼" thick glass so that there is a sandwich made of two glass panels. The rafters are rabbeted to support the long edges of the glass roofing that sit in between adjacent rafters. It is not known how the glass is held in place. Originally, the tops of the rafters had small lengths of metal flashing that kept rainwater off the wood and out of the glass joint. The majority of those pieces of metal flashing have disappeared (see photo 3) exposing the wood to rainwater and causing rot. Furthermore, the wet conditions have also caused the members to sag (see photo 5).

Photo 5
Sagging rafters

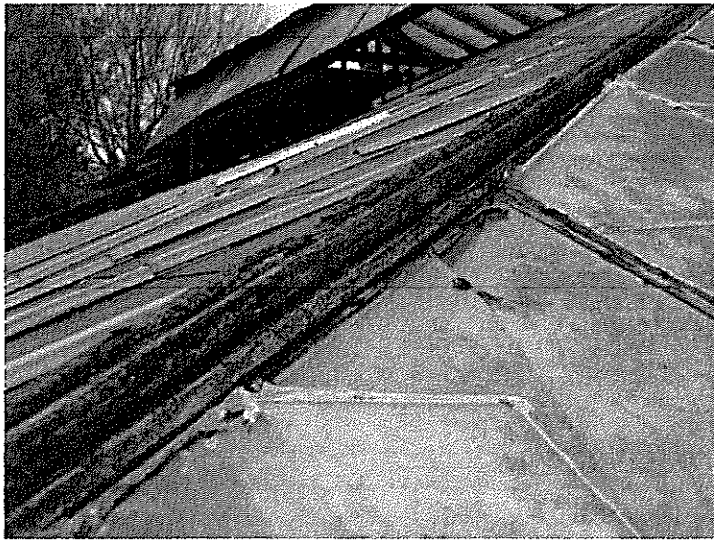
Photo 6
Rotting hip beam

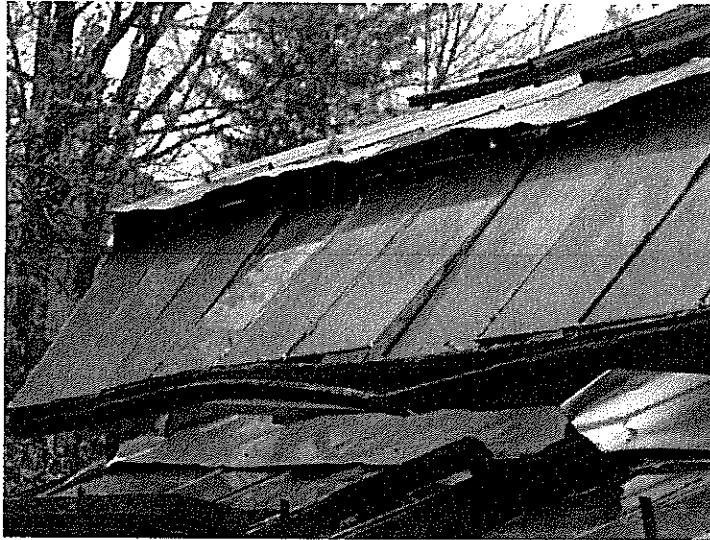
There are front and rear awning windows in the cupola at the top of the roof and the rear one is in an advanced state of decay and ready to lose panes of glass (see photo 7)

Photo 7
Loose glass panes and rotten lumber in awning window

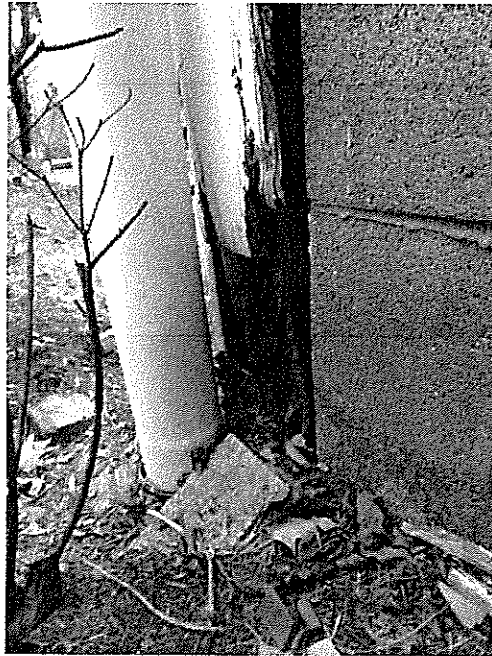
The wood at the northwest corner of the garage has rotted (see photo 8) and two of the three garage doors are rotting and in danger of losing their glass (see photo 9).

Photo 8
Rotten lumber

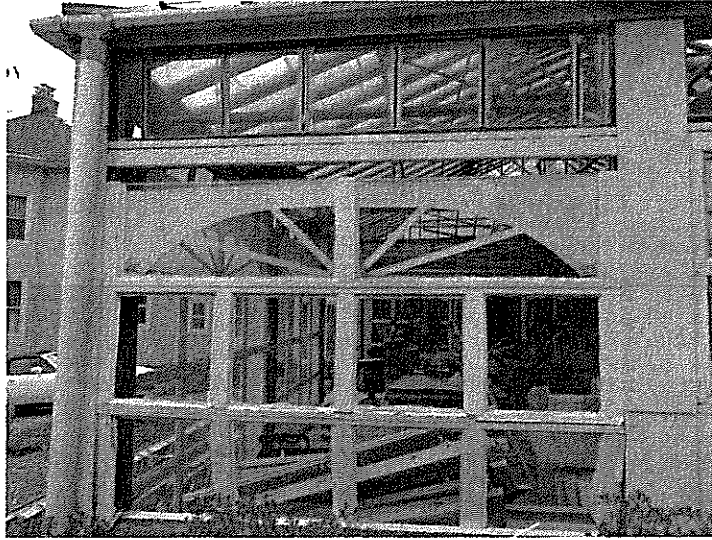
Photo 9
Collapsing wall
