*Preliminary Consultation*  
**MONTGOMERY COUNTY HISTORIC PRESERVATION COMMISSION**  
**STAFF REPORT**

<b>Address:</b>	900 Jessup Blair Dr., Takoma Park	<b>Meeting Date:</b>	6/27/18
<b>Resource:</b>	Individually Listed Master Plan Site <b>The Moorings/Jessup Blair House</b>	<b>Report Date:</b>	6/20/18
<b>Applicant:</b>	M-NCPPC	<b>Public Notice:</b>	6/13/18
<b>Review:</b>	Preliminary Consultation	<b>Staff:</b>	Dan Bruechert
<b>Proposal:</b>	Building Rehabilitation

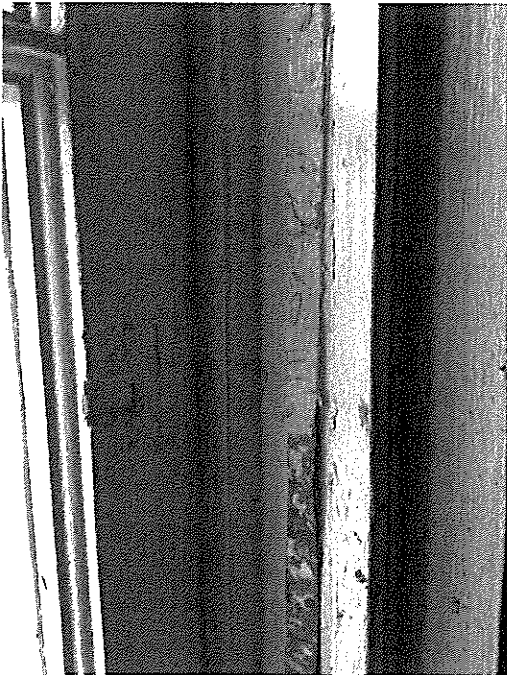
Photo C. 'Strap pulley' window with intact strap and damaged stile

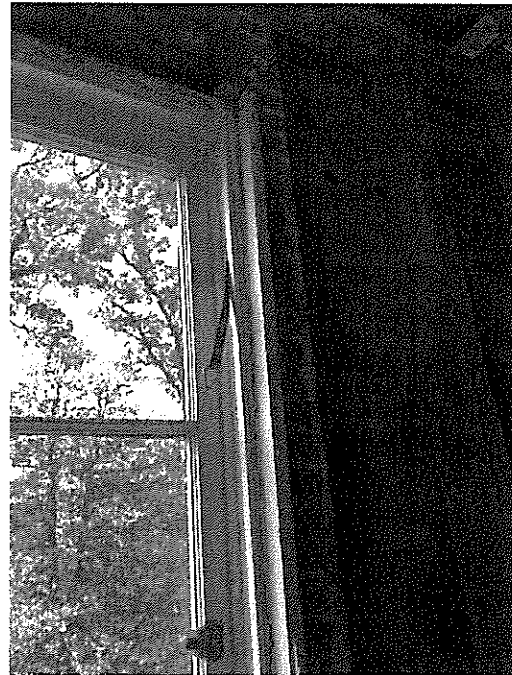
Photo D. 'Strap pulley' window with detached strap

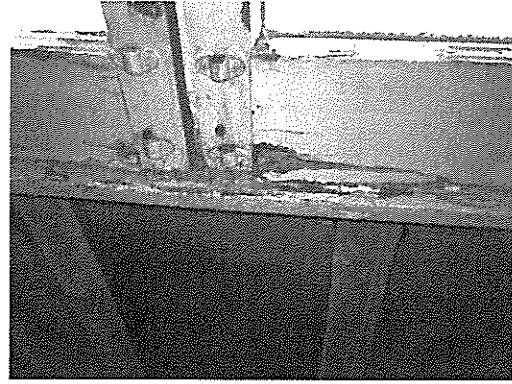
Photo F. Casement window, interior, showing hardware and damage

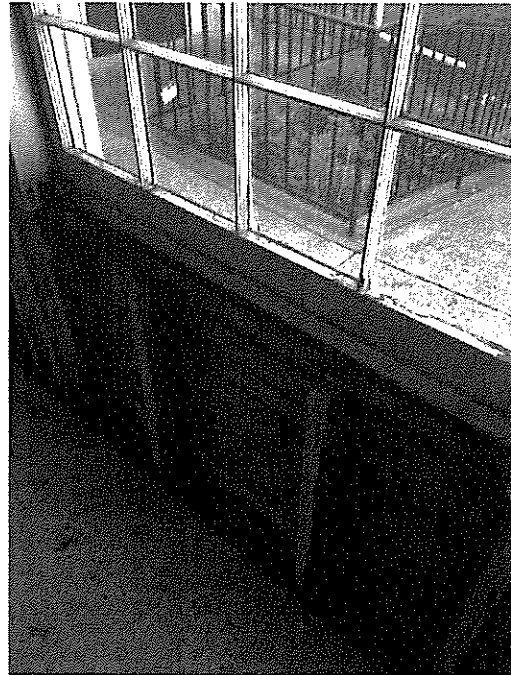
Photo H. Twelve-over-twelve window, replacement bottom rail

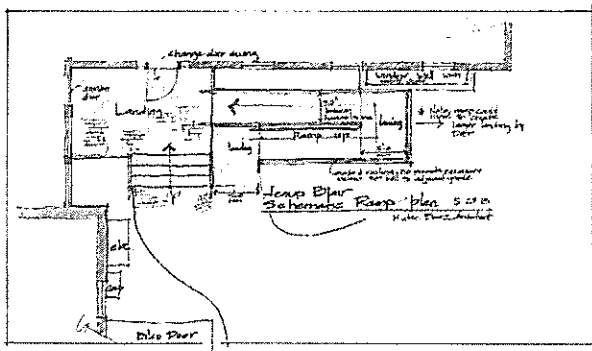
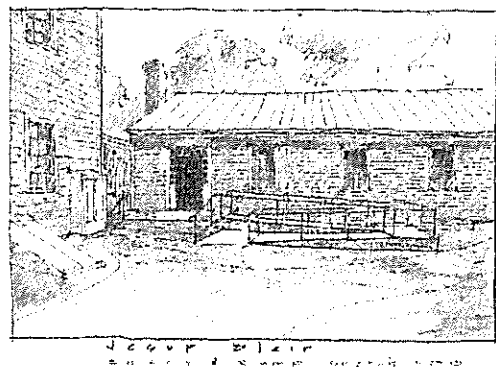
As MNCPPC contemplates a public use for the Moorings, the agency is committed to making the building accessible. The extant ADA ramp does not meet current code requirements. MNCPPC proposes removing the extant ramp and steps and replacing them with a code-compliant ramp and steps. (NOTE: The scheme proposed in the plans has been replaced with the concept schematic ramp plans.) Because this entrance is somewhat removed from public view (it is located opposite the parking lot and away from main pedestrian routes), MNCPPC believes it is important to make the entrance more inviting and obvious. This entrance will provide direct access to the Silver Spring Historical Society's archives, which will be located in the library wing's basement, and the library space, which could become venue for public events, such as lectures, presentations, or events.

The proposed ramp and stairs would invite all visitors to approach the ADA library entrance from the same path. Three stairs rise directly to a slightly enlarged landing, while the ADA ramp switches back parallel to the library wing. The ramp will be faced in brick. The ramp will be forward of the existing window well, such that the ramp will not engage the building and the window well will continue to receive daylight. The ramp, steps, and landing will have metal railings (see example in Section 4), but because the height above grade may not trigger life-safety codes requirements, spindles may not be needed, thereby lessening the ramps visual impact. The door swing will be reversed, for access purposes.

*MNCPPC seeks the HPC's affirmation that proposed accessible entrance, including reversing the door swing, is consistent with the HPC's criteria for approval.*

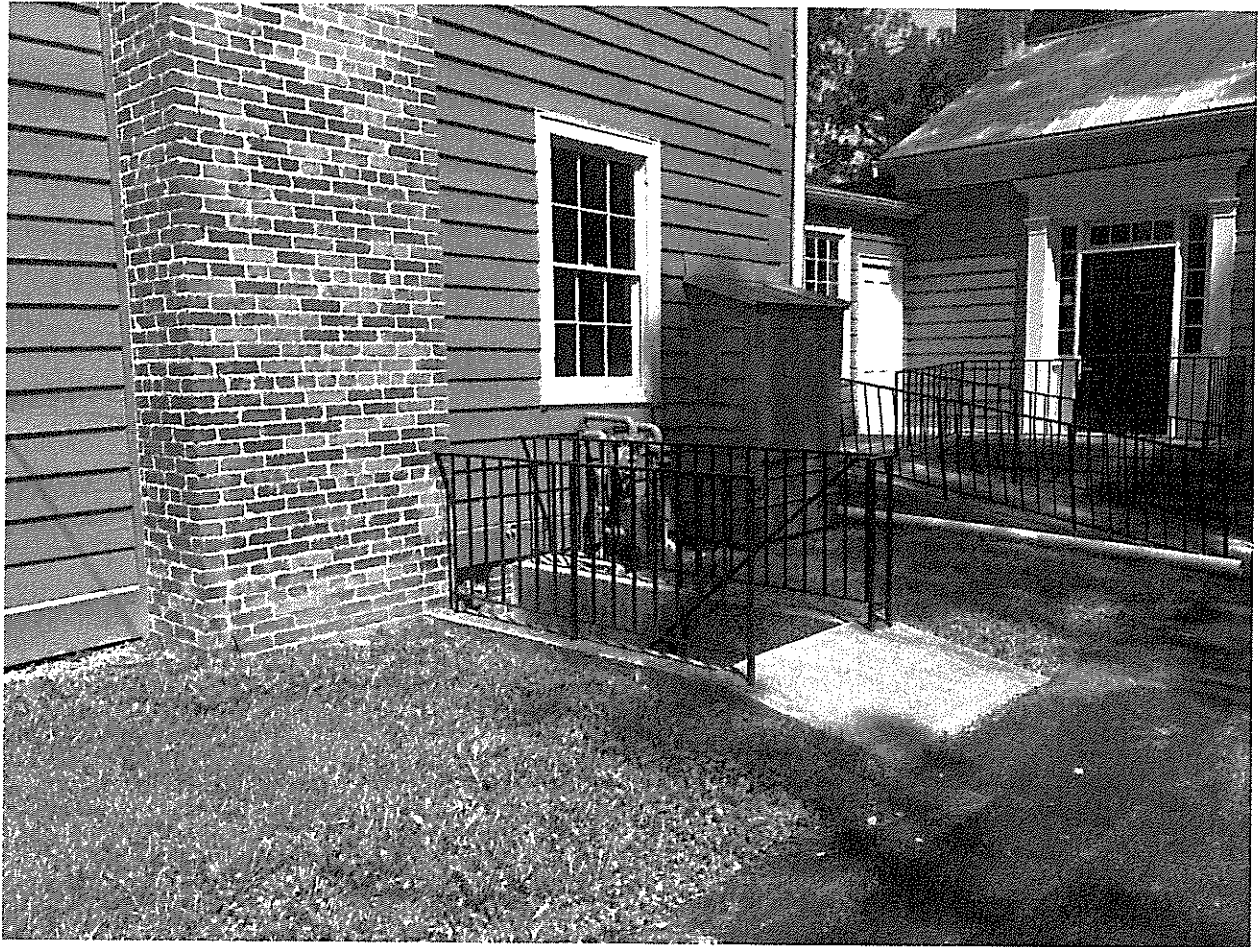
**Cover Areaway:** An existing areaway that provides access to the basement under the main mass of the house creates maintenance and security issues, as well as provides an opportunity for significant water infiltration in the basement. The areaway provides necessary external access to mechanical systems in the basement and needs to be retained. MNCPPC proposes securing the areaway with a metal, Bilco-type cover (see example in Section 4). The existing railings would be removed. The gas meter, a cabinet housing the electrical equipment, and the existing handicap ramp are clustered on the side (south) elevation, nearby the existing areaway, so the introduction of a cover over the areaway will not be the first alteration in the area. Relocation of the utilities *is not* contemplated, due to cost and complexity involved.

Areaway at side (south) elevation, library ADA entrance at right. Note gas meter and electrical cabinet.

*MNCPPC seeks confirmation that a metal areaway cover of some sort is consistent with the HPC's criteria for approval.*

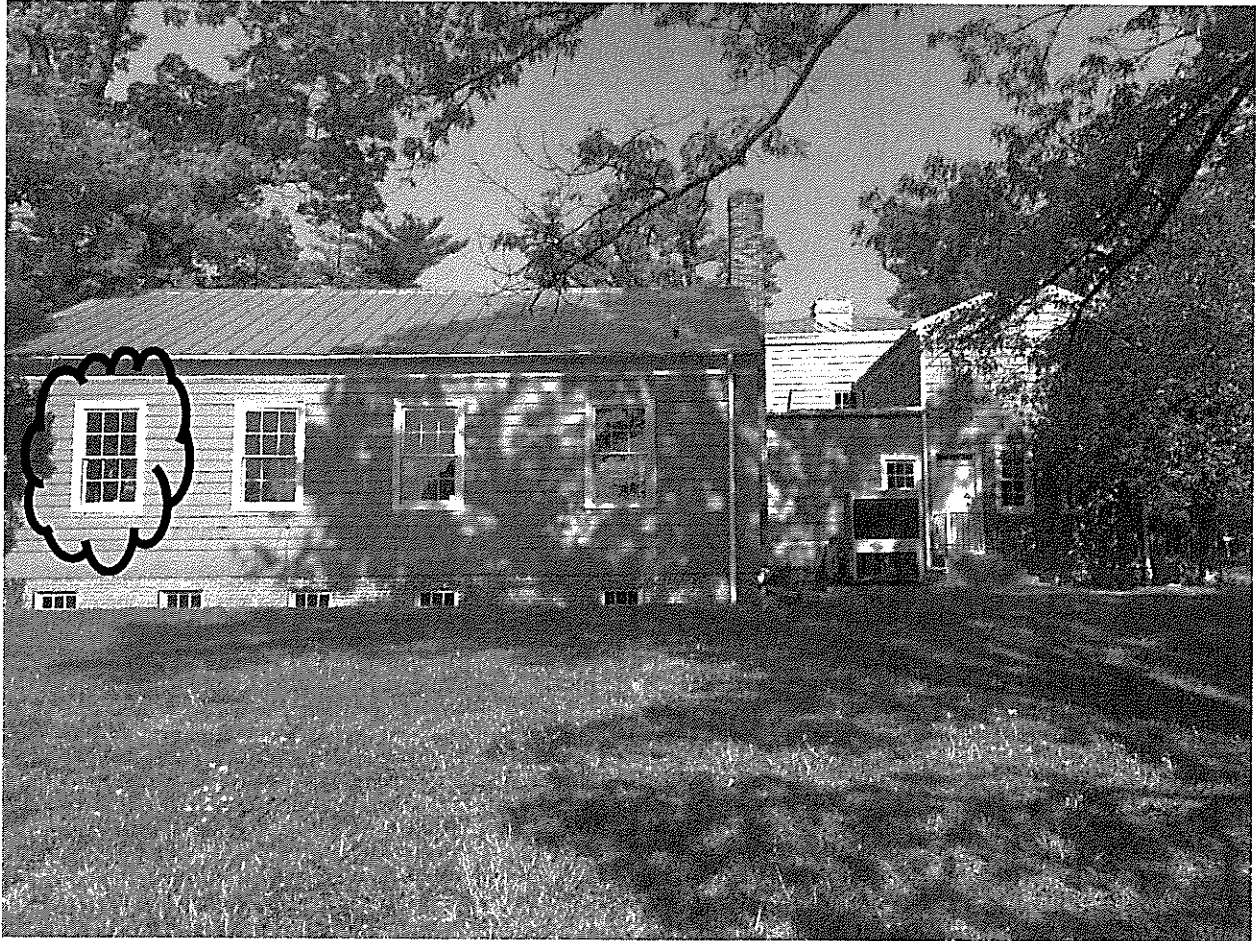
**Add Egress Door:** Due to the change in use and the square footage of the existing library addition, the code requires a second means of egress from the room. MNCPPC proposes converting a window in the rear (east) elevation to a door, accessed via a small wooden landing and steps. The door would be inserted in the location of the existing window. This is a secondary elevation in a later addition.

Proposed location of new egress door, east elevation of library wing (above), and illustrating context and visibility within Jesup Blair Park (right) (Illustration: googlemaps)

*MNCPPC seeks the HPC's guidance on the proposal to convert this window to a door in order to meet secondary egress requirements related to the building's change of use.*

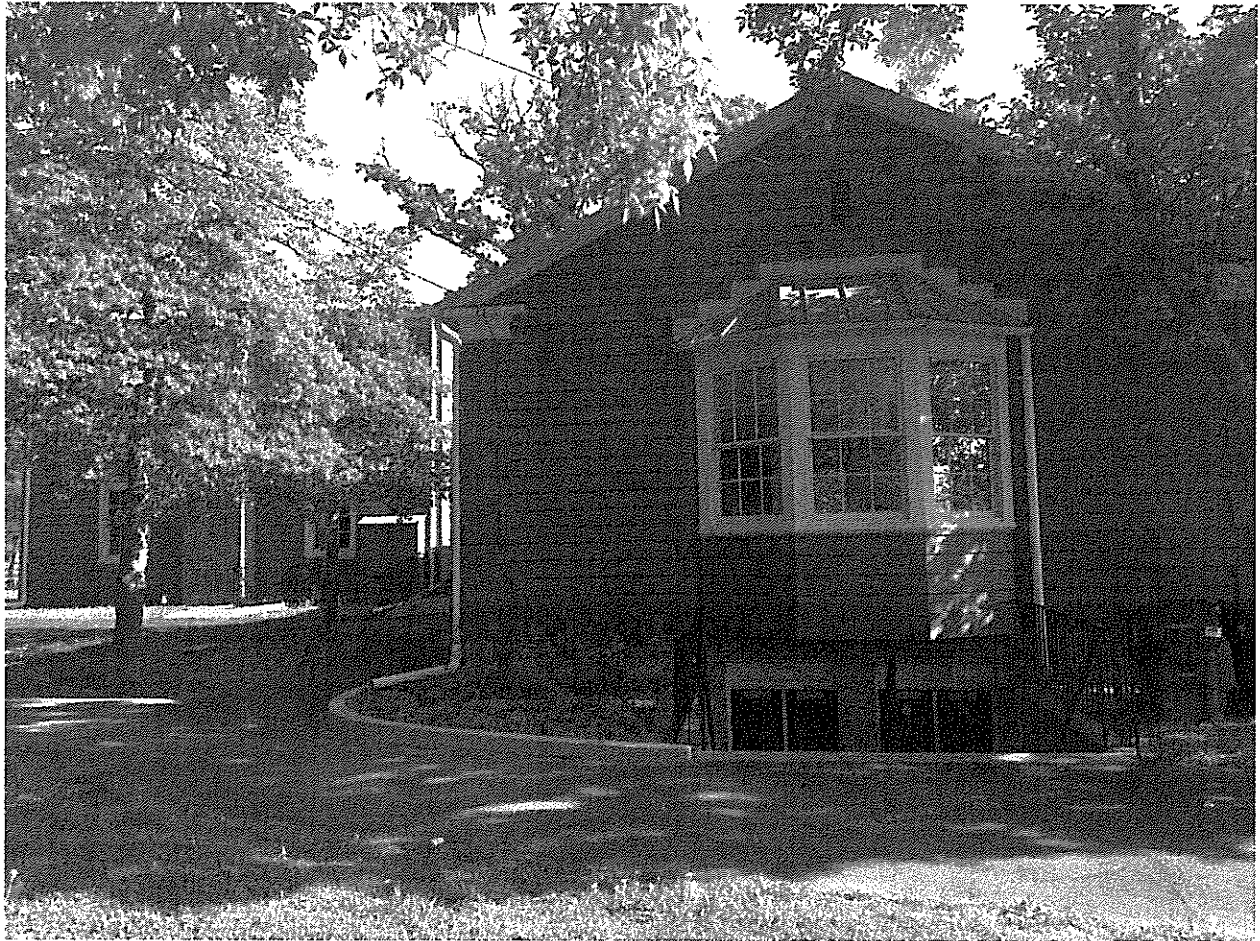
**Abandon Areaway:** An areaway providing access to the library wing basement creates maintenance and safety problems and provides an opportunity for significant water infiltration in the basement. MNCPPC proposes abandoning this areaway. The stairs would be removed, backfilled, graded to provide positive drainage, and landscaped like the adjacent planning bed. Access to the library wing basement would be via a new, internal stair.

Areaway providing access to library wing basement.

*MNCPPC seeks confirmation that abandoning this areaway is consistent with the HPC's criteria for approval.*

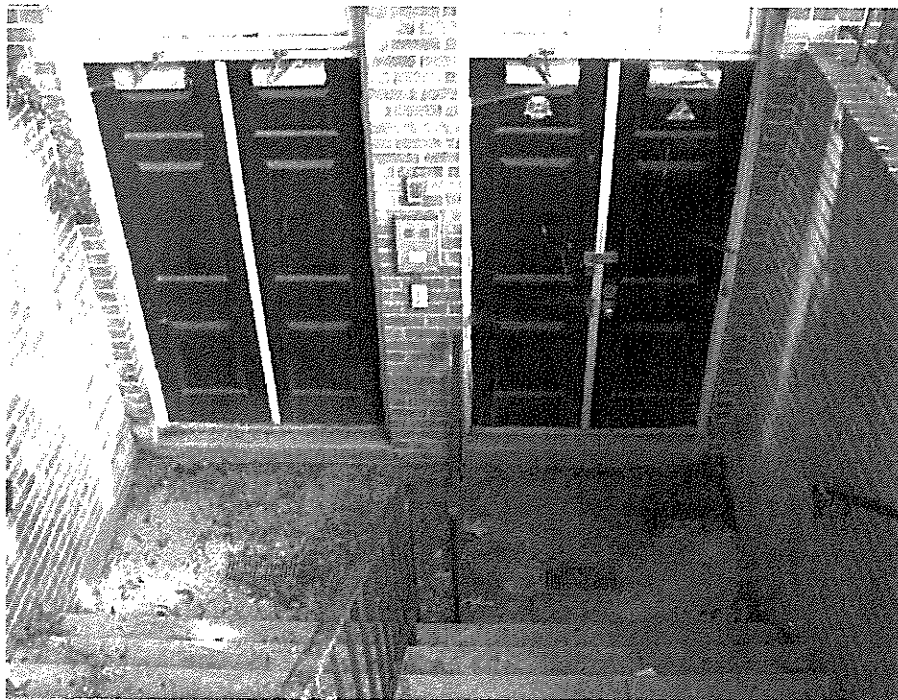
**Photograph 8**  
**Open Exterior Stair to Library Wing Basement**

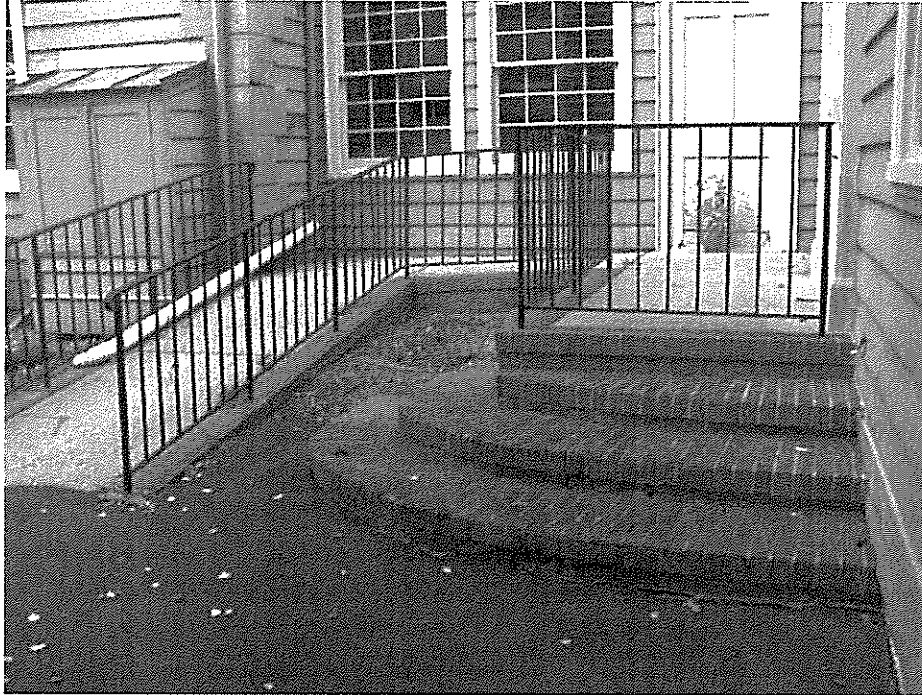
**Photograph 9**  
**Porch, Stairway & Ramp at Library Connector & Library Wing Entrance**
