# APPLICATION FOR HISTORIC AREA WORK PERMIT

House Number: 10500 & 10520 Street: ST. PAUL STREET  
Town/City: KENSINGTON Nearest Cross Street: METROPOLITAN AVE  
Lot: P6 Block: \_\_\_\_\_ Subdivision: \_\_\_\_\_  
Liber: \_\_\_\_\_ Folio: \_\_\_\_\_ Parcel: \_\_\_\_\_

## **INTRODUCTION**

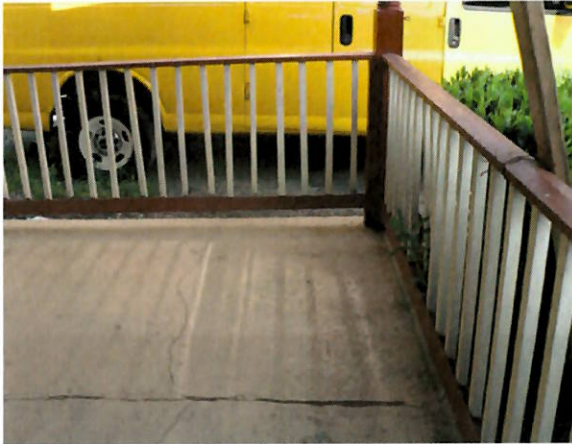
FIGURE 17 Crack in concrete slab; non-original wood balusters and banister.

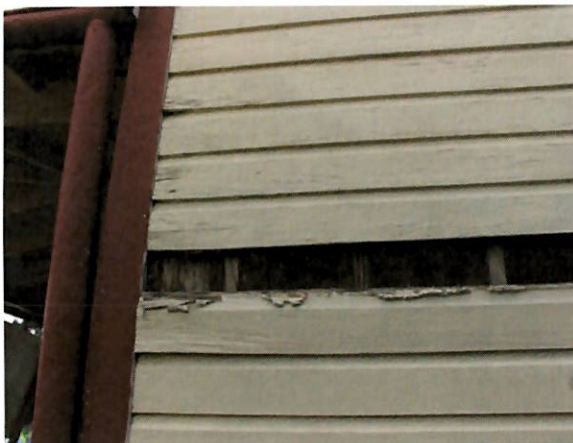
FIGURE 31 Missing German lap siding that reveals the extant vertical siding.

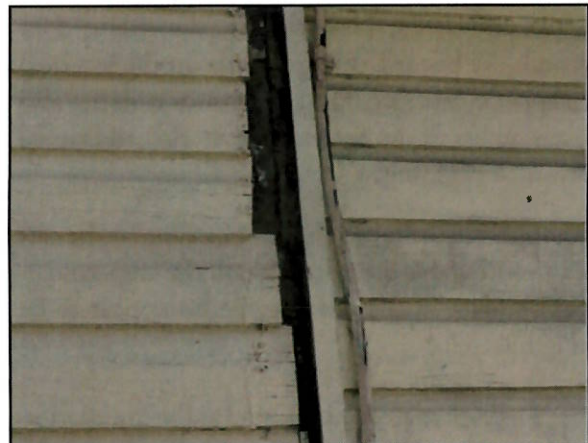
FIGURE 34 Missing portion of wood siding, exposed framing, north elevation.

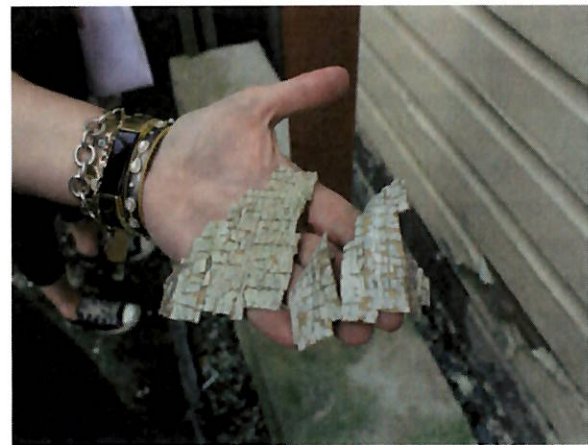
FIGURE 33 Flaking paint.

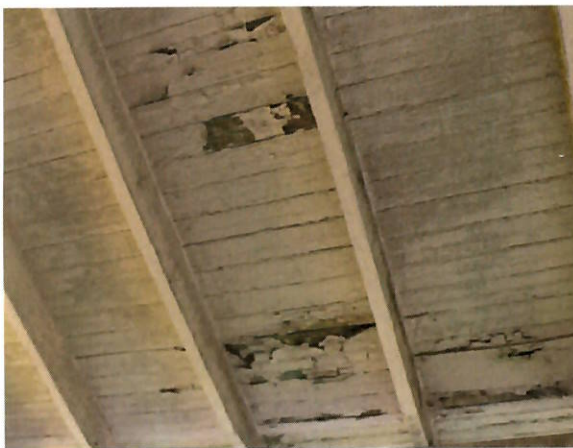
The porch roof joists appeared to be in good condition; however, the member sizes and framing configuration do not appear to be adequate for current code drifting snow loads and wind uplift forces.

FIGURE 39 Deteriorated porch ceiling.

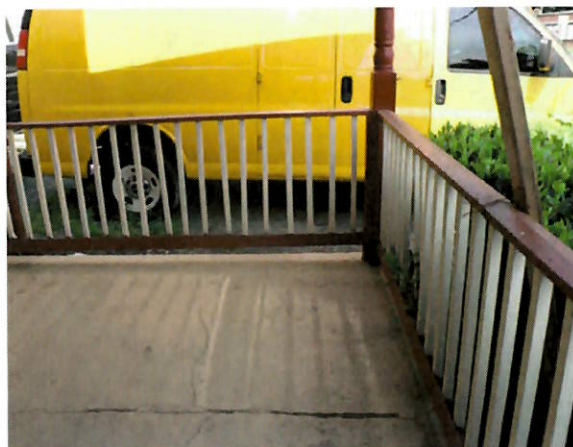
*Concrete* - Contemporary concrete at the rear west elevation is generally in fair condition. The original concrete at the front porch, however, is in fair to poor condition showing signs of cracking and settlement.

FIGURE 41 Cracks in concrete slab.

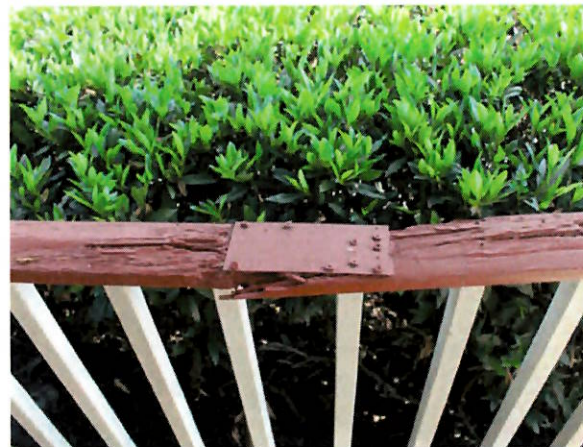
FIGURE 42 Splintered banister (non-original).

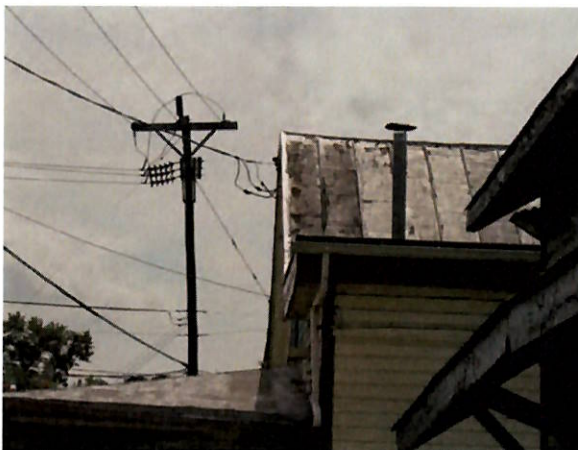
A standing seam metal roof remains extant on the building. The roof appears generally worn and past its useful life. Water infiltration on the interior suggests damage and deterioration. The wings are covered in membrane roofing which was recently added on top of what was likely a standing seam metal roof. The rear roof slope and new addition are covered in contemporary metal roofing.

FIGURE 43 Rust and deterioration of metal sheathing visible on center gable.

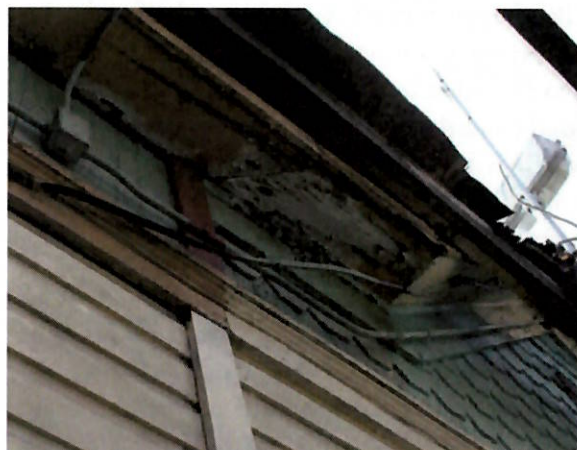
FIGURE 44 Deteriorated eave condition.

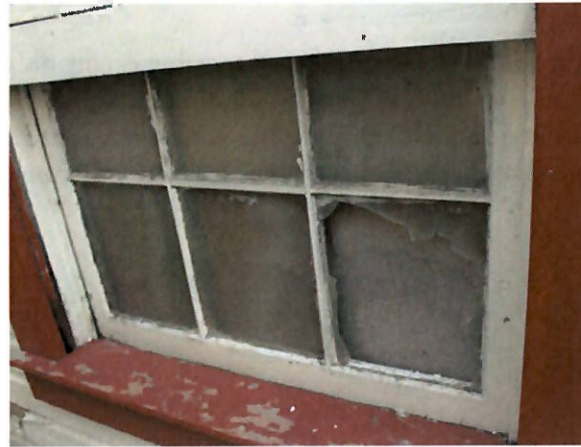
FIGURE 47 Broken glazing.

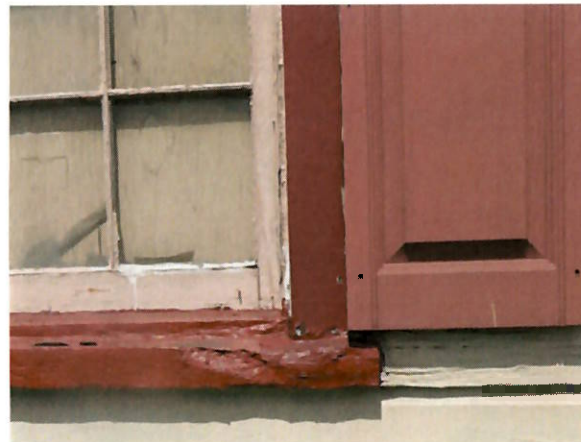
Most of the windows are not original; however, many of the window frames and sills appear to be original. Exterior trim around those openings appears to have been replaced, likely when the siding was replaced.

FIGURE 48 Sill deterioration.

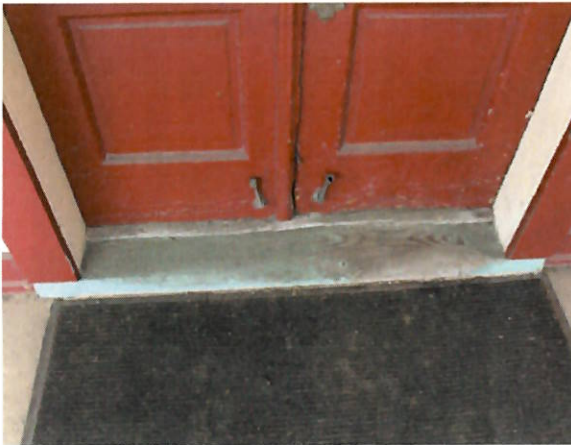
The main entry door is worn and is in fair to poor condition but is operable. The bottom rails have worn unevenly. The bead or astragal has worn and chipped. The wood threshold is also worn and very uneven. The frame appears to be original, though given the multiple layers of wood cladding, the wood trim and exterior surround appear to be replacements.

FIGURE 56 Wood threshold.

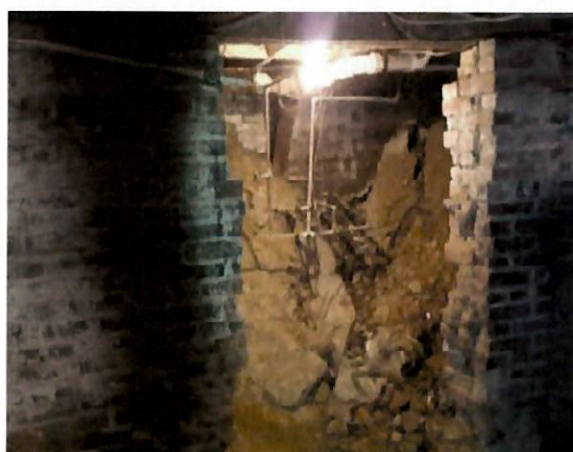
FIGURE 58 Opening in section of foundation wall. Structura, Inc., 2018.

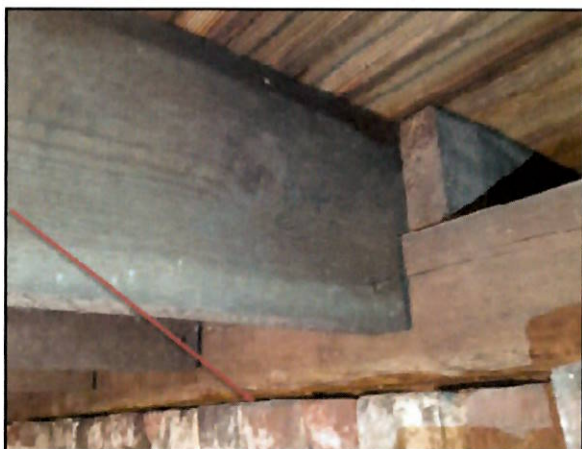
The first floor framing general consists of wood joists supported on the existing foundation walls. The sill plates are not fully bearing on the foundation wall. A significant amount of the floor framing

FIGURE 59 Sill plate not fully bearing on foundation wall. Structura, Inc., 2018.

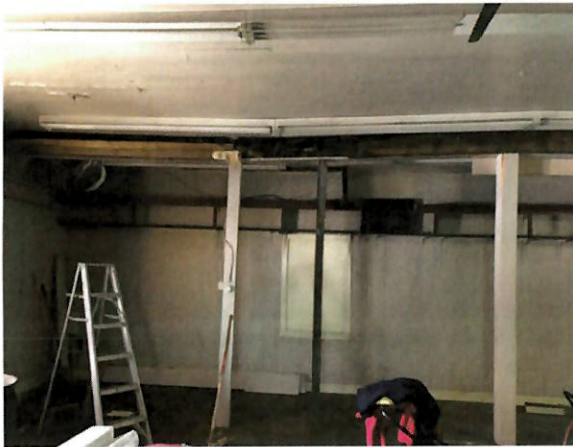
FIGURE 61 Deteriorated wood beam and interior columns.  
Structura, Inc., 2019.

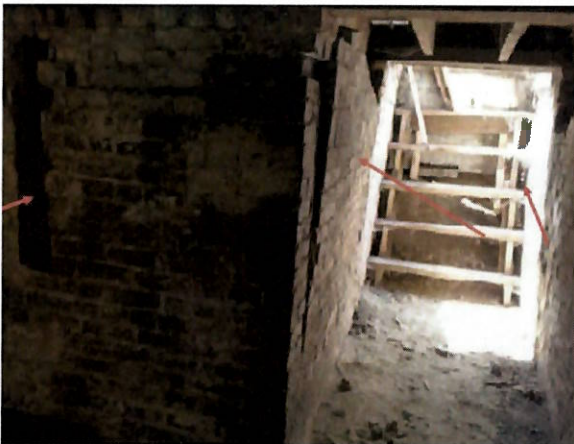
In early 2019, Structura excavated a test pit on the south side of the building. The test pit revealed that there was no footing below the foundation wall. The bottom of the foundation wall was measured to be approximately 32 inches below grade.

FIGURE 63 Laterally displaced foundation wall, undermined footing below access hatch and stair, and previous foundation wall retrofit. Structura, Inc., 2018.

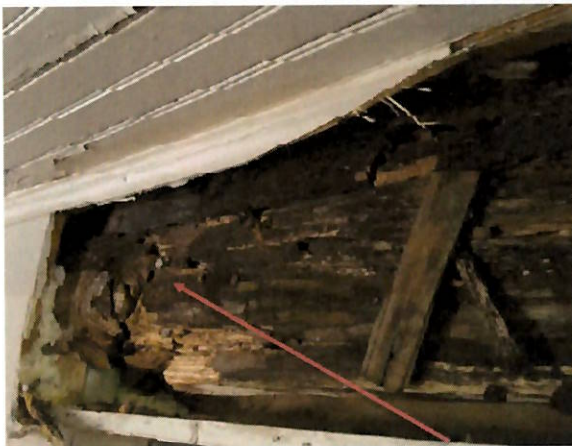
FIGURE 66 Severely deteriorated support beam. Structura, Inc., 2018.

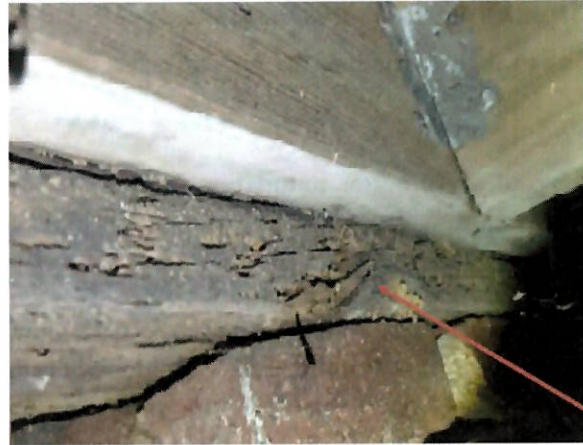
FIGURE 67 Replacement wood joist framing. Wood ledge connected to original wood sill plate that exhibits insect damage. Joist and ledger are not adequately connected. Structura, Inc., 2018.

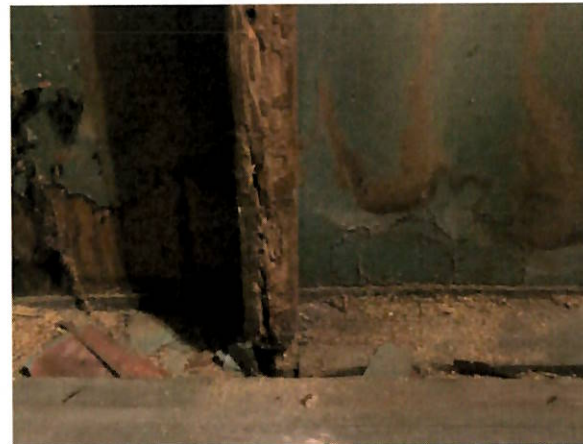
FIGURE 65 Termite damage visible in wall framing. Structura, Inc., 2019

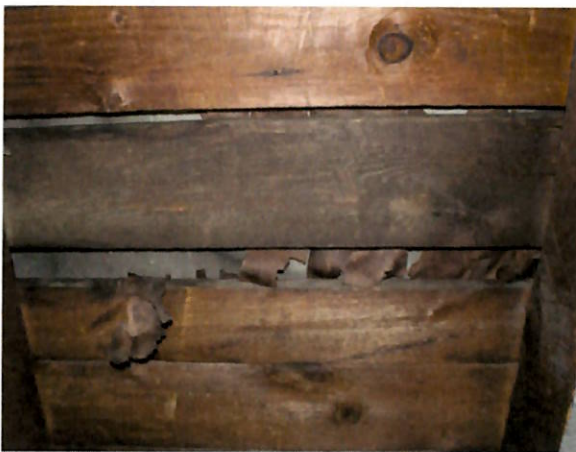
FIGURE 68 Deteriorated roof sheathing.

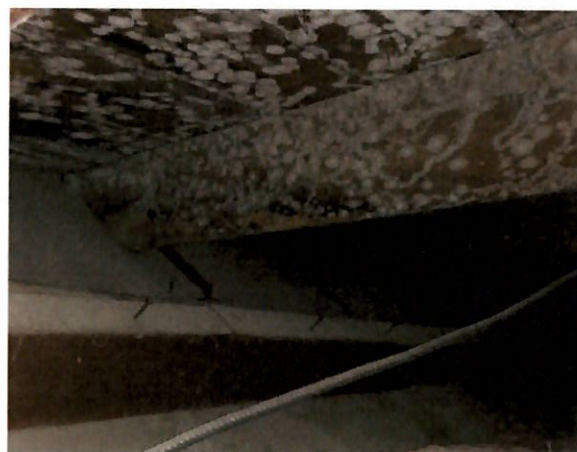
The north wing roof framing is supported by the exterior wood stud wall and what appears to be the original exterior wall that remained in place after the north wing was added. A significant amount of mold was observed on the underside of the north wing roof framing.

FIGURE 69 Termite damage and mold on the underside of north wing roof framing. Structura, Inc., 2019.

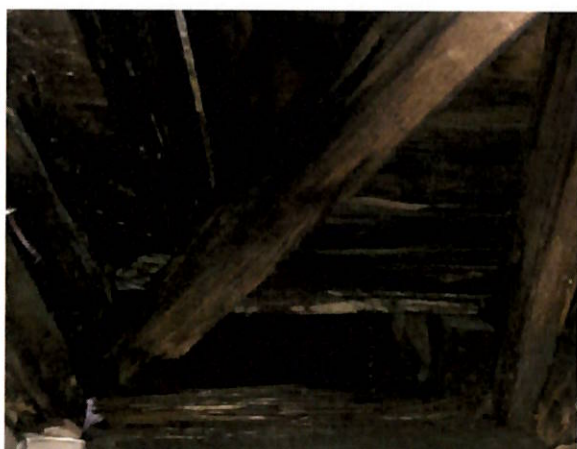
FIGURE 71 Deteriorated roof framing. Structura, Inc., 2019.
