CONDITION ASSESSMENT REPORT

EXPLORATORY WORK FIELD NOTES

HISTORIC PRESERVATION REPORT

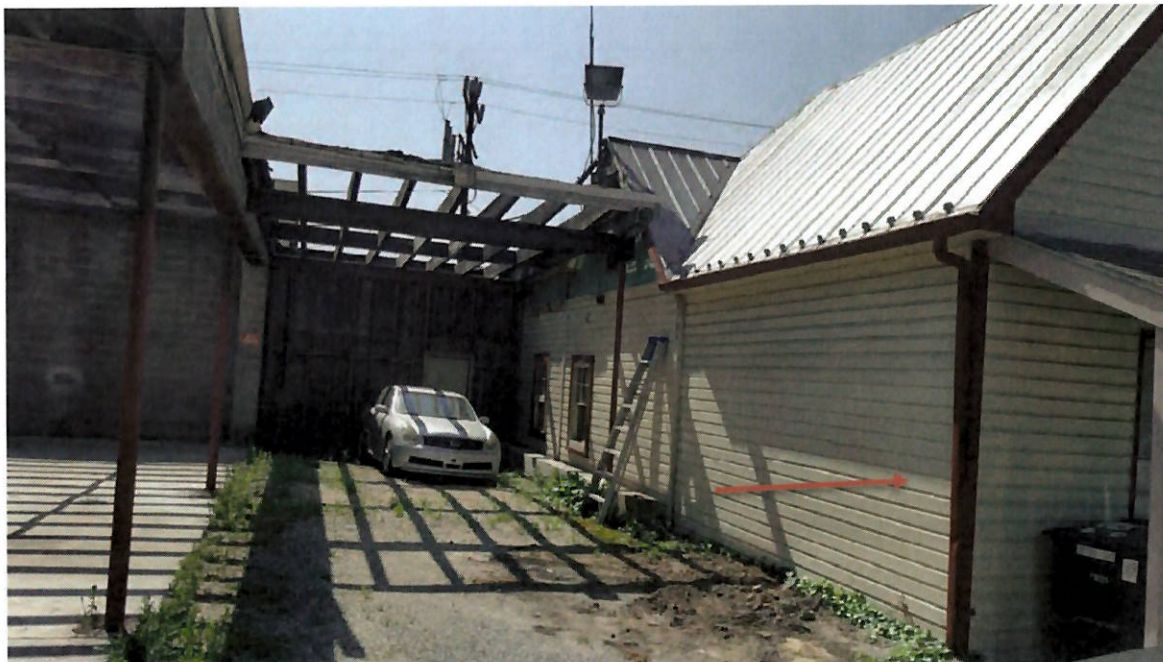
3. West Elevation (Note addition built in 1980s)

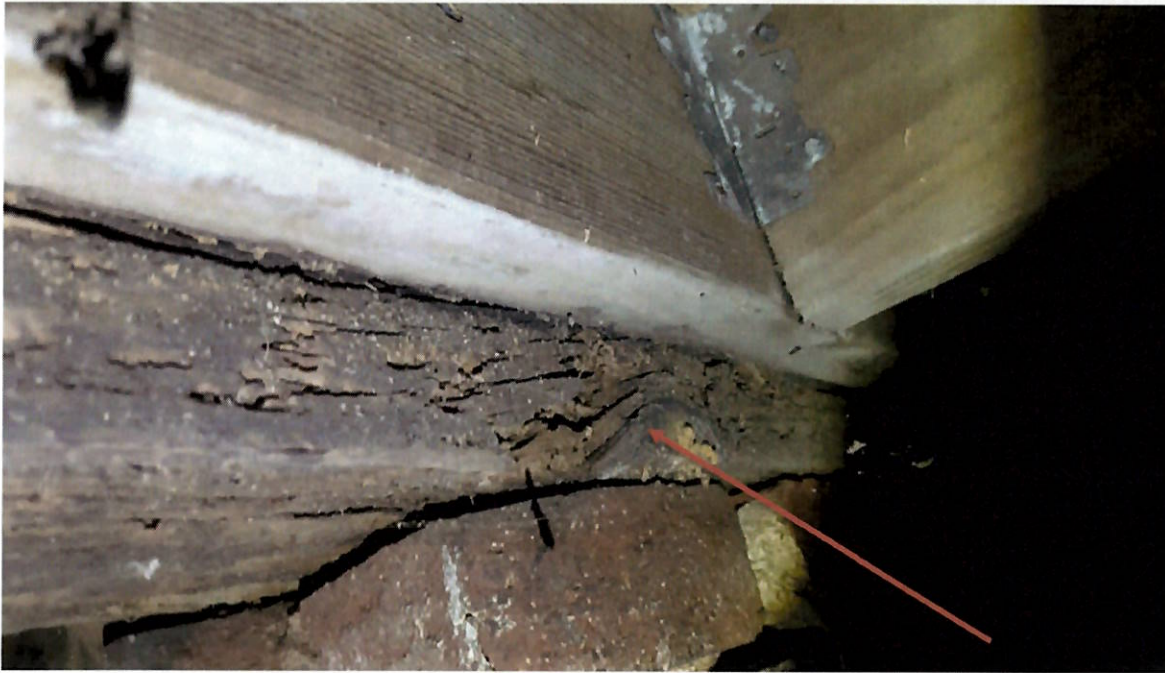
8. Existing wood joists with moisture and insect damage. In addition, note deteriorated masonry foundation wall and mortar joints.

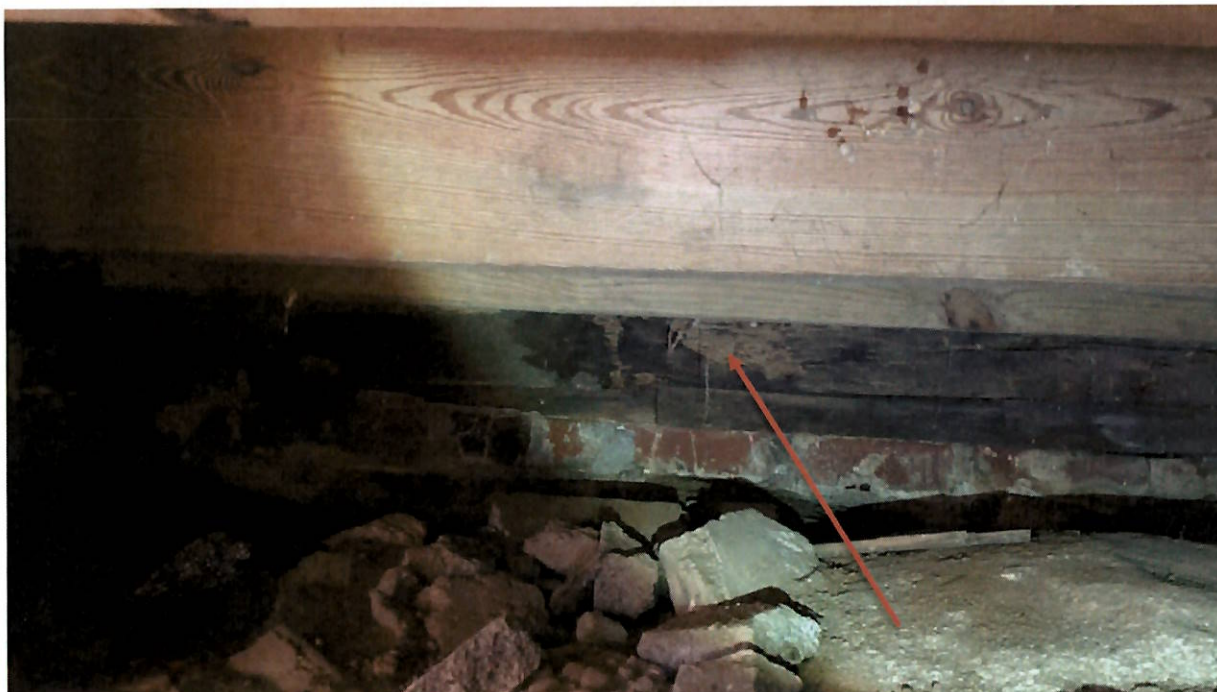
11. Original band joist still in place appears to have been damaged by wood destroying insects.

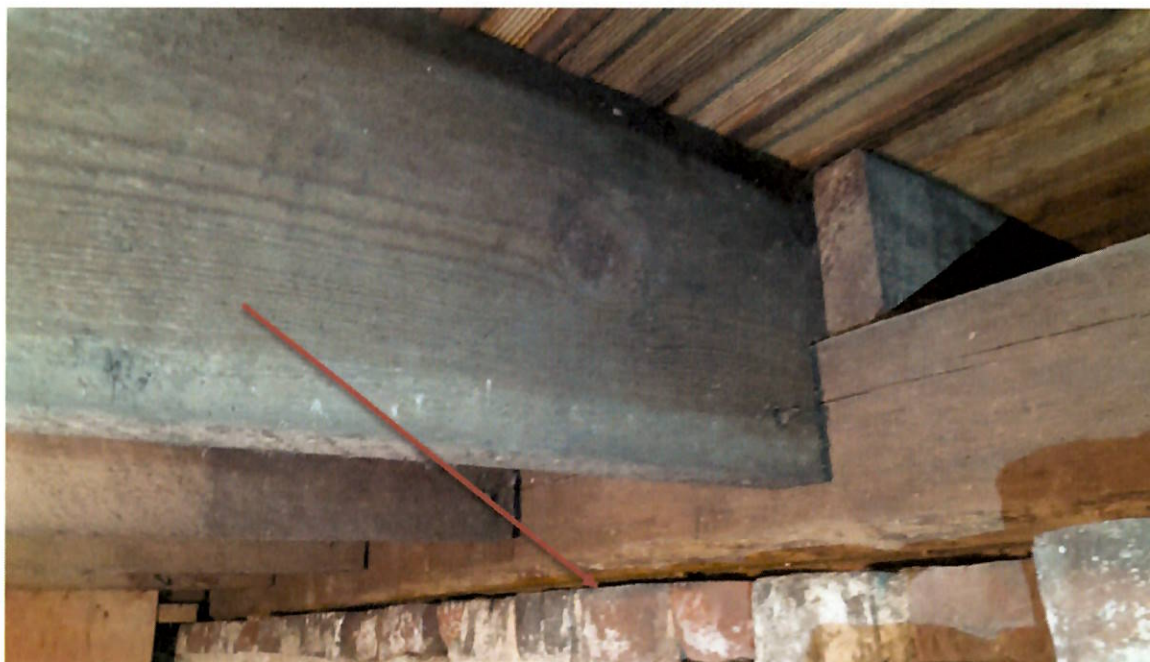
12. Replacement wood joists. Note existing joist remaining that appears to have damage from wood destroying insects.

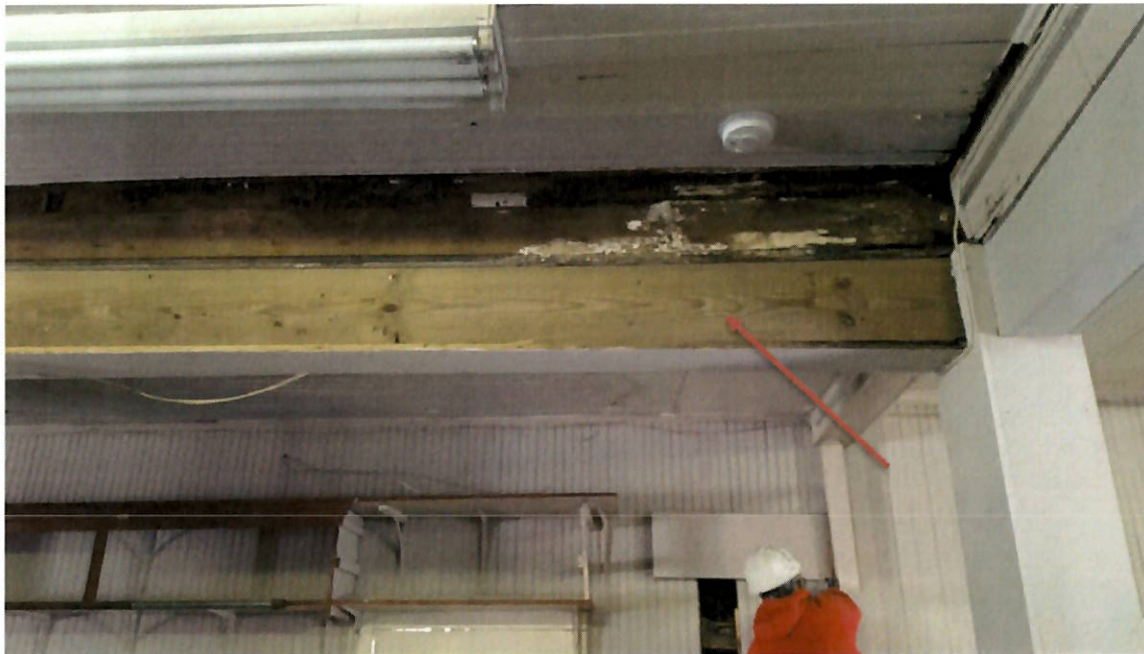
14. Severely deteriorated wood beam supporting roof framing on south wing of building.

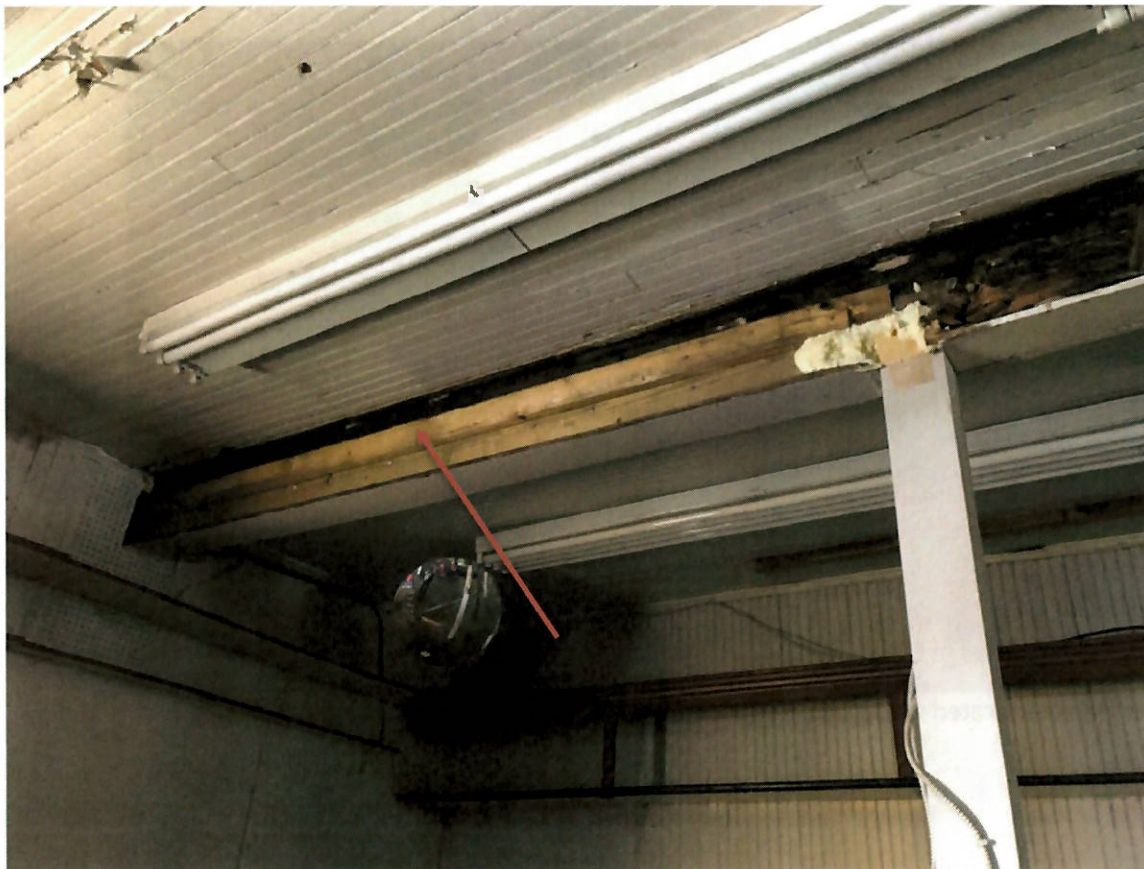
15. New wood beam placed below deteriorated wood beam on south wing of building.

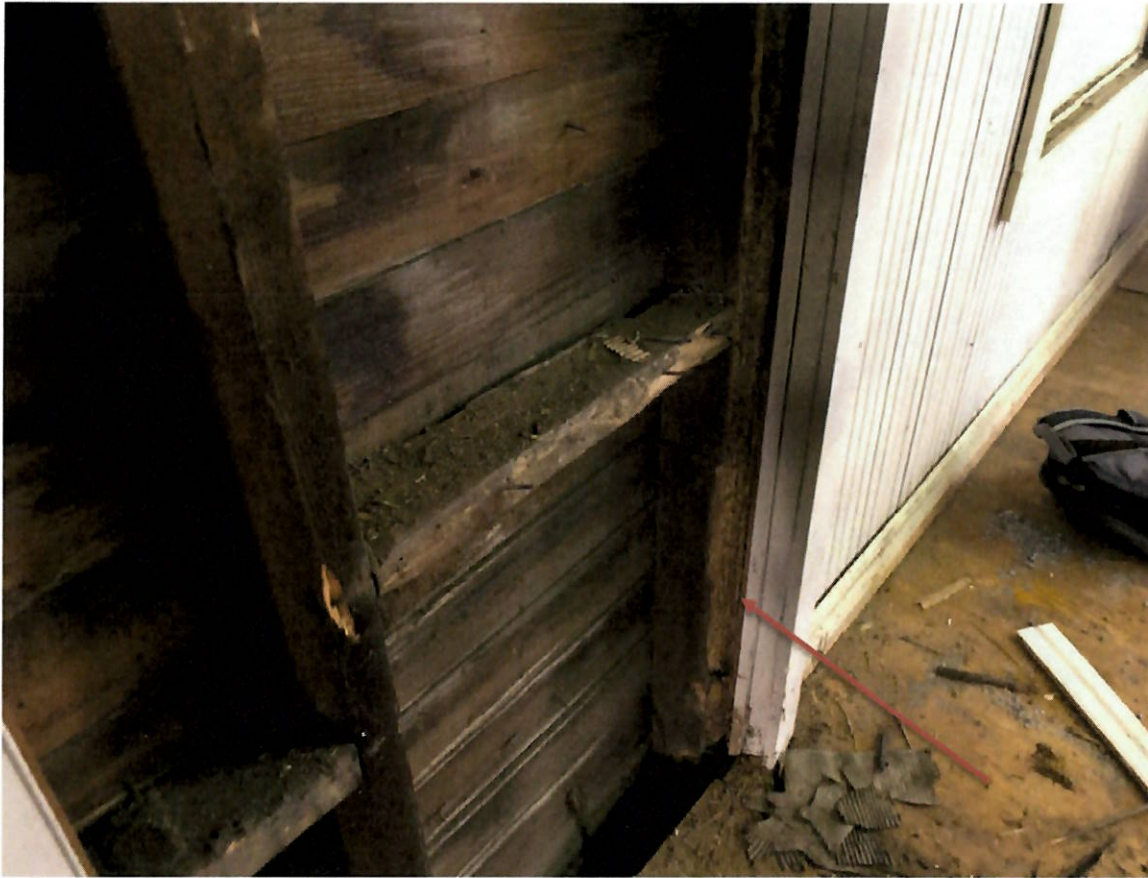
16. New wood beam placed at south wing of building.

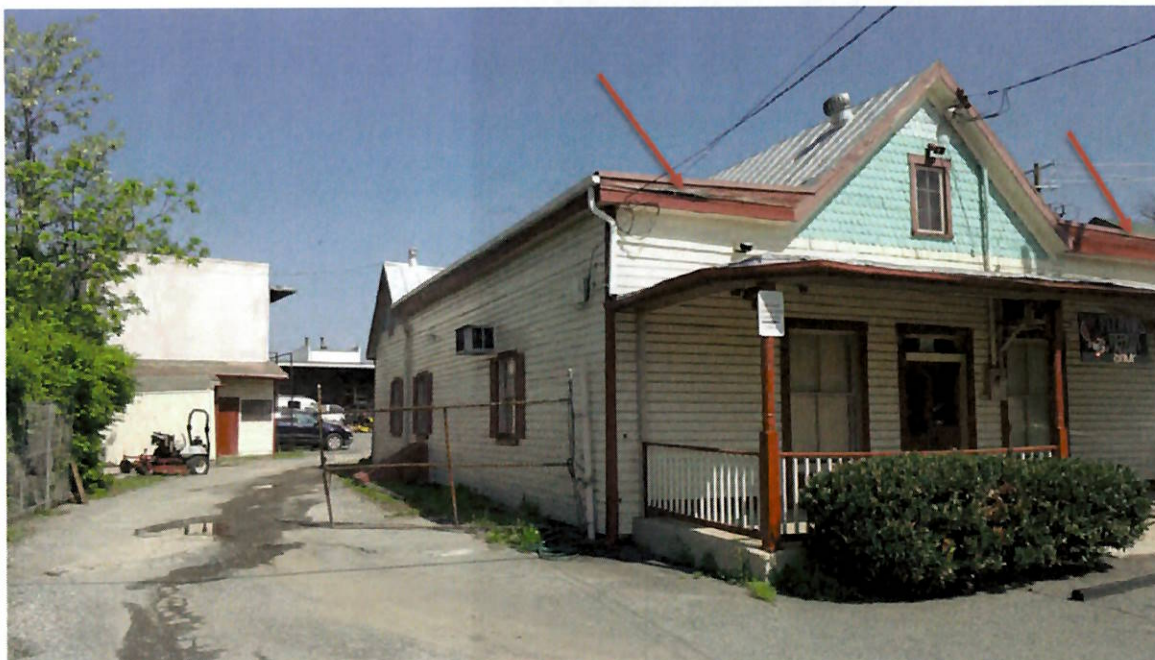
21. Existing porch roof framing

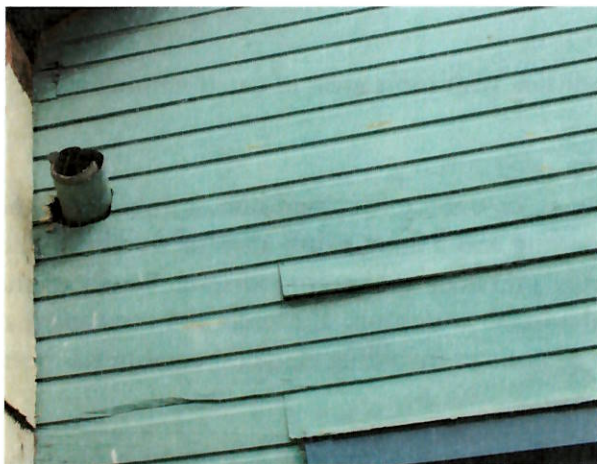
Wood Siding - The painted exterior wood cladding is in overall fair condition, exhibiting some deterioration including warped or missing boards, peeling and flaking paint, areas of wood rot, and termite damage. Damage to wood siding is especially prevalent at the ground level. Much of the painted wood trim appears to have been replaced and is in fair condition. The fascia and vergeboard at the roofline is also very deteriorated. Miscellaneous equipment including electrical conduit has been attached to the exterior walls.

FIGURE 20 Detail, wood siding, loose boards.

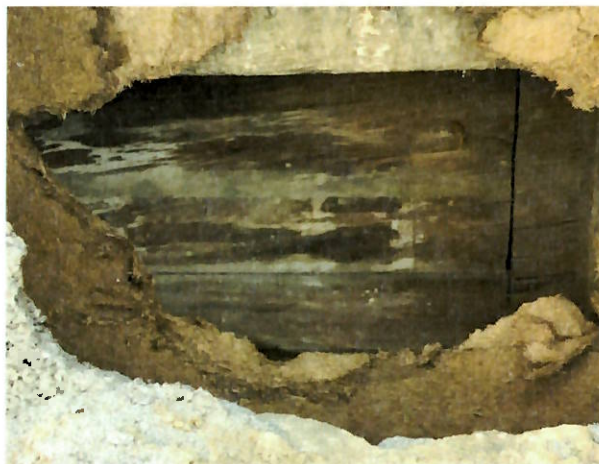
Exploratory demolition on the west elevation revealed that wood siding remains extant behind the concrete block wall. The siding appears to be severely deteriorated, largely due to water and termite damage. Additional evaluation and exploratory demolition should be performed to determine the condition of the wood siding at the west elevation.

FIGURE 23 Exploratory demolition revealed wood siding in poor condition on west elevation. Antunovich Associates, 2019.

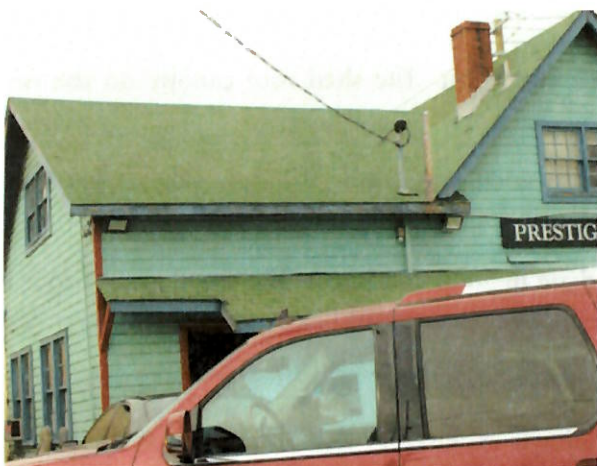
FIGURE 21 Asphalt shingle roof appears to be in generally good condition.

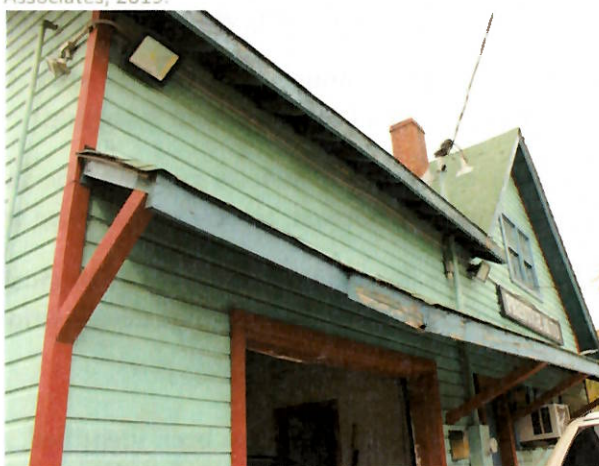
Roof - The asphalt shingle roof appears to be in fair condition. The shed roof canopy on the east elevation, however, is damaged and is sagging.

FIGURE 24 Deteriorated, non-original, shed canopy.

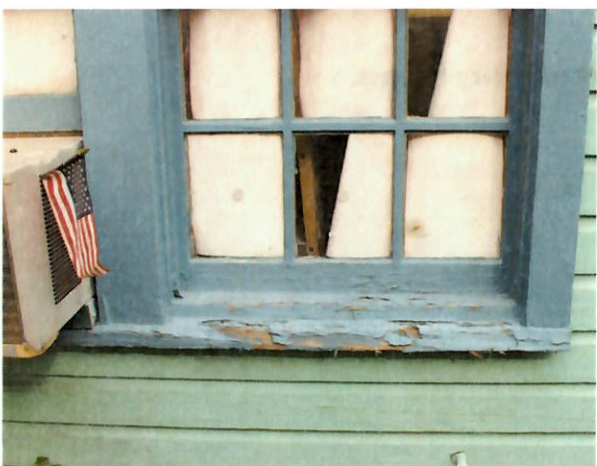
Windows & Doors - Windows appear to be in fair to good condition. Window sills at first floor windows are deteriorated, especially where the window air conditioning unit is installed.

FIGURE 22 Deteriorated sill, south elevation.

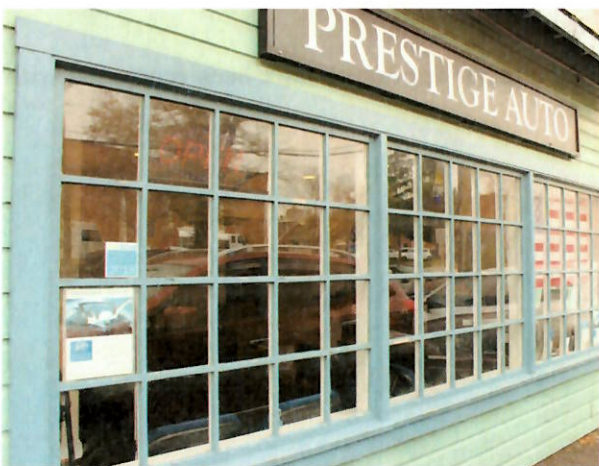
FIGURE 25 Non-original multi-light windows, north elevation, in generally good condition.
