PHYSICAL DESCRIPTION AND ASSESSMENT OF EXISTING CONDITIONS

EHT Tracerics conducted site visits and surveyed the building's exterior and interior in August and November 2018 in order to identify and photograph existing conditions. Supplementary survey was conducted by Structura, Inc. Structural Engineers to assess the structural conditions of framing members and the foundation in May 2018. At that time, observations were limited to components and structures that were readily accessible and observable without the use of destructive probes. Additional assessment and limited exploratory demolition was performed in January 2019 to provide greater insight into the building's existing conditions. Structura's findings can be found in the report included as Appendix A.

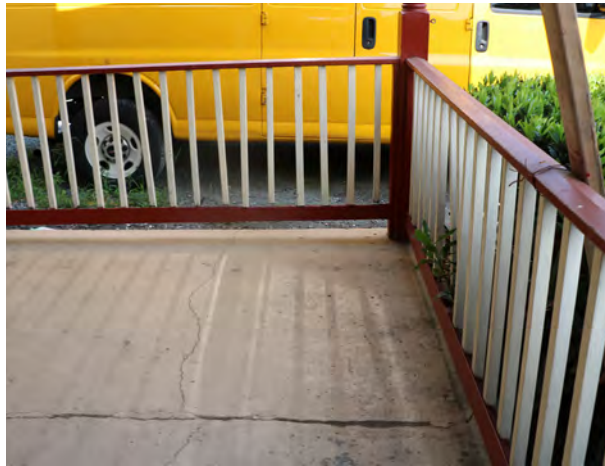
FIGURE 17 Crack in concrete slab; non-original wood balusters and banister.

Concrete - Contemporary concrete at the rear west elevation is generally in fair condition. The original concrete at the front porch, however, is in fair to poor condition showing signs of cracking and settlement.

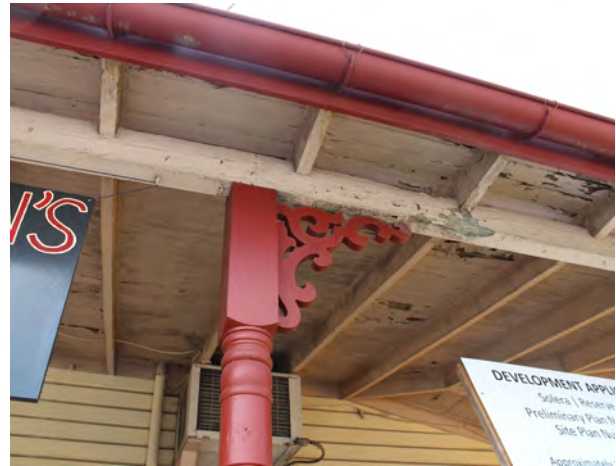
FIGURE 18 Non-original decorative Queen Anne-style brackets.

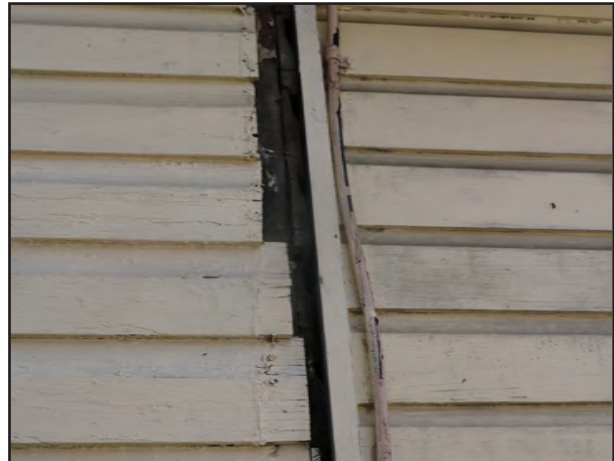
FIGURE 34 Missing portion of wood siding, exposed framing, north elevation.

On the north elevation where the low concrete wall has been added, ongoing water issues are visible. Damage includes wood rot, missing siding, evidence of termite damage or other wood-destroying insect damage.

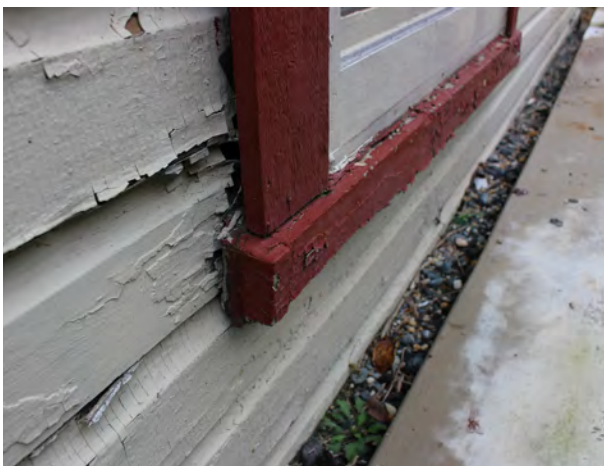
FIGURE 32 North elevation, intermediary space between low concrete wall and wall filled with gravel.

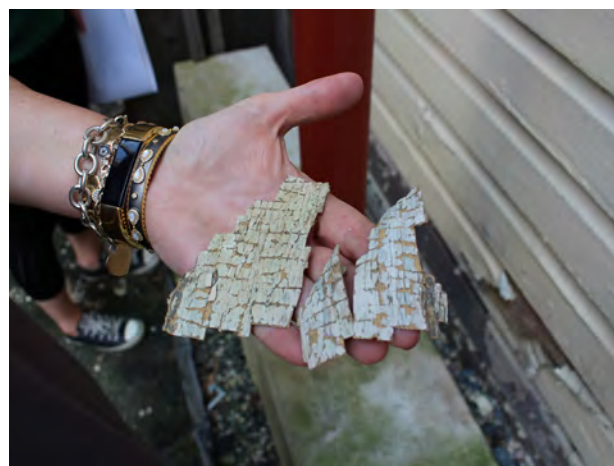
Wood Siding and Shingles- The painted exterior wood cladding, including the siding and shingles, exhibit some deterioration caused by moisture and insects. Visible deterioration includes peeling and flaking paint, areas of wood rot, and termite damage. The painted wood shingles within the gable roofs are worn and some of the shingles appear to have split. Painted wood trim is in fair to good condition.

FIGURE 33 Flaking paint.

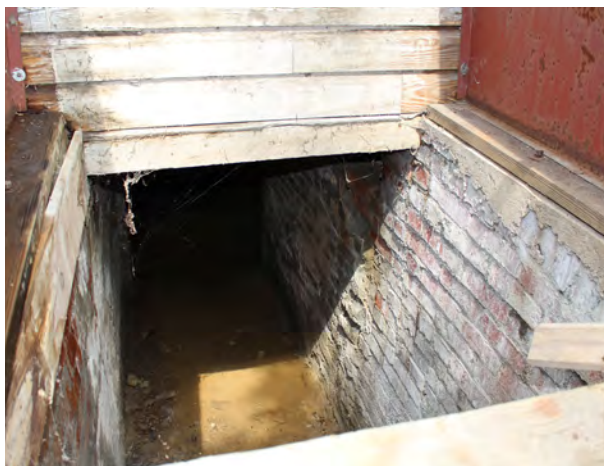
Brick - Brick foundation walls exhibit damage and deterioration. Efflorescence and moisture damaging mortar. On the south side the foundation is not visible and the wood siding is set directly touching the ground.

FIGURE 37 Brick foundation walls visible at basement access hatch.

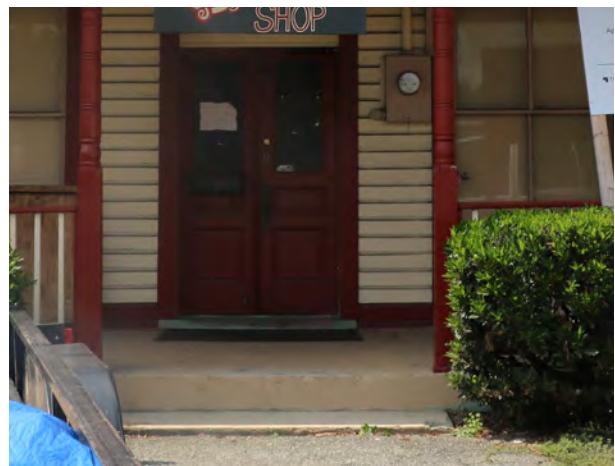
FIGURE 38 Painted concrete porch and step.

The original components of the front porch include the roof, roof framing, and concrete slab. The concrete slab is painted and in fair condition, showing some signs of cracking and settlement. When constructed the porch was reached by a concrete ramp or walkway from St. Paul Street and a single concrete step. Today asphalt has covered all of the walkway and much of the step. The painted wood framing of the porch roof is deteriorated, and several boards exhibit termite damage and rot. The metal roofing appears to be original and is extremely worn. The columns, railing, and decorative elements were added between the 1990s-2000s. While the posts appear to be in fair condition, the balusters and railing are extremely deteriorated.

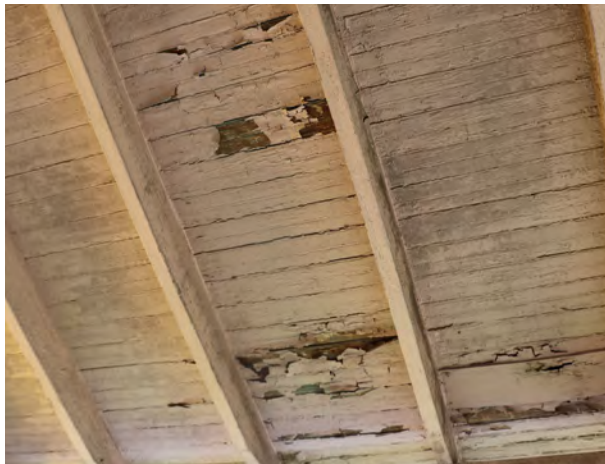
FIGURE 39 Deteriorated porch ceiling.

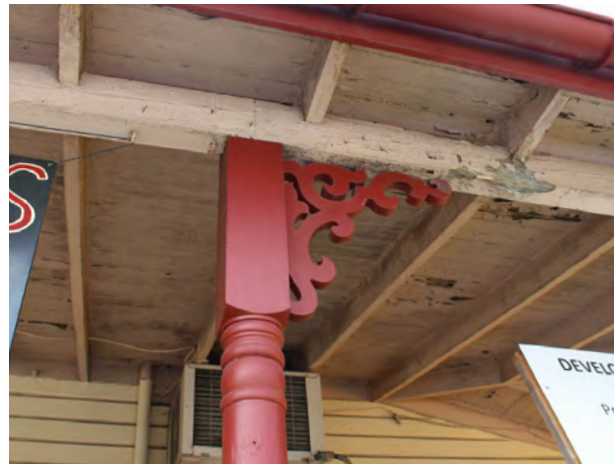
FIGURE 40 Non-original porch posts and decorative brackets.

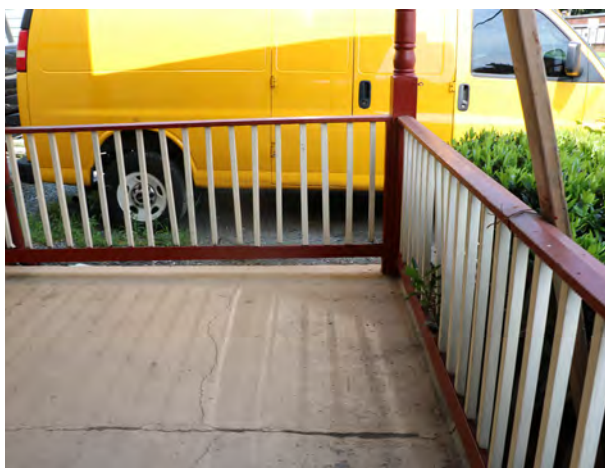
FIGURE 41 Cracks in concrete slab.

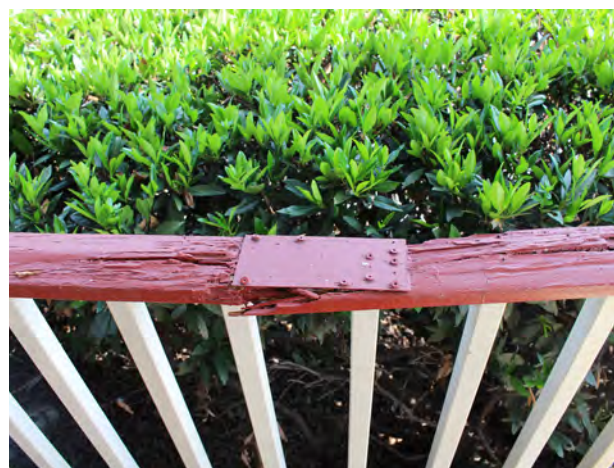
FIGURE 42 Splintered banister (non-original).

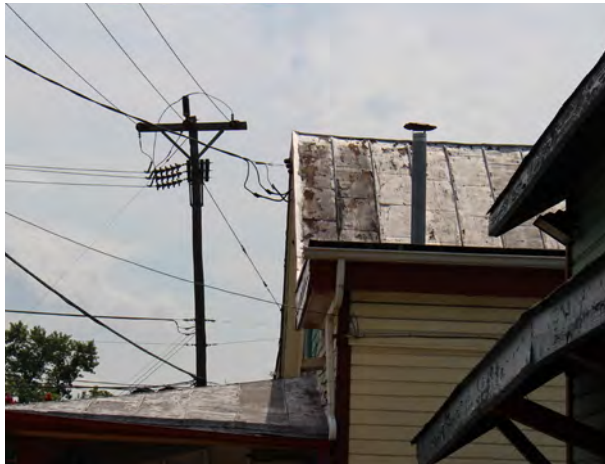
A standing seam metal roof remains extant on the building. The roof appears generally worn and past its useful life. Water infiltration on the interior suggests damage and deterioration. The wings are covered in membrane roofing which was recently added on top of what was likely a standing seam metal roof. The rear roof slope and new addition are covered in contemporary metal roofing.

FIGURE 43 Rust and deterioration of metal sheathing visible on center gable.

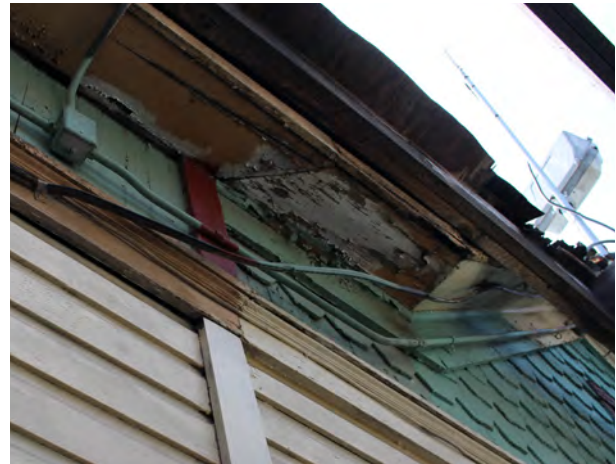
FIGURE 44 Deteriorated eve condition.

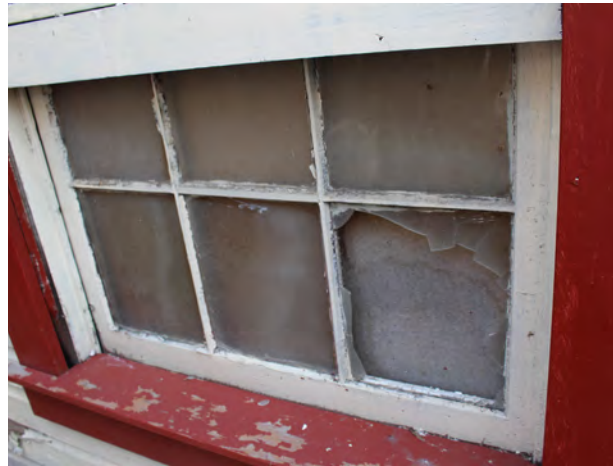
FIGURE 47 Broken glazing.

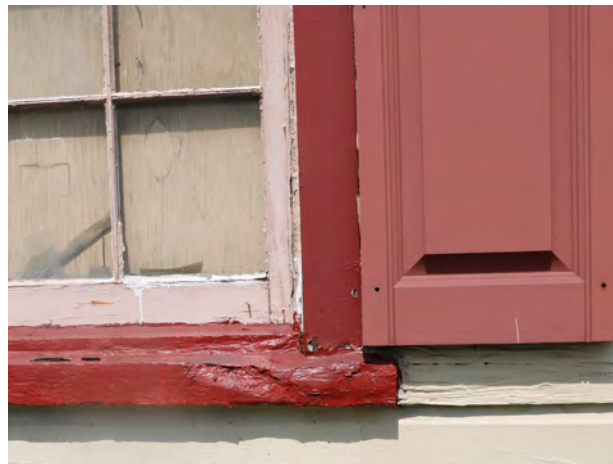
The wood frames and sills for all three windows on the southern elevation exhibit deterioration likely caused by water and/or insect damage.

FIGURE 48 Sill deterioration.

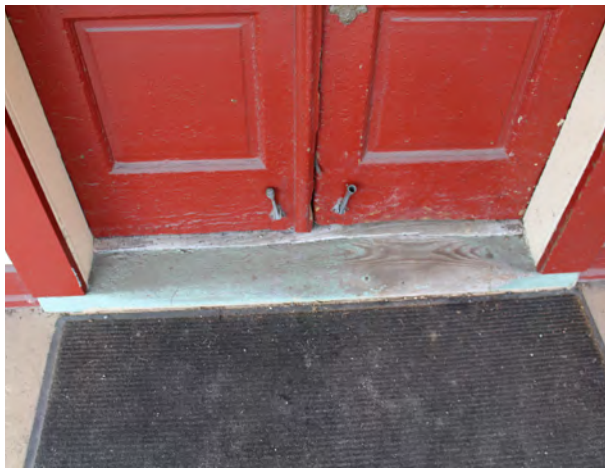
The main entry door is worn and is in fair to poor condition but is operable. The bottom rails have worn unevenly. The bead or astragal has worn and chipped. The wood threshold is also worn and very uneven. The frame appears to be original, though given the multiple layers of wood cladding, the wood trim and exterior surround appear to be replacements.

FIGURE 56 Wood threshold.

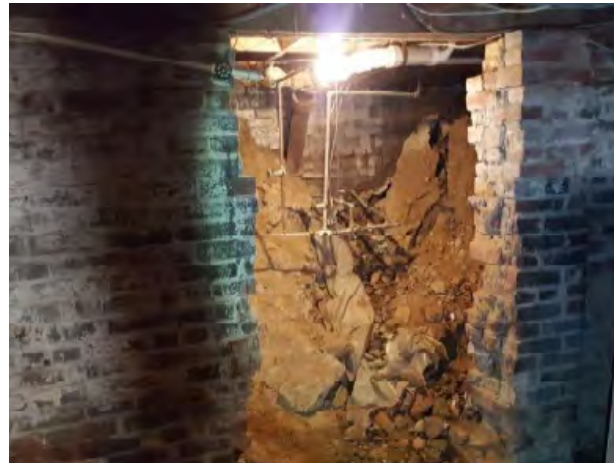
FIGURE 58 Opening in section of foundation wall. Structura, Inc., 2018.

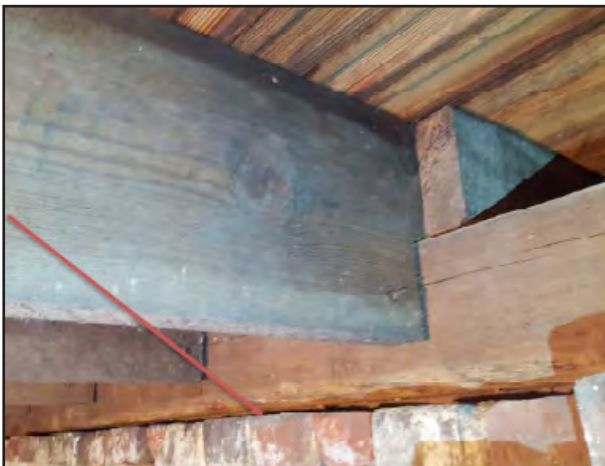
FIGURE 59 Sill plate not fully bearing on foundation wall. Structura, Inc., 2018.

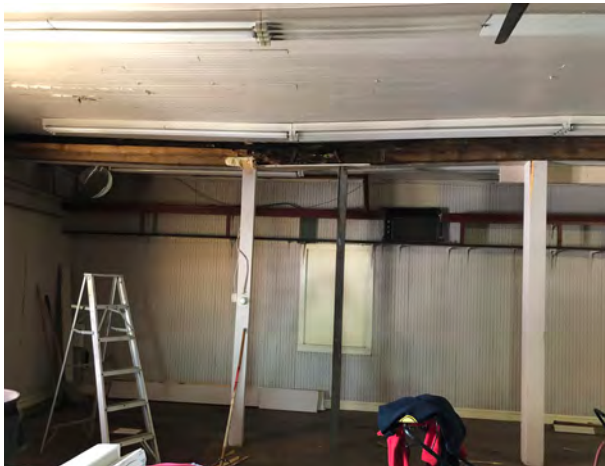
FIGURE 61 Deteriorated wood beam and interior columns. Structura, Inc., 2019.

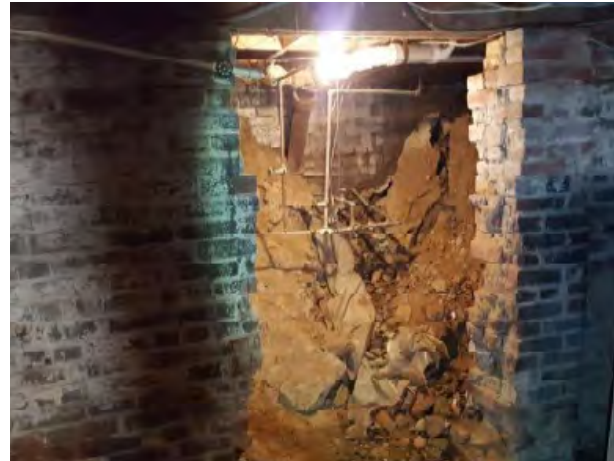
FIGURE 64 Opening demolished in section of foundation wall. Structura, Inc., 2018.

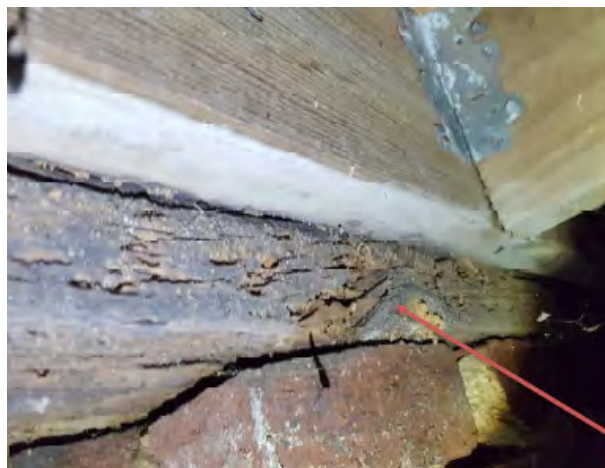
Floor joists are generally inadequate exhibit decay. The joist sizes are inadequate for the constructed spans and required loading, and joist connections are inadequate in areas where the floor joists have

FIGURE 67 Replacement wood joist framing. Wood ledge connected to original wood sill plate that exhibits insect damage. Joist and ledger are not adequately connected. Structura, Inc., 2018.

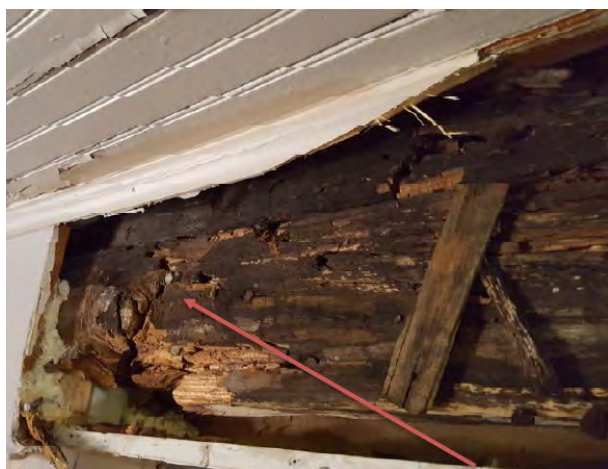
been replaced. In addition, a center support beam visible in the basement below the footprint of the original construction appears to be damaged by termites and other wood-destroying insects and the beam has been retrofitted with nominal lumber on each side. A combination of wood and adjustable steel posts were added to support the beam.

FIGURE 66 Severely deteriorated support beam. Structura, Inc., 2018.

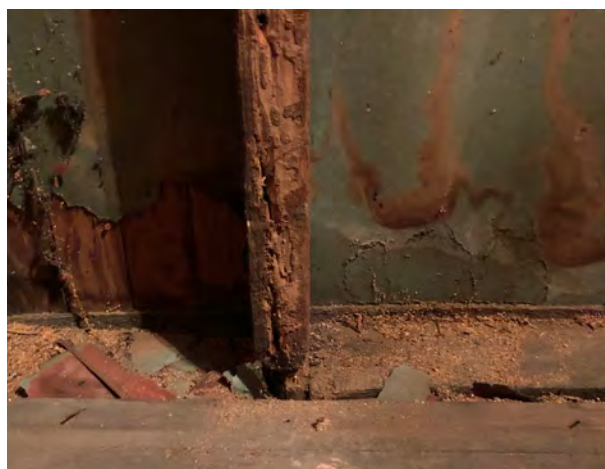
FIGURE 65 Termite damage visible in wall framing. Structura, Inc., 2019.

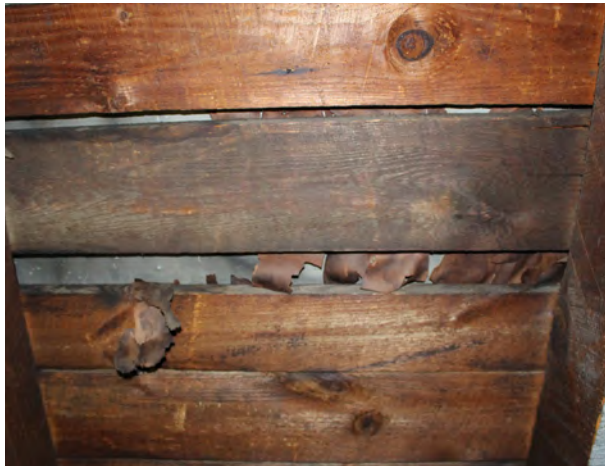
FIGURE 68 Deteriorated roof sheathing.

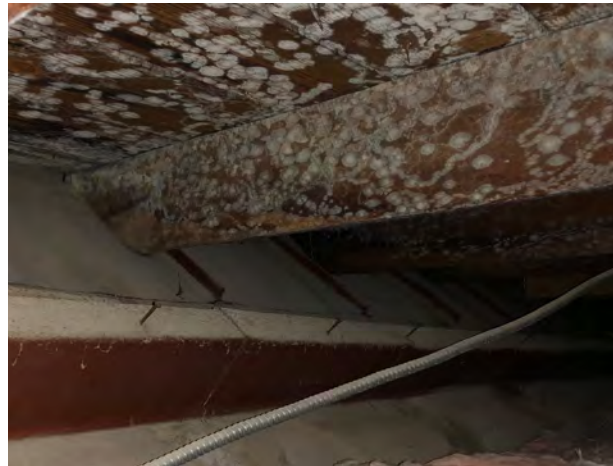
The north wing roof framing is supported by the exterior wood stud wall and what appears to be the original exterior wall that remained in place after the north wing was added. A significant amount of mold was observed on the underside of the north wing roof framing.

FIGURE 69 Termite damage and mold on the underside of north wing roof framing. Structura, Inc., 2019.

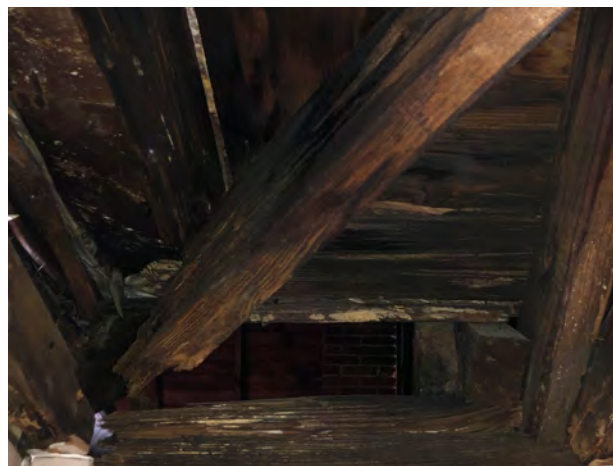
FIGURE 71 Deteriorated roof framing. Structura, Inc., 2019.

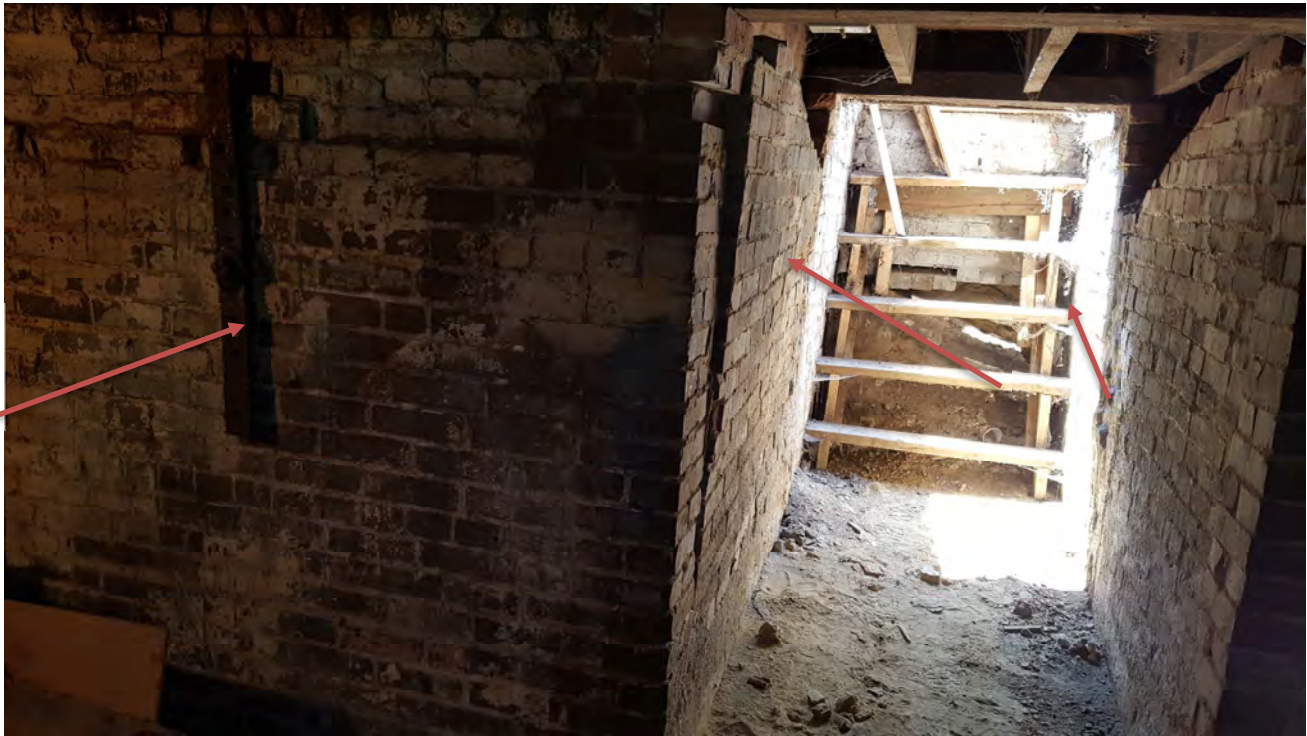
5. Basement wall. Note laterally displaced foundation wall, undermined footing below access hatch and stair, what appears to be a previous foundation wall retrofit.

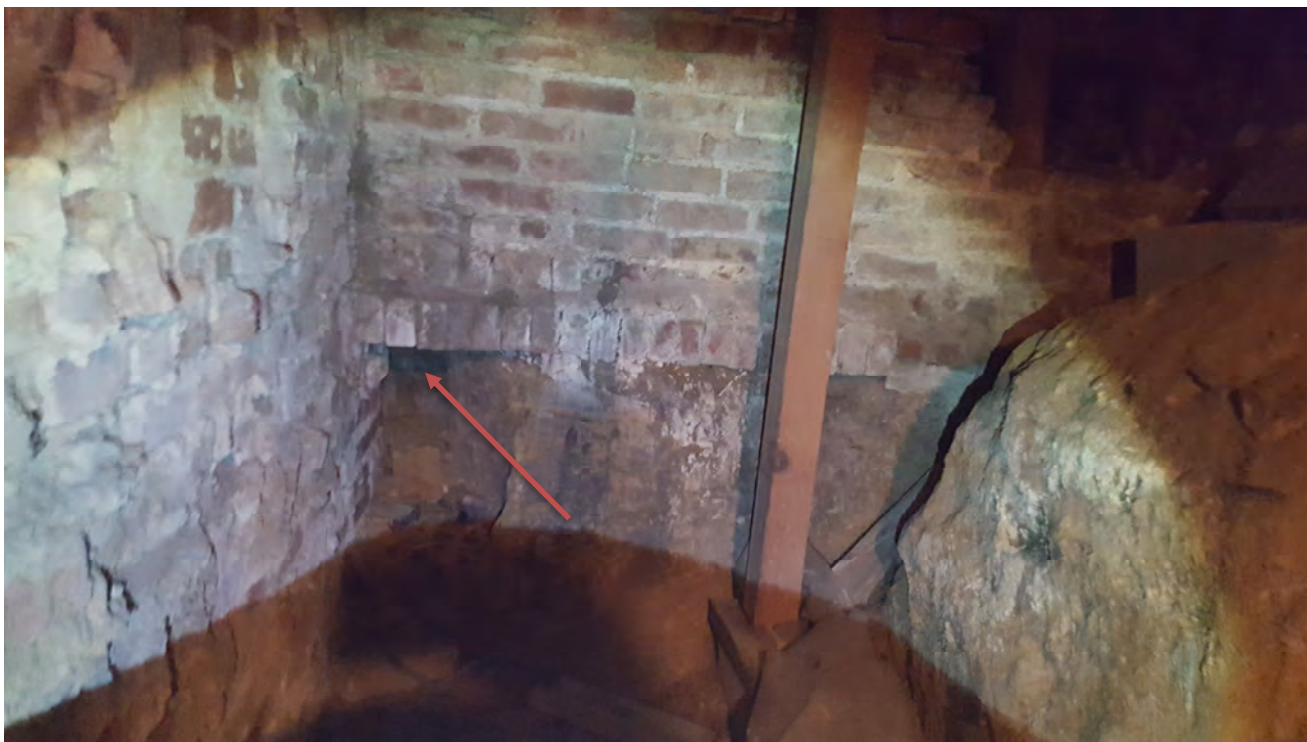
6. Undermined section of foundation wall

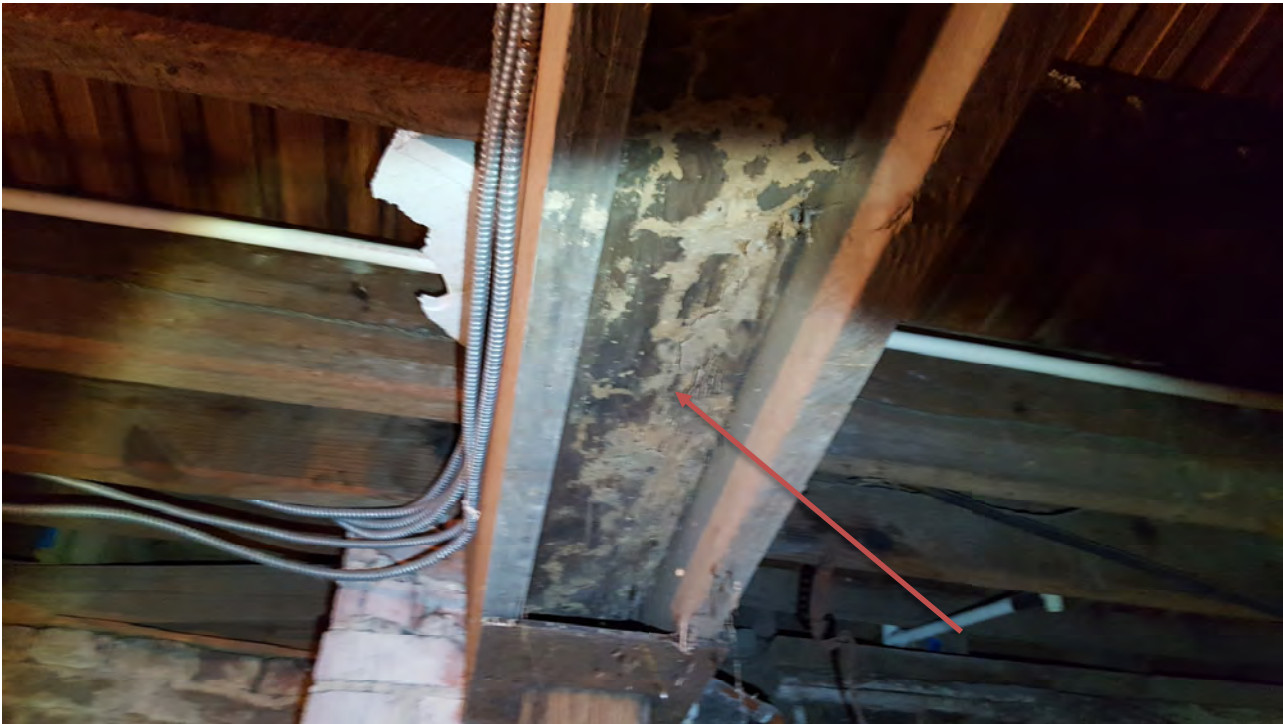
7. Wood support beam damaged by wood destroying insects. Note previous retrofit attempt on with 2x nominal lumber on both sides of beam.

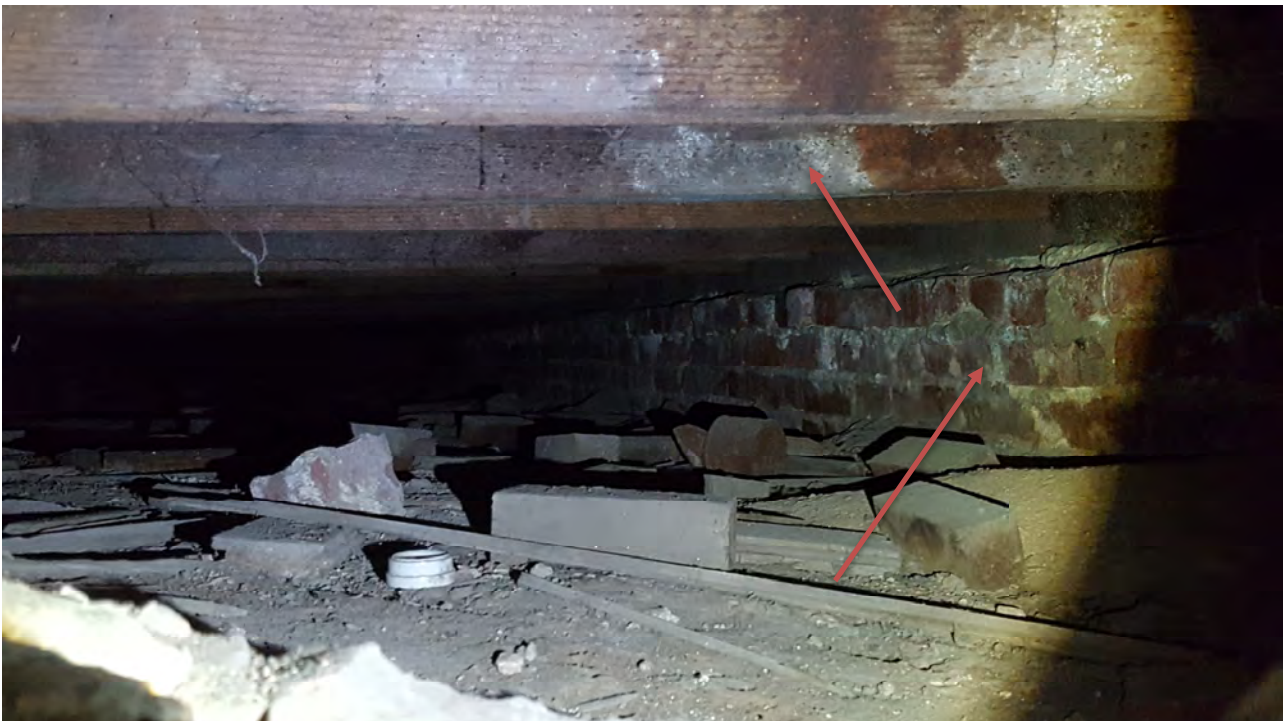
8. Existing wood joists with moisture and insect damage. In addition, note deteriorated masonry foundation wall and mortar joints.

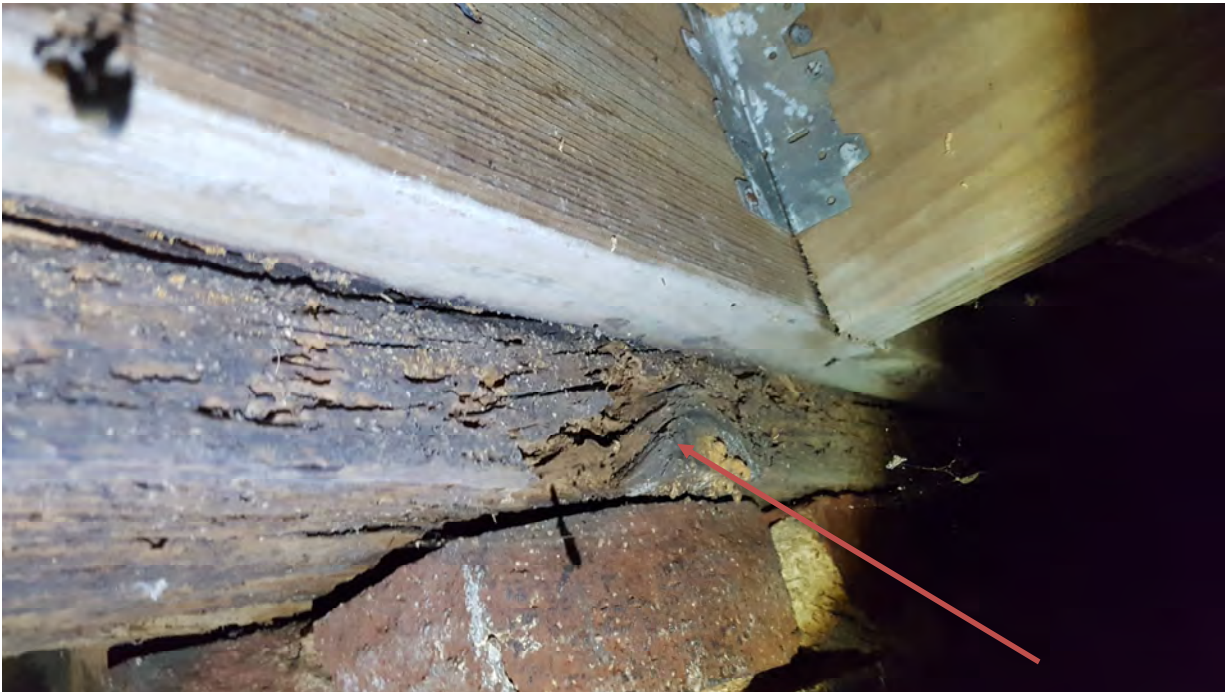
9. Wood joist framing that replaced the original joist framing. Wood ledge connected to original wood sill plate with what appears to be wood destroying insect damage. Joist and ledger connects are not adequate for required design loads.

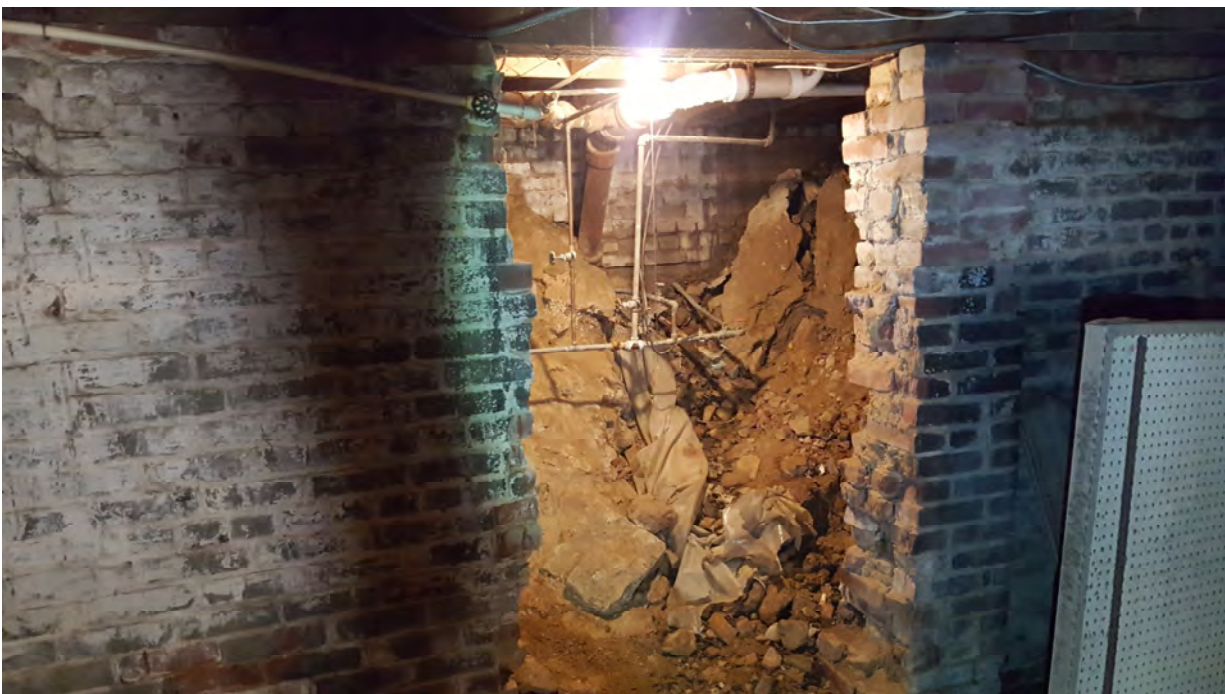
10. Opening demolished in section of existing foundation wall.

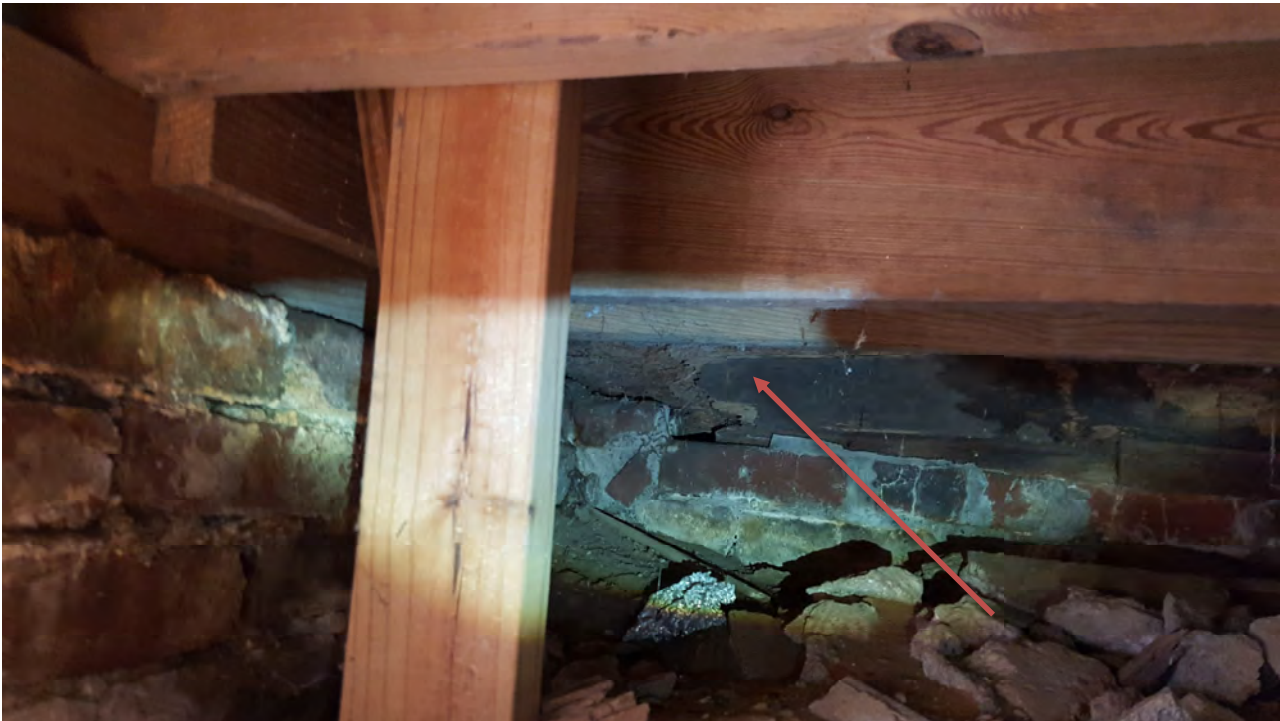
11. Original band joist still in place appears to have been damaged by wood destroying insects.

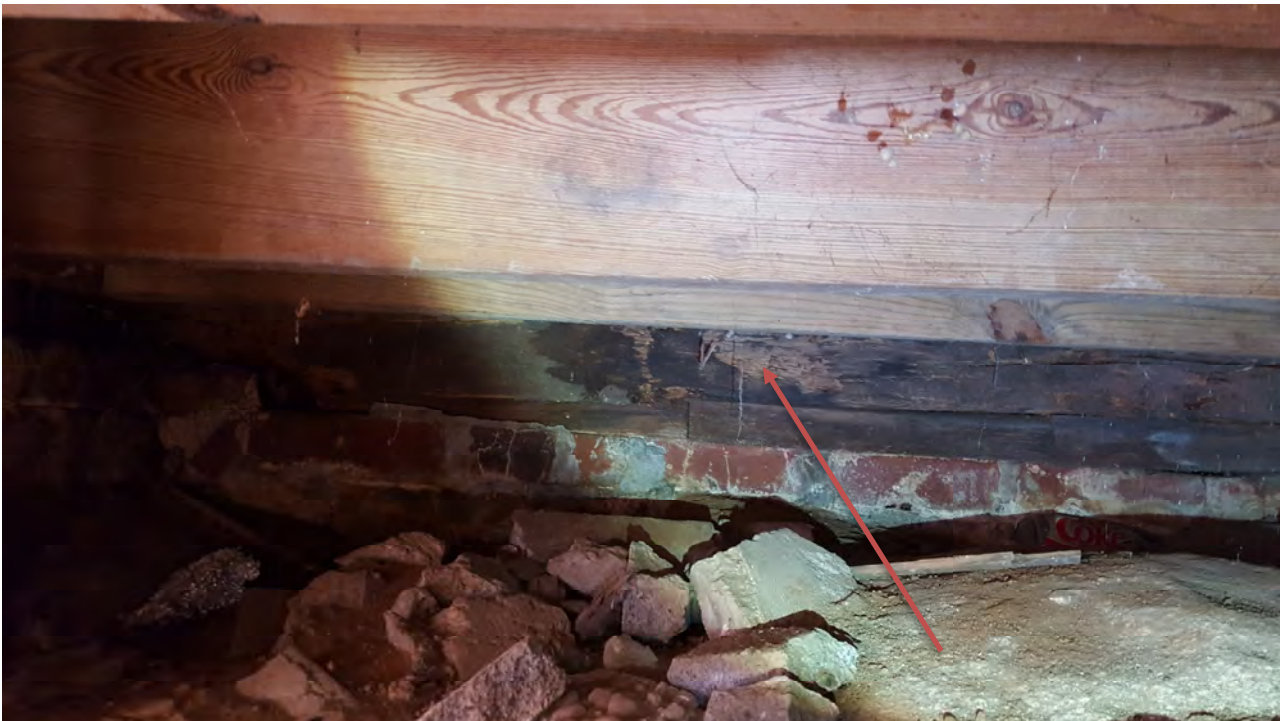
12. Replacement wood joists. Note existing joist remaining that appears to have damage from wood destroying insects.

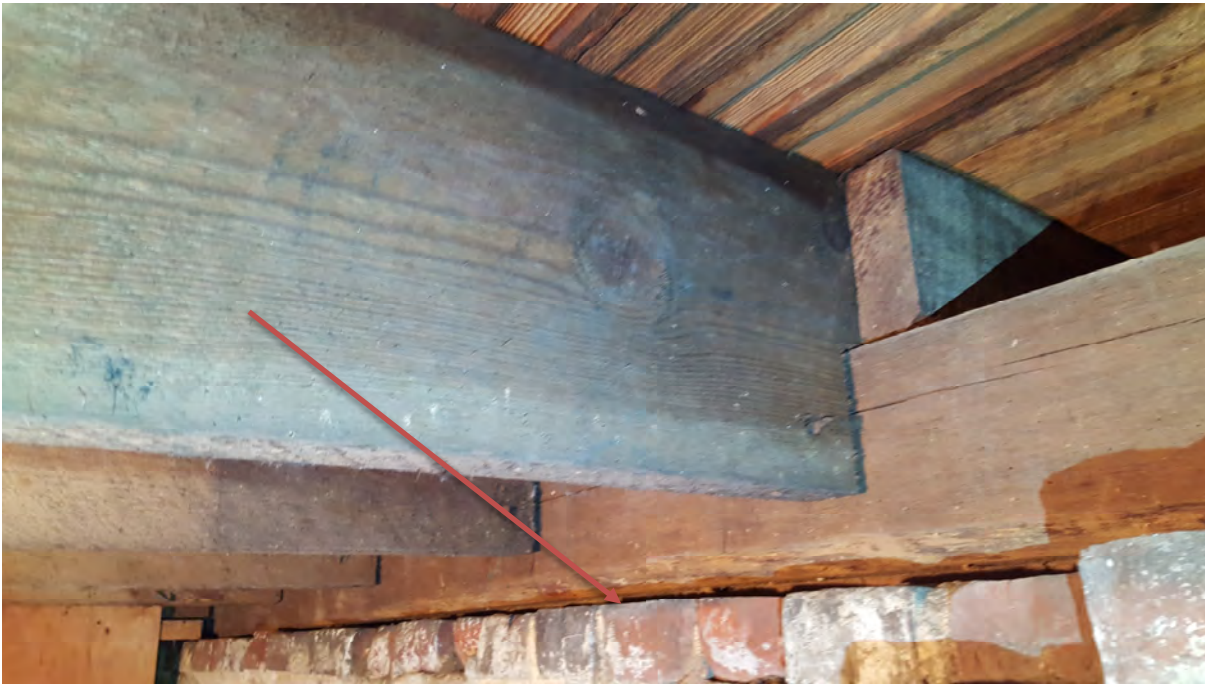
13. Existing joists notched at support. Sill plate is not fully bearing on foundation wall.

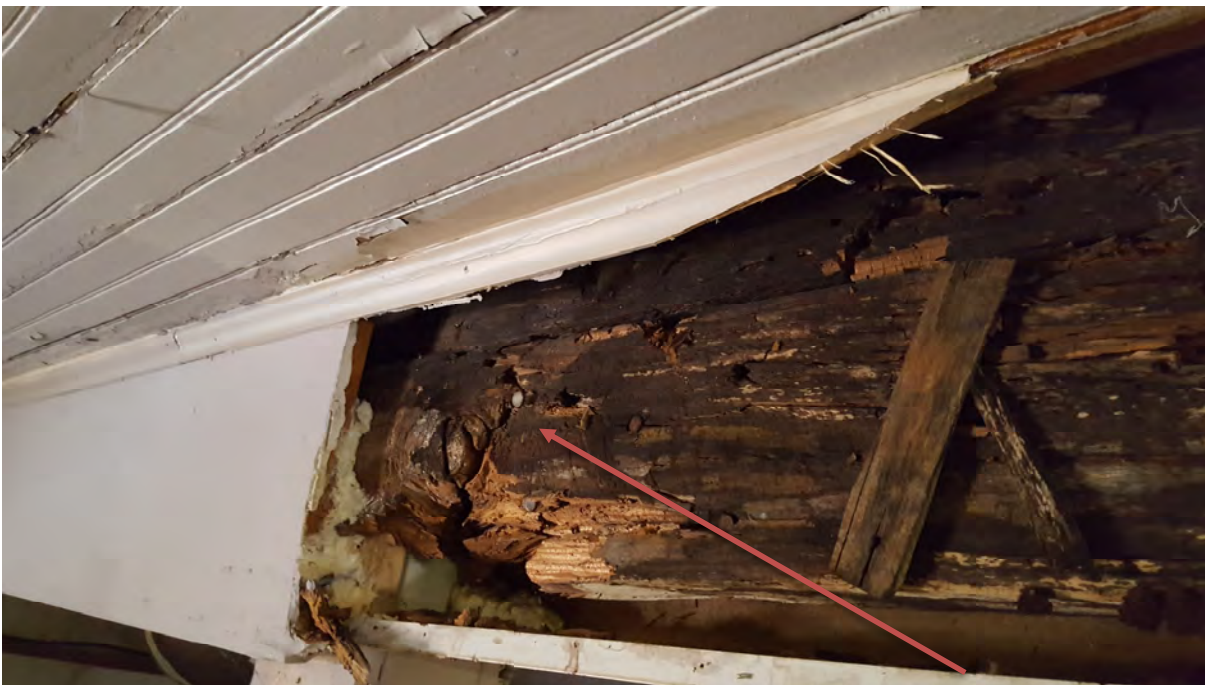
14. Severely deteriorated wood beam supporting roof framing on south wing of building.

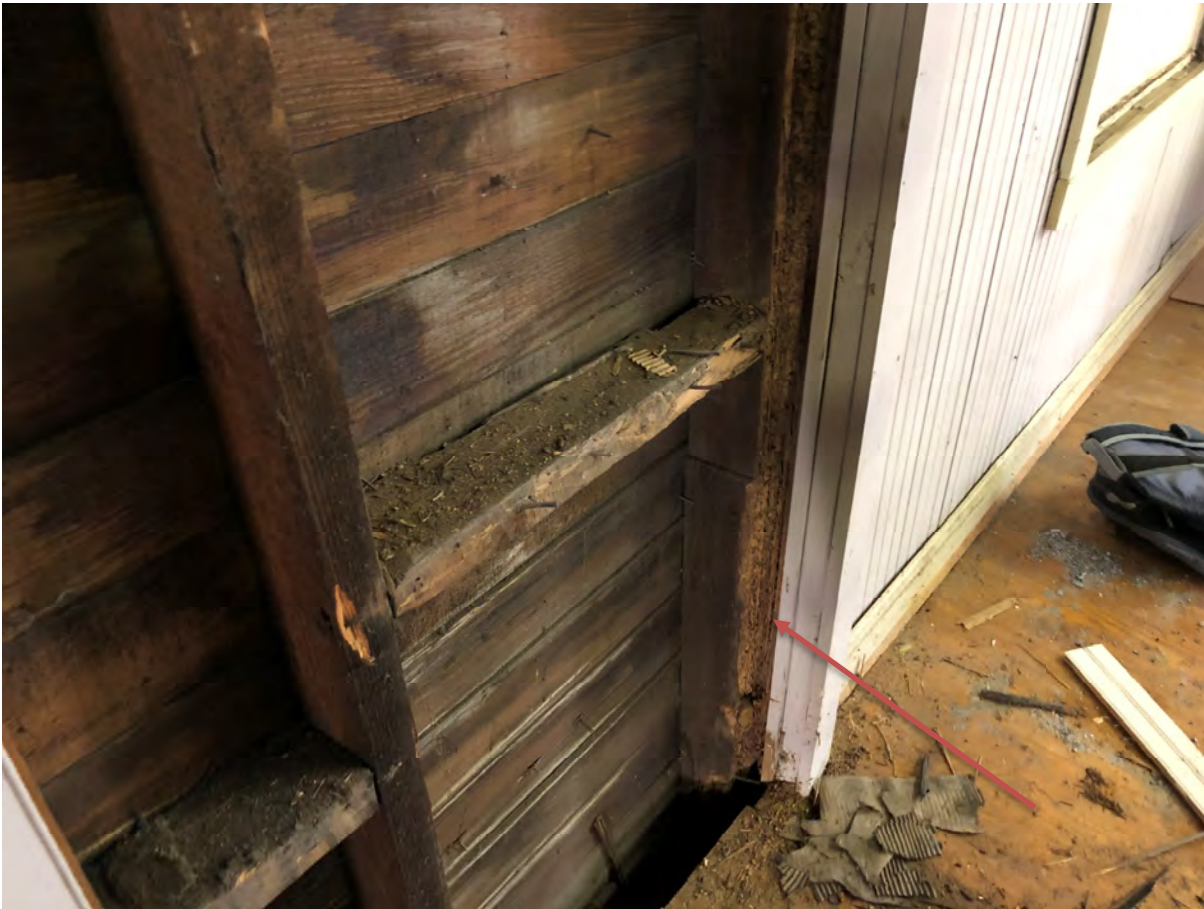
17. Termite damage to wood post on south wall of building.

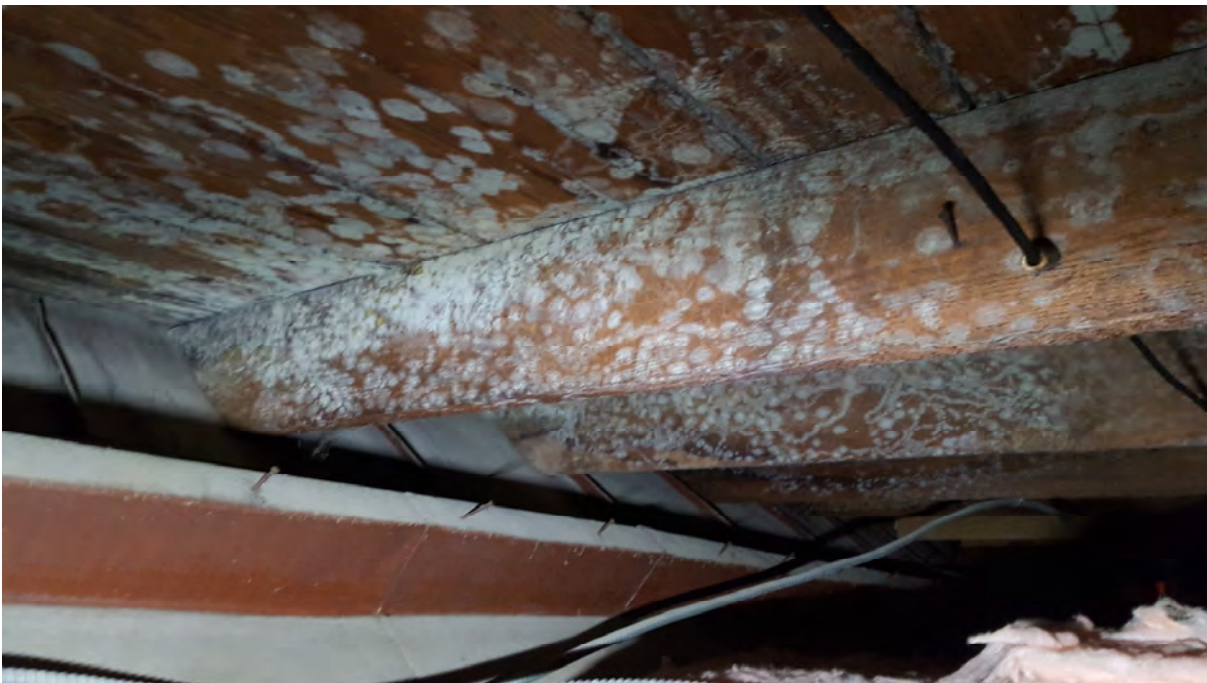
18. Low roof joists on north wing of building with significant mold growth.

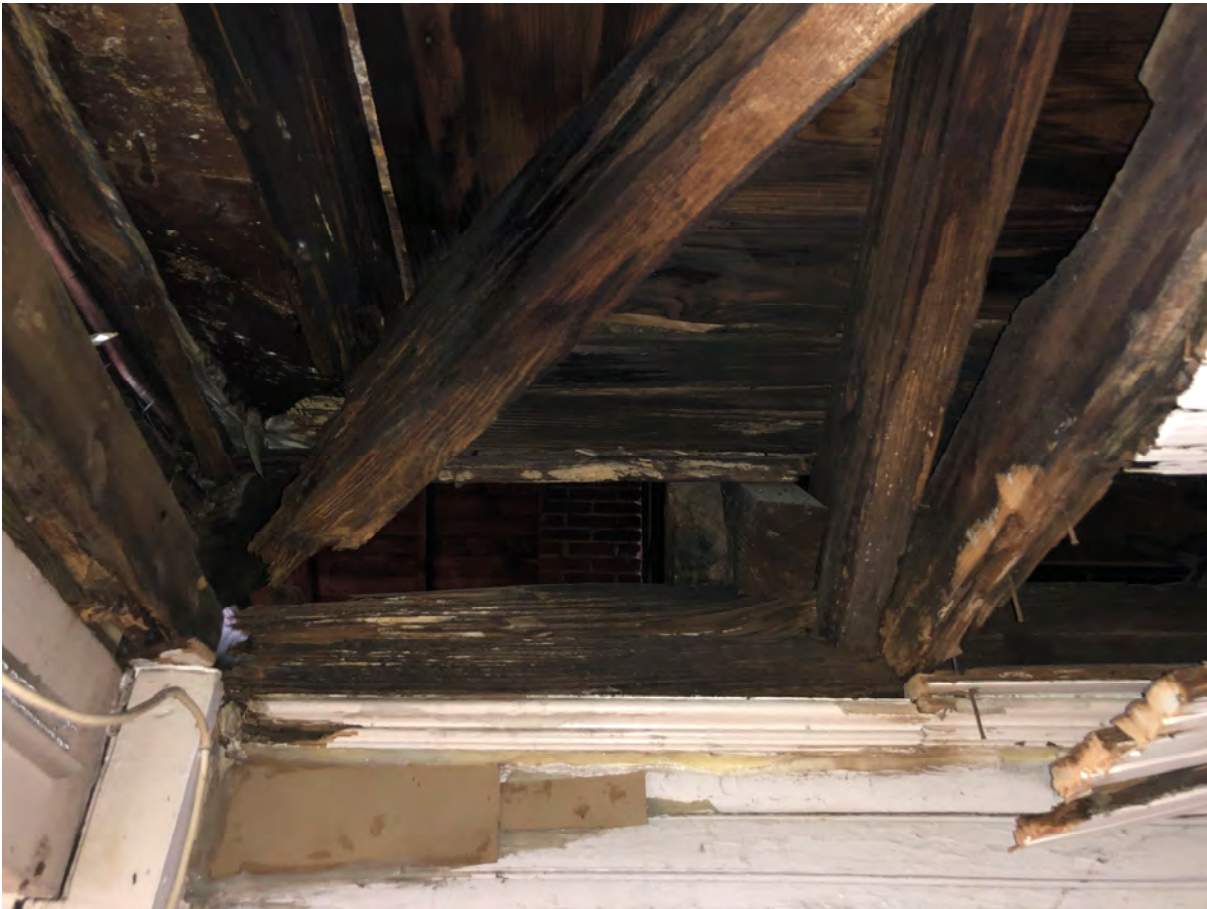
19. Deteriorated low roof framing on south wing of building.

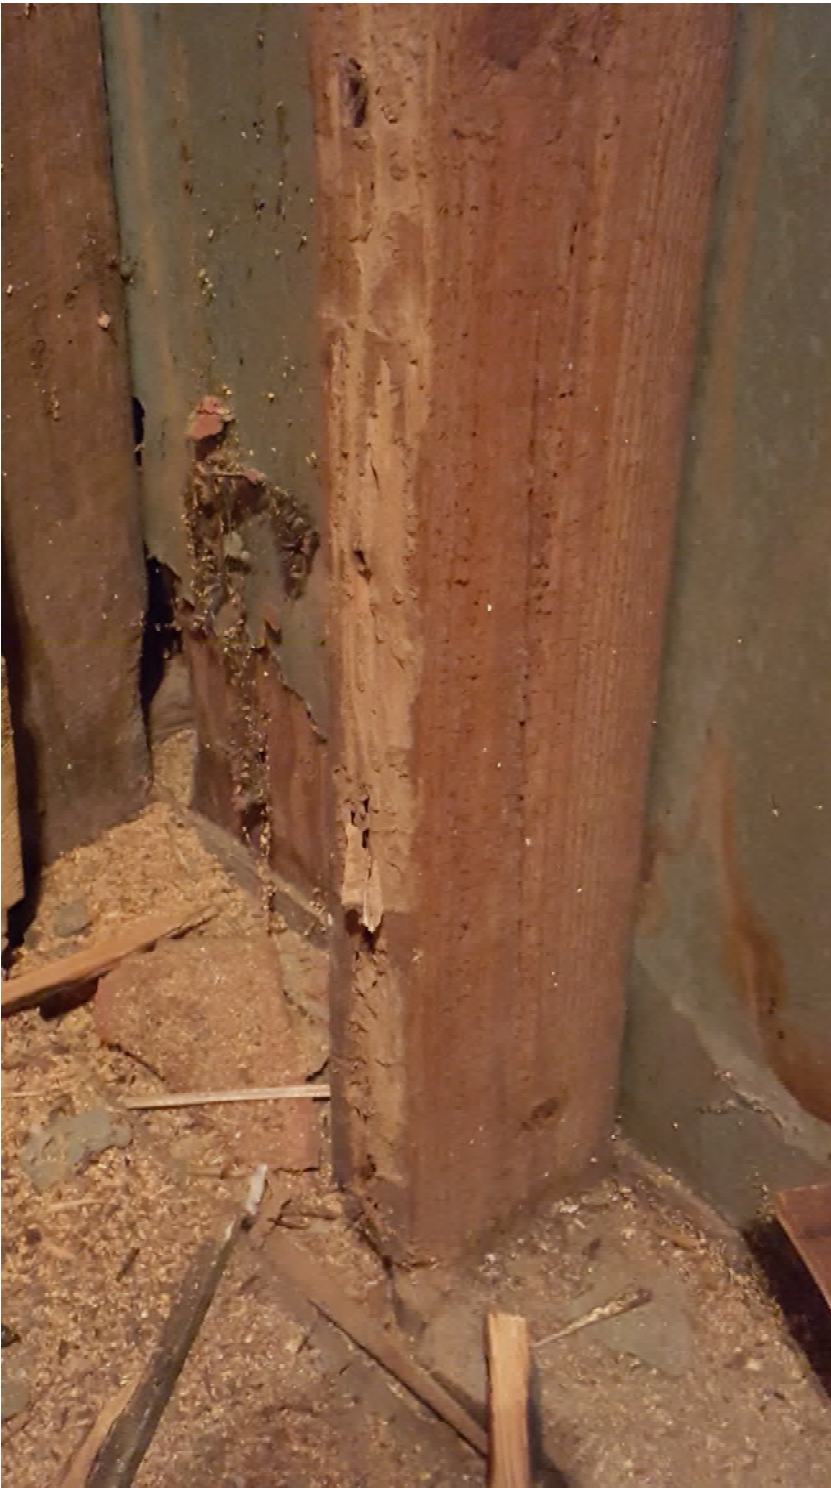
20. Termite damage to existing wall stud at interior load bearing wall on north wing of building.

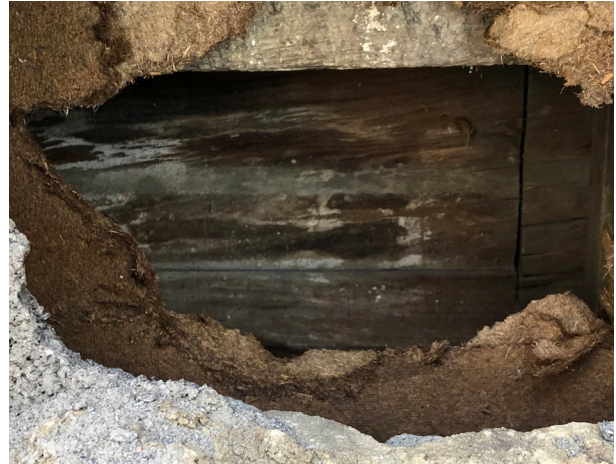
FIGURE 23 Exploratory demolition revealed wood siding in poor condition on west elevation. Antunovich Associates, 2019.
