PHYSICAL DESCRIPTION AND ASSESSMENT OF EXISTING CONDITIONS

EHT Tracerics conducted site visits and surveyed the building's exterior and interior in August and November 2018 in order to identify and photograph existing conditions. Supplementary survey was conducted by Structura, Inc. Structural Engineers to assess the structural conditions of framing members and the foundation in May 2018. At that time, observations were limited to components and structures that were readily accessible and observable without the use of destructive probes. Additional assessment and limited exploratory demolition was performed in January 2019 to provide greater insight into the building's existing conditions. Structura's findings can be found in the report included as Appendix A.

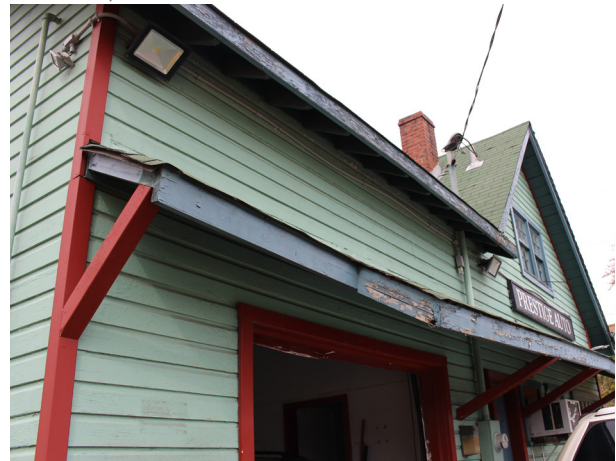
FIGURE 24 Deteriorated, non-original, shed canopy.

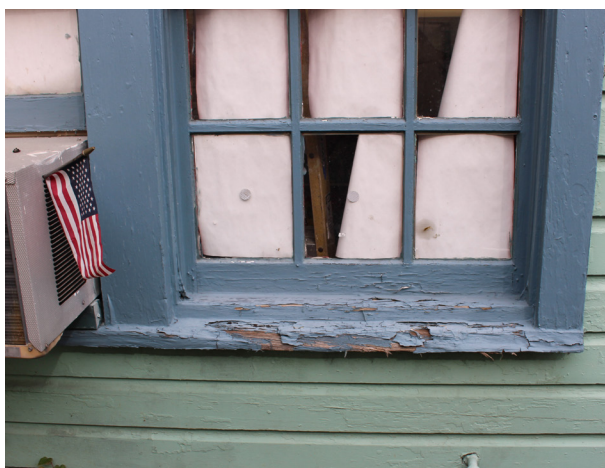
FIGURE 22 Deteriorated sill, south elevation.

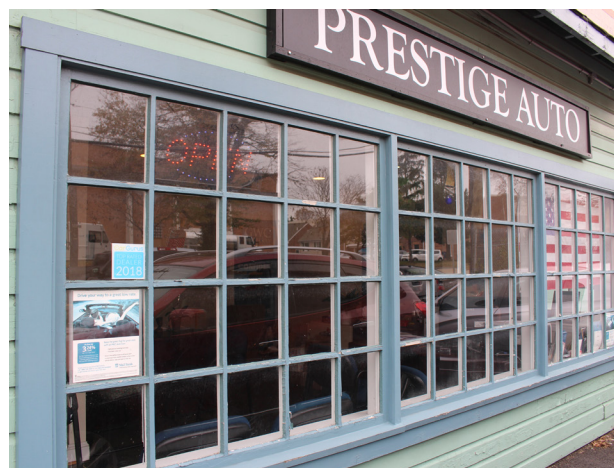
FIGURE 25 Non-original multi-light windows, north elevation, in generally good condition.
