## MONTGOMERY COUNTY HISTORIC PRESERVATION COMMISSION STAFF REPORT

Address: 10221 Menlo Ave., Silver Spring Meeting Date: 6/12/2019

**Proposal:** Building Demolition

Reference: House Structural Evaluation

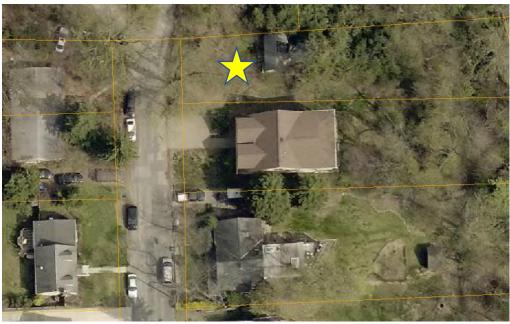
Figure 1: The 2015 aerial photograph of 10211 Menlo Ave. shows significant damage to the roof.

My field observation indicated that more than half of the existing home was completely damaged and collapsed years ago. Mr. Bautista indicated that the damage stemmed from a tree that fell on the house about 15 years ago. The damage was so extensive that basically no structural frame was left of the house to evaluate. Since no repair or any maintenance was followed, the house dilapidated further.

Based on my observations, it is my professional opinion that the house should be destroyed completely and immediately. It is actually very dangerous to be left in its current condition and could collapse any time and is a hazard to humans should anyone come in close contact to it, especially kids and/or animals. The owner could be liable for any damage to anyone or to animals should they get injured as a result of its collapse and should take immediate steps to destroy what is left of the house.

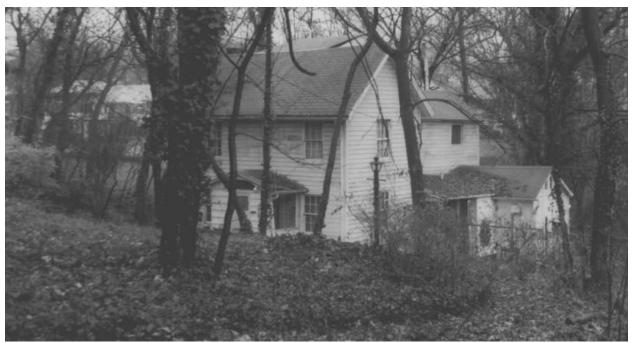
Figure 2: View of the subject property from December 1999.
