# EXPEDITED MONTGOMERY COUNTY HISTORIC PRESERVATION COMMISSION STAFF REPORT

Address: 12001 Skylark Rd., Clarksburg Meeting Date: 7/10/2019

**Ned Watkins House**

**PROPOSAL:** Partial Demolition of Accessory Structure

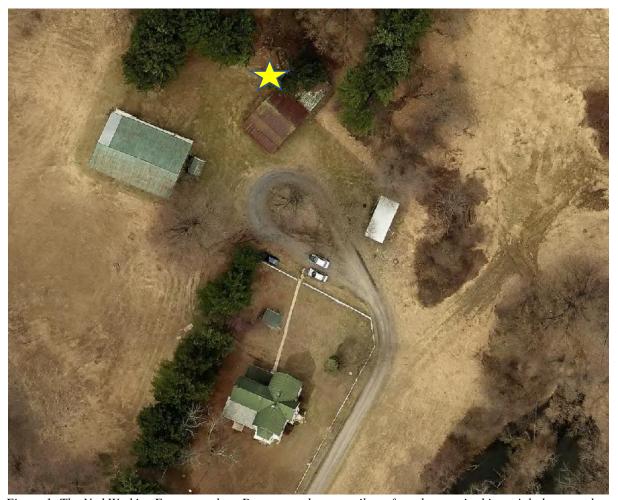
Figure 1: The Ned Watkins Farm complex. Damage to the corncrib roof can be seen in this aerial photograph.

The applicant proposes to demolish a partially collapsed, non-original, section of the corncrib and retain the original center and left bay. Parks Staff has indicated they can remove the non-original section without damaging the historic portion of the corncrib. None of the property is visible from the public right-of-way.
