FARM WOMEN’S COOPERATIVE MARKET
7155 WISCONSIN AVENUE | BETHESDA, MD

Second Draft Submission
July 2019

Farm Women's Market Investigation Conditions Assessment

December 18th, 2018

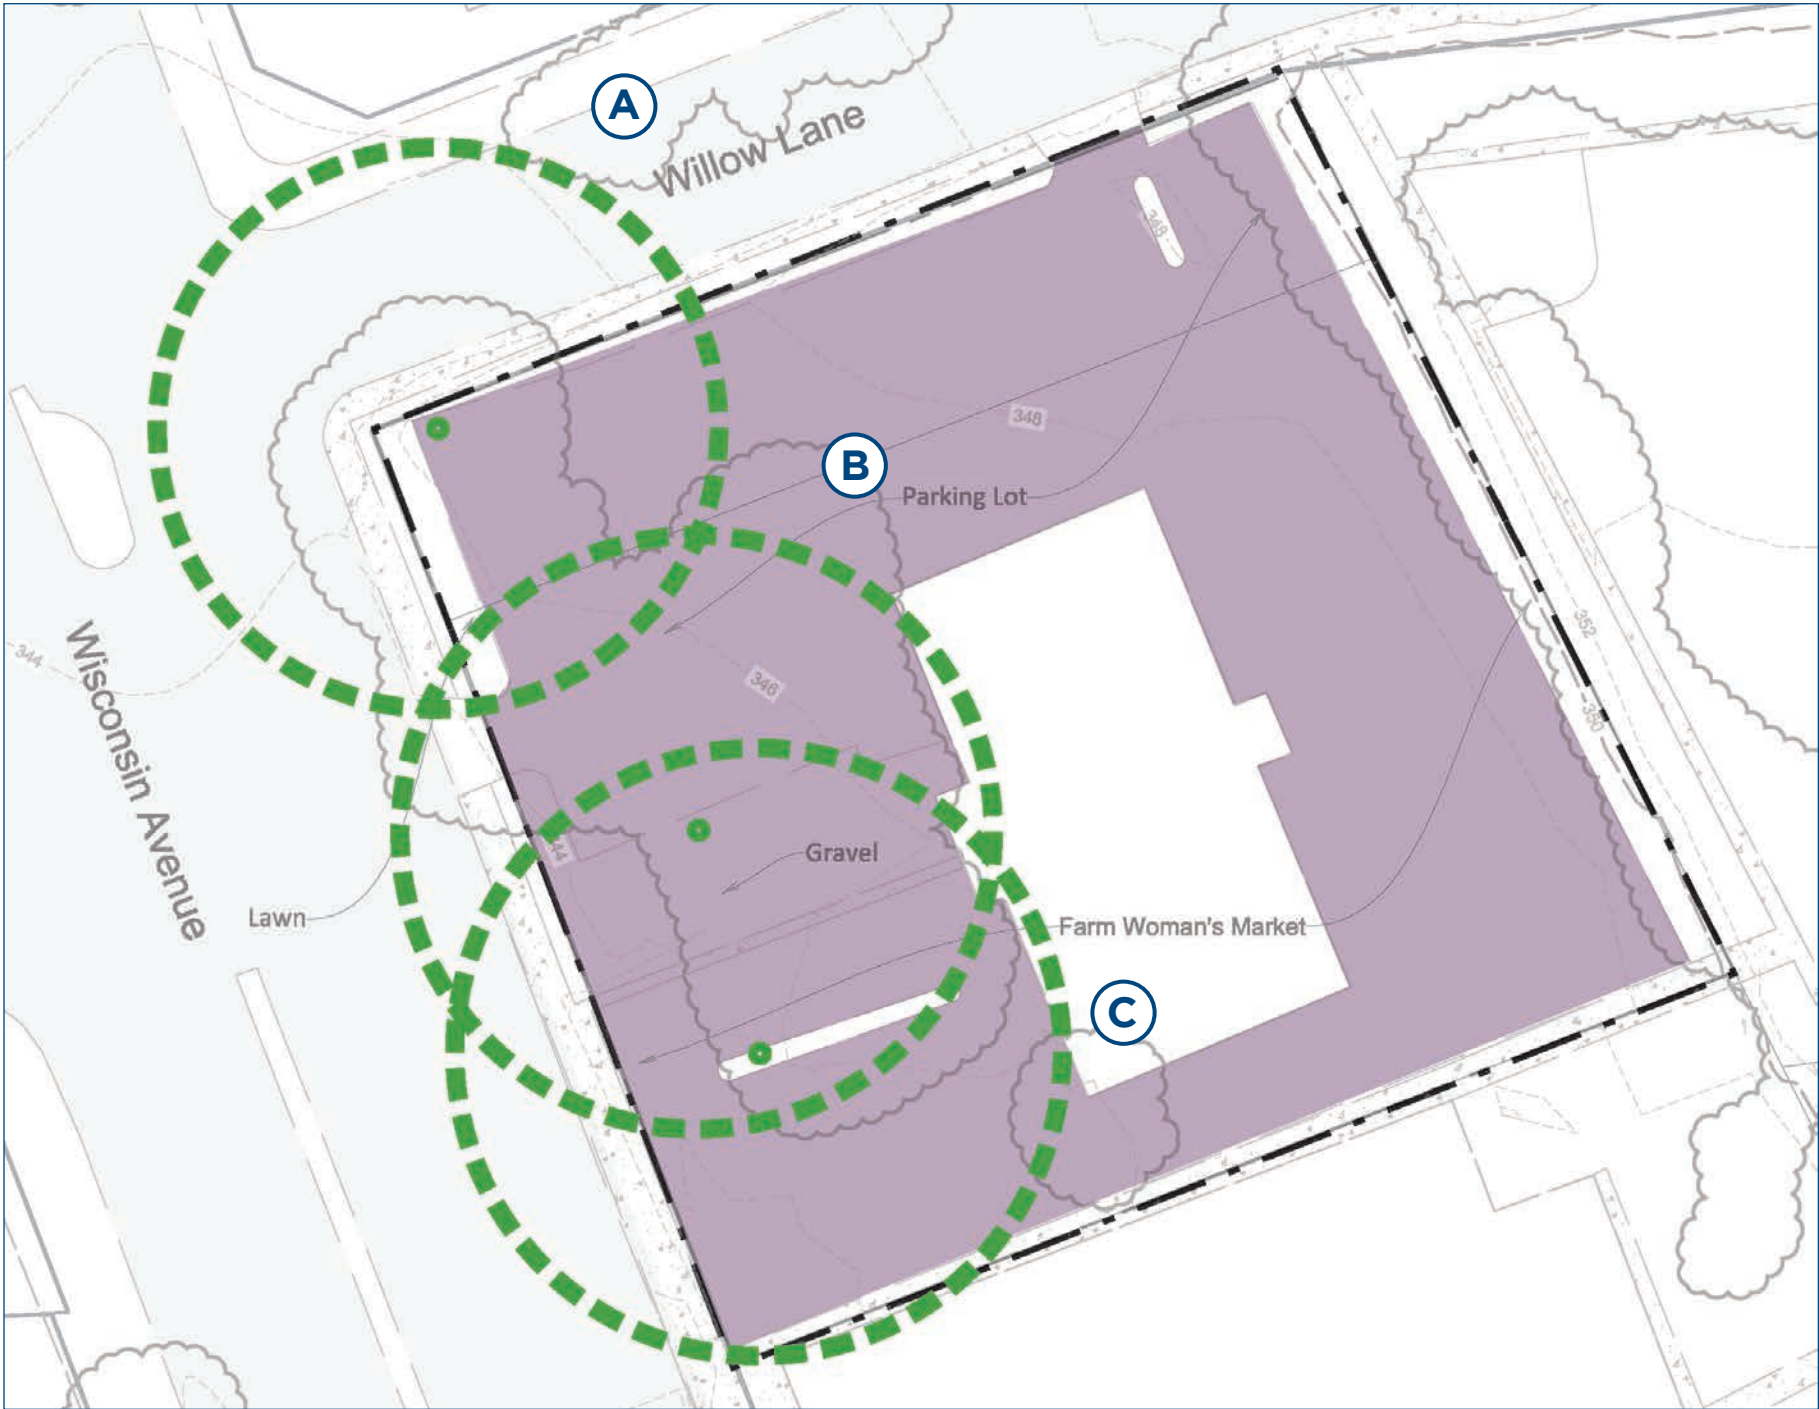
Farm Women's Market Existing Conditions

- A** TREE 'A' HAS BEEN IDENTIFIED AS AN ELM, AND HAS TWO OR MORE STEMS GROWING CLOSELY TOGETHER, CAUSING WEAK, UNDER-SUPPORTED BRANCH ANGLES.
- B** TREE 'B' HAS BEEN IDENTIFIED AS A SYCAMORE, WITH MAJOR STRESS TO BRANCHES.
- C** TREE 'C' IS ALSO A SYCAMORE BROKEN, STRESSED BRANCHES. ALL (3) TREES ARE IN FAIR CONDITION, AS DETERMINED BY THE NRI.

REPAIR, REPLACEMENT OR REMOVAL OF APPROXIMATELY 22,800 SQUARE FEET OF EXISTING ASPHALT AND GRAVEL WOULD RESULT IN 30% - 80% OF EACH TREE’S CRITICAL ROOT ZONE WILL BE IMPACTED. IN ACCORDANCE WITH THE MONTGOMERY COUNTY TREES: A TECHNICAL MANUAL, THE (3) SPECIMEN TREES SHOULD BE REMOVED AND REPLACED WITH LARGE SHADE TREES OF SIMILAR FORM.

Tree	Impact	% CRZ Impact
A	EXISTING ASPHALT REMOVAL	30%
B	EXISTING ASPHALT & GRAVEL REMOVAL	80%
C	EXISTING ASPHALT & GRAVEL REMOVAL	70%

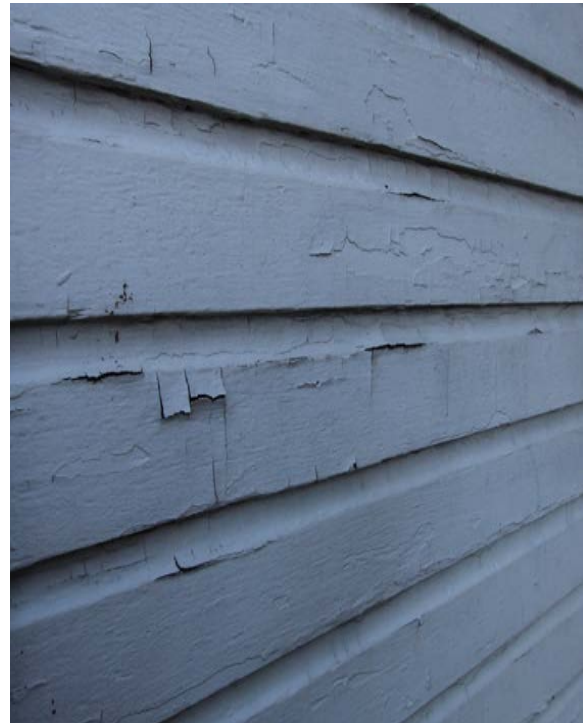
FIGURE 19 Detail of the wood siding and deteriorated paint.

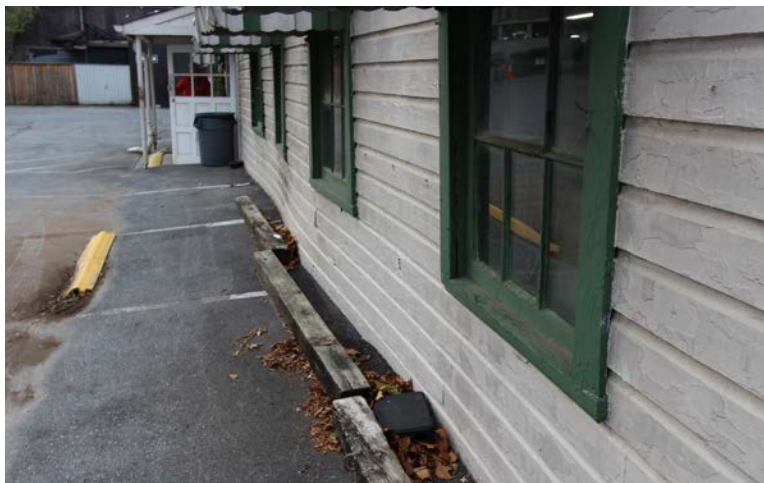
The north side of the elevation, undulates. This undulation is a result of the asphalt paving being poured against the wood frame walls (Figure 32). The areas of wood framing indent into the building, while the locations of the steel frame on the interior have pushed out against the pressure.

FIGURE 32 Undulation of the elevation

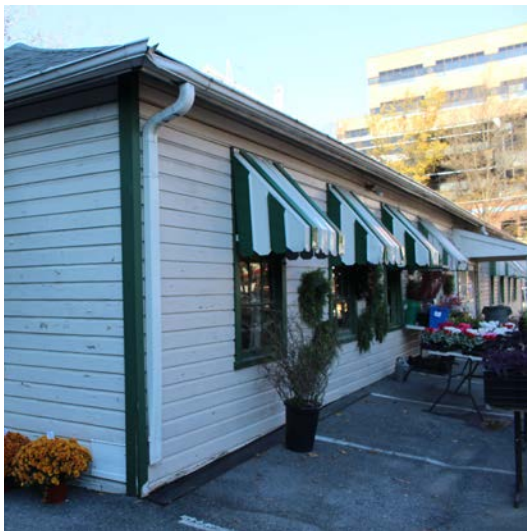
FIGURE 34 Reconstructed southeast corner.

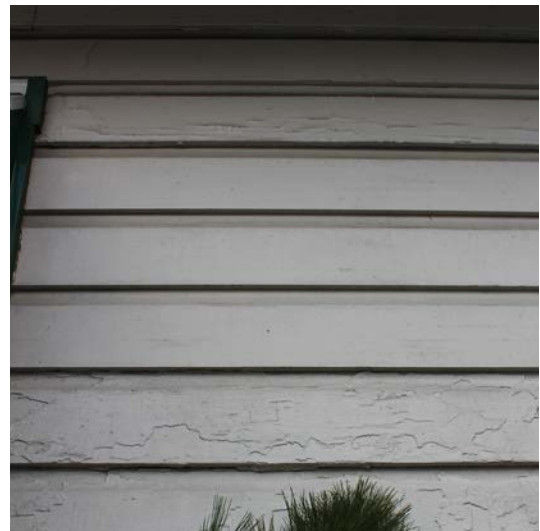
FIGURE 35 Replacement siding visible on east elevation.

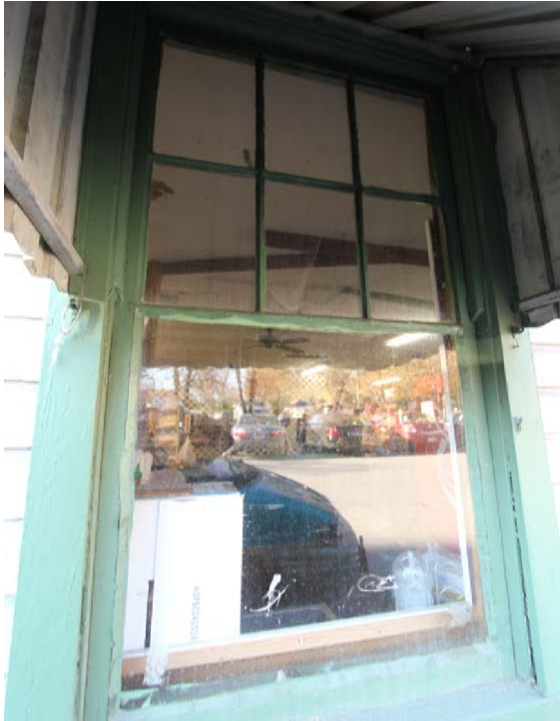
FIGURE 44 Extant window missing lower muntins.

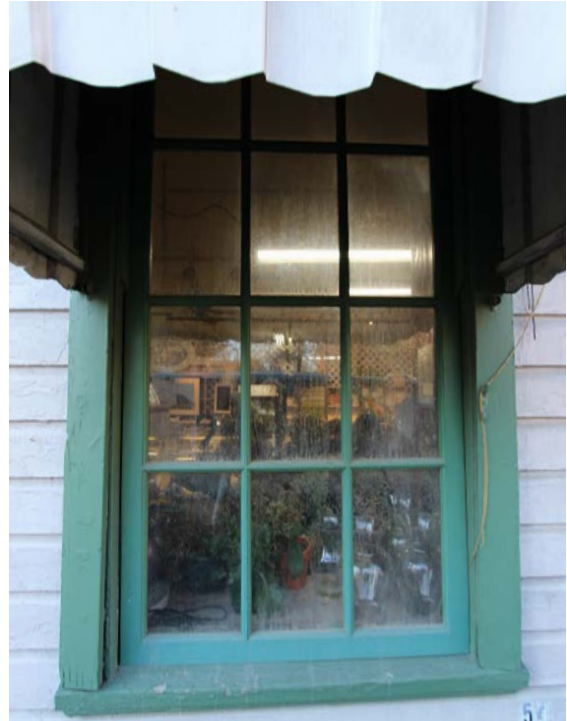
FIGURE 45 Replacement window on the east elevation.

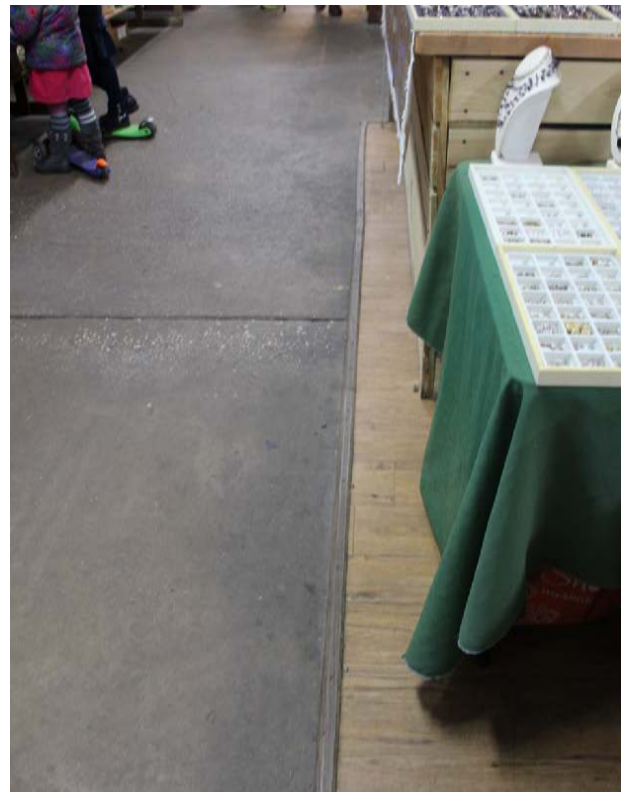
FIGURE 65 Detail of concrete flooring with added wood.

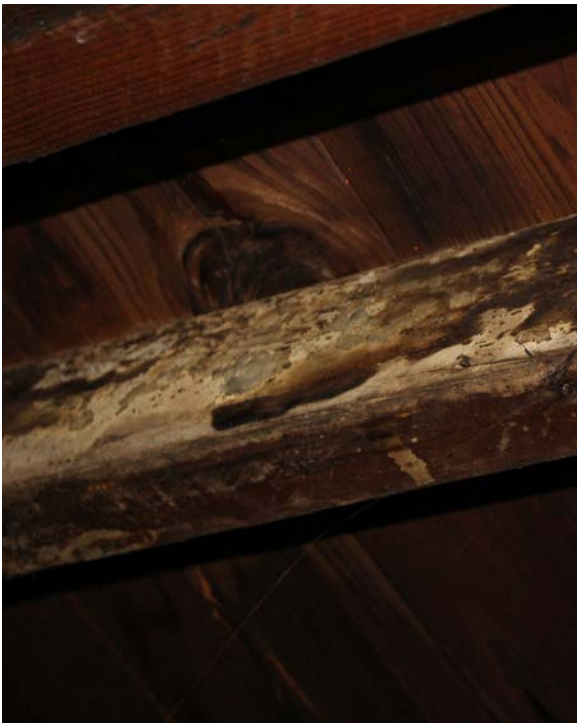
FIGURE 82 Termite damage evident in attic.

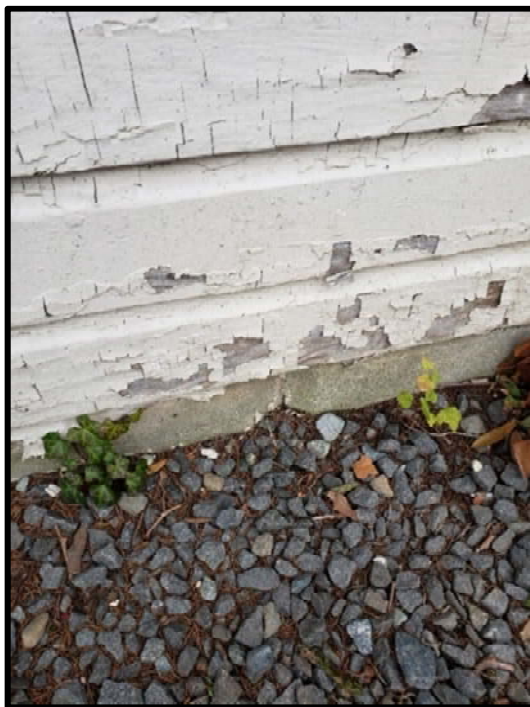
Visible concrete block located at the Southeast corner of the building indicates that a masonry "stem wall" extends up to grade to support the wood framed walls and avoid water exposure. Gravel around the perimeter assures proper drainage in this area. For the other perimeter areas, asphalt pavement has been built up and sand bags have been placed in an attempt to prevent water from entering the building. However, this condition has caused the wall elements to be pushed inward and create a condition where the wood wall framing is in constant contact with moisture from the pavement. Examples of both conditions can be seen in Figure 3 and Figure 4.

Figure 3 - Existing Drainage Conditions Along East Wall

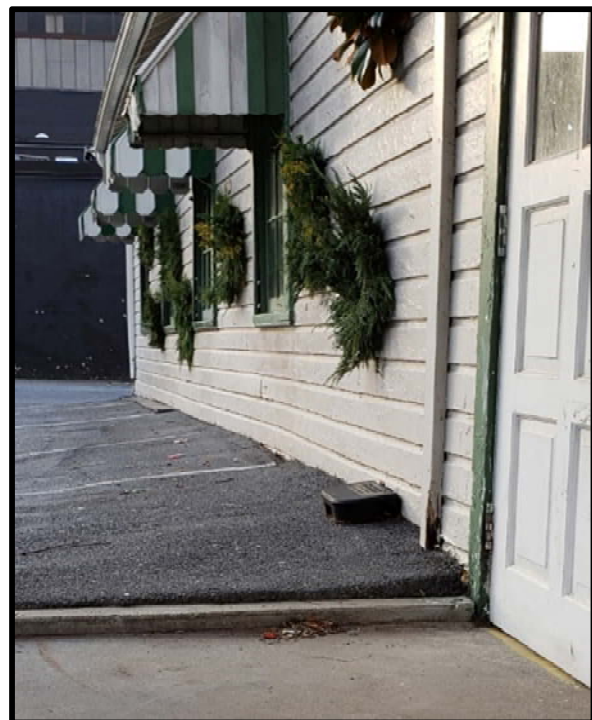
Figure 4 – Built Up Asphalt Against East Wall

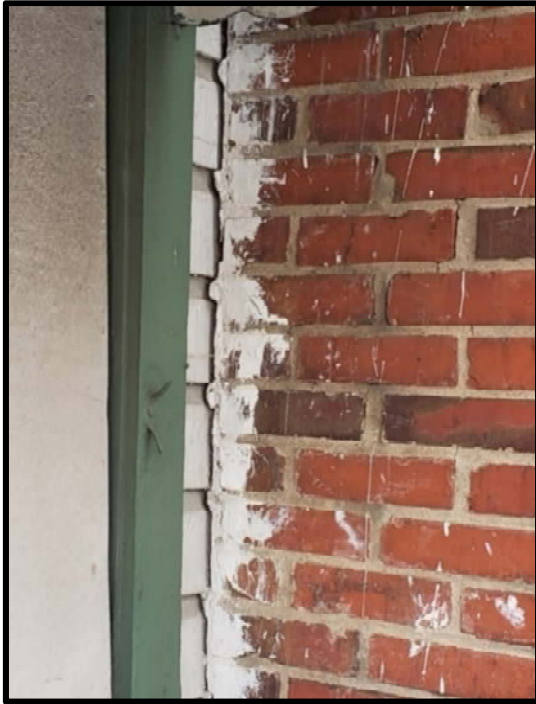
Figure 16 – Visible Gap Between Buildings and Chimney
