Preliminary Consultation
MONTGOMERY COUNTY HISTORIC PRESERVATION COMMISSION
STAFF REPORT

Address:	7700 Seven Locks Rd., Bethesda	Meeting Date:	2/26/2020
Resource:	Master Plan Site #29/39 Gibson Grove AME Zion Church	Report Date:	2/19/2019
Applicant:	First Agape AME Zion Church (Thomas Taltavull, Architect)	Public Notice:	2/12/2019
Review:	Preliminary Consultation	Tax Credit:	N/A
Case Number:	N/A	Staff:	Michael Kyne
PROPOSAL:	Demolition and stabilization

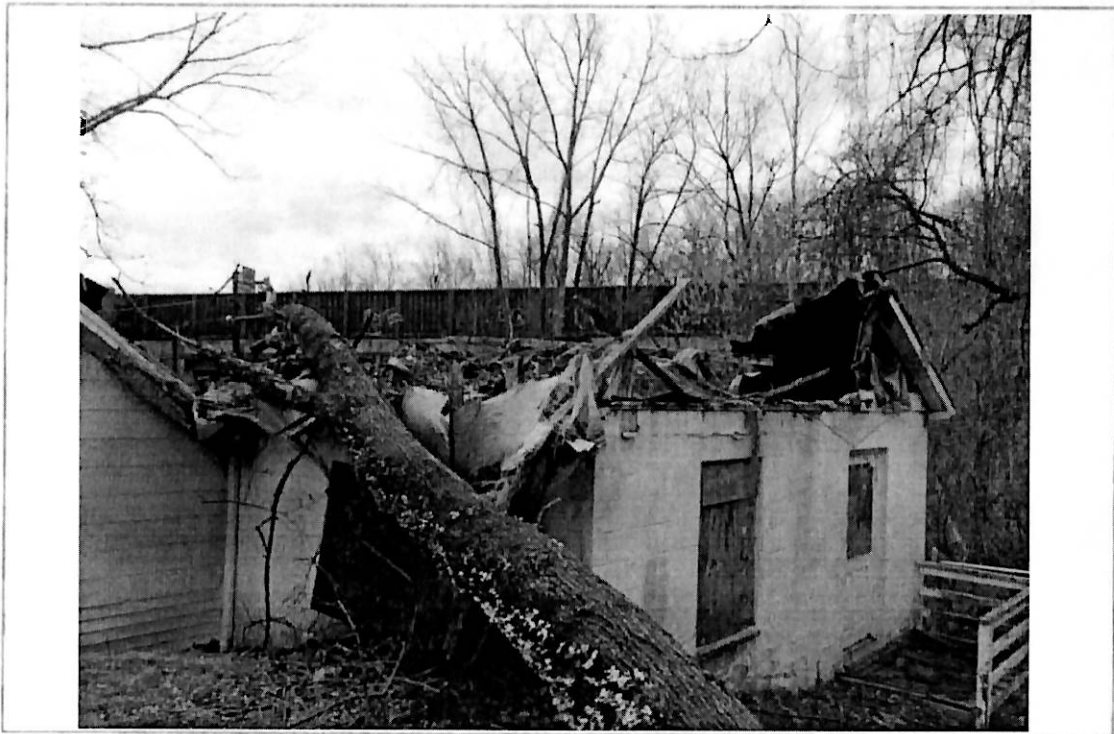
Detail: Photo No. 4: Rear (West) elevation view of damaged structure

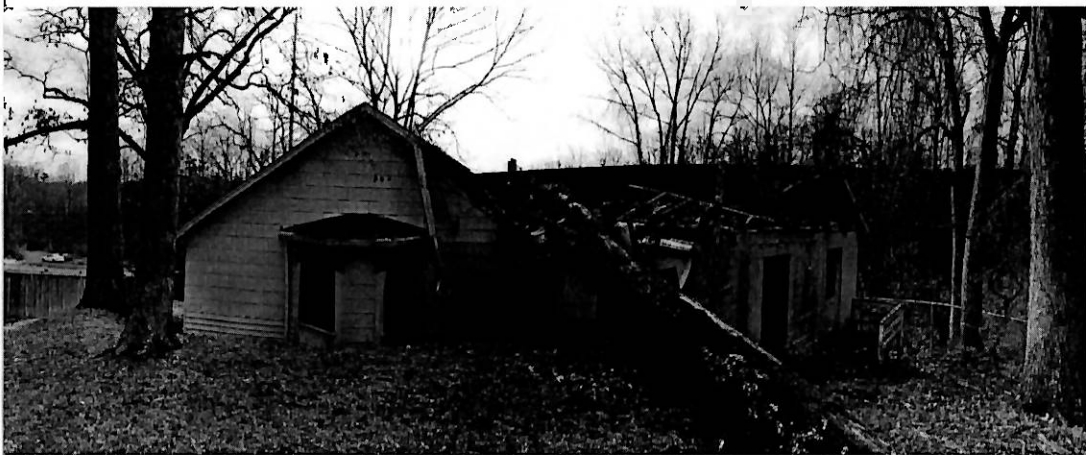
Photo No. 5: Rear (West) elevation view of damaged structure
Detail: _____

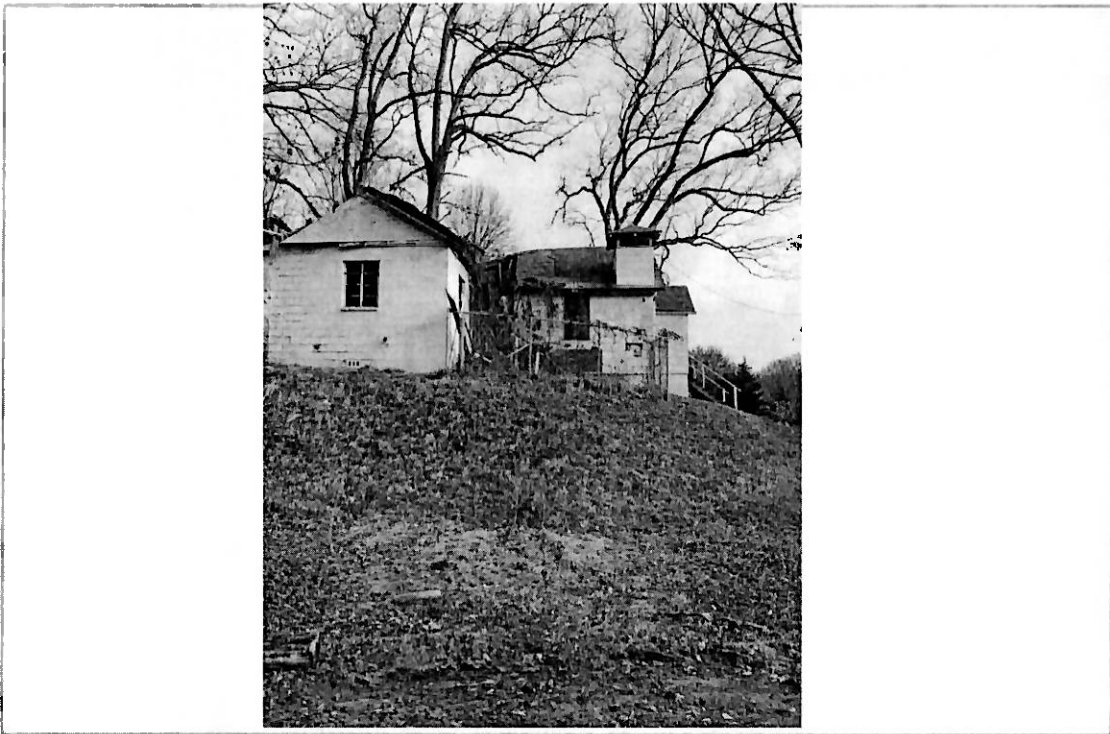
Photo No. 6: Left Side (South) elevation view of damaged structure
Detail: _____

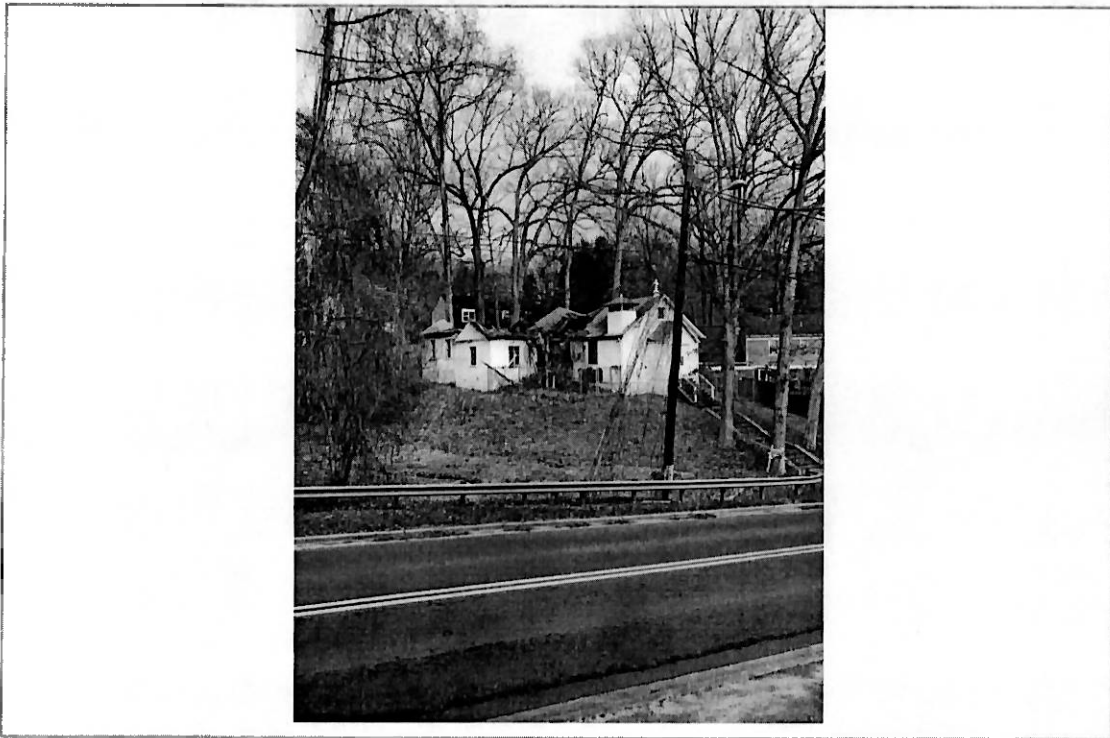
Photo No. 7: View of damaged structure looking Northwest

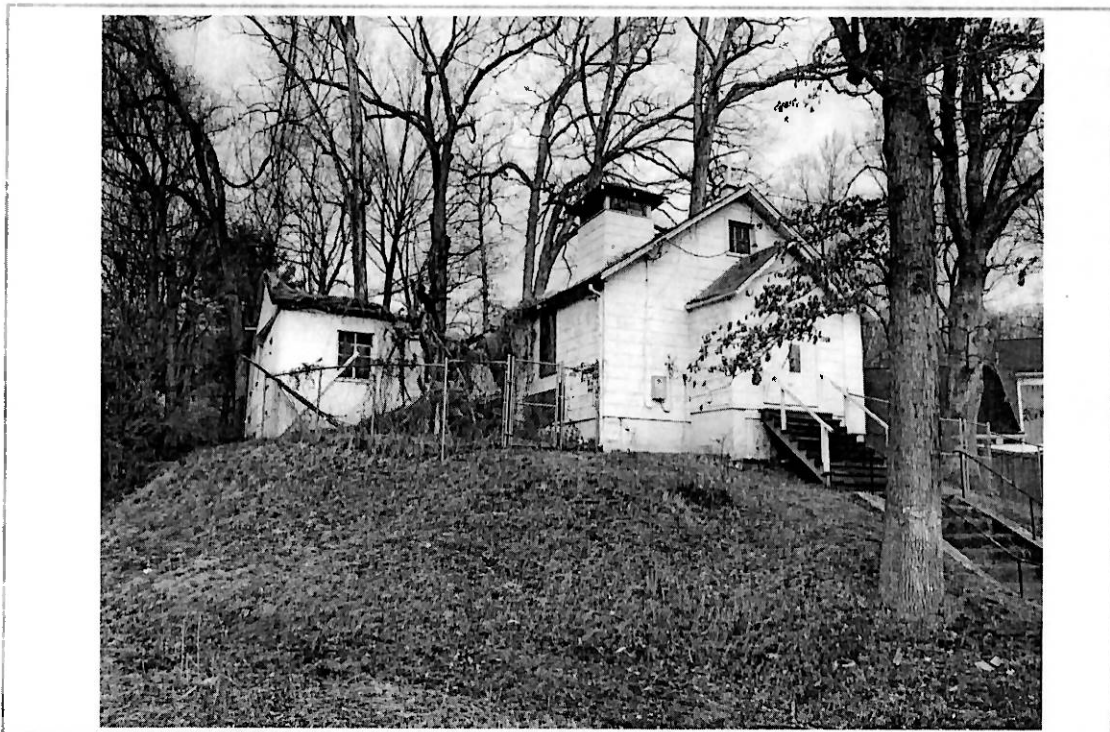
Photo No. 8: View of damaged structure looking Northwest

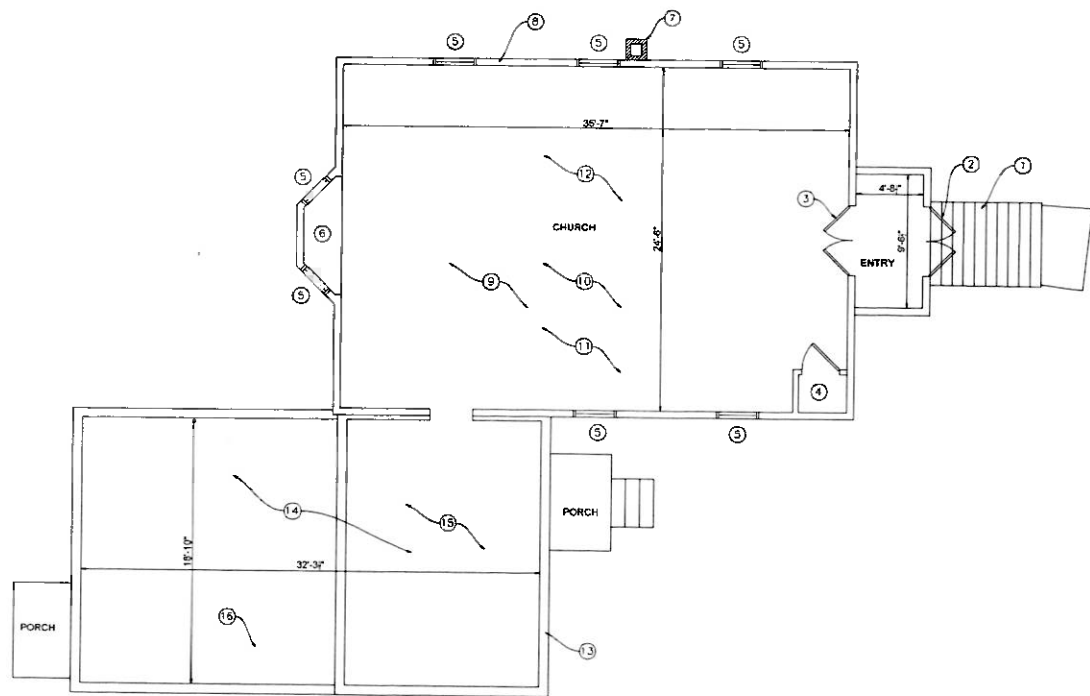
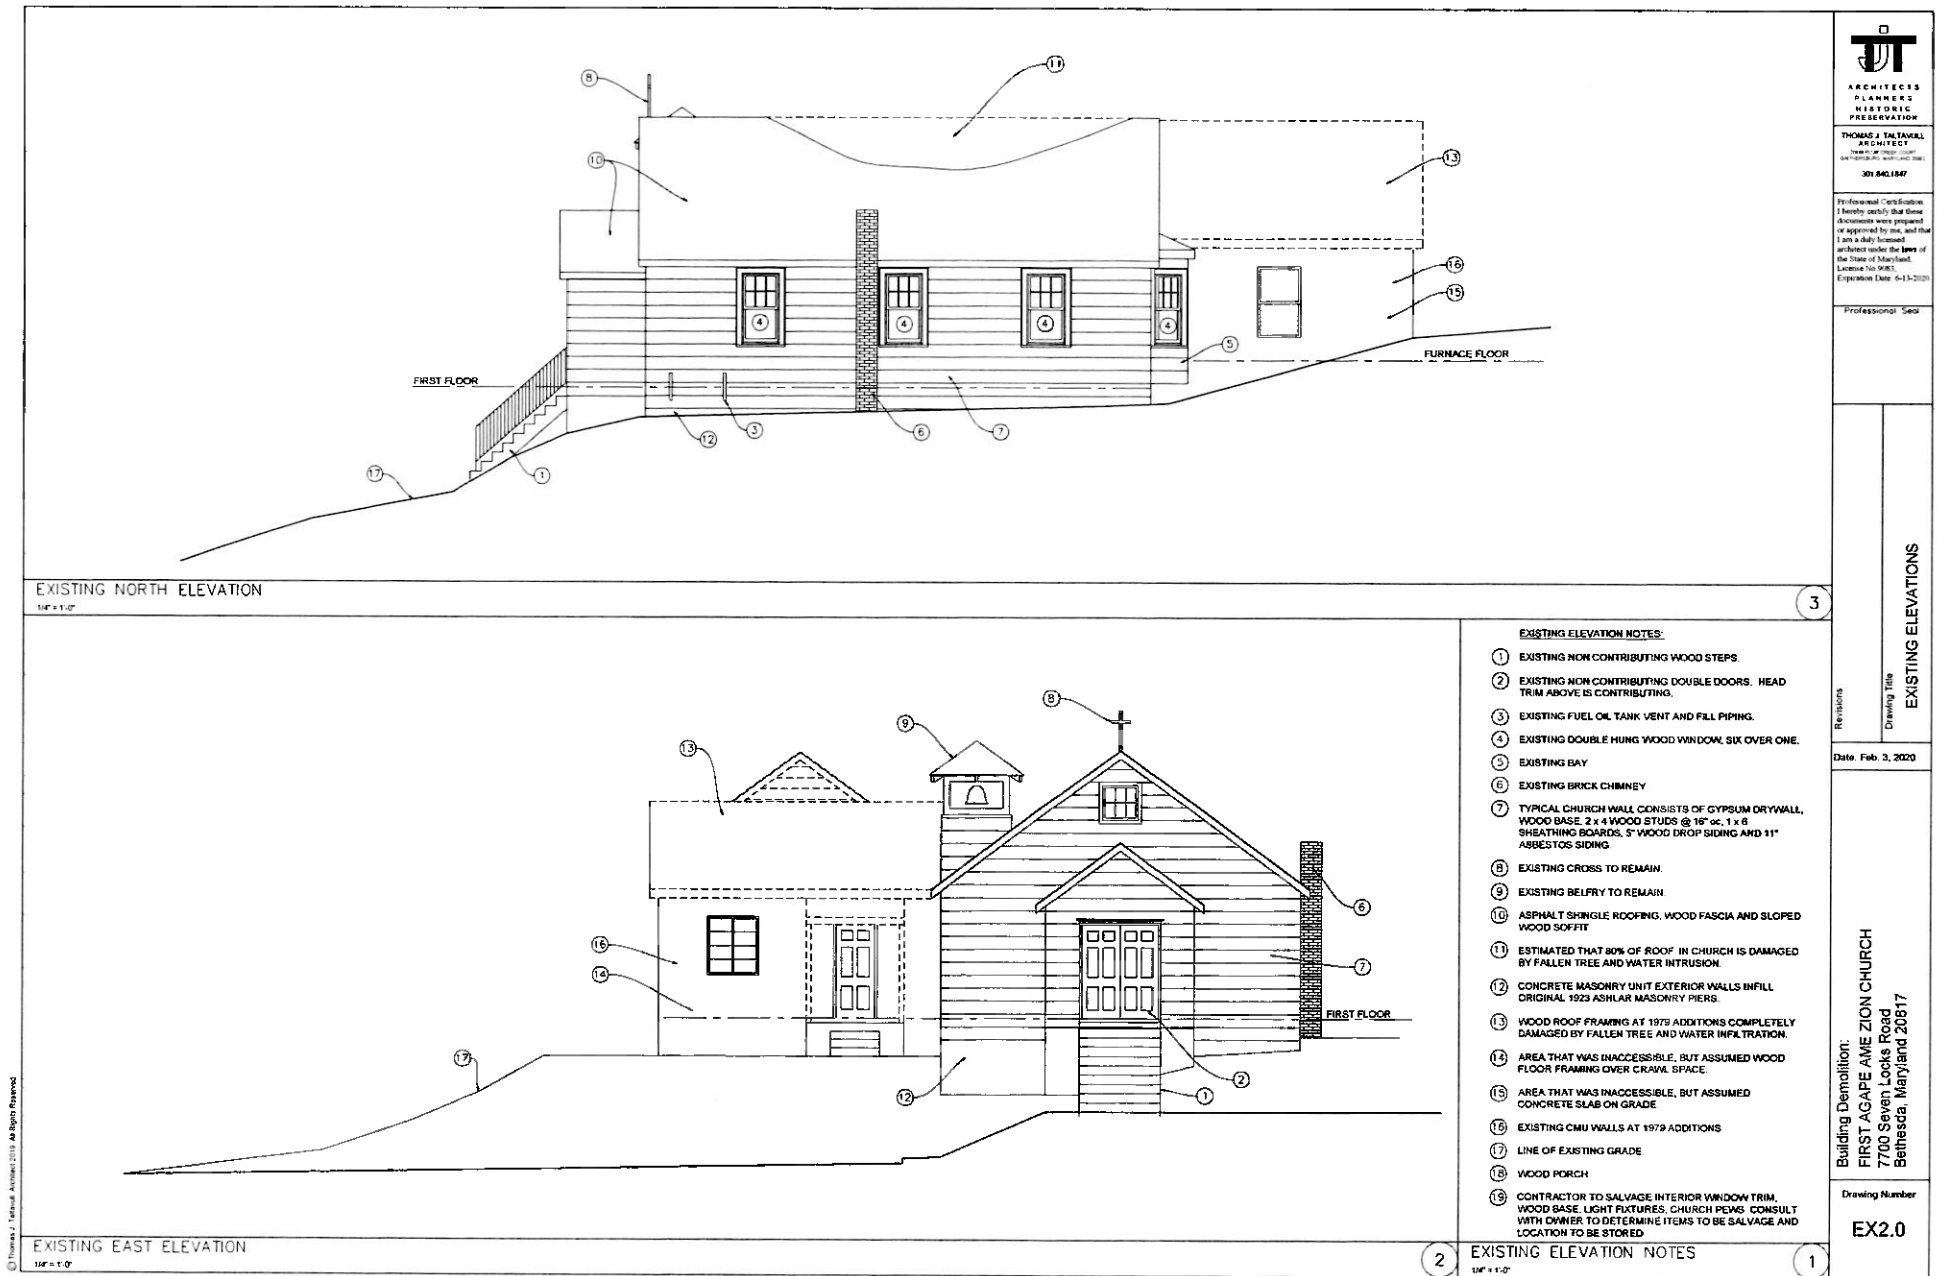
EXISTING FLOOR PLAN

- ⑨ WOOD FLOOR FRAMING (2 x 12" @ 16")
- ⑩ WOOD ROOF FRAMING 2 x 8 @ 24" oc WW 2 x 6 @ 24" CEILING JOISTS AT 11'-2" A.F.F.
- ⑪ ESTIMATED THAT 80% OF ROOF AND FLOOR FRAMING IN CHURCH IS DAMAGED BY FALLEN TREE AND WATER INTRUSION.

- ⑫ CARPET FLOORING
- ⑬ CONCRETE MASONRY UNIT EXTERIOR WALLS.
- ⑭ WOOD ROOF FRAMING AT 1975 ADDITIONS COMPLETELY DAMAGED BY FALLEN TREE AND WATER INFILTRATION.

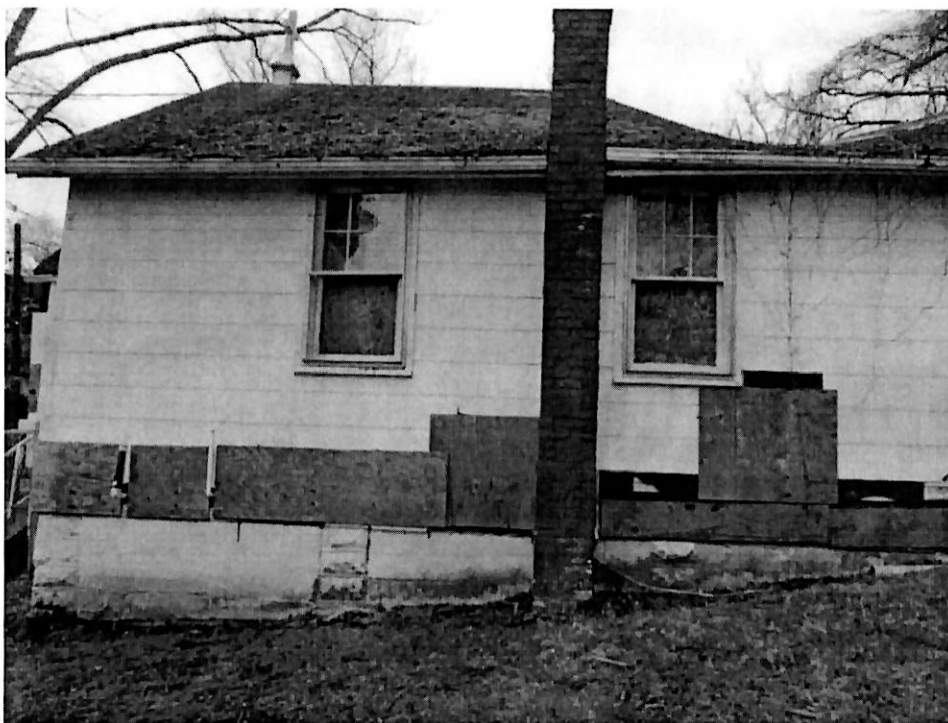
Photo No. 6: Partial view of the front half of the north elevation showing boarded wall openings and windows, extreme moss growth on the intact portion of the roof, as well as the collapsed section of the roof (right side).

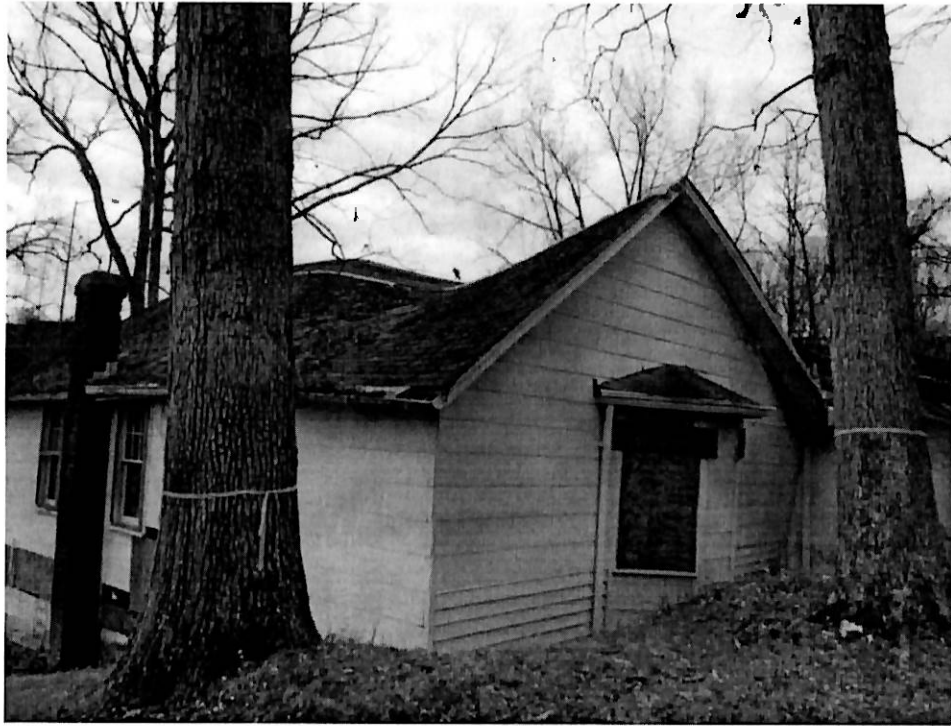
Photo No. 7: View of the northwest corner of the structure, showing similar issues noted in the previous photo.

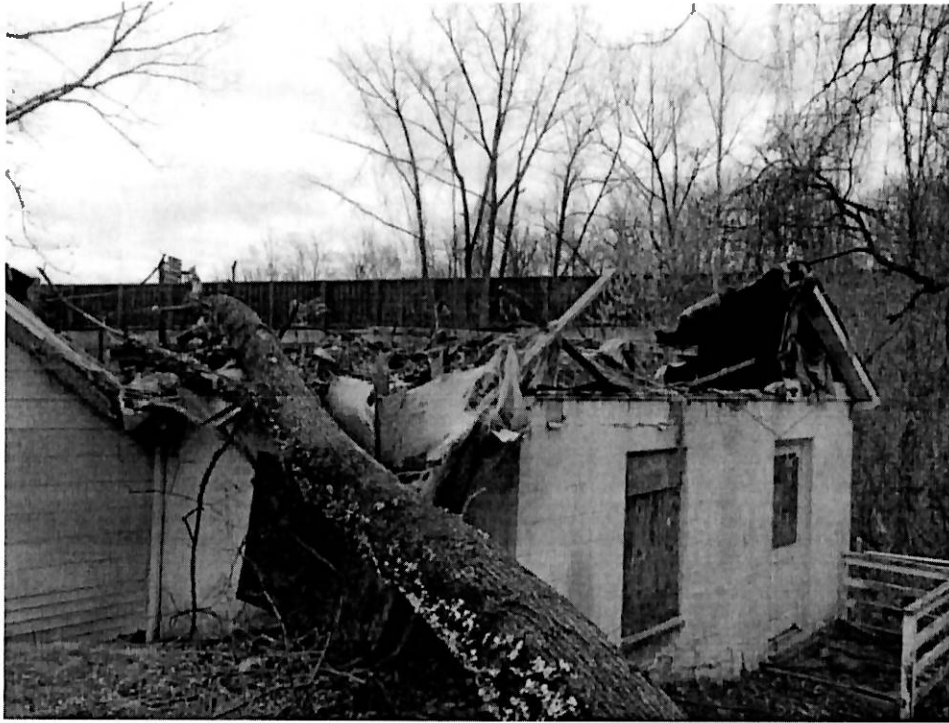
In 2007, the existing structure was damaged by a fire which caused it to be uninhabitable since that time. Approximately four years ago, the structure was impacted by a collapsed tree which severely damaged the south and west portions of the roof structure such that there has been a very large opening in the roof (Photo Nos. 8 and 10 thru 13). Not only has this portion of the roof been completely compromised, the structure beneath this opening has been exposed to the elements for over 10 years, including rain, wind, snow, and frankly, local wildlife. In our opinion, this portion of the structure cannot be saved.

Photo No. 8: View of the southwest portion of the structure (see from the northwest) which has been impacted by a collapsed tree (purportedly in 2007).

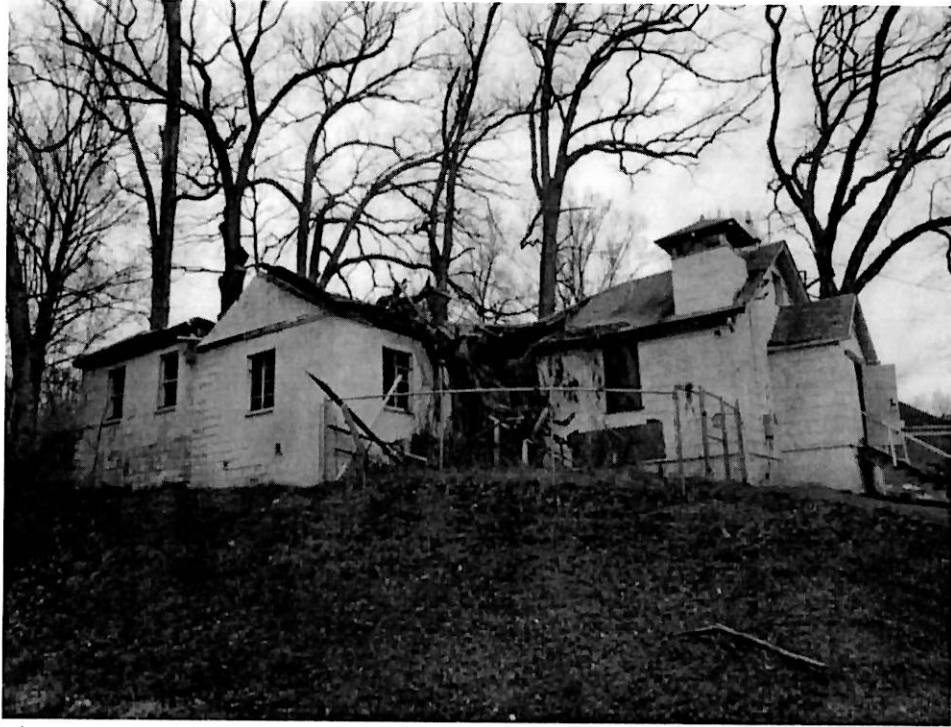
Photo No. 9: General view of the structure's southeast corner as seen from the level of the streambed to the south. Note that the roof of the structure's southwest has been completely collapsed; however, the front portion of the structure (including front entranceway and bell tower) remain intact.

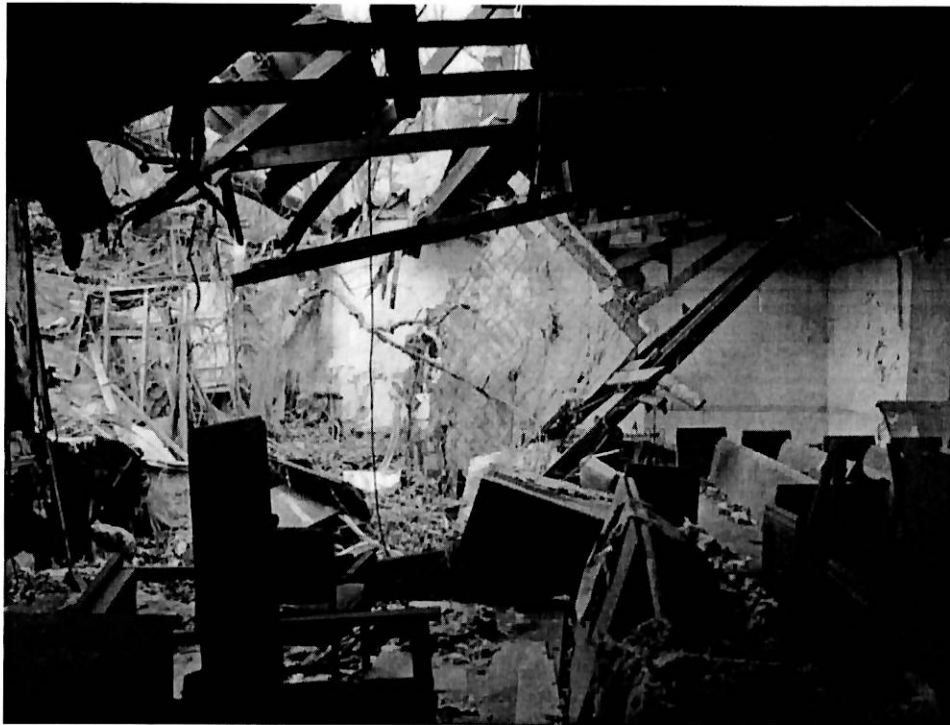
Photo No. 11: Interior view of the structure (looking west from the front entranceway), exhibiting the collapsed roof of the southwest corner.

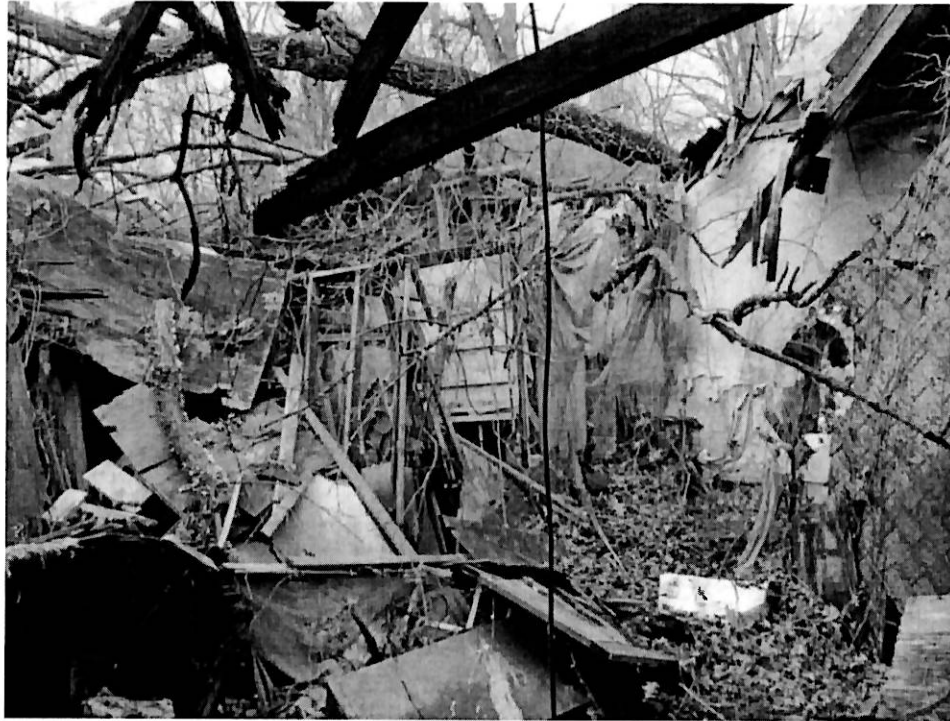
Photo No. 12: Similar view as the previous photo, looking south from the center of the floor plan.

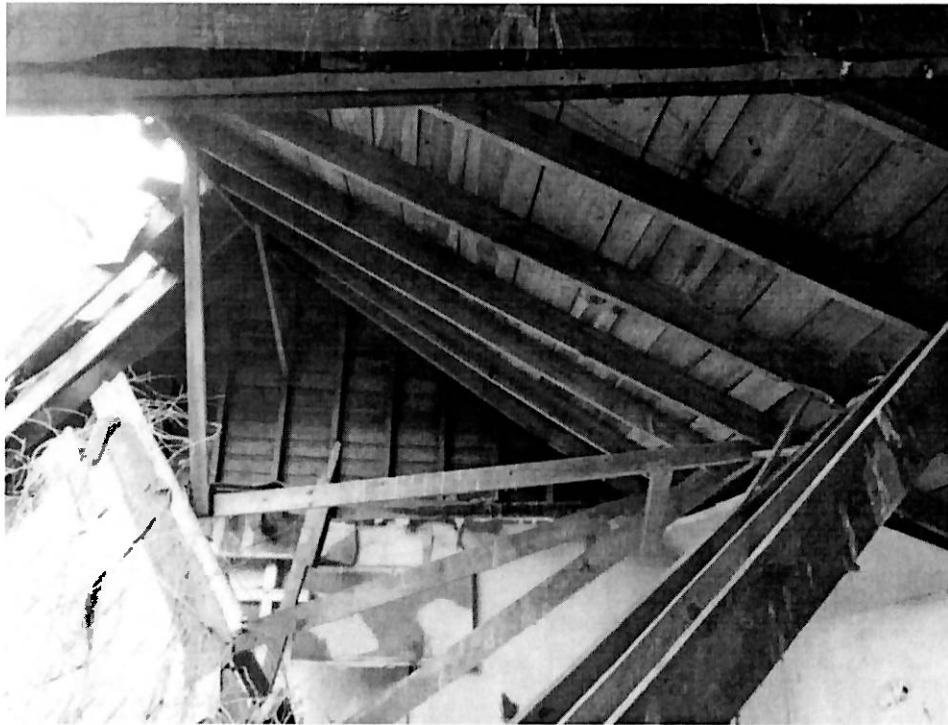
Photo No. 13: View collapsed roof framing along the west end of the structure. Note that wall and roof framing consists of 1" thick wood boards of various widths attached to solid sawn rafters or studs.

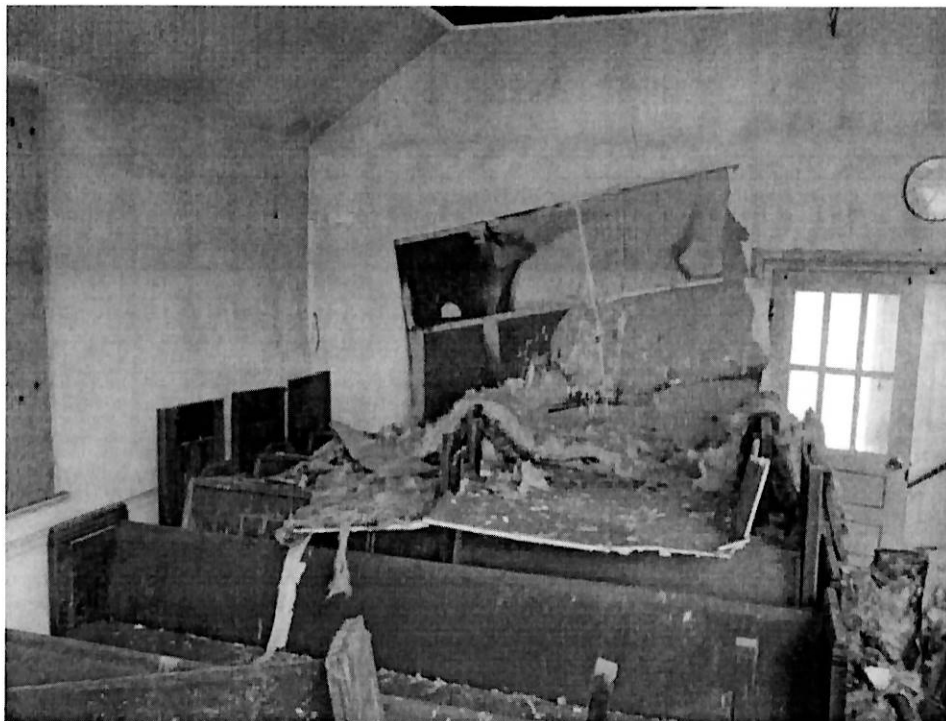
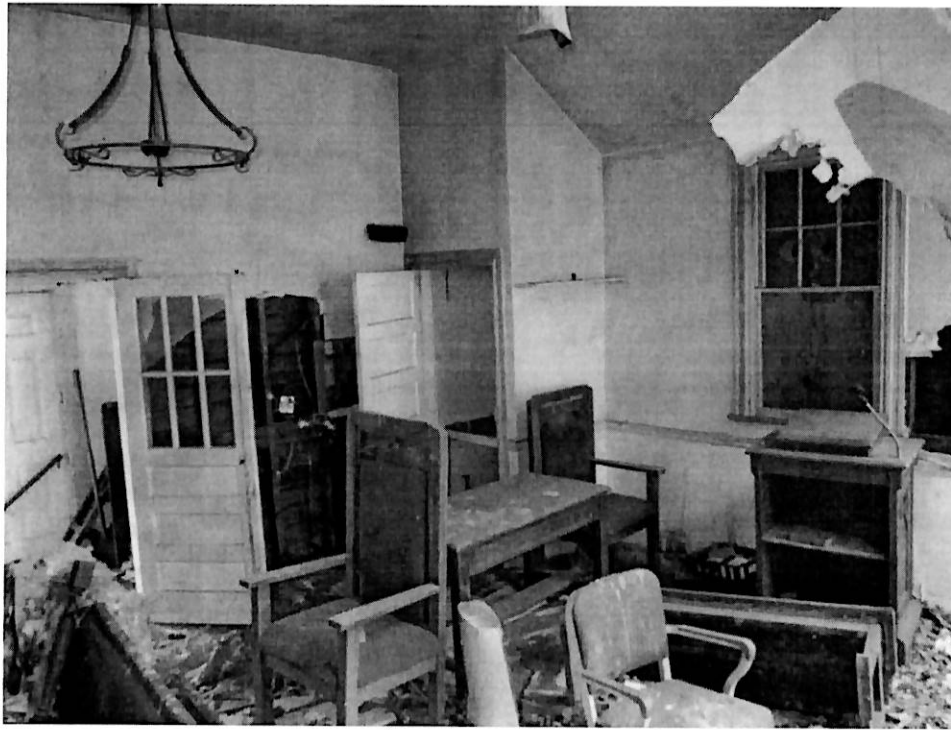
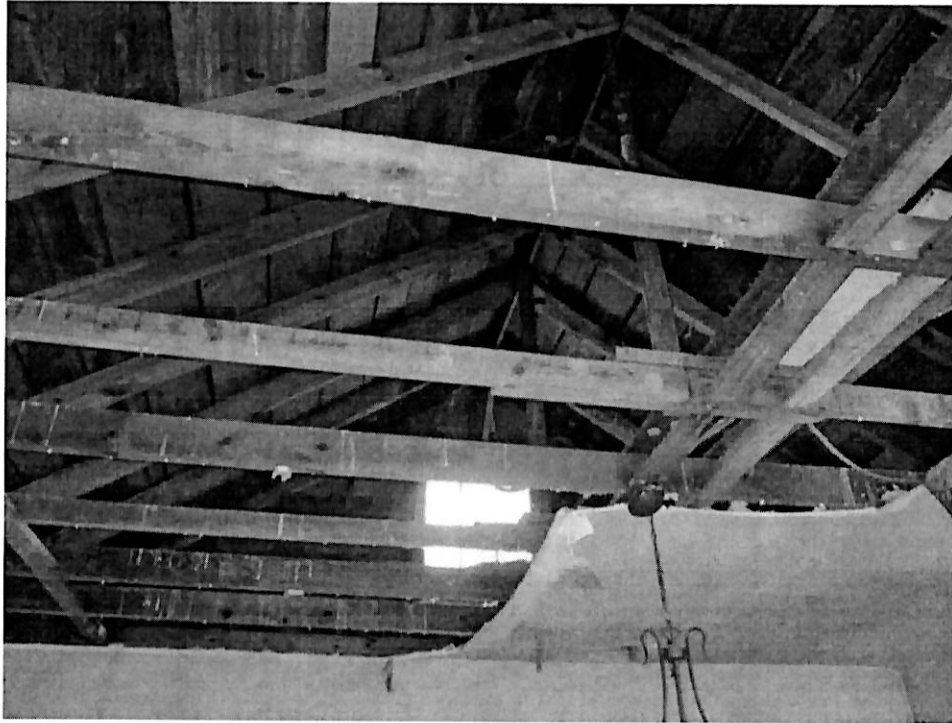
Though no area of the structure is completely unaffected by the fire or the collapsed tree, the front (east end) of the structure is relatively unscathed in comparison to the west and south portions. As seen in Photo Nos. 14 thru 16, the roof and wall framing of the entrance enclosure as well as the first 5' to 6' of the main structure (including the bell tower) remain upright, plumb and intact. In our opinion, it is indeed possible to carefully detach this portion of the structure from the remainder of the structure for the purposes of re-integrating it into a replacement structure.

Photo No. 14: View of structure's relatively intact northeast corner at the front entrance area.

Photo No. 15: View of structure's relatively intact southeast corner at the front entrance area.

Photo No. 16: View of structure's intact roof framing above the front entrance area.

Assuming that complete demolition is deemed to be unacceptable, we strongly recommend that only the entrance enclosure and the first 5' to 6' of the main structure (including the bell tower) be saved, and that the remainder of the structure be demolished. In addition, the exterior cladding of the portion to be saved (i.e., the asbestos wall tiles and severely compromised asphalt roof shingles) should be removed in its entirety due to health and material degradation reasons. In other words, only the underlying wood framing elements should be re-integrated into the replacement structure.
