*Preliminary Consultation*  
**MONTGOMERY COUNTY HISTORIC PRESERVATION COMMISSION**  
**STAFF REPORT**

<b>Address:</b>	7417 Maple Ave., Takoma Park	<b>Meeting Date:</b>	3/11/2020
<b>Resource:</b>	Contributing Resource <b>Takoma Park Historic District</b>	<b>Report Date:</b>	3/4/2020
<b>Applicant:</b>	David Bend	<b>Public Notice:</b>	2/26/2020
		<b>Tax Credit:</b>	No
<b>Review:</b>	Preliminary Consultation	<b>Staff:</b>	Michael Kyne
<b>Case Number:</b>	N/A		
<b>PROPOSAL:</b>	Window replacement

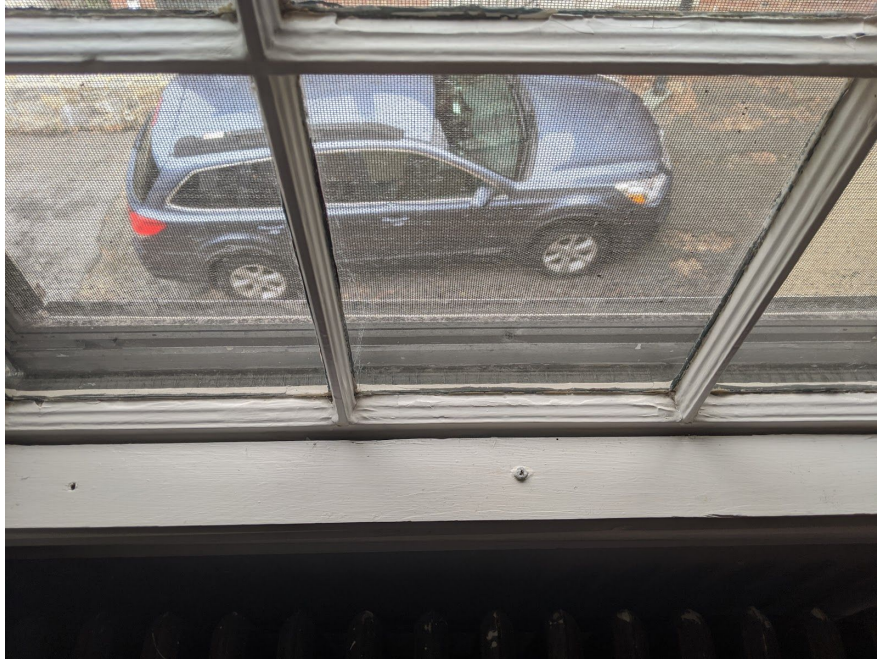
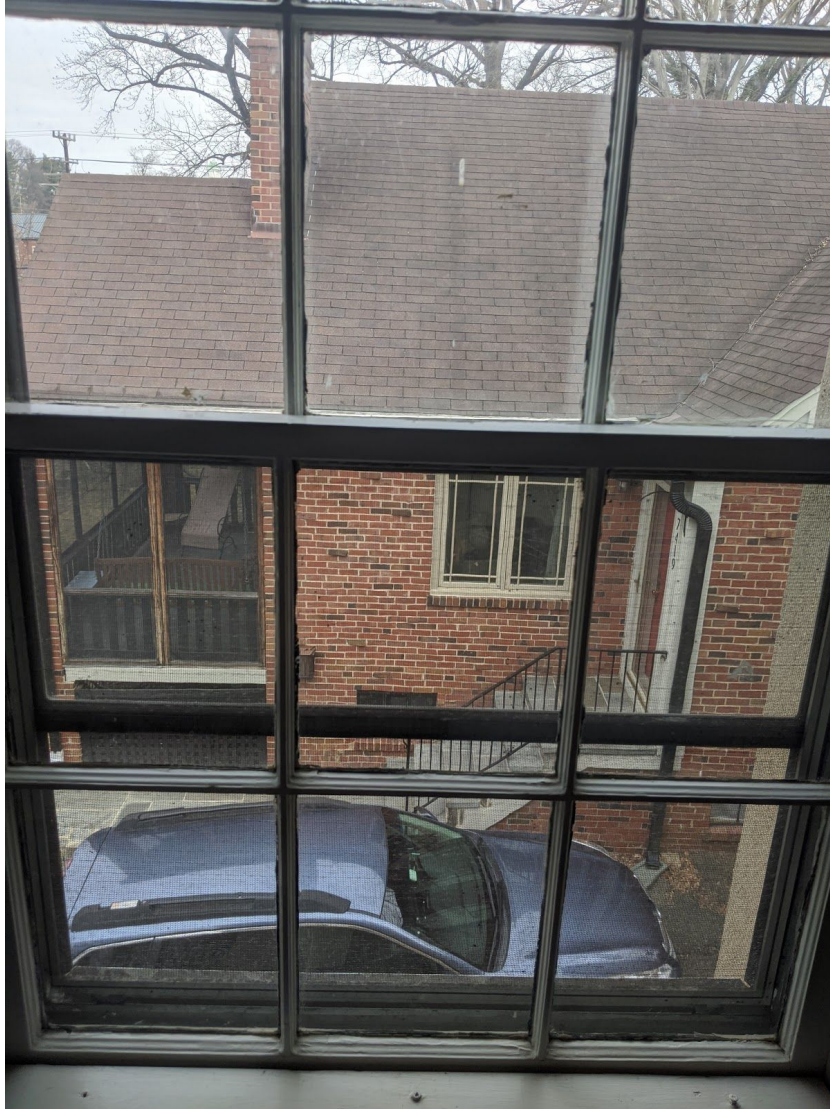
#### Child's Bedroom 1 Photos

- Conditions assessment
  - The window is extremely energy inefficient and leaks cold air into our home. The bottom of the window is severely deteriorated (photo included) which is leading to the leakiness. Our daughter has asthma and she has had breathing challenges since we moved in as a result of the cold air which is also disturbing her sleep. An energy audit commissioned through Pepco (attached) identified our windows as one of the biggest sources of energy loss in our home. We are very committed to doing what is in our control to limit our carbon footprint which is also in alignment with Montgomery County's climate commitments. In addition, the leakiness makes the room very noisy and since we live on a busy street and the frequent honking and transit bus noise has been disturbing our daughter's sleep.

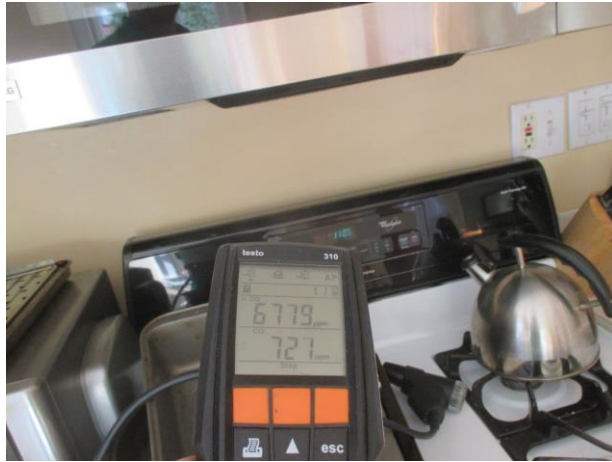
The oven for this house is currently outputting a high level of carbon monoxide. This is typically caused by having an improper fuel to air mixture or dirty burners. The oven should be serviced by an appliance technician like Sears or A&E Appliance to lower Carbon Monoxide output below 100ppm.

High CO reading from oven

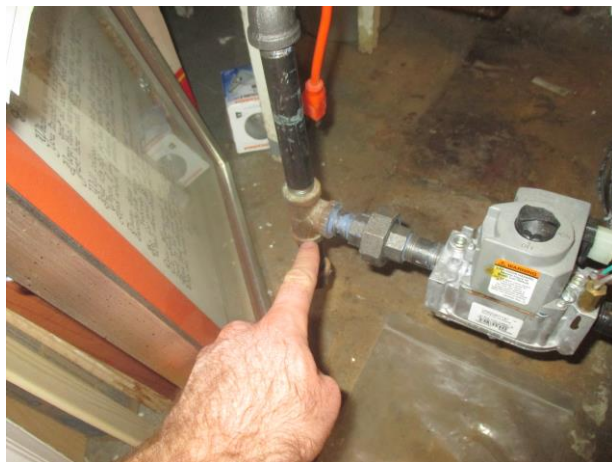
The auditor detected a potential natural gas leak / issue in the basement. An HVAC technician or certified plumber should remediate this situation before air sealing and insulation work can be done in your home. The specific location where a gas leak was detected is at the gas line near the water heater in the basement. Refer to picture.

Gas leak detected near water heater

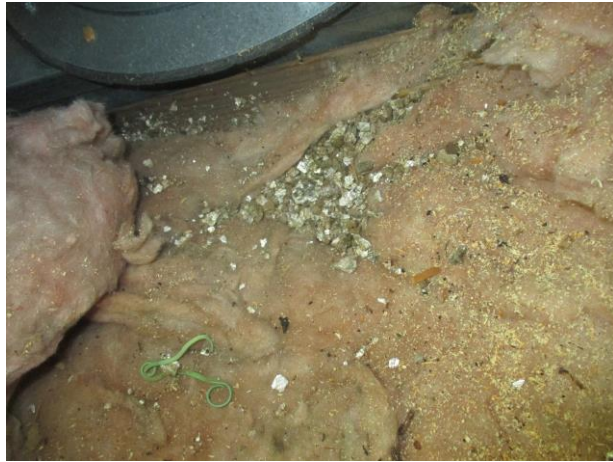
Currently, the attic is insulated with vermiculite. This is a pebble-like insulation that is no longer used because of potential health risks. Vermiculite may contain asbestos, and because of this, your attic should be inspected and remediated by a professional abatement company.

Potential vermiculite with asbestos

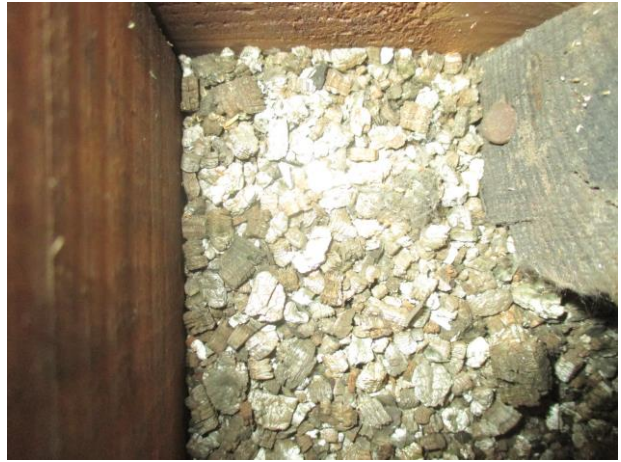
Vermiculite under fiberglass batts

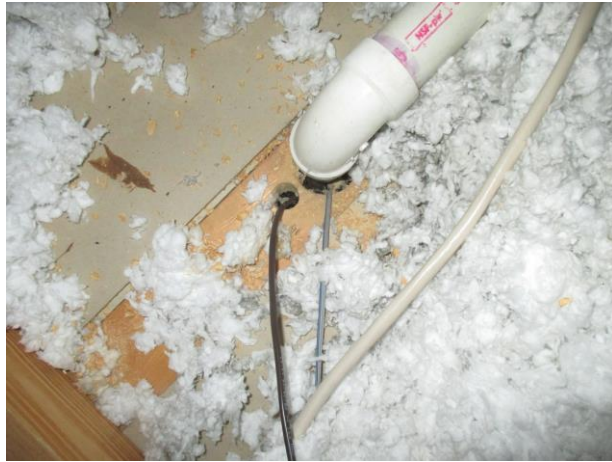
There are numerous gaps and cracks at top plates, electrical/mechanical/plumbing penetrations and recessed lights which allow air leakage into the attic. These areas should be sealed with spray foam insulation to reduce heat loss during the winter and heat gain during the summer.

Common plumbing and wiring penetration

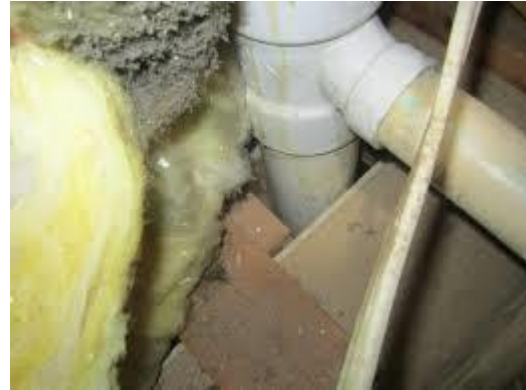
Common plumbing penetration in attic

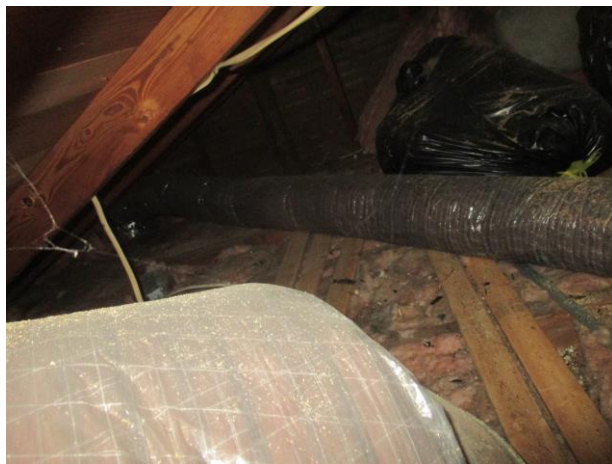
The attic insulation levels are currently only R-13 which is much less than the current code of R-49. In addition, there are areas in the attic where the insulation has been trampled by maintenance work and is as low as R-0 levels. Additional loose fill insulation should be added to bring the attic to R-49.

Current main attic insulation

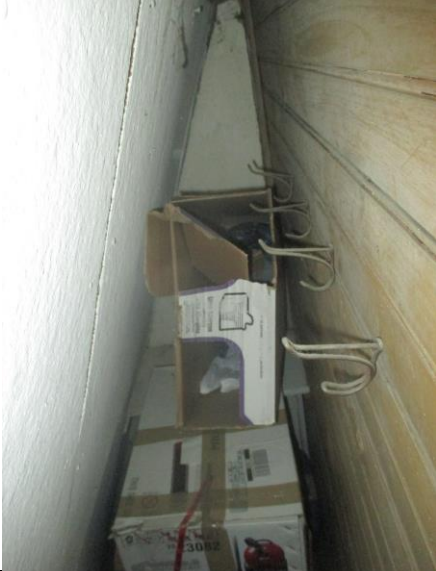
The dormer closet areas in the 2nd floor are currently not sealed to prevent air from leaking into the house. All of the existing fiberglass insulation should be removed to allow access to install spray foam insulation that will stop air movement and provide a superior insulation value. This should occur in all dormer areas.

Dormer within 2nd floor closet

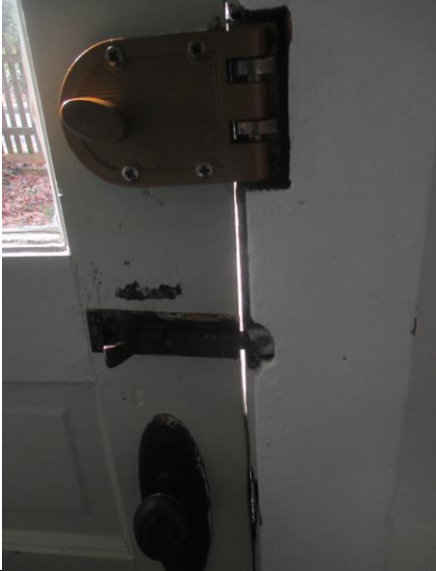
A few doors around the house are poorly sealed and need to have new weather-stripping installed. Kerf style foam weather-stripping should be installed around the perimeter of the door and a new threshold sweep should be installed. The strike plate for the door may need to be adjusted to ensure a tight seal when the doors are closed.

Current basement door weather-stripping
