MONTGOMERY COUNTY HISTORIC PRESERVATION COMMISSION
STAFF REPORT

Address:	7700 Seven Locks Rd., Bethesda	Meeting Date:	3/25/2020
Resource:	Master Plan Site #29/39 Gibson Grove AME Zion Church	Report Date:	3/18/2019
Applicant:	First Agape AME Zion Church (Thomas Taltavull, Architect)	Public Notice:	3/11/2019
Review:	HAWP	Tax Credit:	N/A
Case Number:	29/39-20A	Staff:	Michael Kyne
PROPOSAL:	Demolition and stabilization

29/39 Gibson Grove African Methodist Episcopal Zion Church (1923)

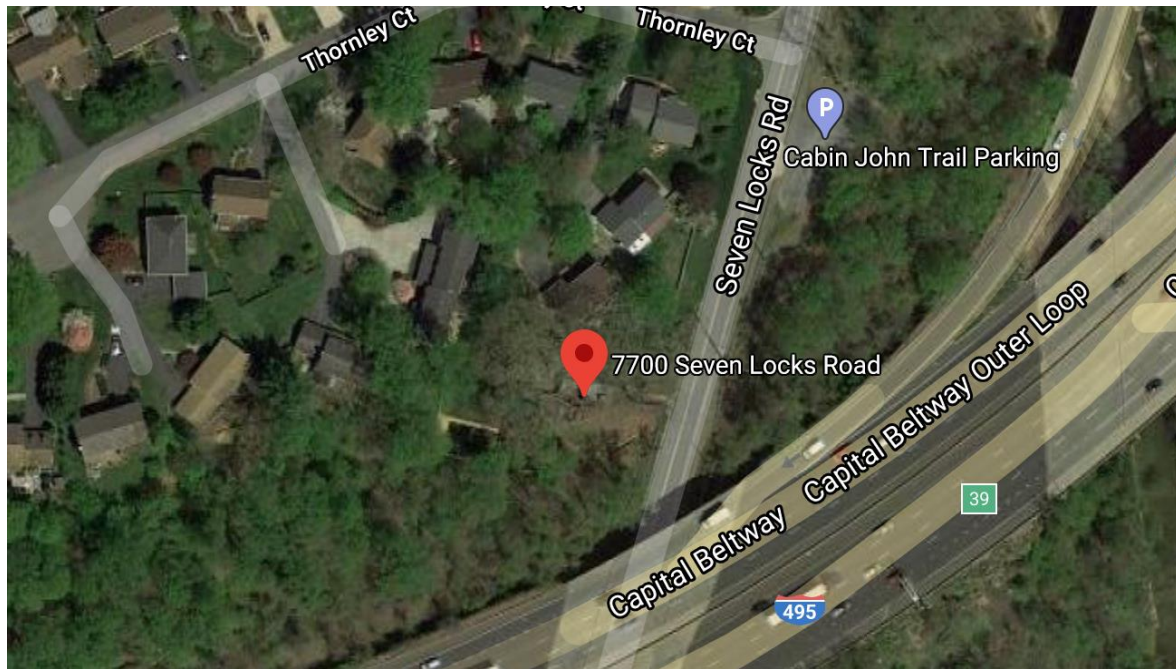
The church was damaged by fire in 2004 and by a fallen tree in July 2015.

Fig. 1: Subject property.

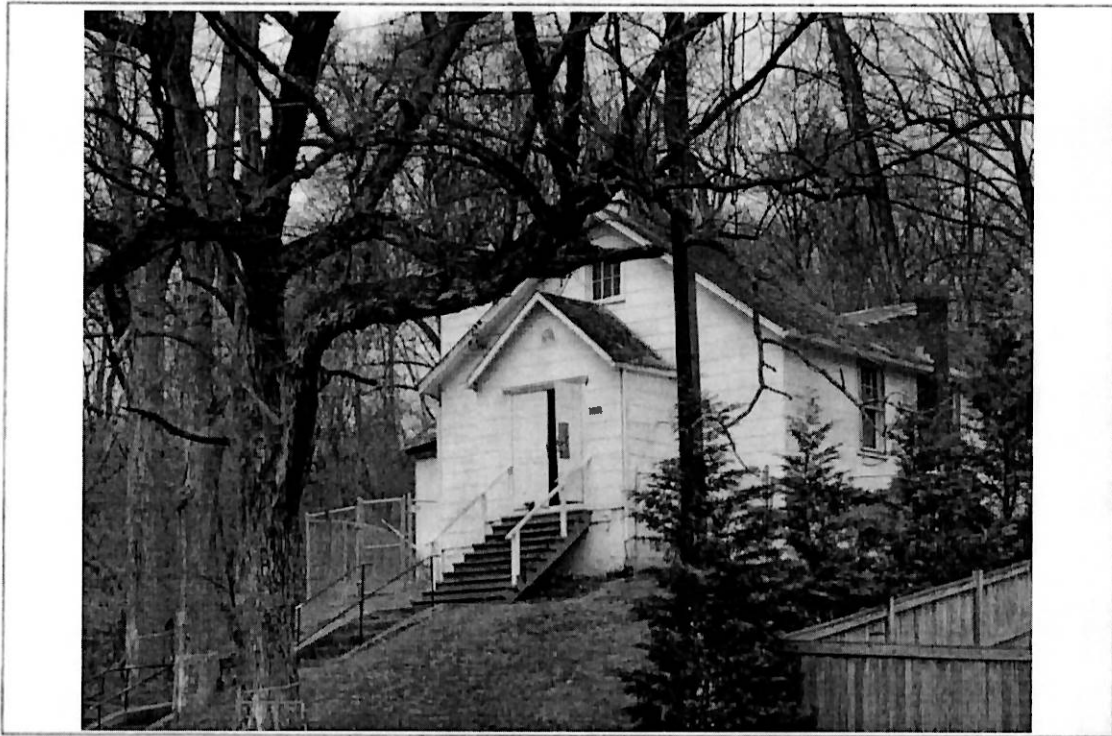
Photo No. 1: View of church structure (looking southwest)
Detail: _____

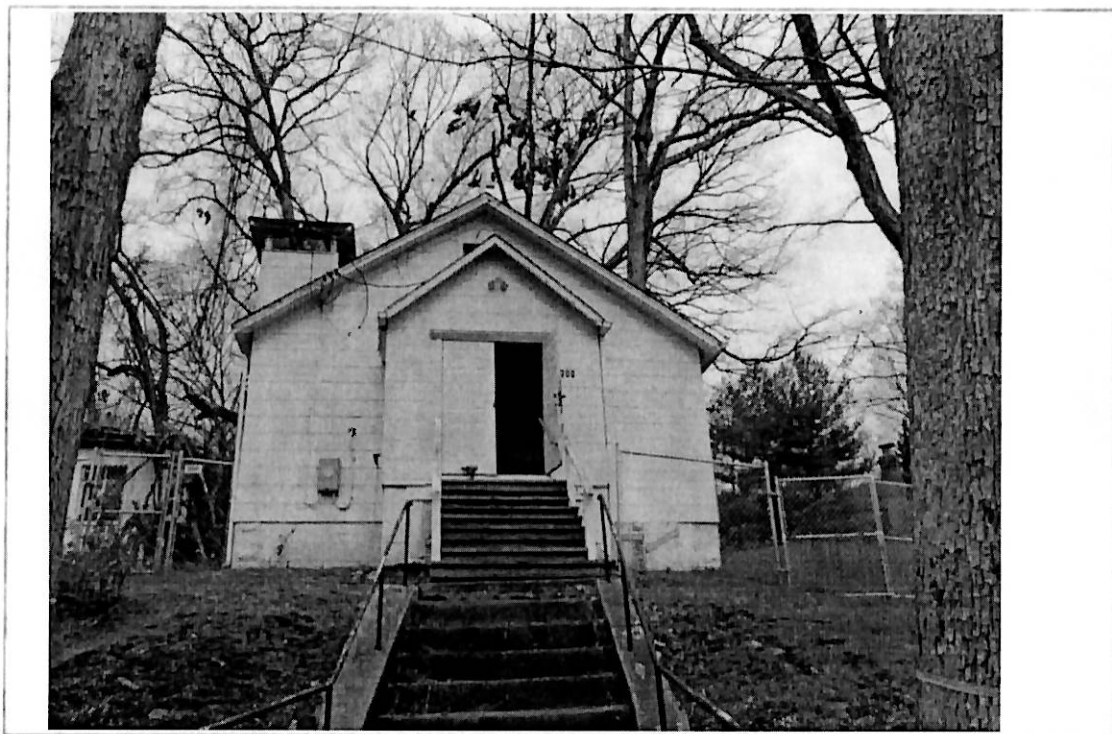
Photo No. 2: Front (east) elevation view of structure
Detail: _____

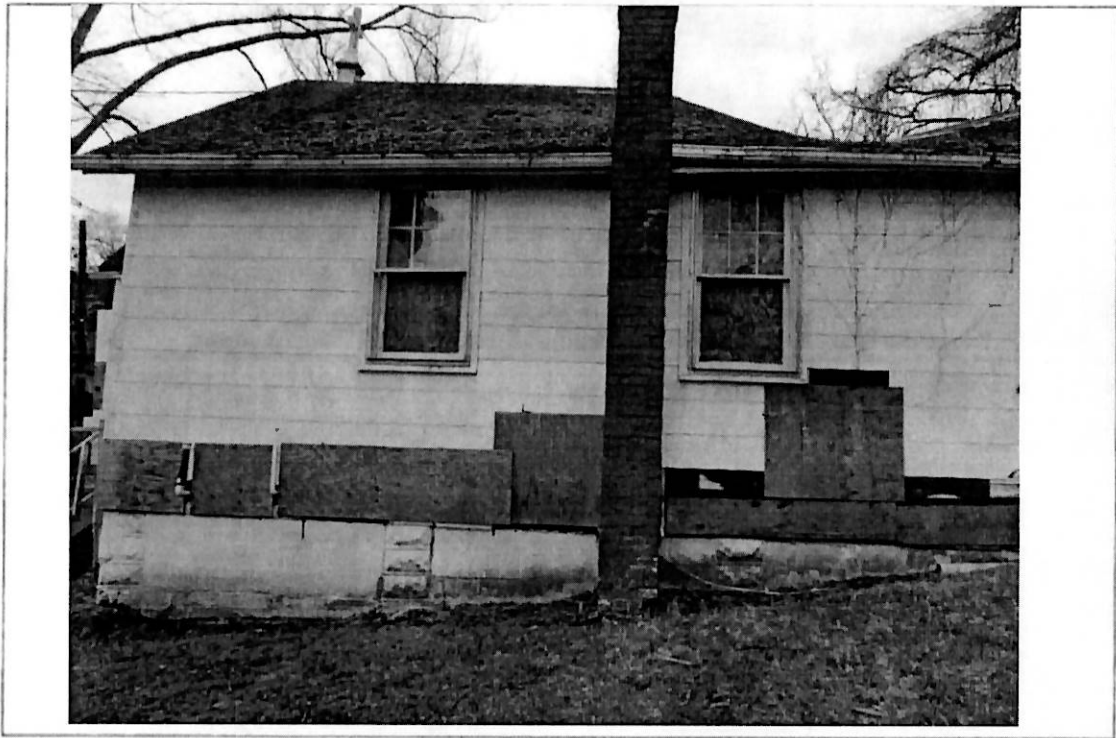
Detail: Photo No. 3: Right Side (North) elevation view of structure

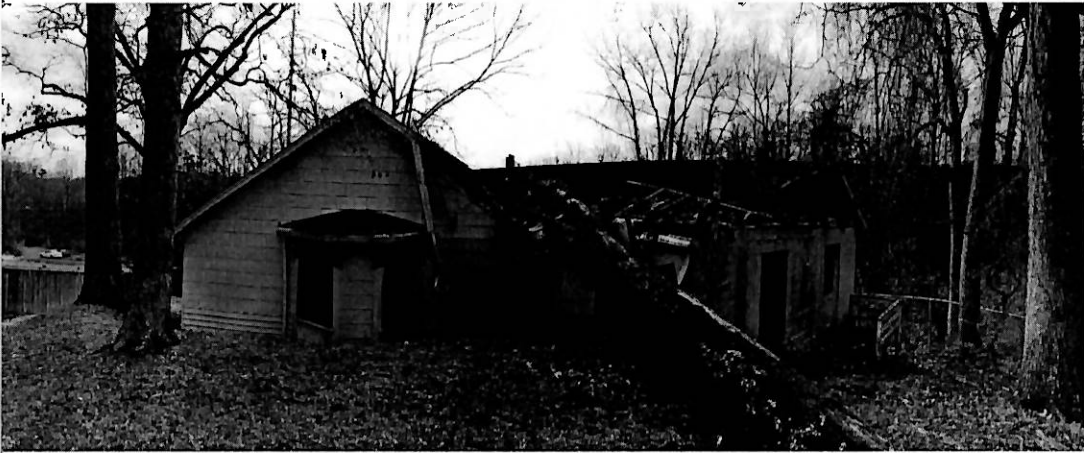
Photo No. 5: Rear (West) elevation view of damaged structure
Detail: _____

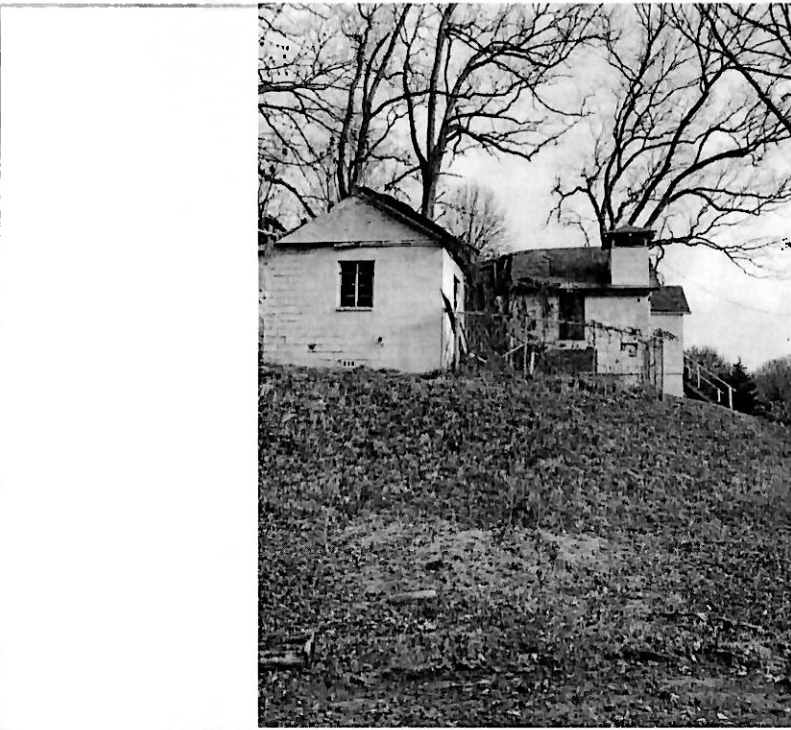
Photo No. 6: Left Side (South) elevation view of damaged structure
Detail: _____

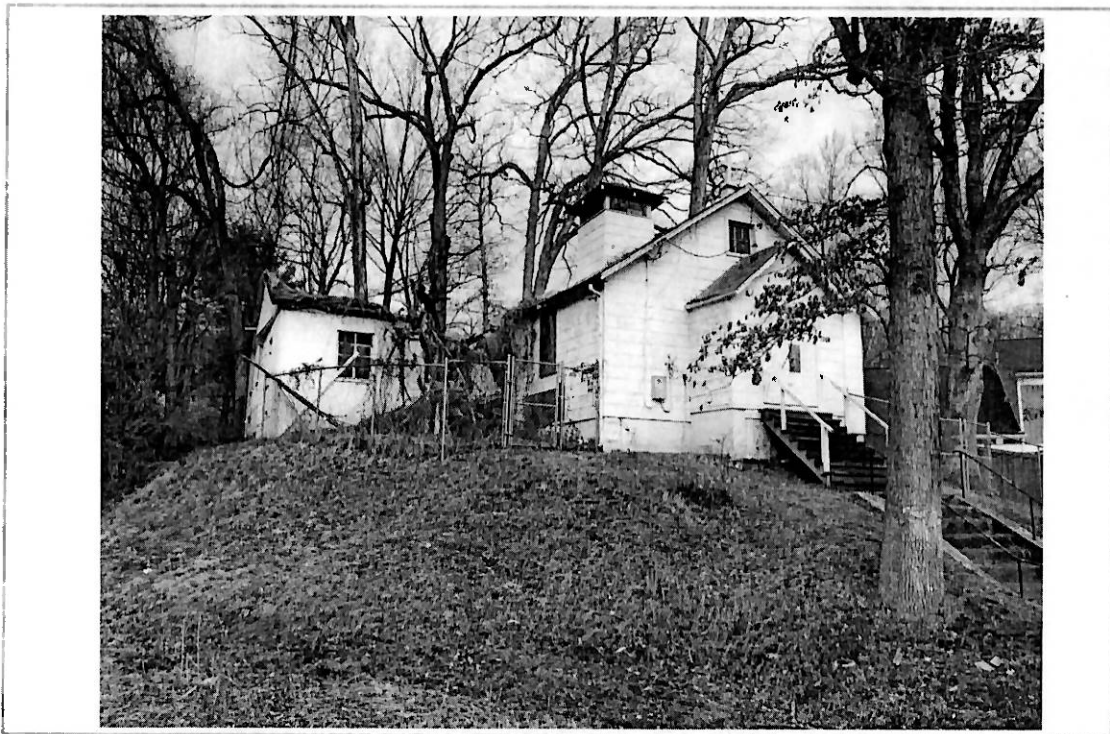
Photo No. 8: View of damaged structure looking Northwest

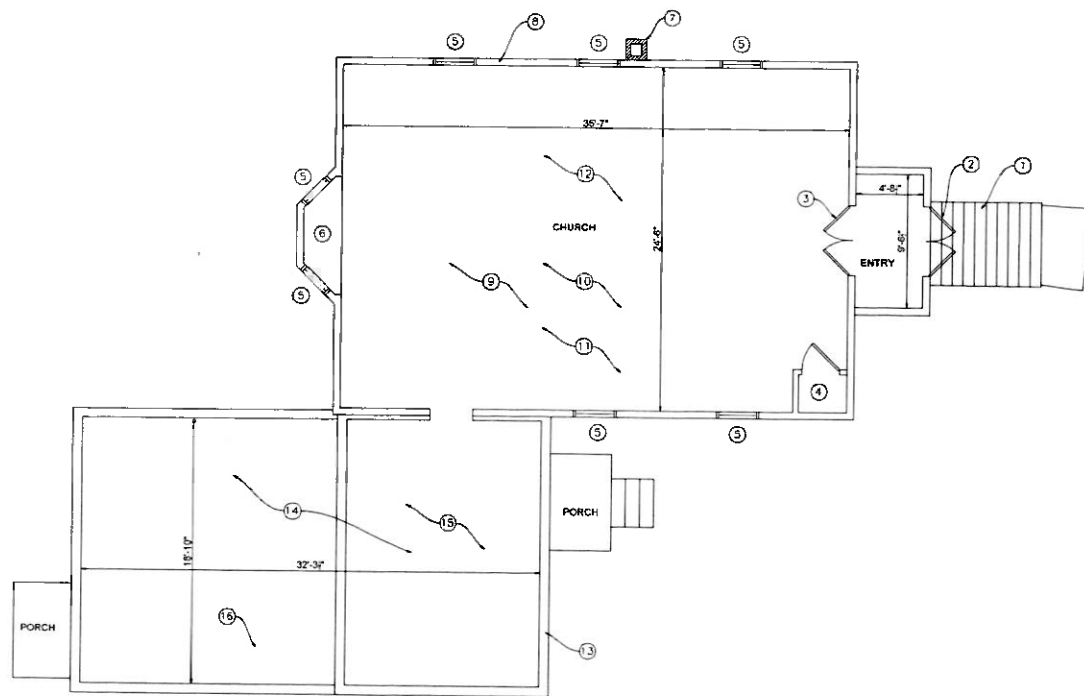
EXISTING FLOOR PLAN

- ⑨ WOOD FLOOR FRAMING (2 x 12" @ 16")
- ⑩ WOOD ROOF FRAMING 2 x 8 @ 24" oc W/ 2 x 6 @ 24" CEILING JOISTS AT 11'-2" A.F.F.
- ⑪ ESTIMATED THAT 80% OF ROOF AND FLOOR FRAMING IN CHURCH IS DAMAGED BY FALLEN TREE AND WATER INTRUSION.

- ⑫ CARPET FLOORING
- ⑬ CONCRETE MASONRY UNIT EXTERIOR WALLS.
- ⑭ WOOD ROOF FRAMING AT 1975 ADDITIONS COMPLETELY DAMAGED BY FALLEN TREE AND WATER INFILTRATION.

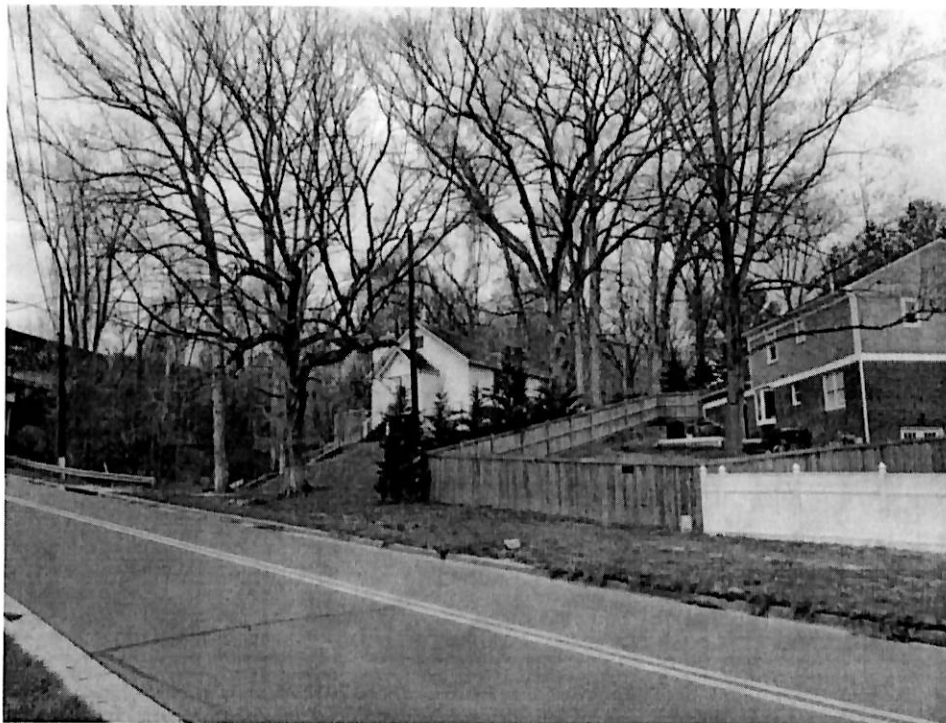
Photo No. 2: View of church structure (looking southwest) as seen from the parking lot just north and on the other side of Seven Locks Road.

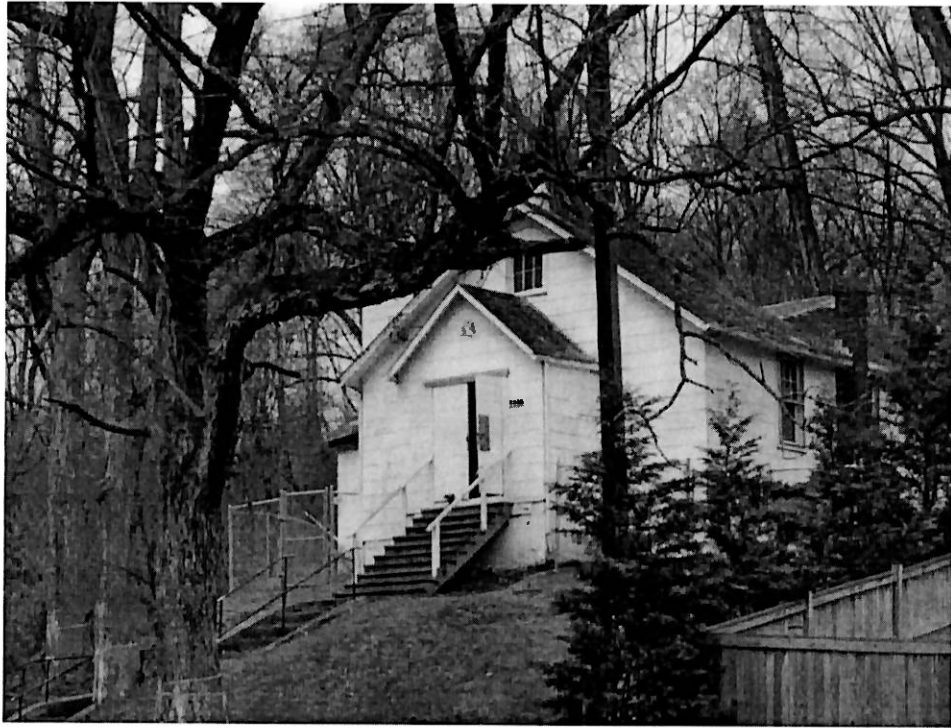
Photo No. 3: Similar (closer) view as previous photo.

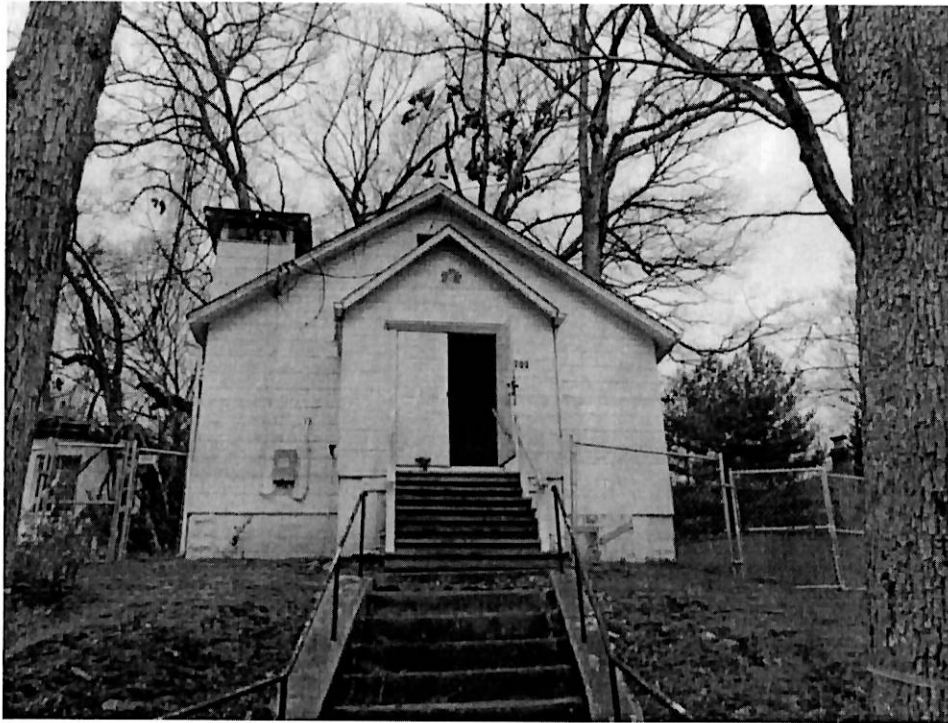
Photo No. 4: Front (east) elevation view of structure as seen from the steps leading up to the entrance from Seven Locks Road.

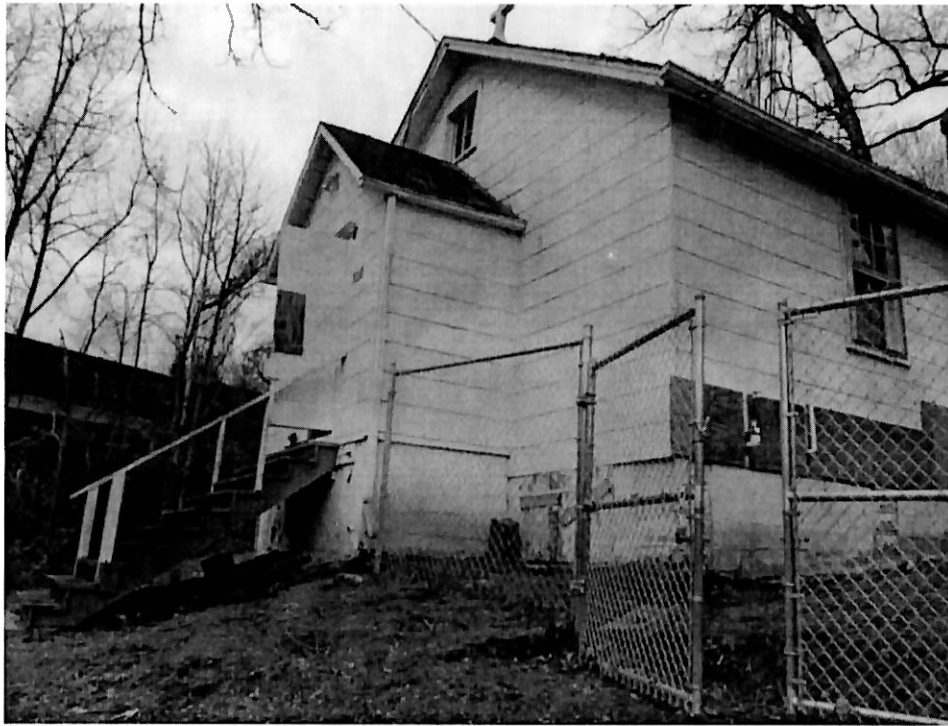
Photo No. 5: View of the front entrance as seen from the northeast corner. Note that the structure is wood-framed and clad with painted asbestos wall tiles and asphalt roof shingles.

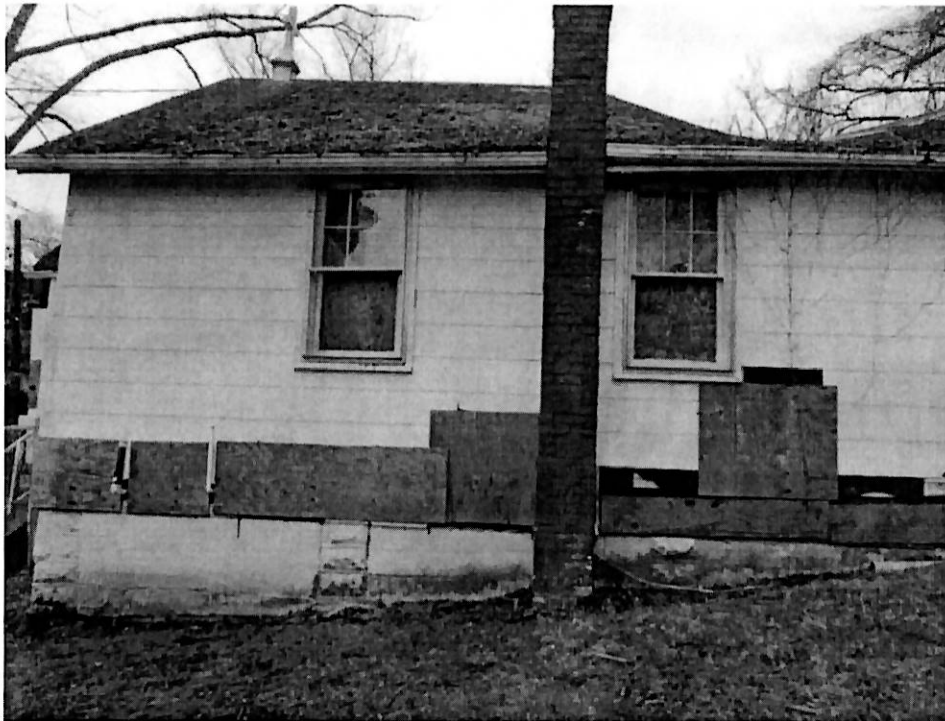
Photo No. 6: Partial view of the front half of the north elevation showing boarded wall openings and windows, extreme moss growth on the intact portion of the roof, as well as the collapsed section of the roof (right side).

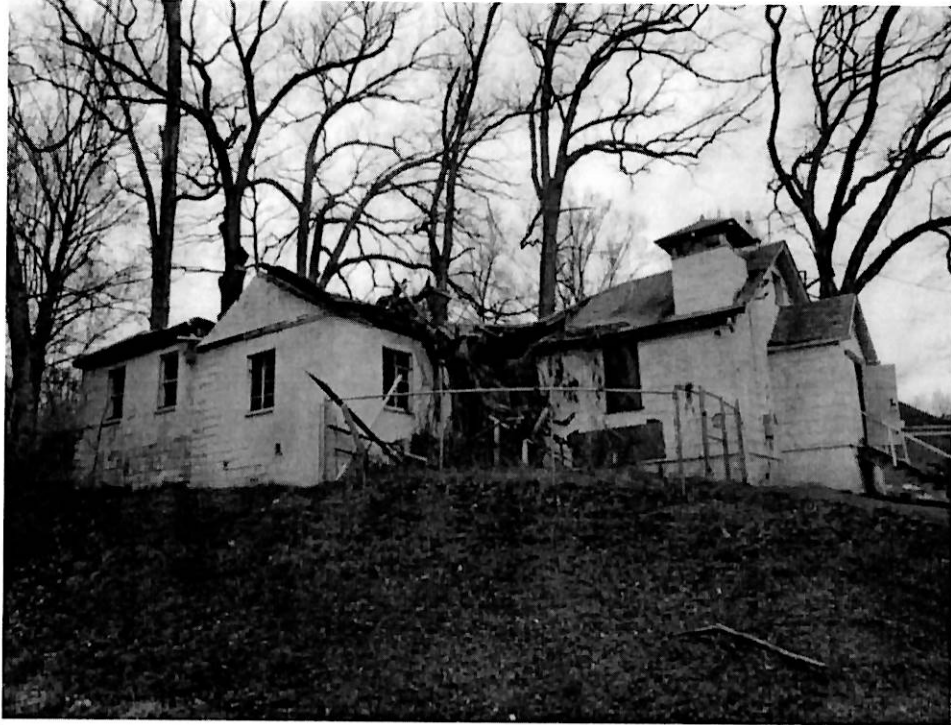
Photo No. 9: General view of the structure's southeast corner as seen from the level of the streambed to the south. Note that the roof of the structure's southwest has been completely collapsed; however, the front portion of the structure (including front entranceway and bell tower) remain intact.

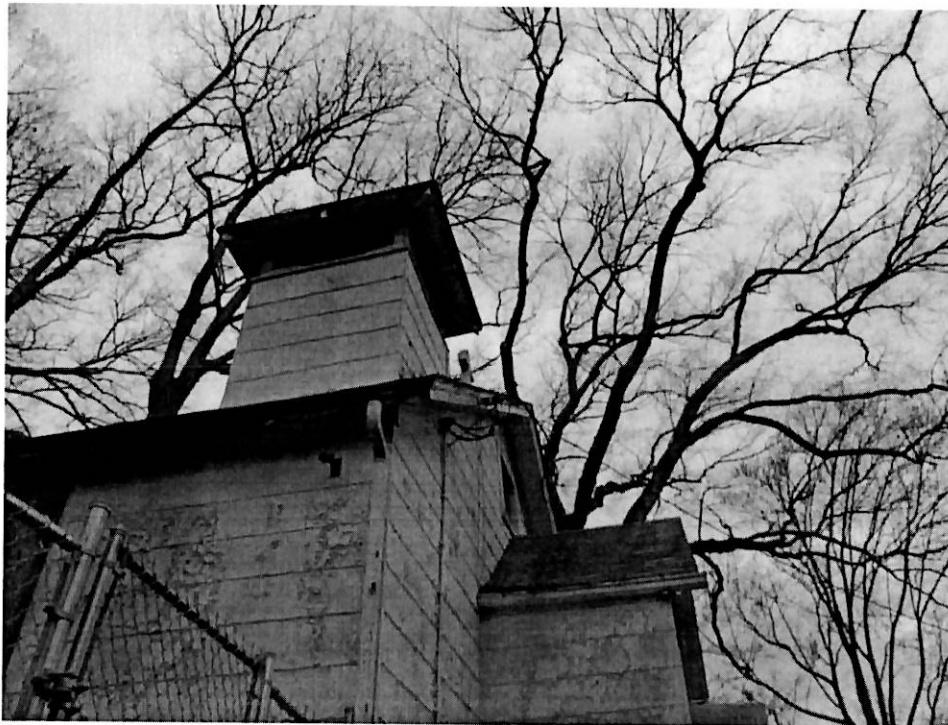
Photo No. 10: Close-up view of the bell tower.

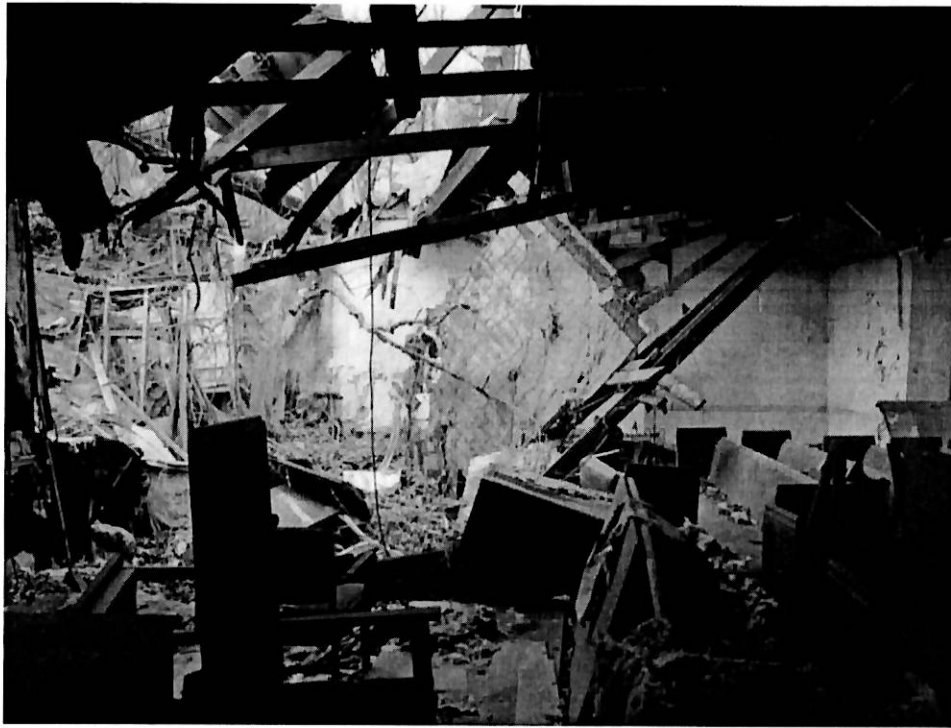
Photo No. 11: Interior view of the structure (looking west from the front entranceway), exhibiting the collapsed roof of the southwest corner.

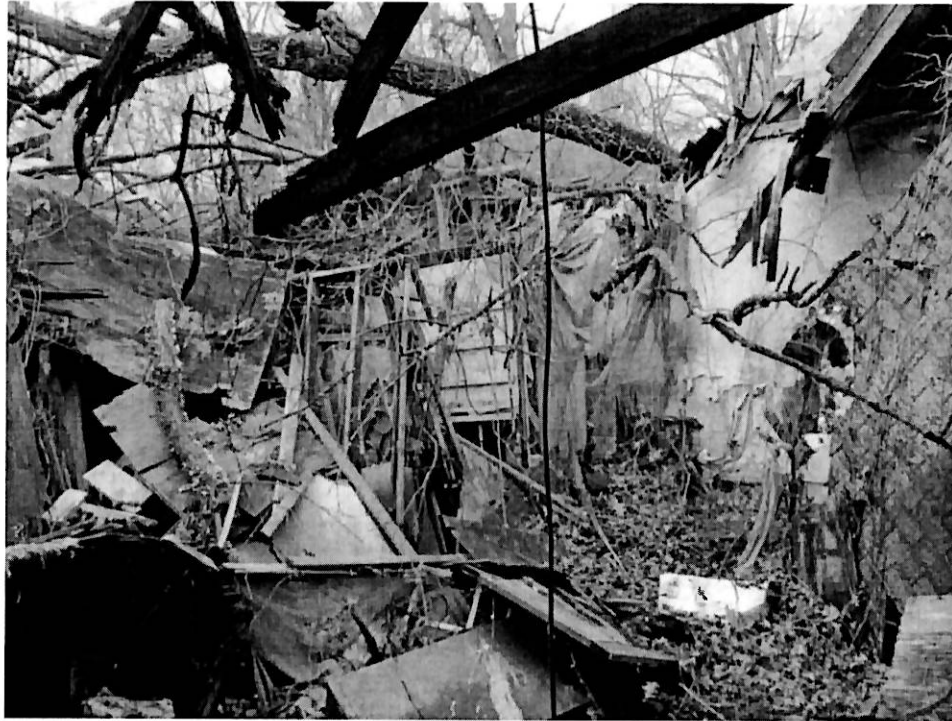
Photo No. 12: Similar view as the previous photo, looking south from the center of the floor plan.

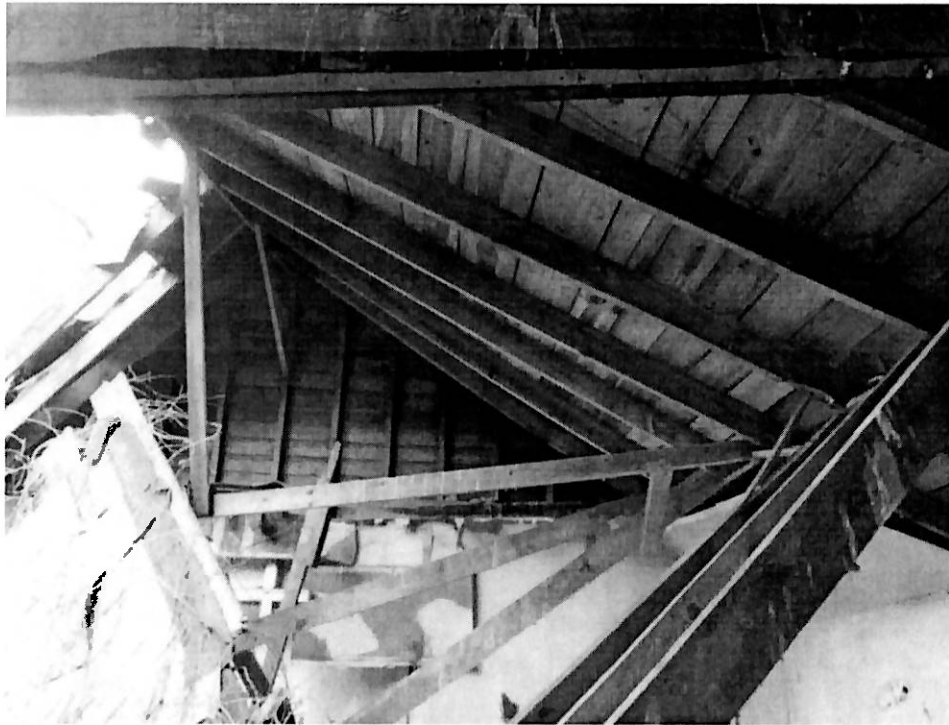
Photo No. 13: View collapsed roof framing along the west end of the structure. Note that wall and roof framing consists of 1" thick wood boards of various widths attached to solid sawn rafters or studs.

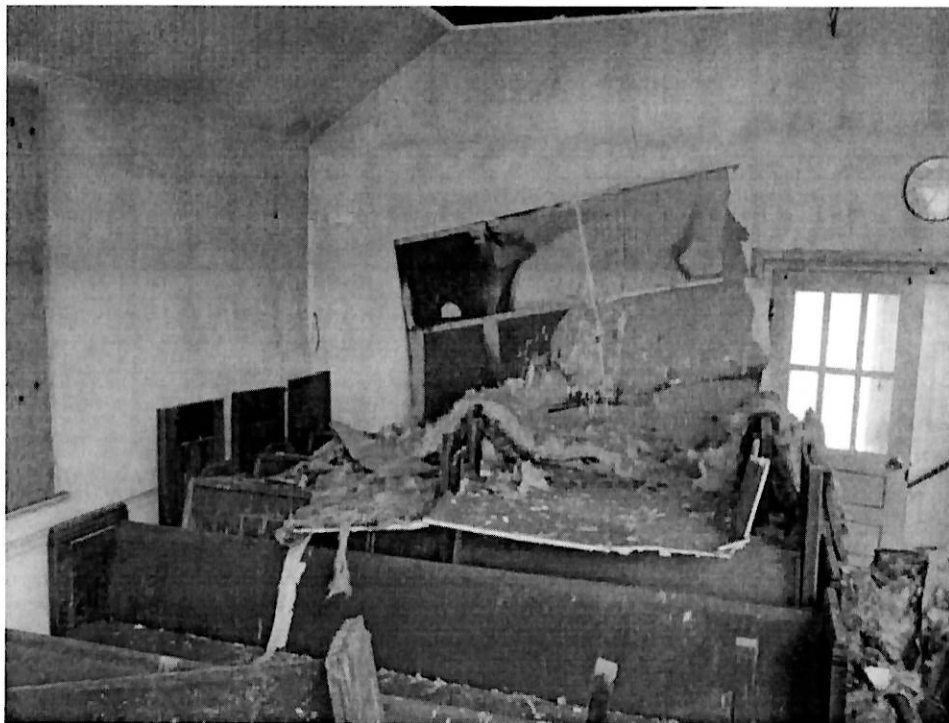
Though no area of the structure is completely unaffected by the fire or the collapsed tree, the front (east end) of the structure is relatively unscathed in comparison to the west and south portions. As seen in Photo Nos. 14 thru 16, the roof and wall framing of the entrance enclosure as well as the first 5' to 6' of the main structure (including the bell tower) remain upright, plumb and intact. In our opinion, it is indeed possible to carefully detach this portion of the structure from the remainder of the structure for the purposes of re-integrating it into a replacement structure.

Photo No. 14: View of structure's relatively intact northeast corner at the front entrance area.

Assuming that complete demolition is deemed to be unacceptable, we strongly recommend that only the entrance enclosure and the first 5' to 6' of the main structure (including the bell tower) be saved, and that the remainder of the structure be demolished. In addition, the exterior cladding of the portion to be saved (i.e., the asbestos wall tiles and severely compromised asphalt roof shingles) should be removed in its entirety due to health and material degradation reasons. In other words, only the underlying wood framing elements should be re-integrated into the replacement structure.
