*Preliminary Consultation*  
**MONTGOMERY COUNTY HISTORIC PRESERVATION COMMISSION**  
**STAFF REPORT**

<b>Address:</b>	22200 Clarksburg Road, Clarksburg	<b>Meeting Date:</b>	5/27/2020
<b>Resource:</b>	Master Plan Site #13/25 <i>Cephas Summers House</i>	<b>Report Date:</b>	5/20/2020
<b>Applicant:</b>	Pulte Homes (Bob Harris, Agent)	<b>Public Notice:</b>	5/13/2020
<b>Review:</b>	Preliminary Consultation	<b>Tax Credit:</b>	N/A
<b>Case Number:</b>	N/A	<b>Staff:</b>	Michael Kyne
<b>PROPOSAL:</b>	Discussion of rehabilitation

# CONDITIONS ASSESSMENT REPORT

**Conditions Assessment and Preservation Plan for the “Cephas Summers House”, located immediately south of 22210 Clarksburg Road, Boyds, Montgomery County, MD.**

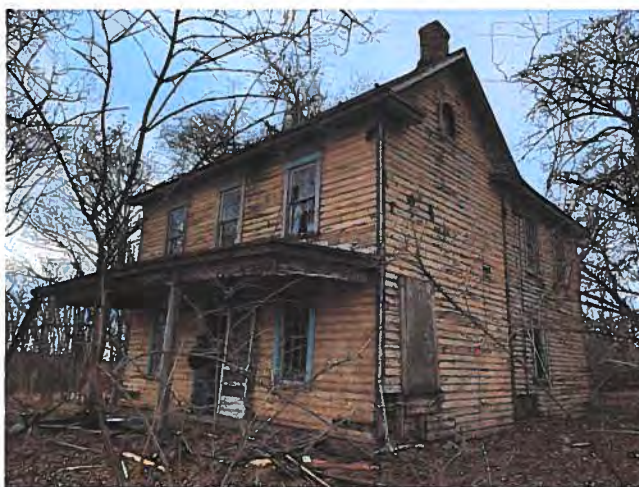
Fig. 2: West (front) and North sides. Note patches in siding below window indicating former door with stoop. 2020-01-02

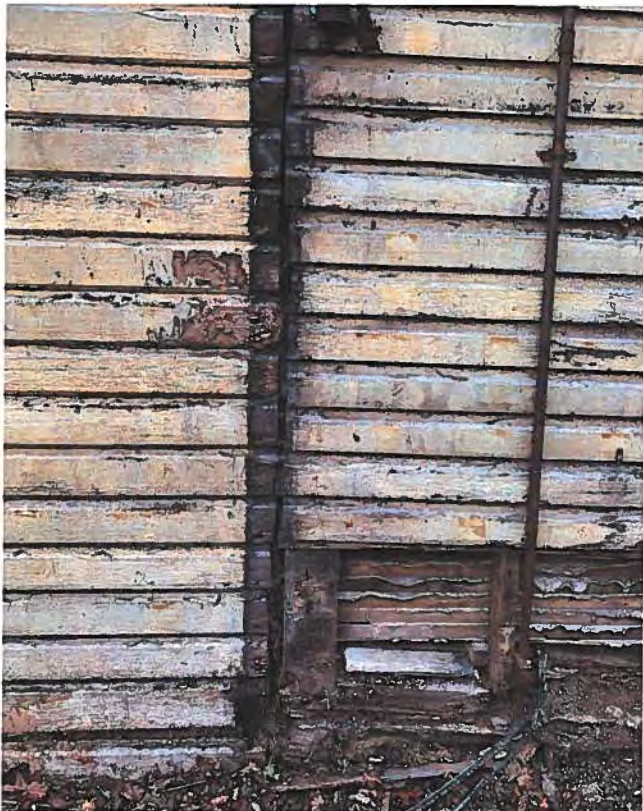
Fig. 7: Closeup showing differences in siding between Main House and Rear L. Notice foundation and sill plate deterioration. 2020-01-02

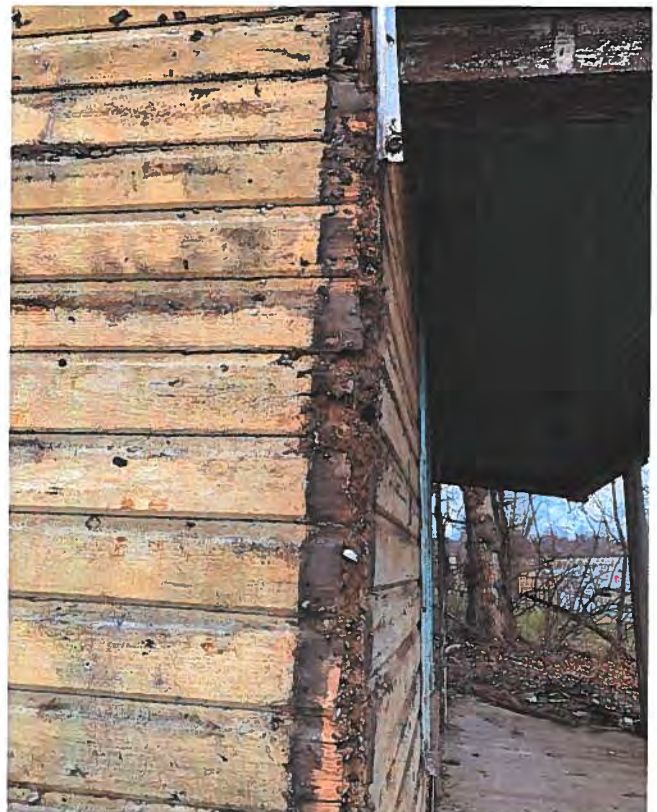
Fig. 8: Typical corner detail throughout showing paint line from removed corner board, insect and fungal damage. 2020-01-02

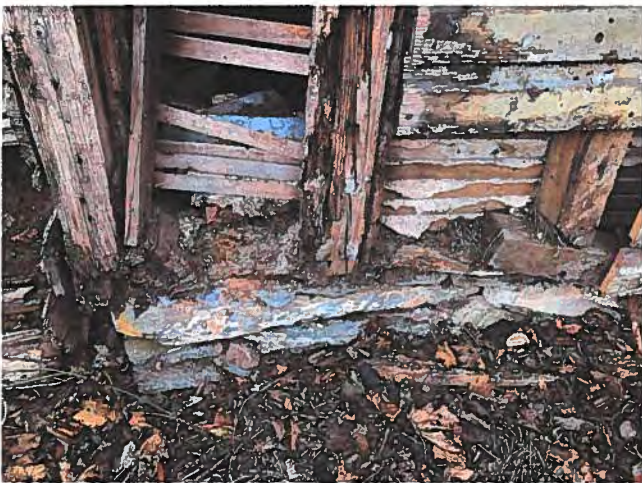
The Front House sits on a stone rubble foundation of indeterminate but most probably shallow depth, with no apparent crawlspace or basement: the floor joists sit directly on the earth (*figs. 7,11*). There is a "root cellar" under the Rear L accessed from an exterior stair at the north corner on the west (rear) side. The cellar is filled with tires and debris and it is not possible to determine its extent, i.e. whether it is full or partial under the Rear L.

Fig. 11: Looking into opening at north west corner showing deteriorated/non-existent sill plate (front wall sill plate and front porch on left), studs, joists, joists laid directly on earth. 2020-01-02

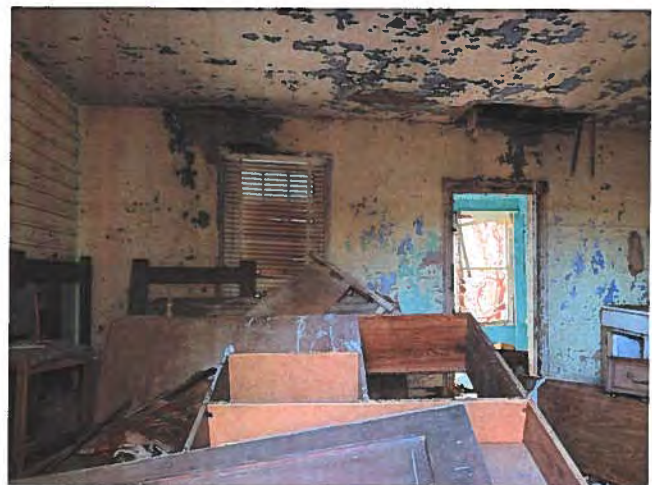
Fig. 16: East Room in Rear L, looking south. Note exterior siding on wall to Main House on left. 2020-01-02

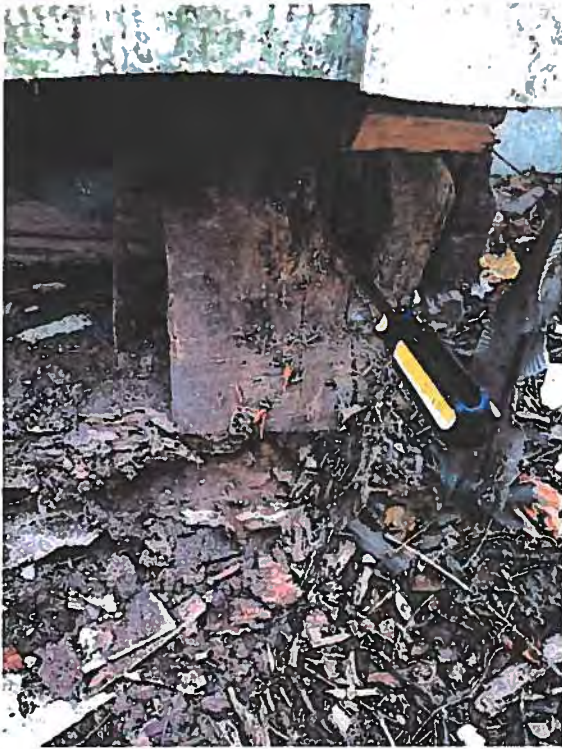
Photo 1: NW corner of rear addition

Numerous test pockets were performed at the base of the stud walls/wooded sill location. In nearly all of these test pocket locations, the timber sill and bottom of the wooden studs are completely deteriorated from a combination of water intrusion/ decay and insect infestation. Some test pockets exposed the ends of the wooden tongue and groove flooring which is severely deteriorated as well. The floor joists are notched where bearing on the perimeter wooden sill. The stone foundation wall is generally dry stack as nearly all of the mortar has broken down. Further up the walls the studs appear to have less deterioration.

The 2-1/2 story addition to the rear of the main house appears to be of a more recent vintage as modern nails and fasteners were used in the construction. Severe deterioration of the bearing exterior walls and underlying support is similar to the original dwelling. Upper level test pockets also have deterioration but not as severe as the base. The South elevation one story enclosed porch and small rear addition are in disrepair as well.

If restoration of the Dwelling is to be considered, we would expect that the stone foundation walls would have to be repaired, all wooden sills replaced, and all exterior stud bearing walls replaced. We would also expect that the majority on the interior floor framing would have to be replaced or reinforced.
