**MONTGOMERY COUNTY HISTORIC PRESERVATION COMMISSION**  
**STAFF REPORT**

<b>Address:</b>	7417 Baltimore Ave., Takoma Park	<b>Meeting Date:</b>	12/16/2020
<b>Resource:</b>	Contributing Resource <b>Takoma Park Historic District</b>	<b>Report Date:</b>	12/9/2020
<b>Applicant:</b>	Benjamin and Jess Bregman	<b>Public Notice:</b>	12/2/2020
<b>Review:</b>	HAWP	<b>Tax Credit:</b>	partial
<b>Case No.:</b>	37/03-20AAAAA	<b>Staff:</b>	Dan Bruechert
<b>Proposal:</b>	Porch Alterations

BREGMAN REPAIRS

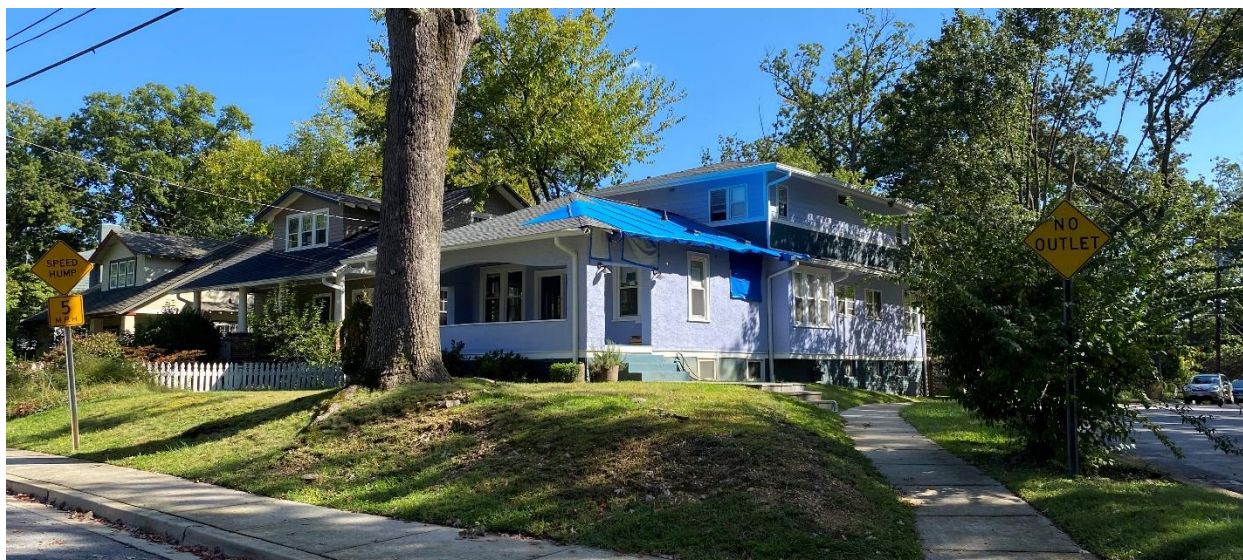
The subject property is a modified two-story Prairie-style house with stucco siding on the first floor and fiber cement siding on the second floor. The first porch has a hipped roof with broad overhangs. The house was constructed as a one-story house that was expanded in 1995 when it received an approved HAWP for a second-floor addition. The second-floor pop up was setback two bays from the historic house form. Recently, a tree fell and damaged the porch rafters and exterior stucco (see below).

*Figure 3: The subject property showing tarps over the damaged roof and exterior stucco.*

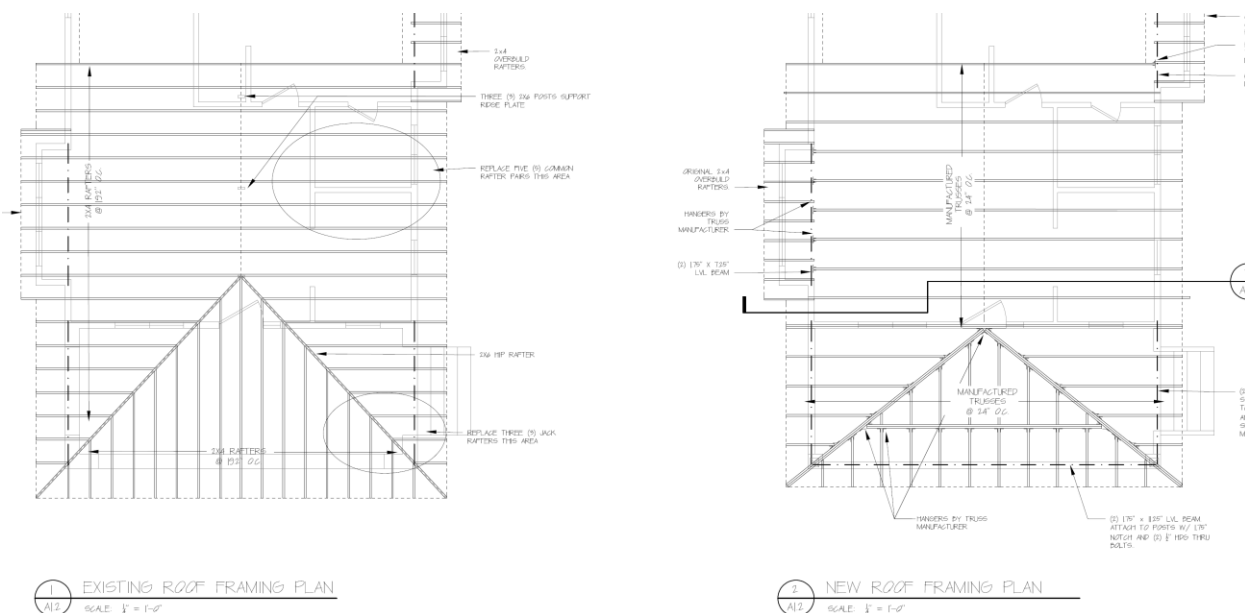
First, the applicant proposes to change the front roof slope. The existing roof framing has been found to be insufficient. Currently, the hip intersects two rafters to the rear of the front wall plane. The new proposal has a slightly steeper pitch on the front roof plain so the hip is directly above the front wall plane. This placement will utilize the front wall framing to provide additional support for the porch roof.

Figure 5: Roof framing showing the existing (left) and the proposed (right) and the intersection of the roof planes.

Staff finds that while this change will alter the roofline, the slope will have a lower pitch than the surrounding houses, it will still stand out as a Prairie design; thereby retaining the character-defining importance of this element. Staff supports approval of the change to the roof pitch under 24A-8(b)(2) and (d).

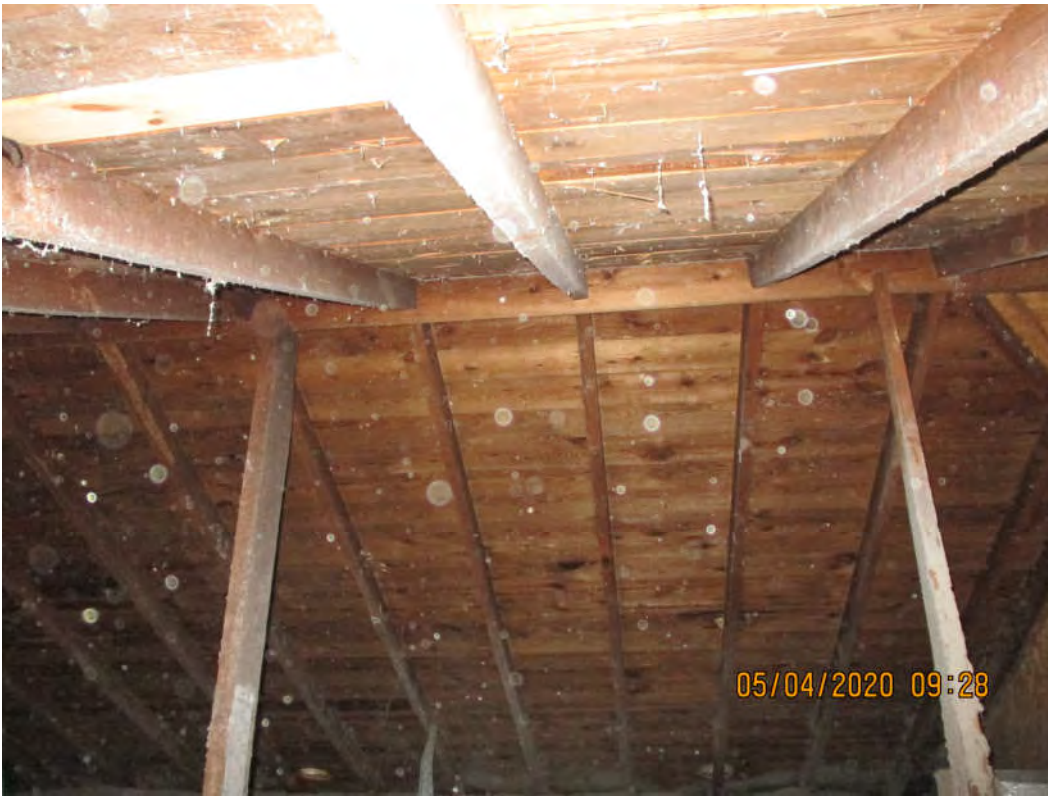
The original home appears to have been constructed during the early decades of the 20<sup>th</sup> century as a Craftsman style “pattern book” house, with light 2x wood-framed walls and rafters, and uninsulated plaster and “gunnite” stucco coated walls. A large modern 2-story addition has been constructed behind the small original house. Although there is some light damage to gutters and a few shingles on the upper roof, the true structural damage is only to the front 1-story older portion of the house. (See photos below).

Figure 5. View of roof

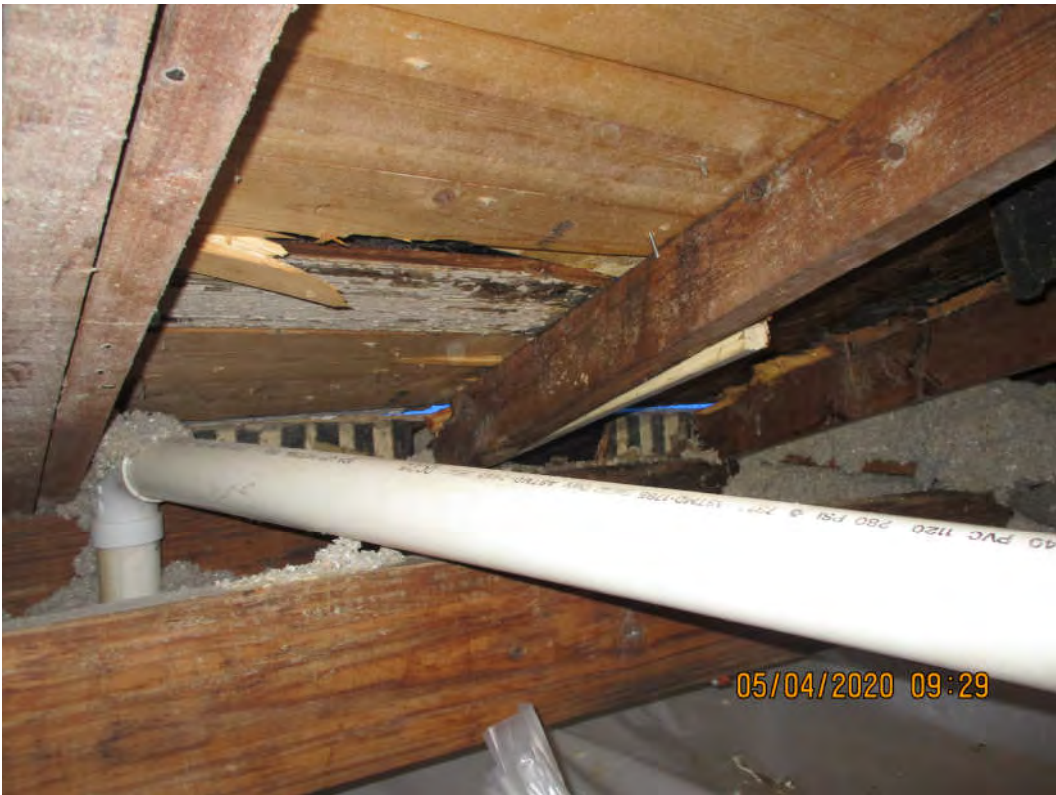
The damage is in three locations: cracked/broken common rafters over a small powder room, broken/displaced jack rafters at the corner over top of the porch stairs, and the displaced/broken framed exterior wall of the powder room. See attached photos, plans, and diagrams. The five (5) cracked/broken common rafters are original 2x4 (actual 1-3/4" x 3-1/2") rafters connected to a 1x6 ridge plate at top. All rafters are noticeably bowed due to the fact that they are very undersized for local snow loads. Also, there are no collar- or bottom ties to restrain the outward movement of the common rafters. The 1x6 ridge plate is supported on three (3) 2x6 “posts” which are located over the ceiling of the Living Room below and are not directly supported by walls or framing. 2x6 ceiling joists run perpendicular to the rafters as shown in the framing diagram below. MacKay CS recommends replacing all five (5) rafter pairs and 1x6 roof deck sheathing above. Several repair challenges will be noticed immediately: the existing roof is quite bowed while the new rafters will be straight and much larger, which will cause sheathing to overlap awkwardly onto existing undamaged bowed rafters. Also, the “birds mouth” for the new larger rafters will intrude inside the building envelope awkwardly and require calculations as to the amount of allowable notching. In addition, 2x6 ceiling joists will have to be moved or altered to accommodate larger new rafters, to name a few challenges.

Figure 6. Broken/cracked common rafters

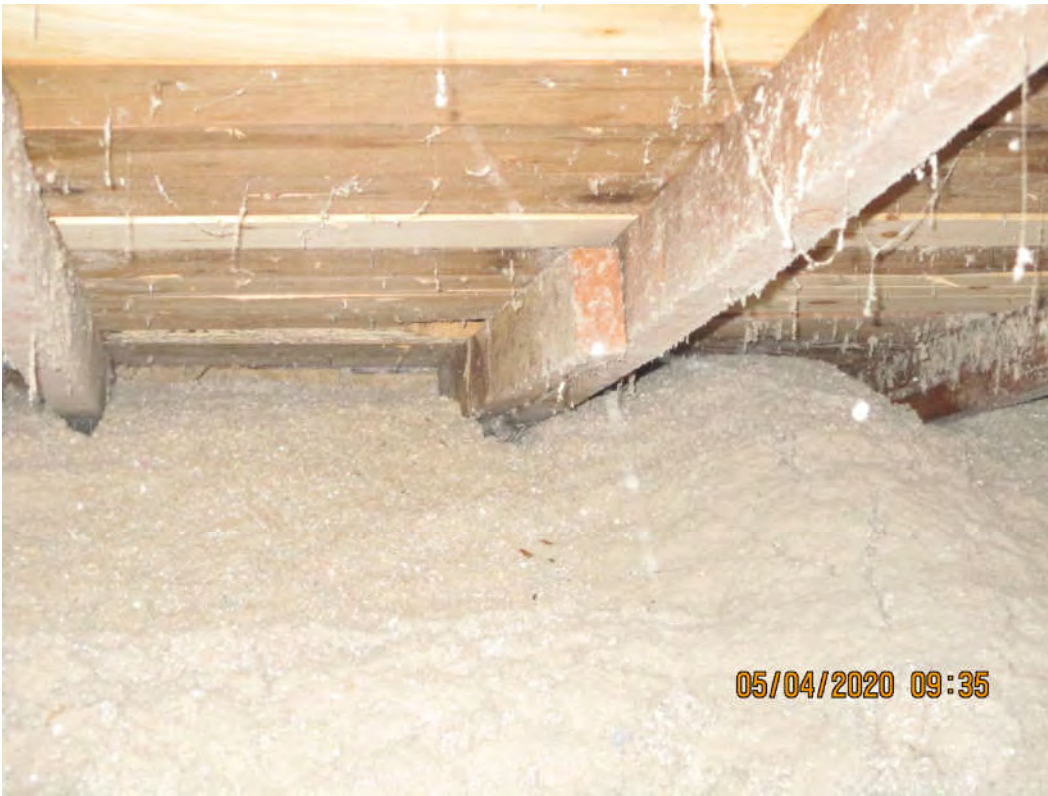
Figure 7. Broken/cracked common rafters

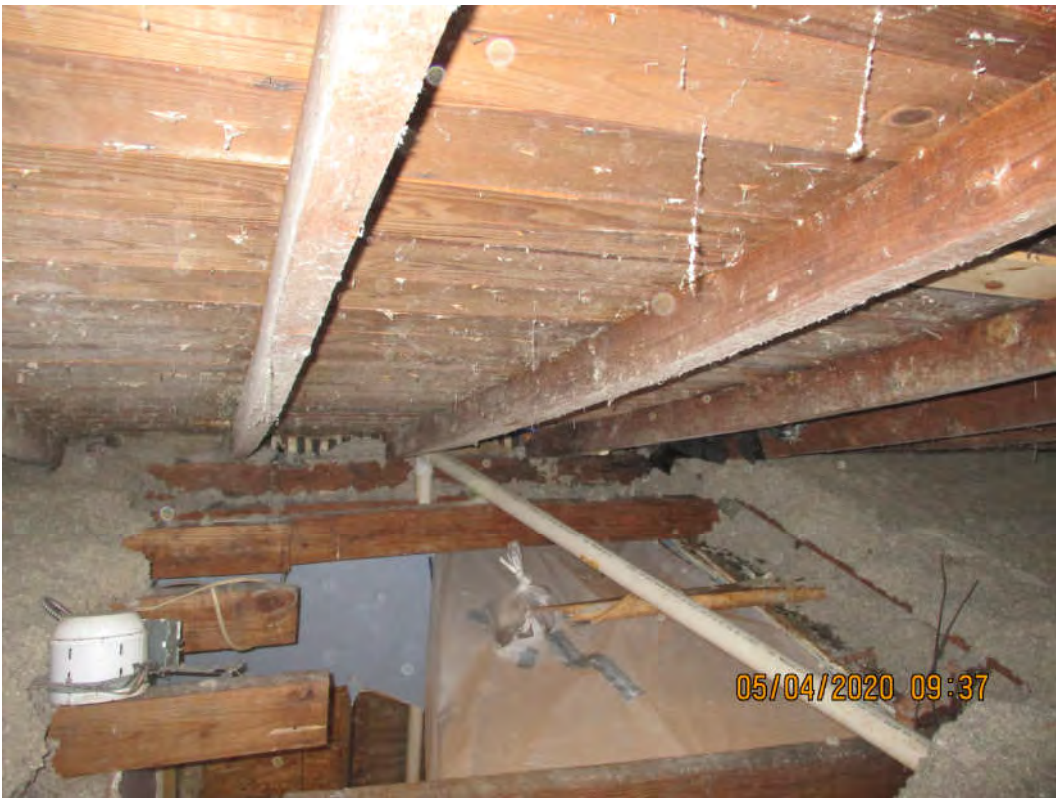
Figure 7. Broken/cracked common rafters

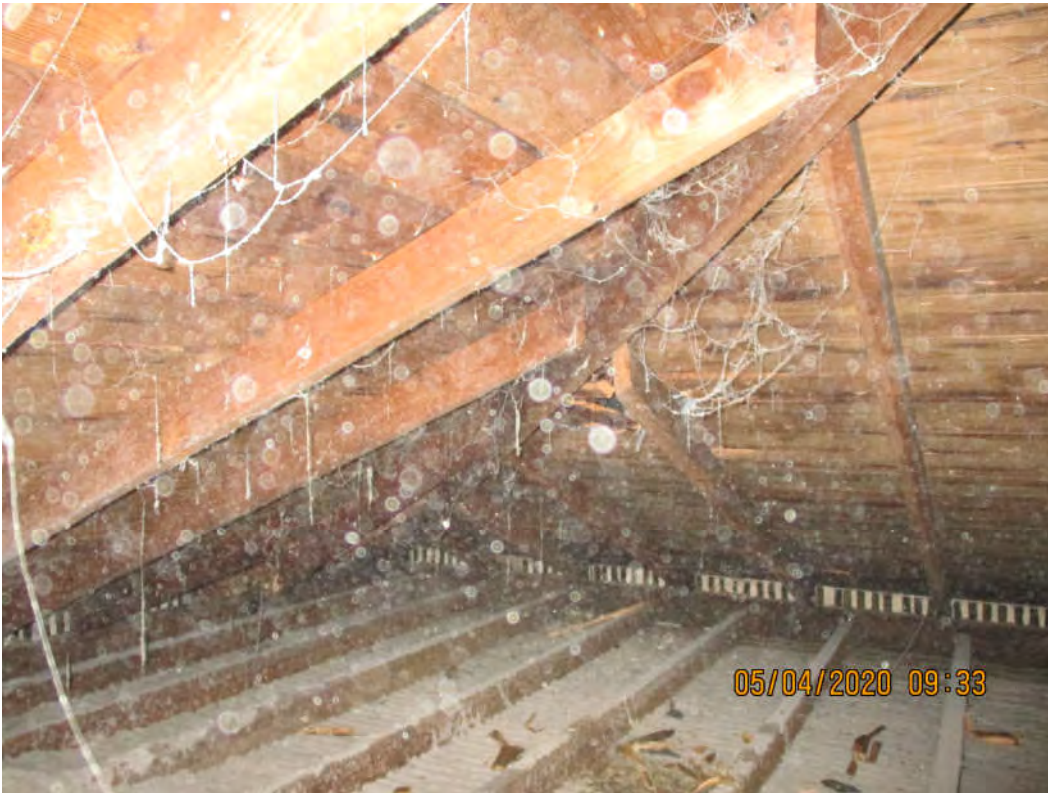
At the corner over the front porch steps, a very long (and also very undersized) 2x6 hip rafter supports 2x4 jack rafters, three (3) of which appear to be broken and/or knocked loose from the hip. The hip rafters themselves are supported by face nails to the ridge plate and rafters, which in turn rest on a 2x6 post and ceiling joist as described above. It was not possible to see whether or not the hip rafter may also have been cracked or broken, but it appeared intact. MacKay CS recommends replacing the jack rafters, along with roof decking above. Again, framing challenges are obvious: the hip rafter itself is very undersized, the peak of the roof is improperly supported, there are no hangers or hardware for the hips, among other problems which will need to be addressed in the repair drawings.

Figure 8. Broken/displaced hip rafters

In order to properly support the hip rafters, and to prevent wind uplift, a solid new post should be installed at each corner. This post should rest on top of a properly sized footing, and should include hardware adequate to restrain  $\frac{1}{4}$  of the entire roof against uplift. Similarly, beams should be installed from the post back to the main house, and from post to post across the front, which are capable of supporting the full weight of the rafters which rest upon them, and which will resist withdrawal and wind uplift. The floor has not been assessed, as it does not appear to have been affected by the wind/tree damage which damaged the roof, but design and installation of the post must not make the floor support conditions worse.

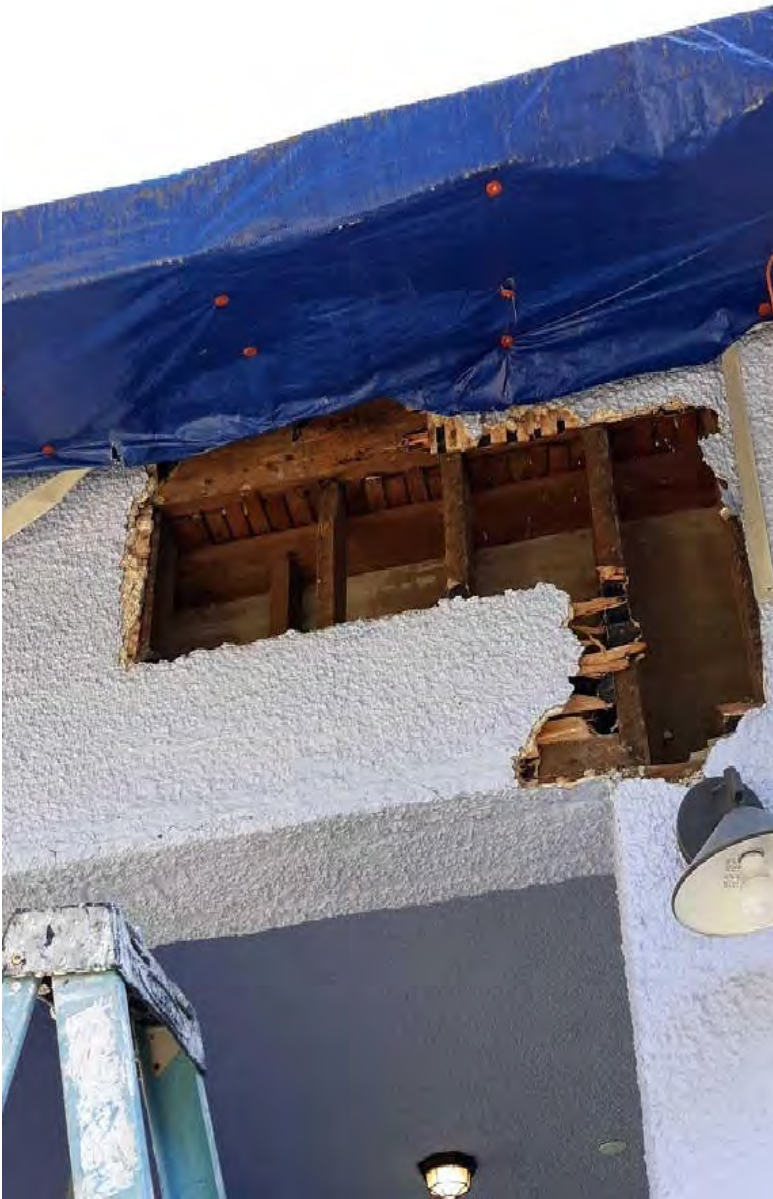
Following this original report, additional information has come to light which must be noted. As mentioned above, cracks were originally noticed in the stucco coating over what was assumed to be a beam above the stairs. The repair contractor, Paul Davis Restorations of Suburban Maryland carefully removed portions of the stucco, and discovered that the whole beam and post assembly is basically hollow. A sort of armature of 2x lumber forms a decorative box which is coated with lath and stucco. The only support for the rafters over the porch stairs are a single 2x6 on each side. The only support (and uplift resistance) for the hip rafters appears to be this stucco box. It may be assumed that the same conditions apply on the other (left) side of the porch, although no additional demo/exploratory work was done on that side. Although this style of construction was traditional in certain regions a century ago, there is no way to quantify the strength of the hollow stucco assemblies briefly described in this paragraph, and they certainly do not comply with modern building codes.

Figure 9. Hole opened up in stucco box over stairs

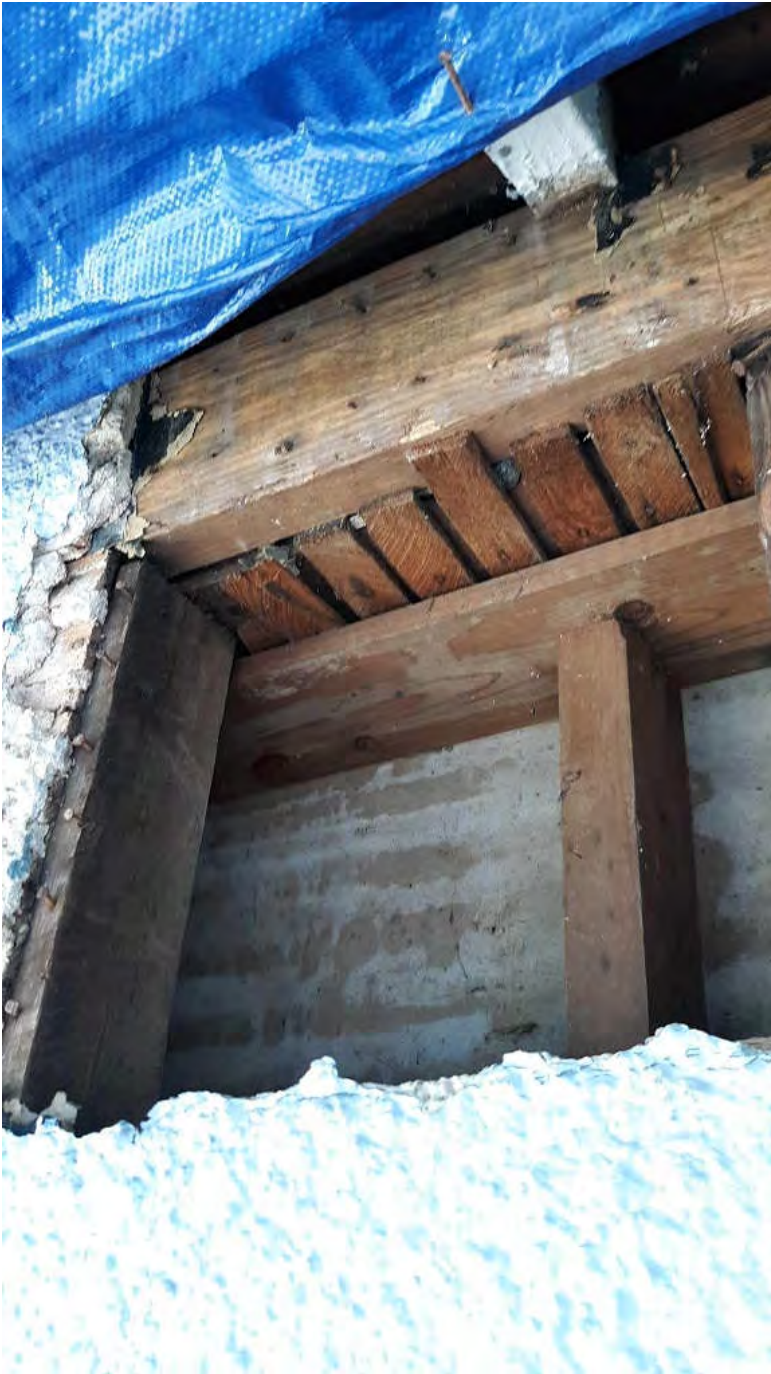
Figure 10. Detail stucco "beam" box over stairs

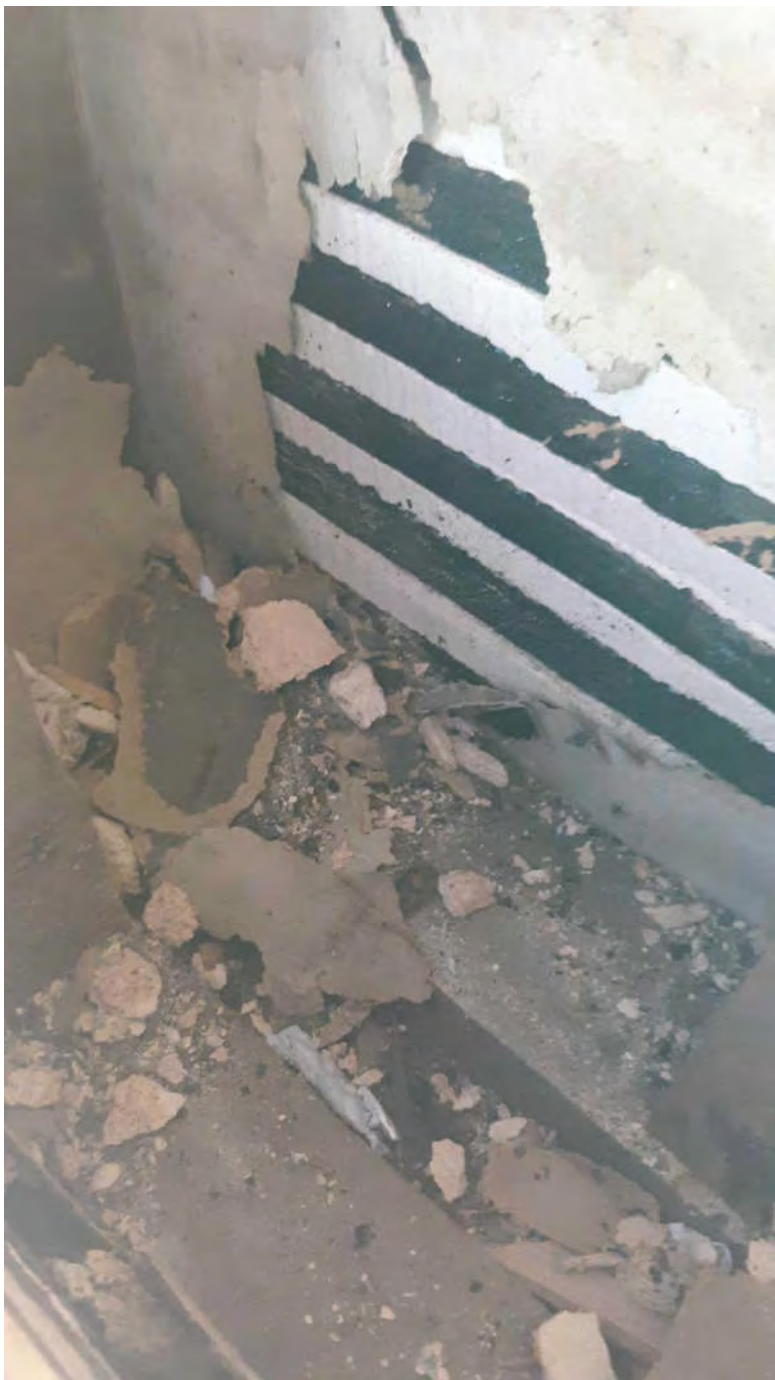
Figure 11. Detail stucco “post” box
