Fourth Preliminary Consultation
MONTGOMERY COUNTY HISTORIC PRESERVATION COMMISSION
STAFF REPORT

Address:	22200 Clarksburg Road, Clarksburg	Meeting Date:	1/27/2021
Resource:	Master Plan Site #13/25 <i>Cephas Summers House</i>	Report Date:	1/20/2021
Applicant:	Pulte Homes (Randall Rentfro, Agent)	Public Notice:	1/13/2021
Review:	4 th Preliminary Consultation	Tax Credit:	N/A
Case Number:	N/A	Staff:	Michael Kyne
Proposal:	Demolition and reconstruction

The applicants propose demolition and reconstruction of the historic Cephas Summers House.

CONDITIONS ASSESSMENT REPORT

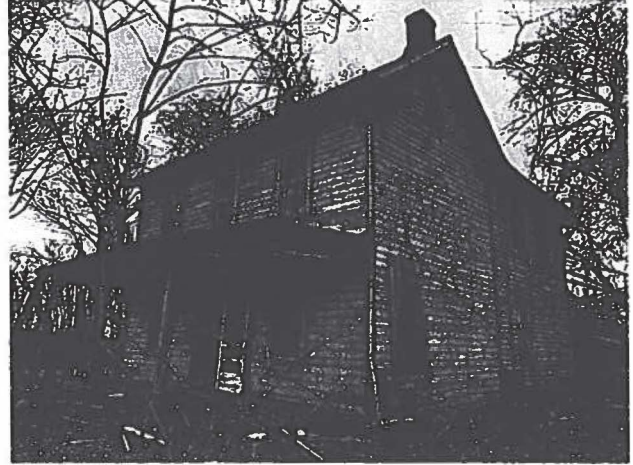
Fig. 2: West (front) and North sides. Note patches in siding below window indicating former door with stoop. 2020-01-02

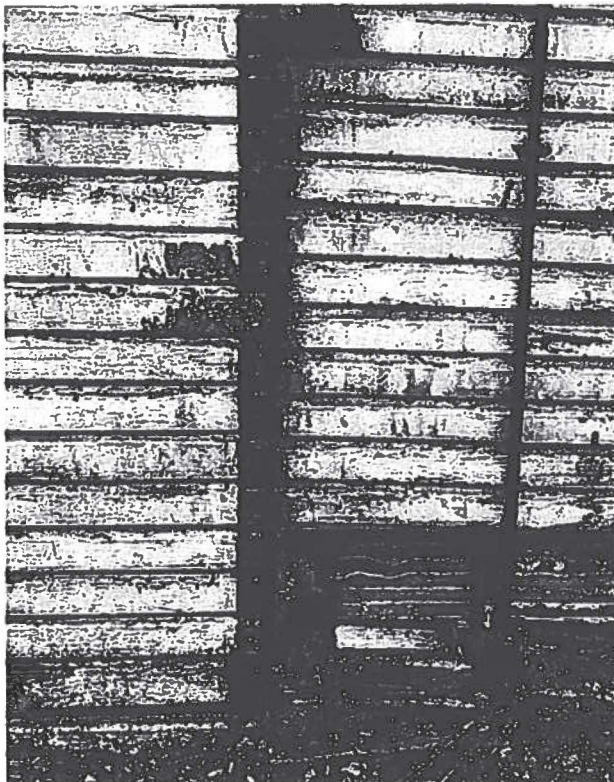
The Front House sits on a stone rubble foundation of indeterminate but most probably shallow depth, with no apparent crawlspace or basement: the floor joists sit directly on the earth (figs. 7,11). There is a "root cellar" under the Rear L accessed from an exterior stair at the north corner on the west (rear) side. The cellar is filled with tires and debris and it is not possible to determine its extent, i.e. whether it is full or partial under the Rear L.

Fig. 7: Closeup showing differences in siding between Main House and Rear L. Notice foundation and sill plate deterioration. 2020-01-02

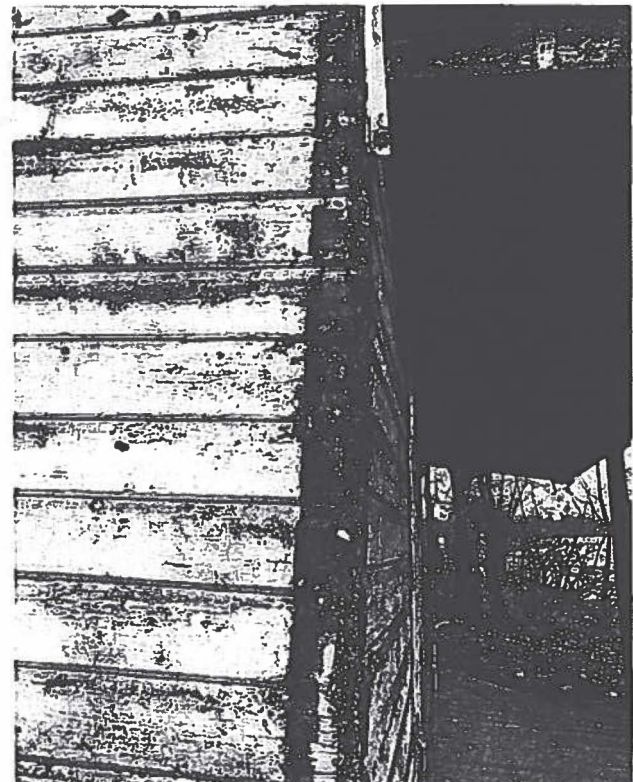
Fig. 8: Typical corner detail throughout showing paint line from removed corner board, insect and fungal damage. 2020-01-02

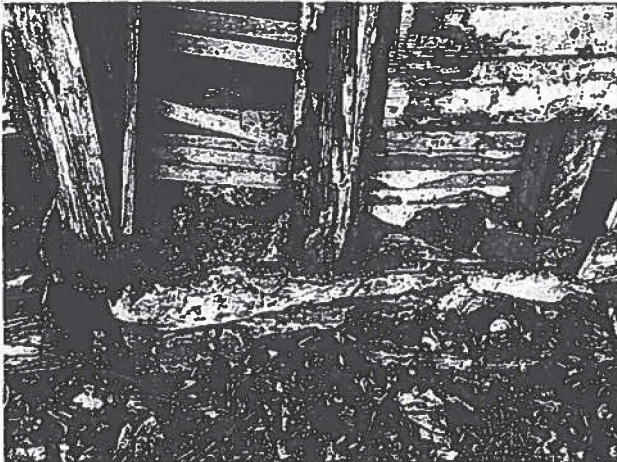
Fig. 11: Looking into opening at north west corner showing deteriorated/non-existent sill plate (front wall sill plate and front porch on left), studs, joists, joists laid directly on earth. 2020-01-02

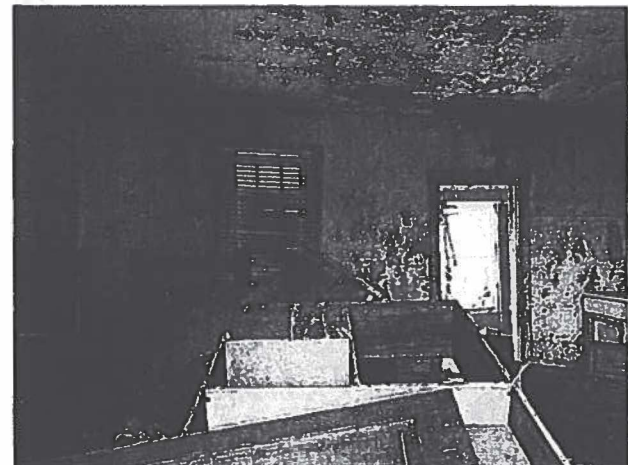
Fig. 16: East Room in Rear L, looking south. Note exterior siding
on wall to Main House on left. 2020-01-02

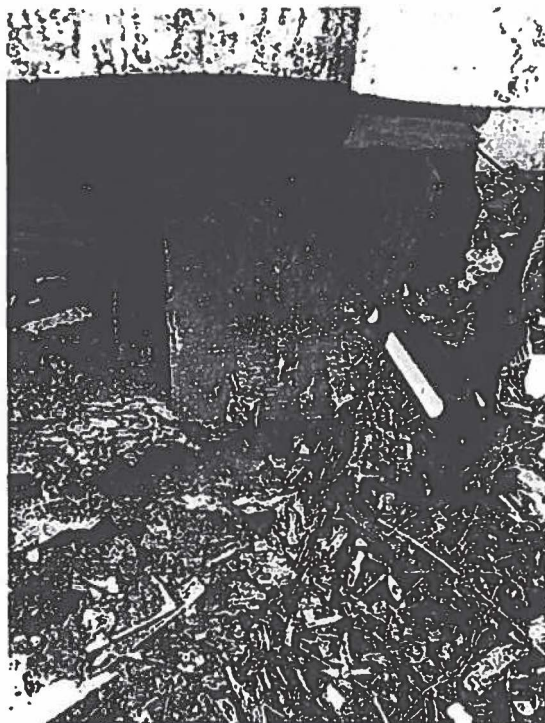
Photo 1: NW corner of rear addition

Numerous test pockets were performed at the base of the stud walls/wooded sill location. In nearly all of these test pocket locations, the timber sill and bottom of the wooden studs are completely deteriorated from a combination of water intrusion/ decay and insect infestation. Some test pockets exposed the ends of the wooden tongue and groove flooring which is severely deteriorated as well. The floor joists are notched where bearing on the perimeter wooden sill. The stone foundation wall is generally dry stack as nearly all of the mortar has broken down. Further up the walls the studs appear to have less deterioration.

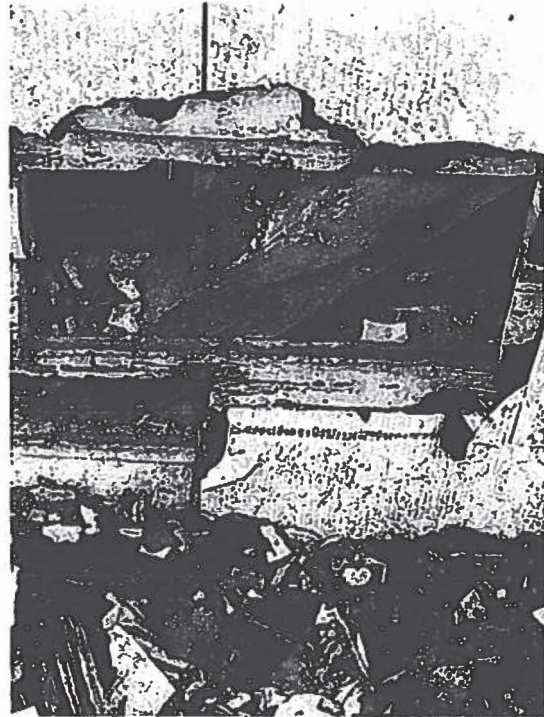
Photo 7: S wall rear addition

The 2-1/2 story addition to the rear of the main house appears to be of a more recent vintage as modern nails and fasteners were used in the construction. Severe deterioration of the bearing exterior walls and underlying support is similar to the original dwelling. Upper level test pockets also have deterioration but not as severe as the base. The South elevation one story enclosed porch and small rear addition are in disrepair as well.
