## $\frac{EXPEDITED}{MONTGOMERY\ COUNTY\ HISTORIC\ PRESERVATION\ COMMISSION}{STAFF\ REPORT}$

Address: 16501 Norwood Rd., Sandy Spring Meeting Date: 8/18/2021

Woodlawn

**Proposal:** Partial Demolition

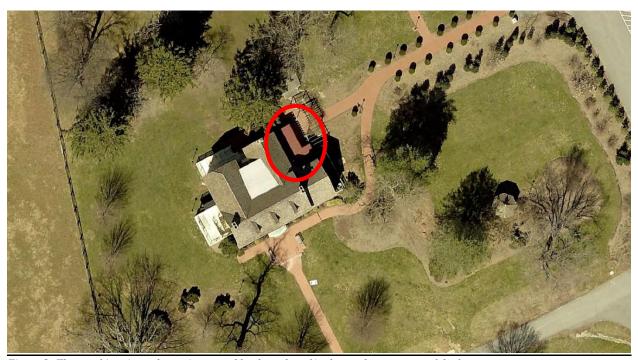
Figure 2: The non-historic mudroom is covered by the red roof in the northeast corner of the house.

The applicant proposes to demolish a c.1980 mudroom in the northeast corner of the house. This non-historic portion of the house has suffered significant insect and water damage, and the walls have begun to shift on its concrete foundation and the room is not a safe space. The applicant proposes to remove the existing frame walls and, depending on the condition, may retain the shed roof.

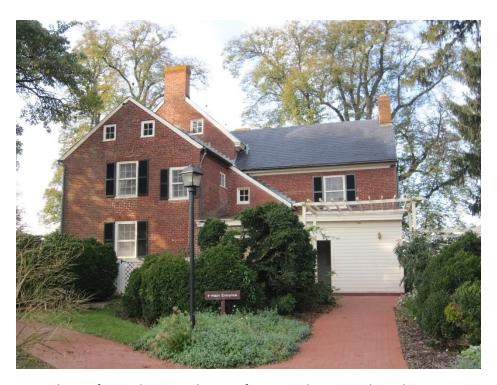
2011 photo of East elevation showing frame mudroom on the right.

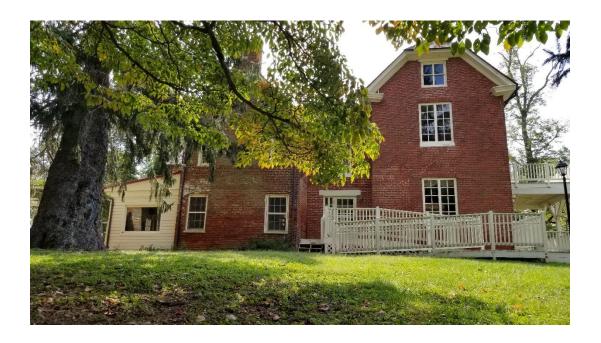
Rear (north) elevation showing frame mudroom on the left.

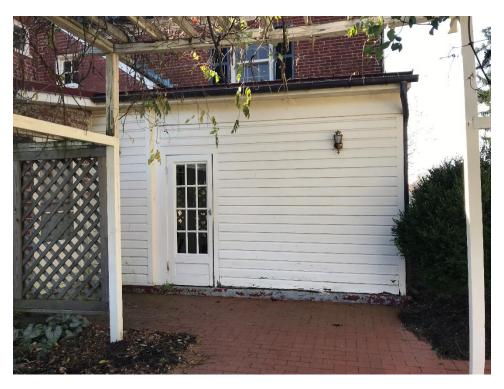
East elevation of mudroom. Note deterioration at sill. Wall is nearly detached. Also note door is no longer plumb. The good condition of the siding belies the deteriorated structural condition of the wall.

Scope of Work Demolish non-historic walls of non-historic mudroom addition due to severely deteriorated condition.

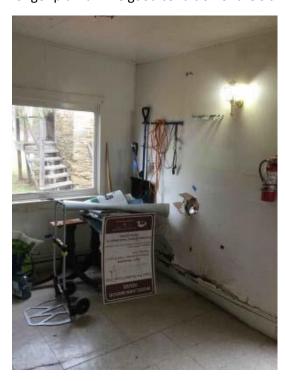
Interior of mudroom showing east wall (right) with separation of wall at foundation.

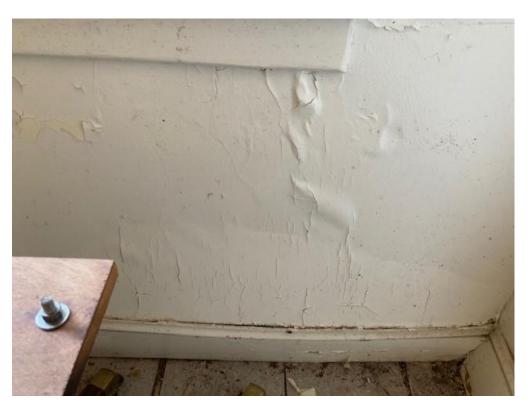
Bowing and separation of north wall under picture window.

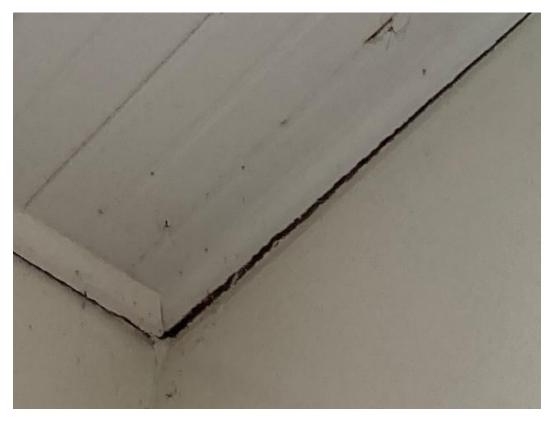
Walls separating from ceiling. These are not just cracks in the paint.
