**MONTGOMERY COUNTY HISTORIC PRESERVATION COMMISSION**  
**STAFF REPORT**

<b>Address:</b>	7102 Maple Ave., Takoma Park	<b>Meeting Date:</b>	7/10/2024
<b>Resource:</b>	Outstanding Resource <b>Takoma Park Historic District</b>	<b>Report Date:</b>	7/3/2024
<b>Applicant:</b>	Roxanne Fulcher & Keith Chamberlin Rosalind Grigsby, Agent	<b>Public Notice:</b>	6/26/2024
<b>Review:</b>	HAWP	<b>Tax Credit:</b>	Yes
<b>Case Number:</b>	1074837	<b>Staff:</b>	Dan Bruechert
<b>Proposal:</b>	Porch Demolition and Reconstruction

The applicant proposes to demolish the existing front porch and construct a new front porch.

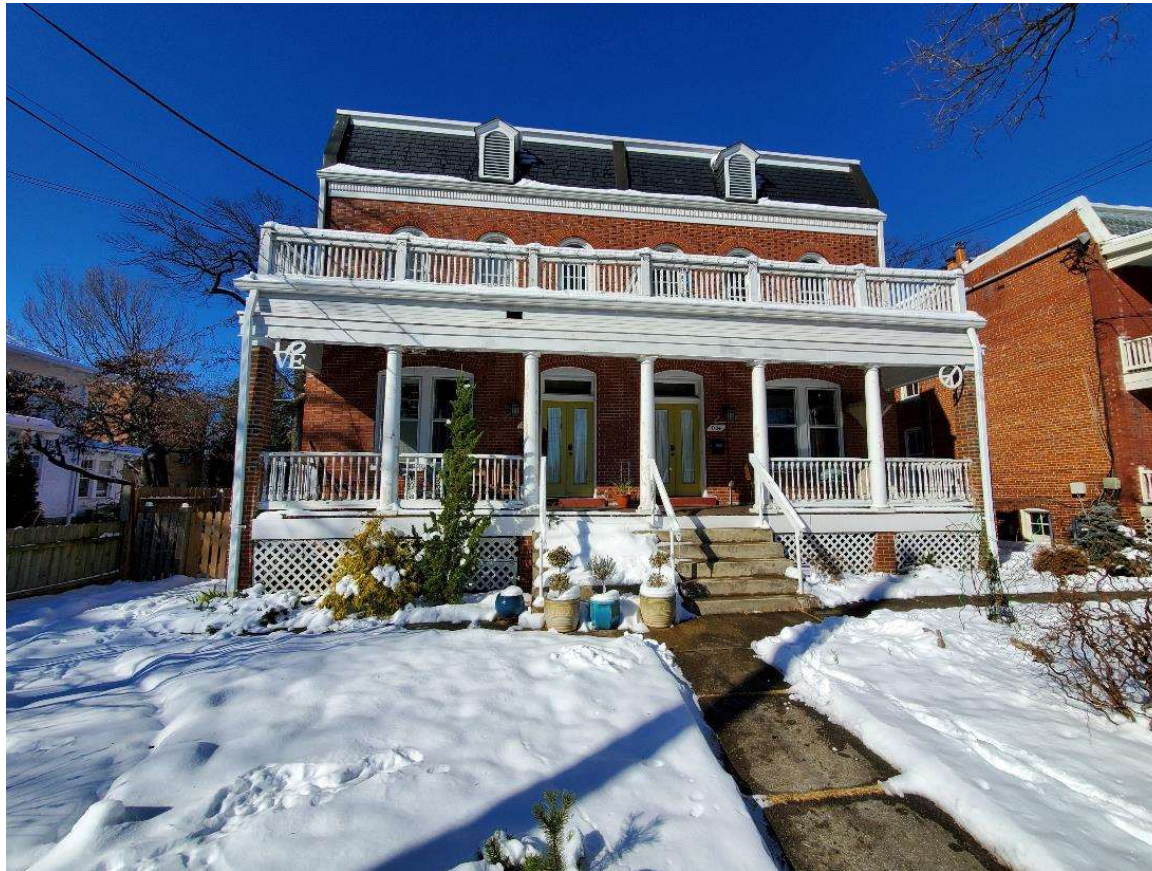
**Photo A - 7102 Maple Ave – Front Elevation**

<p>removed (shortened by ~3'), fascia was made to provide some structural support: 2x4s were installed behind the fascia, which were connected to the two horizontal beams. (Photo A, 1)</p> <p>(8) Roofing materials (tar paper, asphalt, flashing, etc.), not intended to withstand heavy foot traffic or the placement of furniture, were installed over the OSB plywood (that had been installed over and in areas where T&amp;G was missing). (Photo 6,7)</p> <p>(9) The original balustrades have been replaced, Existing are made from pressure treated 2x4s and 5/4" decking materials. Some are tagged <i>Hechinger</i>. Installed without structural support, all wobble. All are deteriorating. Balusters are square, which is the appropriate architectural style for the house and its construction period. (Photo A,7)</p>	
--	--

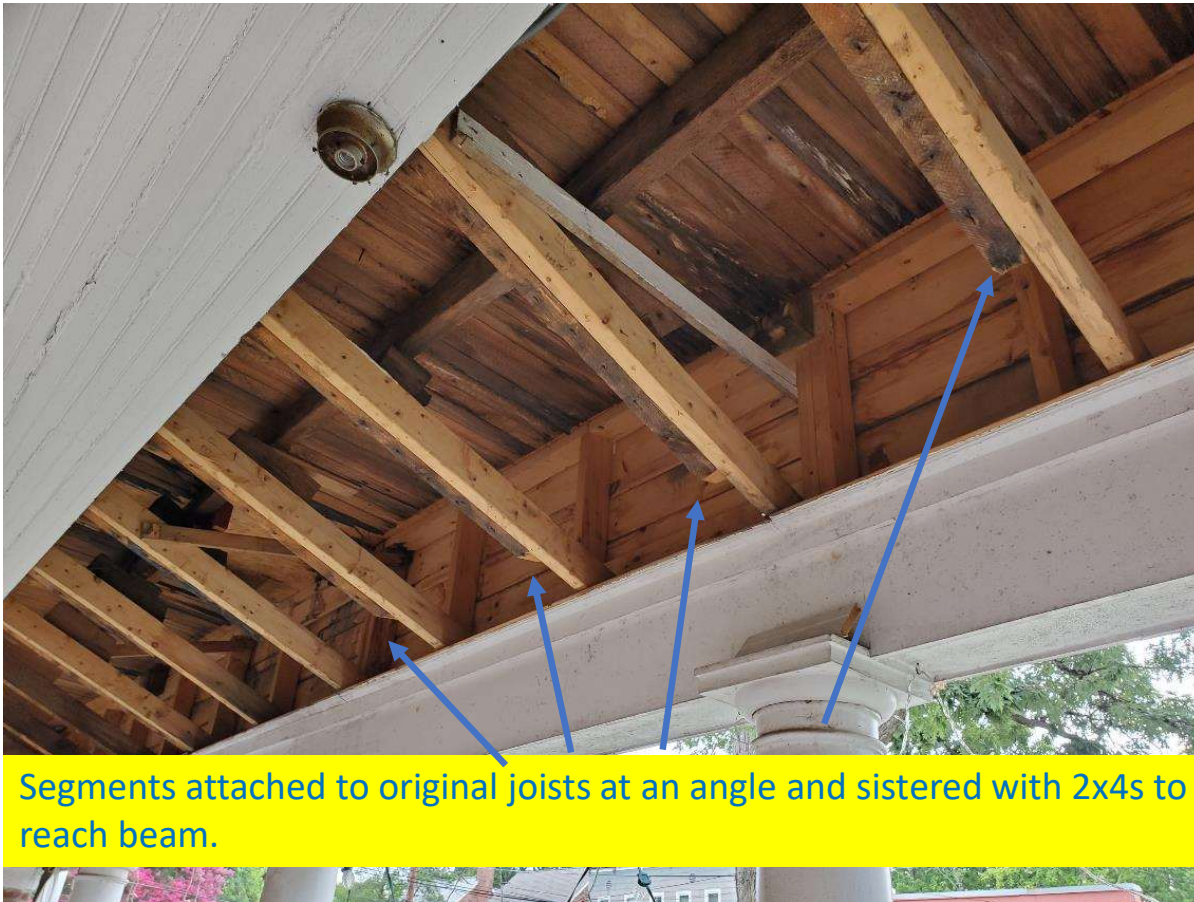
Alterations/repairs were cobbled together with charred, water-damaged, irregularly cut, and painted pieces; planed and un-planed wood; OSB plywood; roofing materials (tar-paper, asphalt, flashing), decking; and off-the-shelf products. Structural changes were likely made to install shorter, wider, and less-expensive columns. (Photo 1).

**Photo 1 - 7102 Maple Ave – cut joists too short**

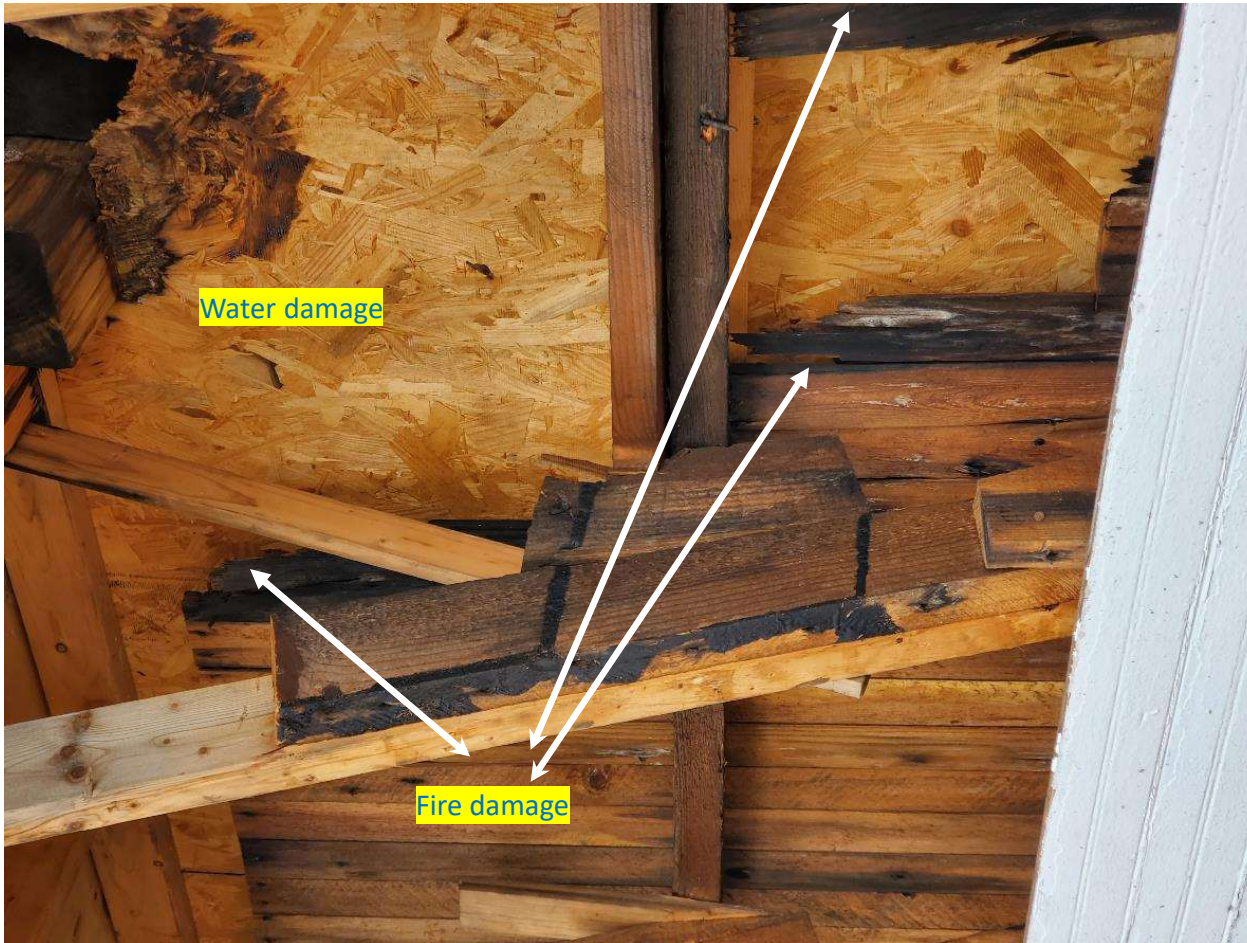
The entire upper-level has been altered, most likely due to a fire that began there and traveled below to damage columns and balustrades but did not reach the tongue and groove (T&G) on the lower floor. (Photos 1,2)

- (1) Upper-level joists extending from the house as well as T&G are charred. And approximately 3 x 42 ft. of T&G and a joist that ran the length of the house upon which T&G was installed are missing from its front. About 3 feet has been cut from the ends of all joists (extending outward from the house). (Photo2)

Photo 2 - 7102 Maple Ave – fire damage

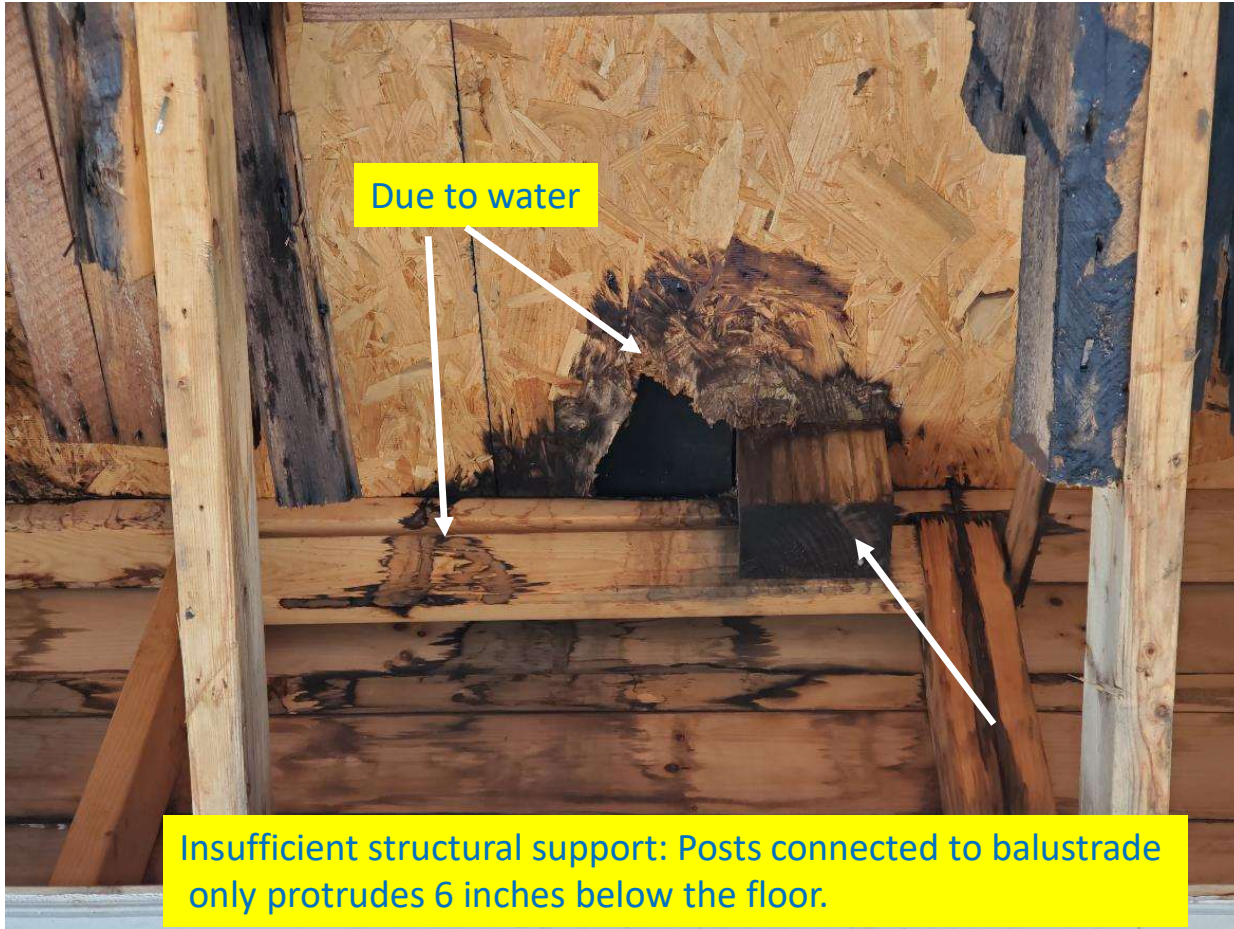
**Photo 3 - 7102 Maple Ave – deteriorated post upper porch**

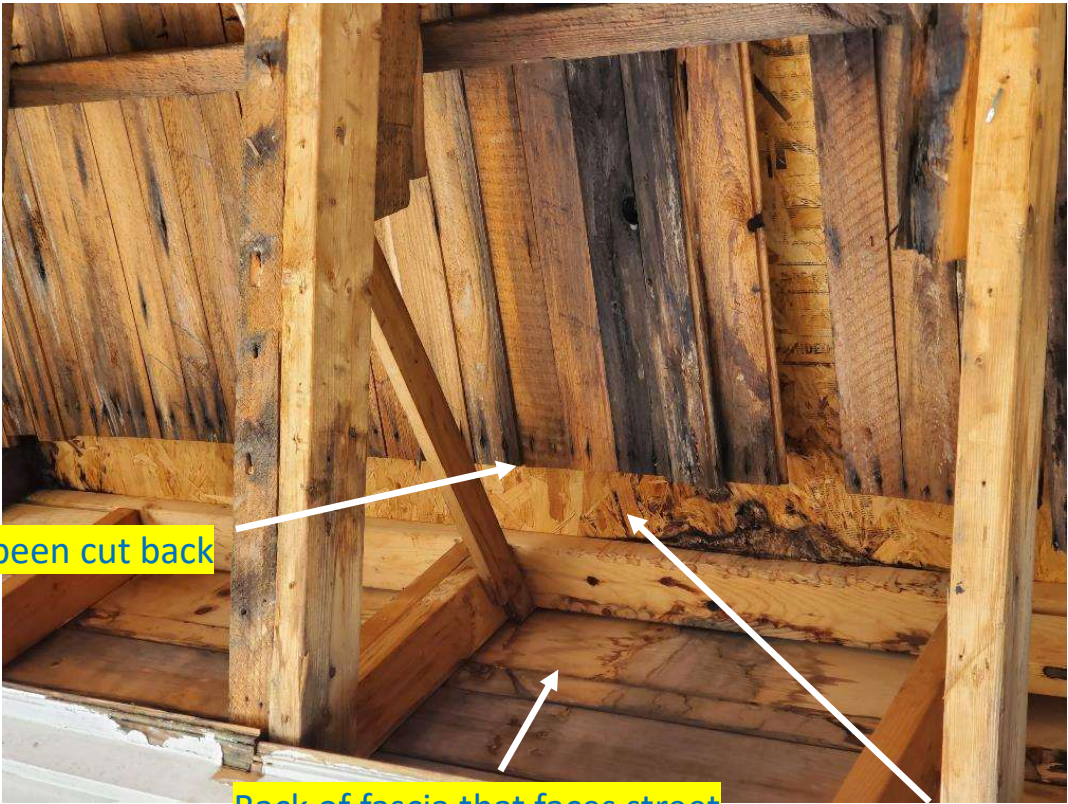
Side 4 - 7102 Maple Ave – OSB flooring and original tongue and groove cut

Original T&G has been cut back

Back of fascia that faces street

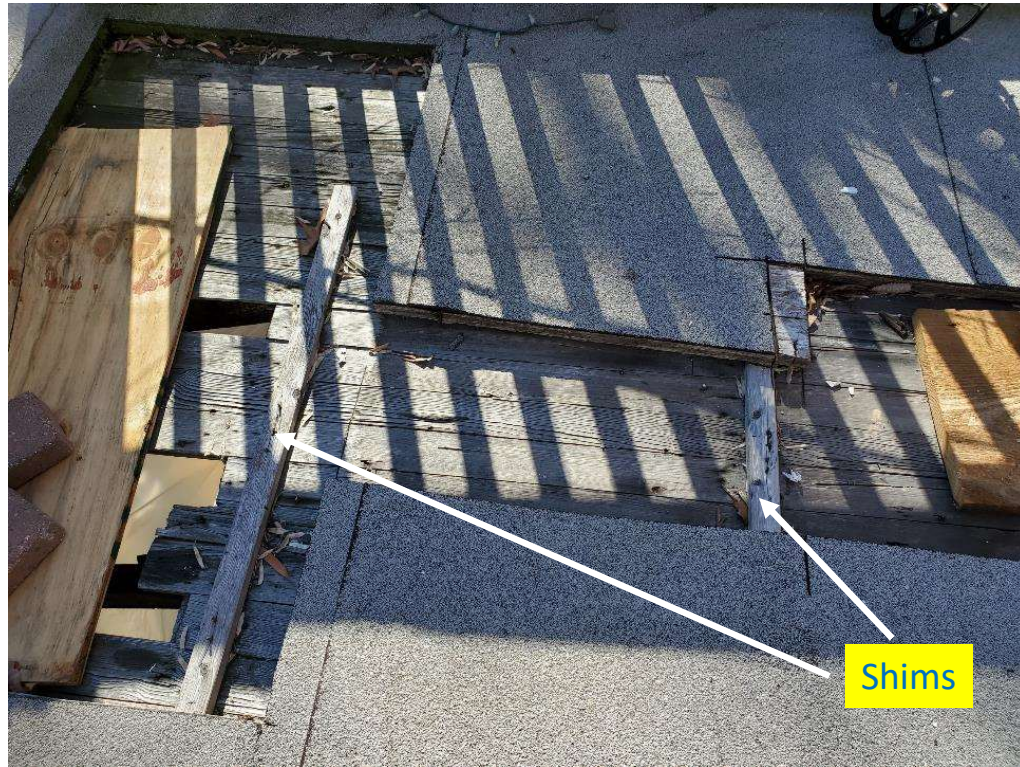
- (2) One-inch thick OSB plywood was installed on top of the remaining T&G as well as over the area where T&G was removed.
- (3) An original slope on the upper-floor causing water to move away from the house was eliminated when OSB was installed level with the thresholds of two doors. This alteration resulted in watering puddling on the floor as well as leaking through the doors into the house. (Photo 6,9)

- (5) A beam that would have run lengthwise likely burned, and a 2x4 was installed to replace it. OSB was attached to the 2x4. (Photo6)
- (6) Joist segments (3') cut from original joists were reattached to them at an angle toward the columns. The joists portions were made long enough to reach and be attached to the beam resting on top of the columns by sistering longer 2x4s to them. (Photo19)

Photo 6 - 7102 Maple Ave – Upper Porch-T&G-OSB-Shims

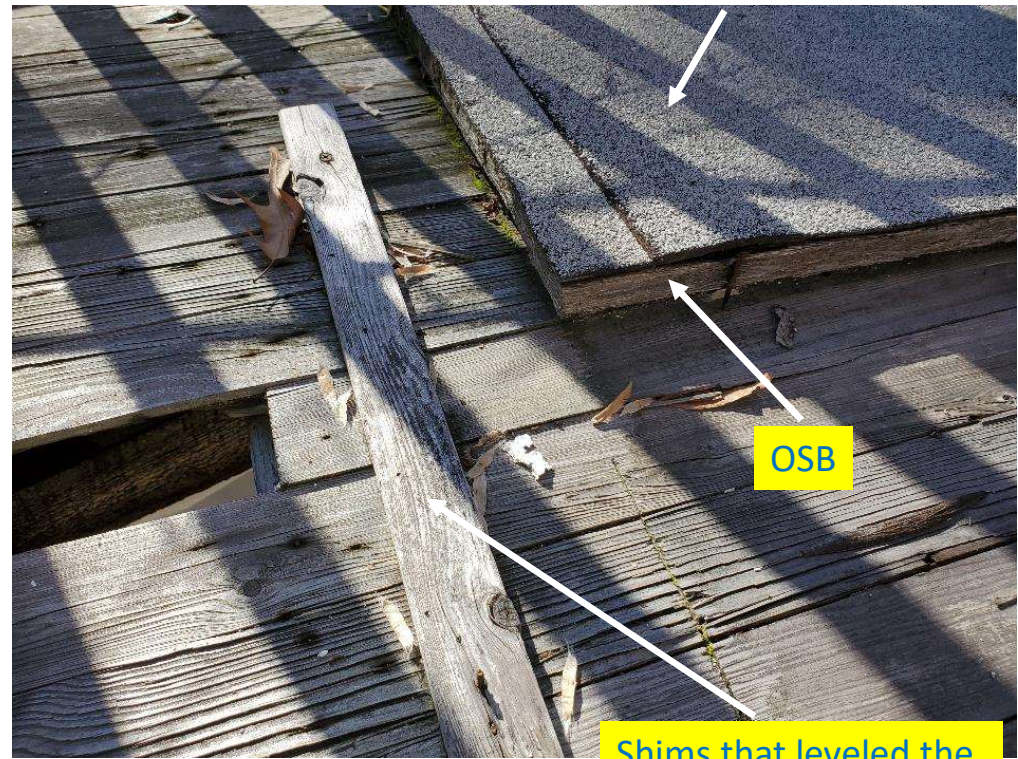
Asphalt roofing material

Shims that leveled the altered flooring

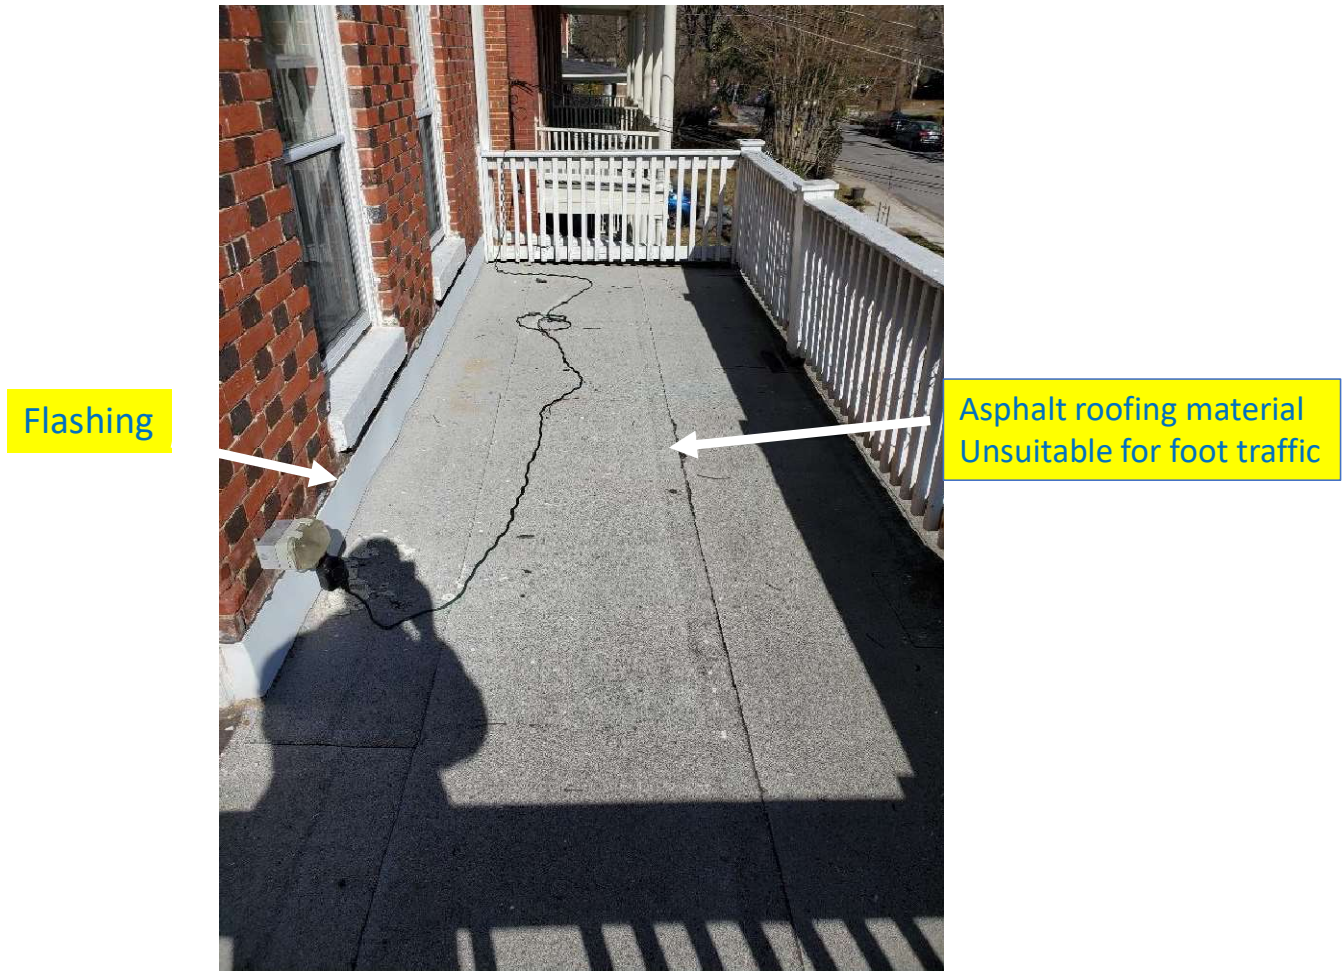
- (5) Roofing materials (tar paper, asphalt, flashing, etc.), not intended to withstand heavy foot traffic or the placement of furniture, were installed over the OSB plywood (that had been installed over as well as to replace some T&G).

**Photo 7 - 7102 Maple Ave – Asphalt roofing material**

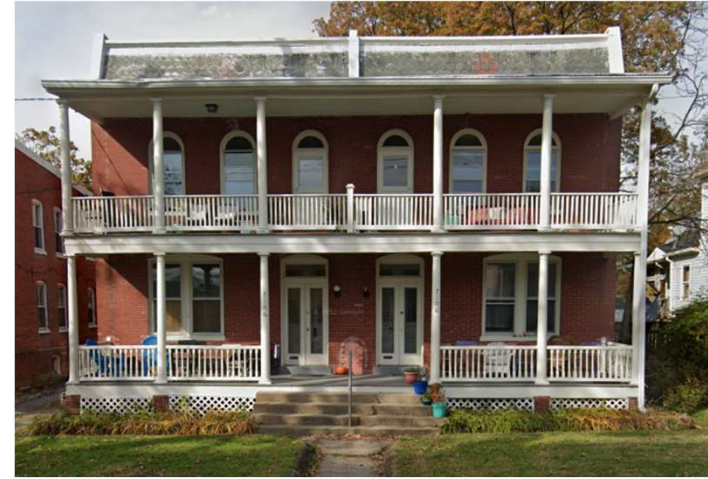
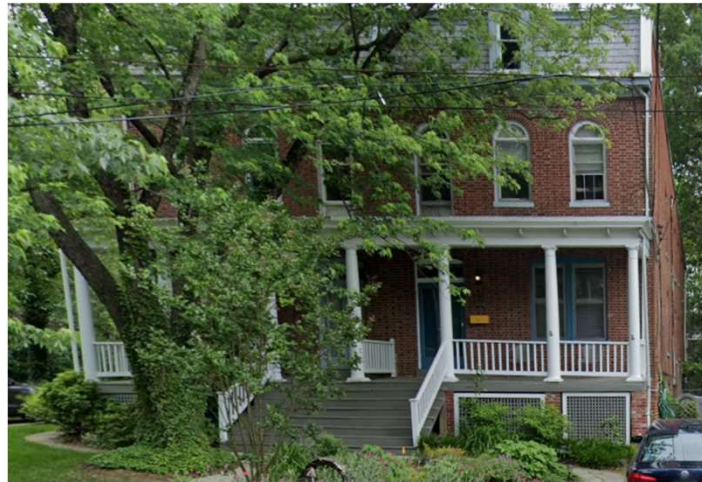
## Photo 8 Fascia Comparisons

- (4) Front fascia, likely original, is missing large segments, and has been covered with synthetic wood in an effort to protect it from additional damage.

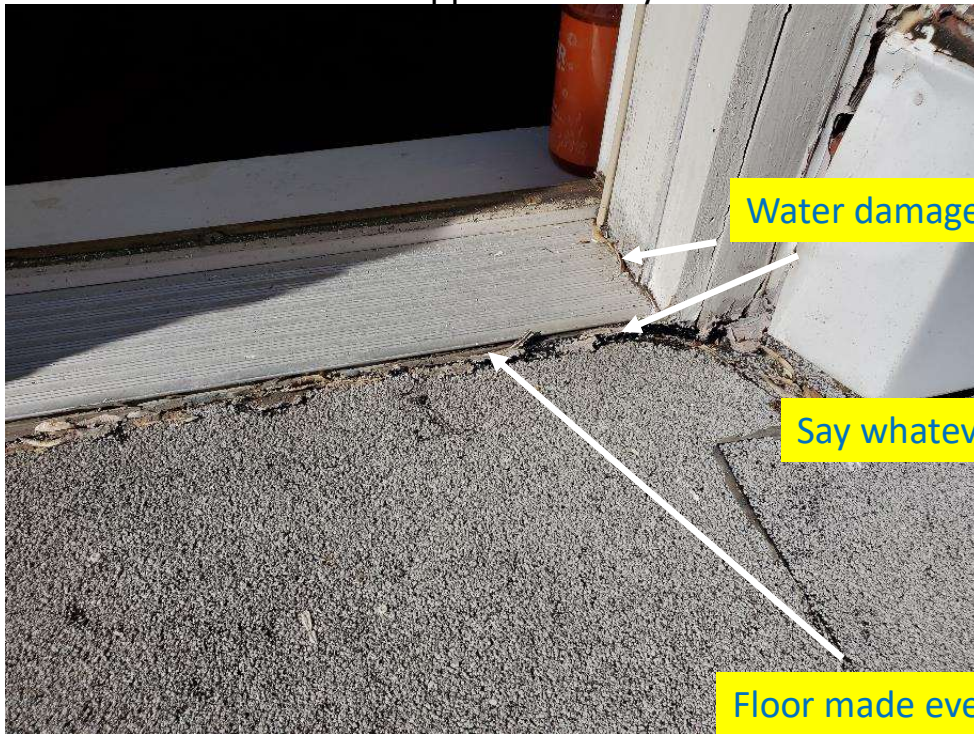
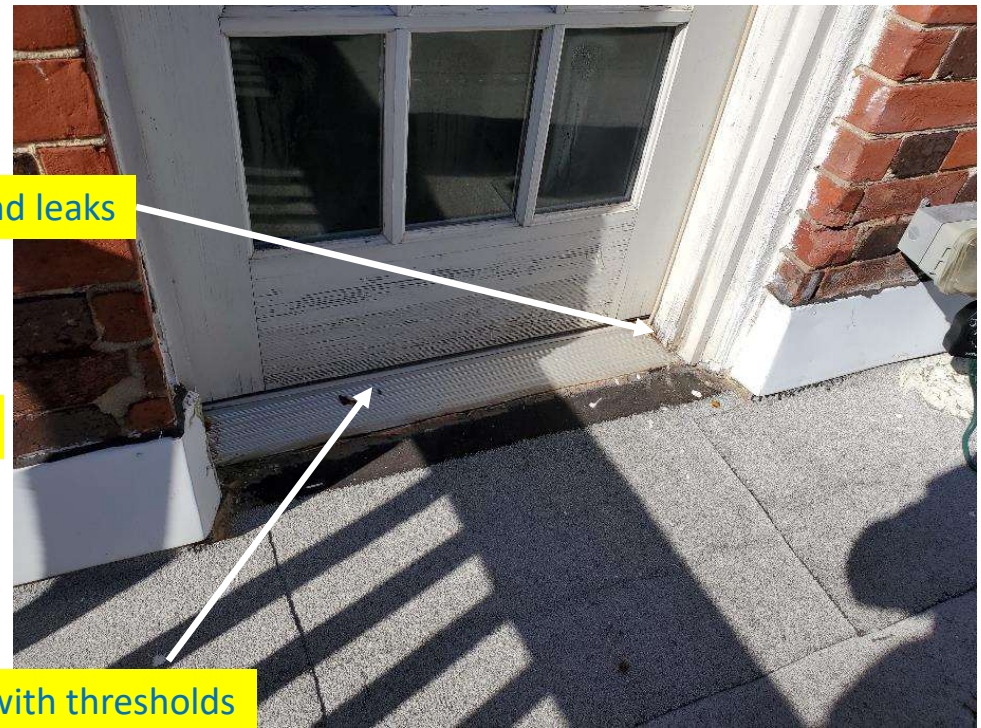
- b. Water leaks into the house through two doors because plywood was installed to be level with the thresholds of those doors.
  - c. The width of the upper-level floor has been reduced, which removed the original floor's slight overhang that directed water away from the porch below: water drops directly onto the lower- from the upper-floor to exacerbate the deterioration (erosion) of the T&G on the lower-floor.

**Photo 9 - 7102 Maple Ave – Upper porch doorways**

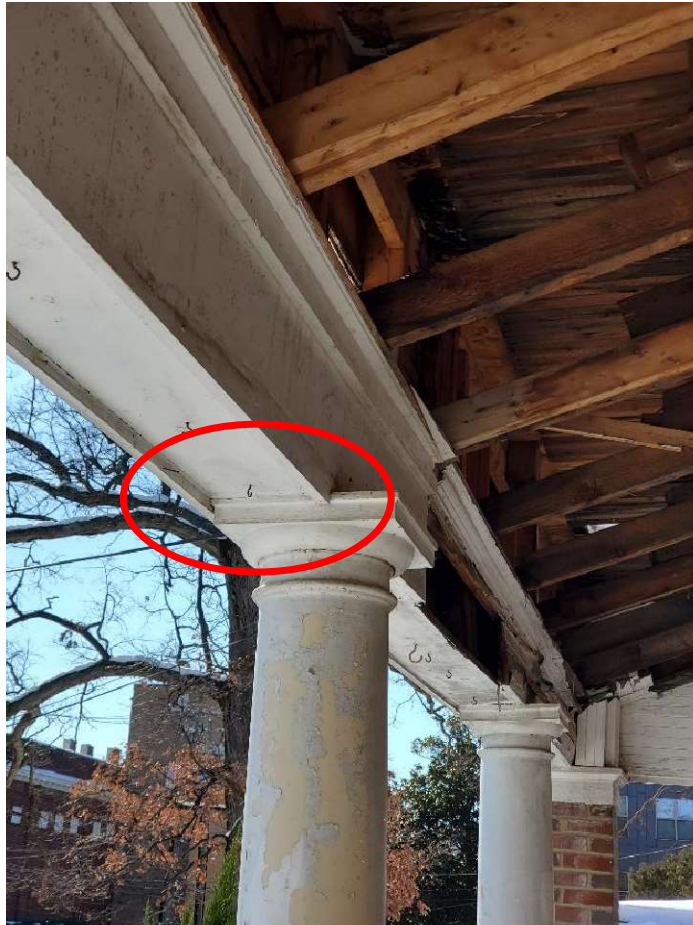
**Photo 10 - 7102 Maple Ave – off center beam**

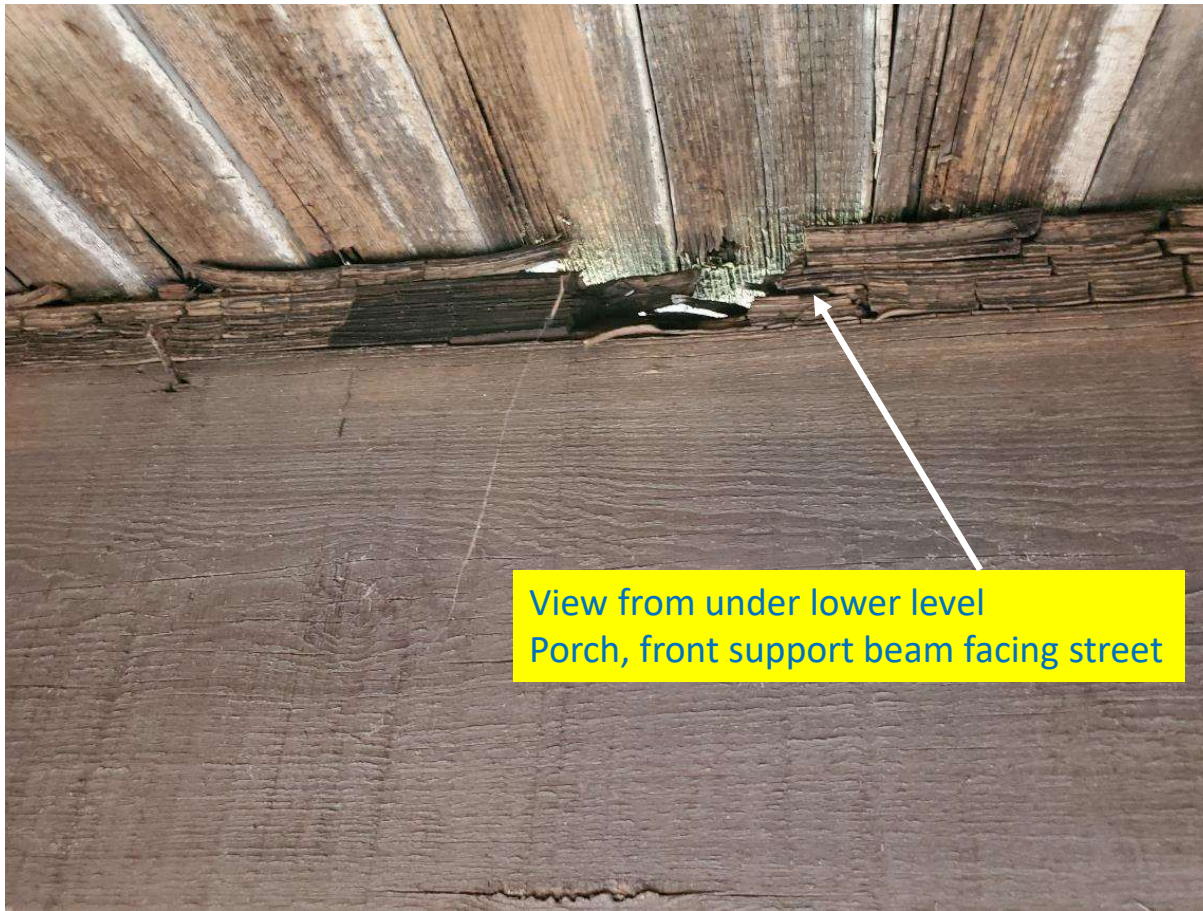
- (3) T&G, underpinning frame (joists, etc.), likely original, are significantly deteriorated. They are chipped, squishy in places, missing wood pieces and nails as well as have protruding nails.

**Photo 11 - 7102 Maple Ave – lower porch floor joist rot**

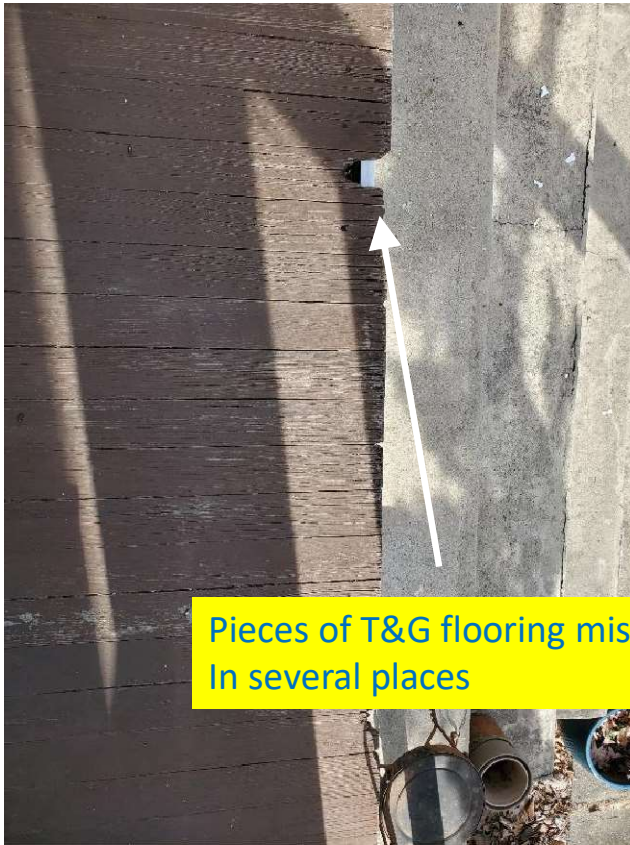
Photo 12 - 7102 Maple Ave – lower porch floor rot

Pieces of T&G flooring missing  
In several places

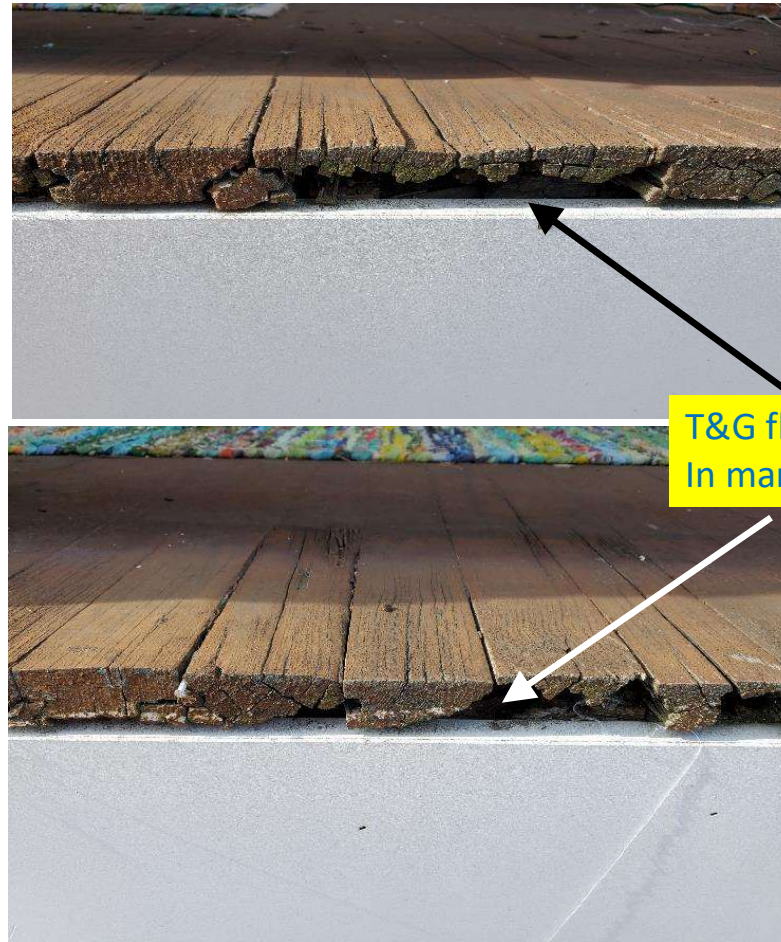
T&G flooring deteriorating  
In many places

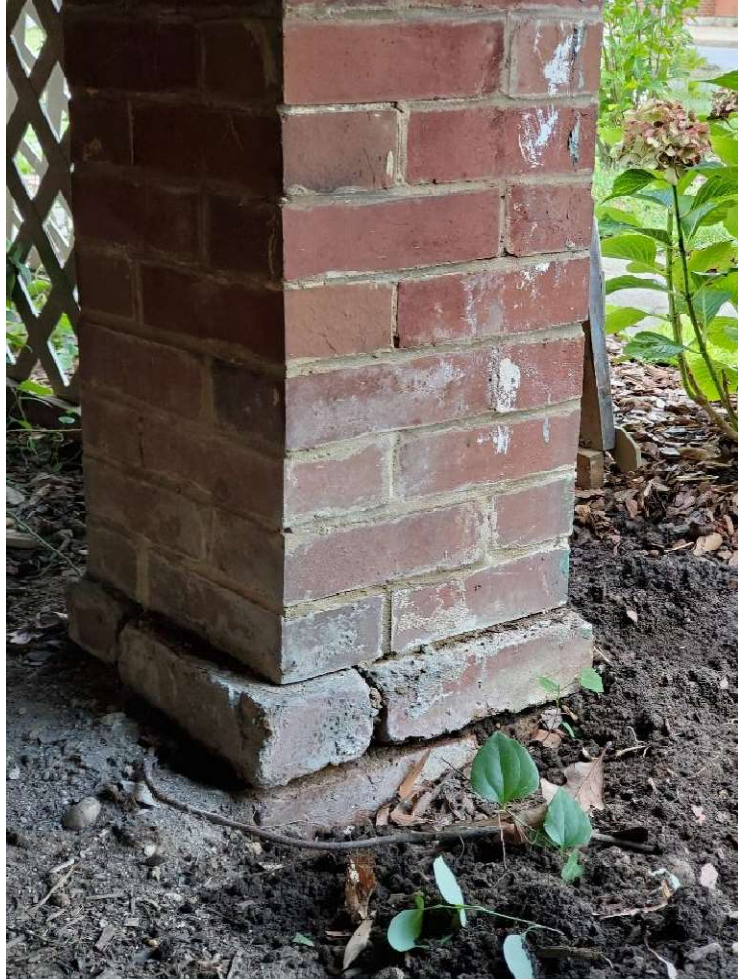
<p><b>Description of Current Condition:</b></p> <ul style="list-style-type: none"><li>(1) Brick piers and their foundations (6) are missing mortar or/and brick. (Photo 13,18)</li><li>(2) Wood is deteriorating or missing and paint is peeling on and around doors (4 (2 double)), thresholds, eight windows and trim.</li><li>(3) Railings along steps are unsafe (no fall protection between railing posts). (Photo 14)</li></ul>	<p><b>Proposed Work:</b></p> <p>Proposed work will to reinstate original architectural design and elements with materials approved by the Montgomery County Historic Commission. And meet 2024 building codes.</p> <p>Proposed work includes:</p> <ul style="list-style-type: none"><li>(1) Repoint/repair brick piers and their foundations.</li><li>(2) Repair two double doors and windows.</li><li>(3) Repair stair railings to 2024 code.</li><li>(4) Prime and paint (2 coats).</li></ul> <p>Note: Proposed work emphasize sustainability. This includes resolving water issues as well as those sun-related—the east-facing porch is beaten by morning sun.</p>

**Photo 13 - 7102 Maple Ave – brick pier base**

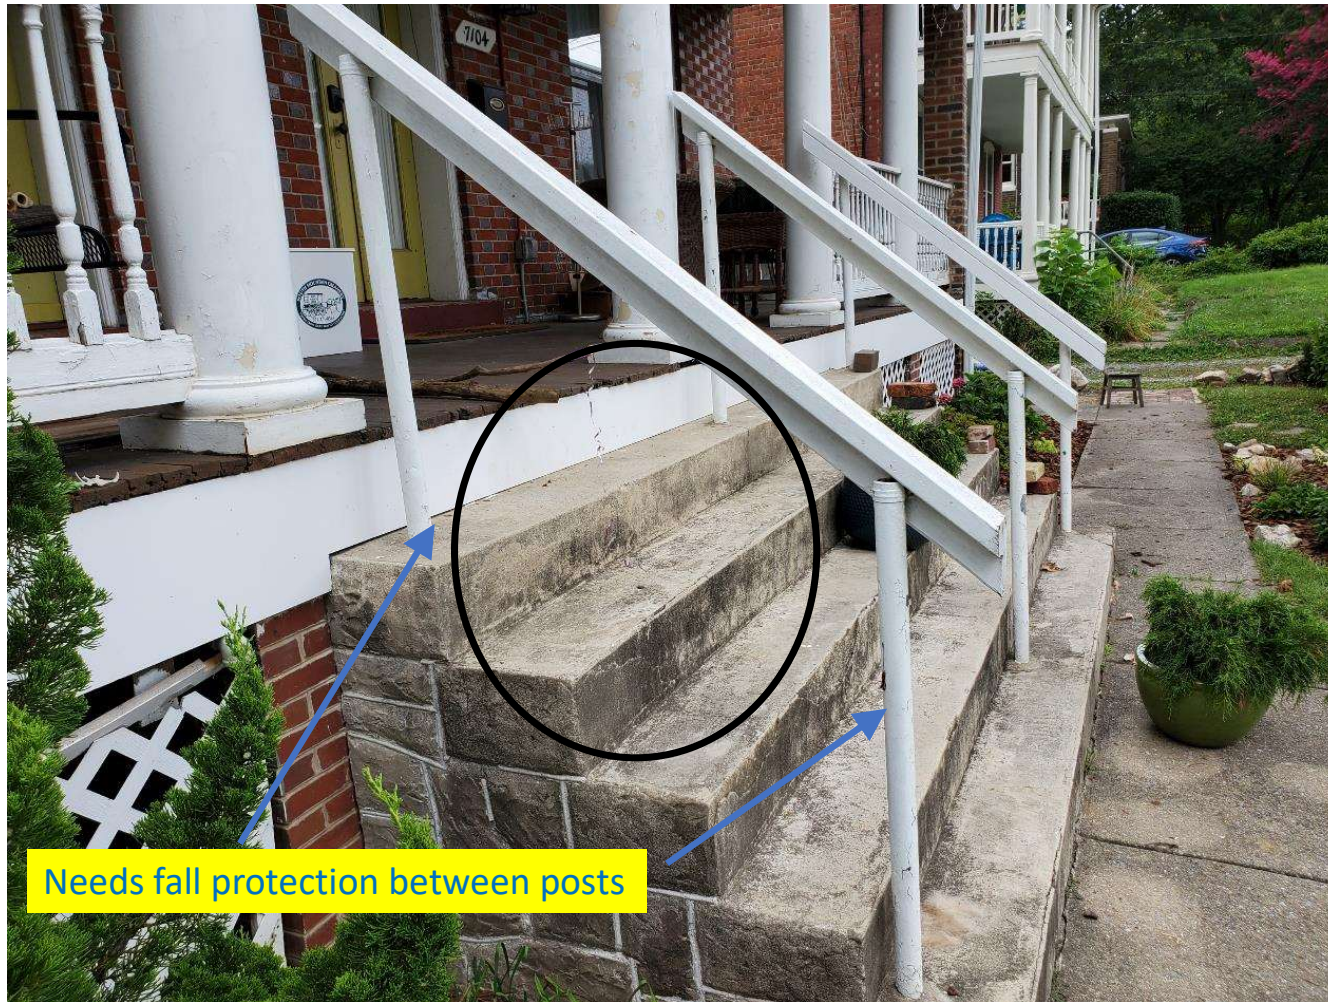
**Photo 14 - 7102 Maple Ave – steps showing no fall protection**

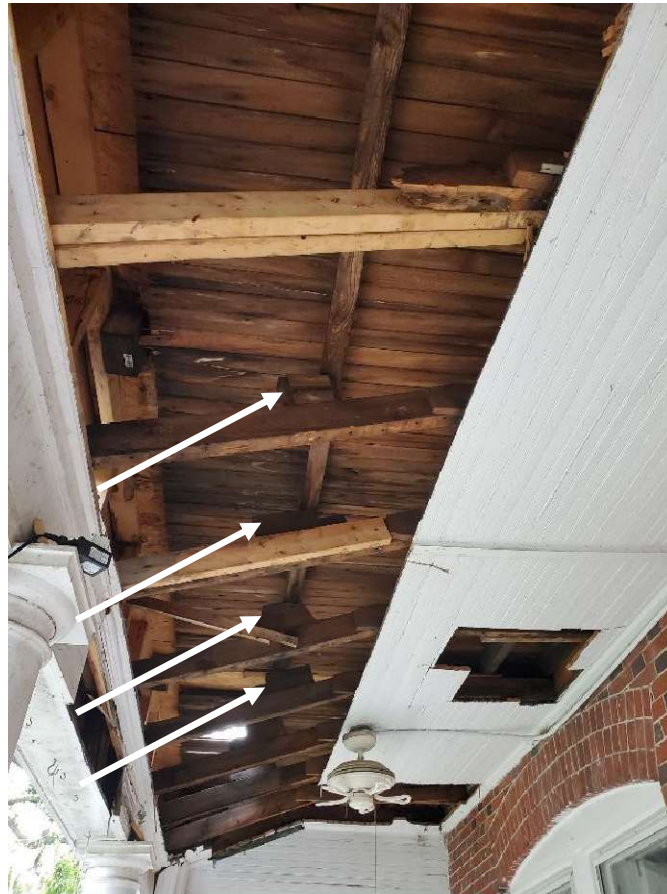
**Photo 15 - 7102 Maple Ave – odd shaped shims holding up 20 Foot long 2x4s**

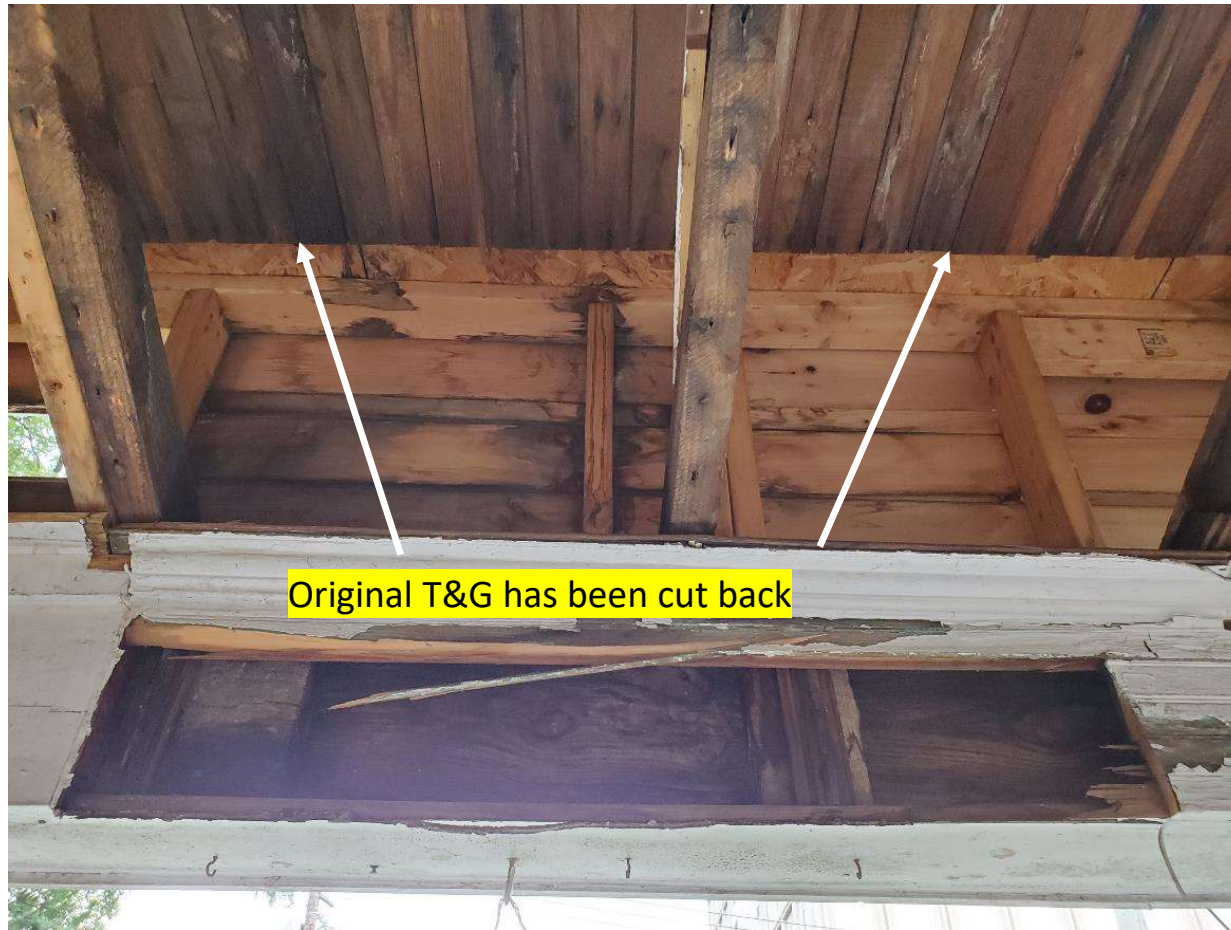
**Photo 16 - 7102 Maple Ave – ‘wall’ above support beam**

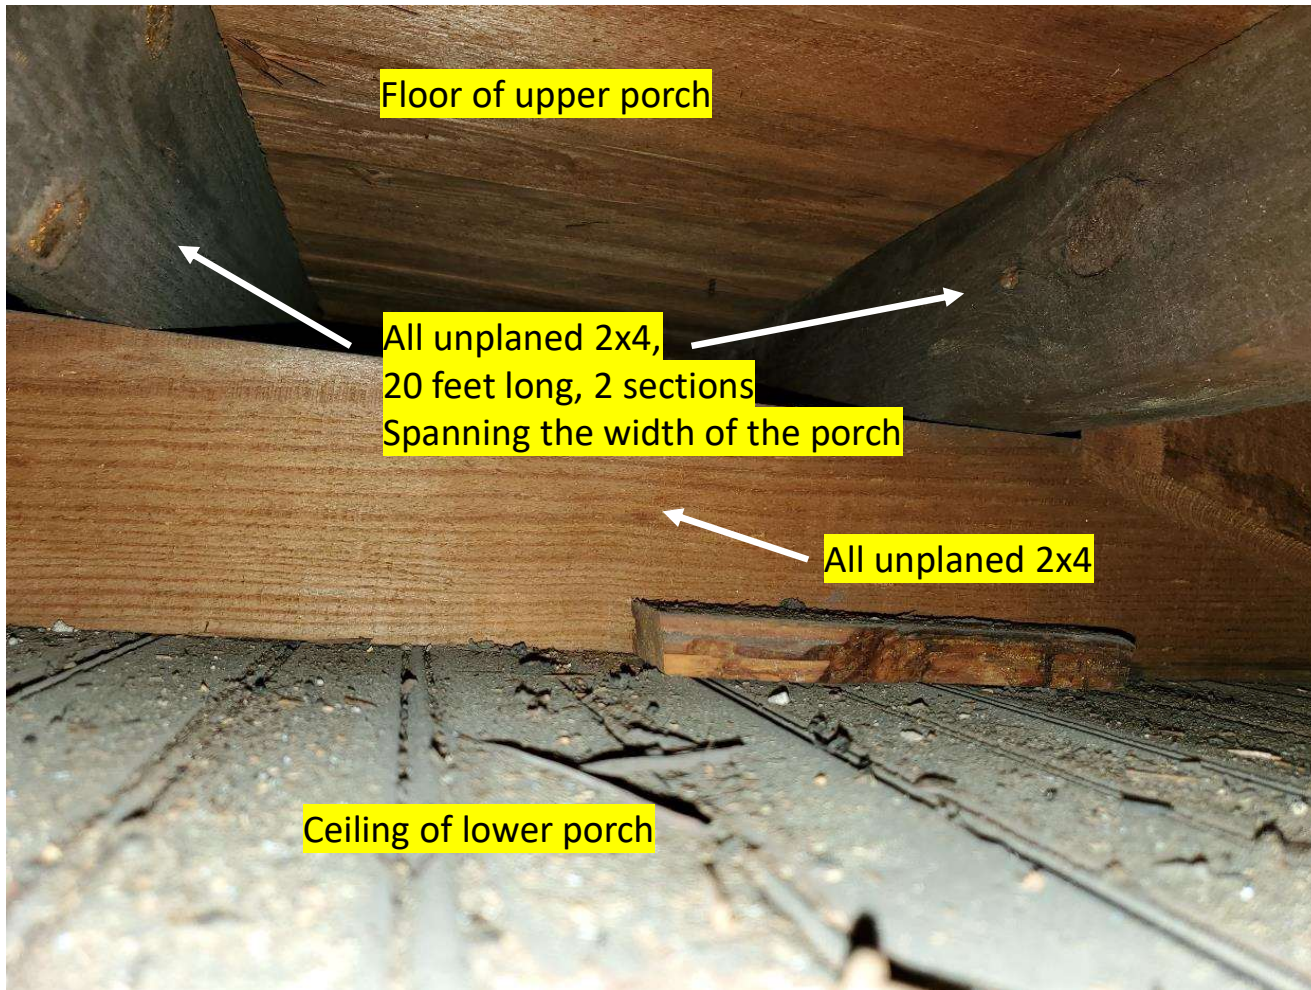
Photo 17 - 7102 Maple Ave – original joists

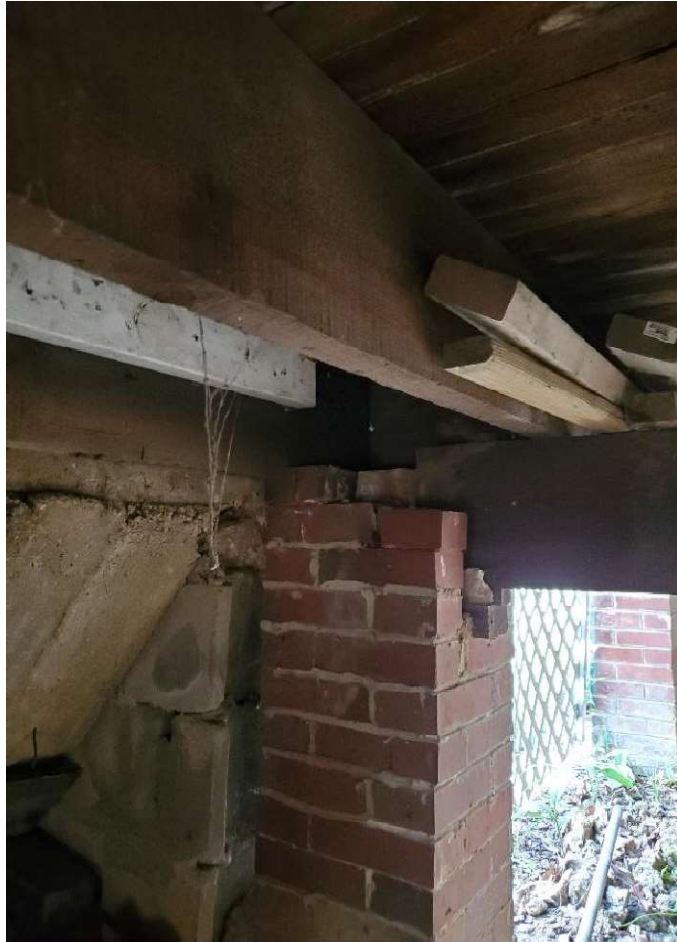
**Photo 18 - 7102 Maple Ave – brick pier**
