**MONTGOMERY COUNTY HISTORIC PRESERVATION COMMISSION**  
**STAFF REPORT**

<b>Address:</b>	2420 Spencerville Rd., Spencerville	<b>Meeting Date:</b>	3/26/2025
<b>Resource:</b>	Master Plan Site #15/55 <b>Spencer-Carr House</b>	<b>Report Date:</b>	3/19/2025
<b>Applicant:</b>	Cedar Ridge Community Church (Ginger Donohue, Agent)	<b>Public Notice:</b>	3/12/2025
<b>Review:</b>	HAWP	<b>Staff:</b>	Dan Bruechert
<b>Permit Number:</b>	1107038	<b>Tax Credit:</b>	n/a
<b>Proposal:</b>	Silo Demolition

Project Name: 2410 Spencerville Road – Masonry/Brick Silo Initial Investigation  
Structural Engineering Services  
Our Project No.: 225C026 – Masonry/Brick Silo

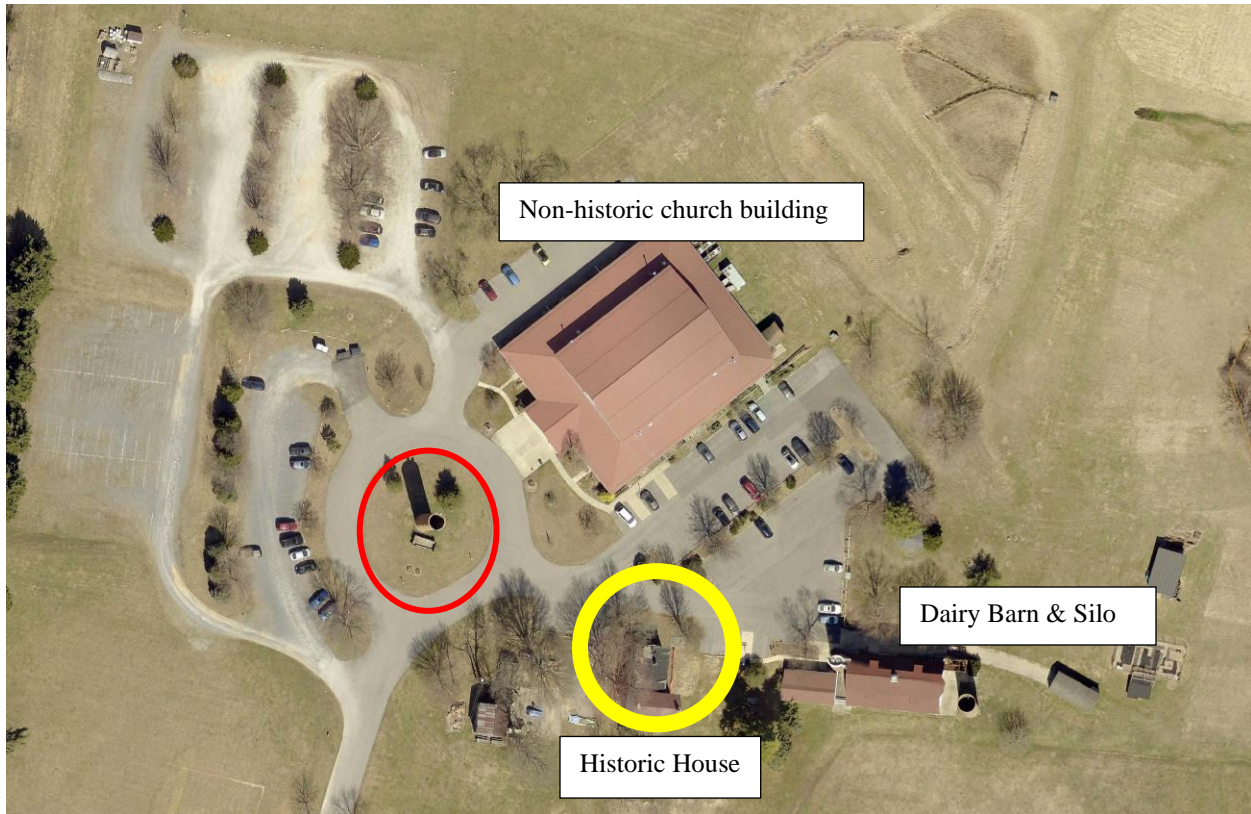
*Figure 2: Detail aerial of the Spencer-Carr House site (historic house circled in yellow) with the silo circled in red.*

The applicant proposes to demolish the existing silo, located in front of the contemporary church serving as the central focus of a traffic circle (see Figure 2, above). The existing silo was constructed using terra cotta blocks, with a brick exterior. Staff's 1996 file photos from the designation of the Spencer-Carr House Master Plan Site show the location and treatment of the silo have not changed in nearly forty years (see Figure 3, below). The 1996 MIHP form identifies the silo as a "brick silo, west of the house, between the cottage and the shed." Staff's cursory research suggests this silo was constructed sometime from c.1910 when the hollow-tiled 'Iowa Silo' became widely adopted to c.1930 when all concrete silos became the norm.

Once the silo is removed, the circle will be re-graded and additional plantings are proposed for the circle. The applicant proposes to integrate any salvageable bricks in a future project on site. The nature of that project is unknown at this time. While Staff finds this to be a thoughtful gesture, Staff does not recommend the retention of the silo bricks as a condition for the approval of this HAWP.

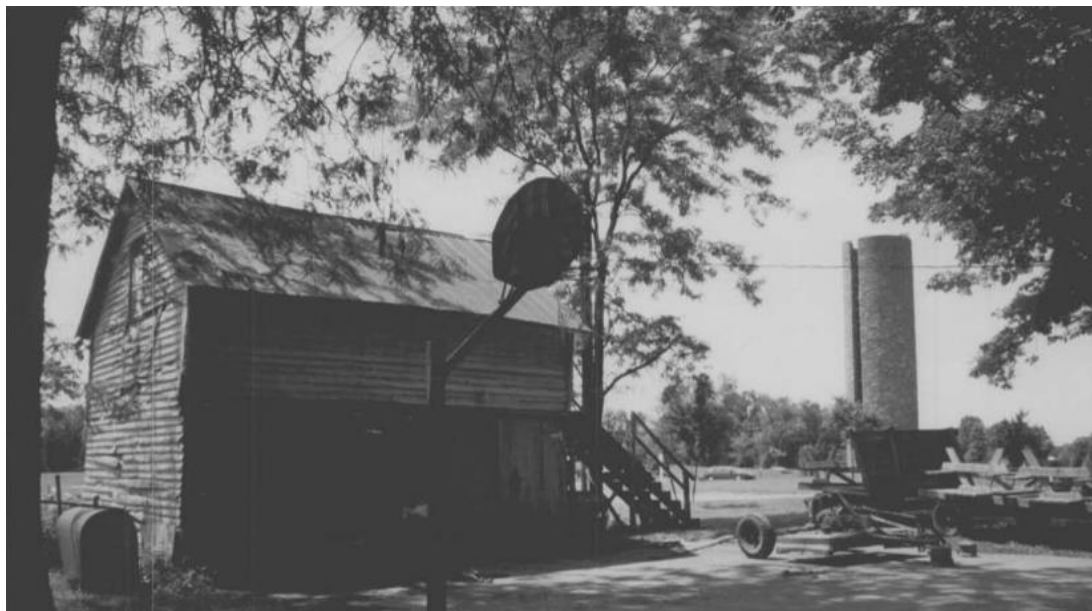
*Figure 3: Circa 1996 file photo documenting the Spencer-Carr House Master Plan site. The silo to be demolished is in the background.*

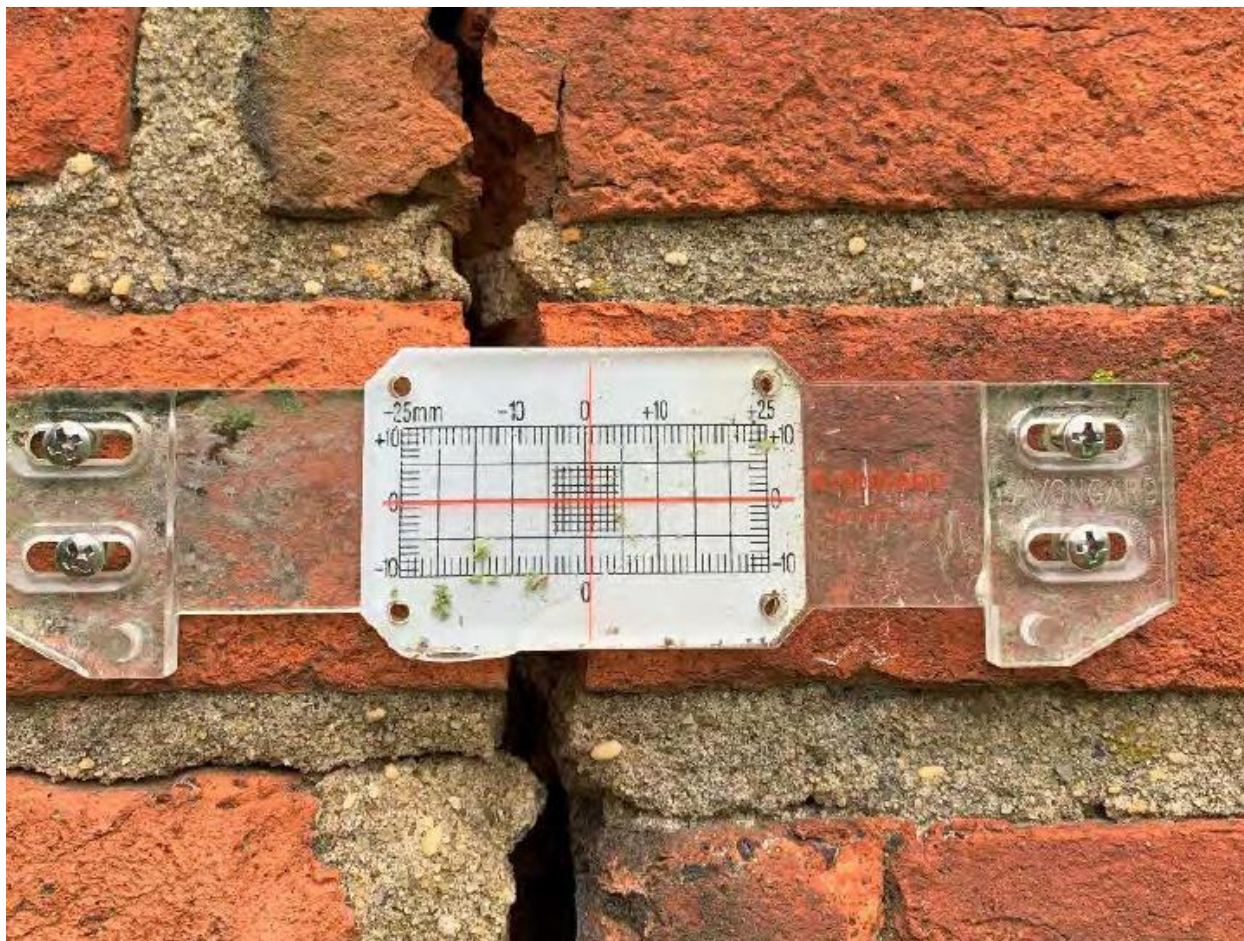
In 2018, the applicant indicated they were concerned about the stability of the silo and installed monitors on the exterior of the silo to measure its movement. Staff's informal discussions with the applicant at that time included an evaluation of potential solutions including installing flashing at the top of the silo walls, stabilizing the foundation with concrete, and any actions that could stabilize the terra cotta blocks. The applicant, with the HPC's support, prioritized the rehabilitation of the Spencer-Carr House over interventions to the silo.

In early 2025, the applicant contacted Resolutions Consulting Engineers to evaluate the condition of the silo (report attached). The engineer identified ongoing crushing and deterioration of the terra cotta blocks and large cracks running through both the interior blocks and the exterior bricks. The foundation was not found to be shifting, and its concrete base remains intact. Lateral movement showing that one of the wall cracks was growing was found on one of the installed crack monitors (see *Figure 4*, below). The steel reinforcing lattices that provide lateral strength were also observed to be causing rust jacking on the interior. The engineer concluded that, in the interest of safety, the silo should be demolished; and that any method of repairing the silo in-situ was infeasible.

*Figure 4: One of the crack monitors shows the crack has spread by approximately 1mm (one millimeter).*

Based on Staff's review of the engineer's report and observations on site, Staff concurs with the engineer's recommendation that the silo should be demolished. The crumbling terra cotta block provides much of the structure's vertical strength and is failing, and the steel reinforcement was rusting. Both of these materials cannot reasonably be repaired without dismantling the building and reconstructing it with new materials. Staff supports the demolition under 24A-8(b)(4), finds that demolishing the silo will remove a potential hazard from the site.

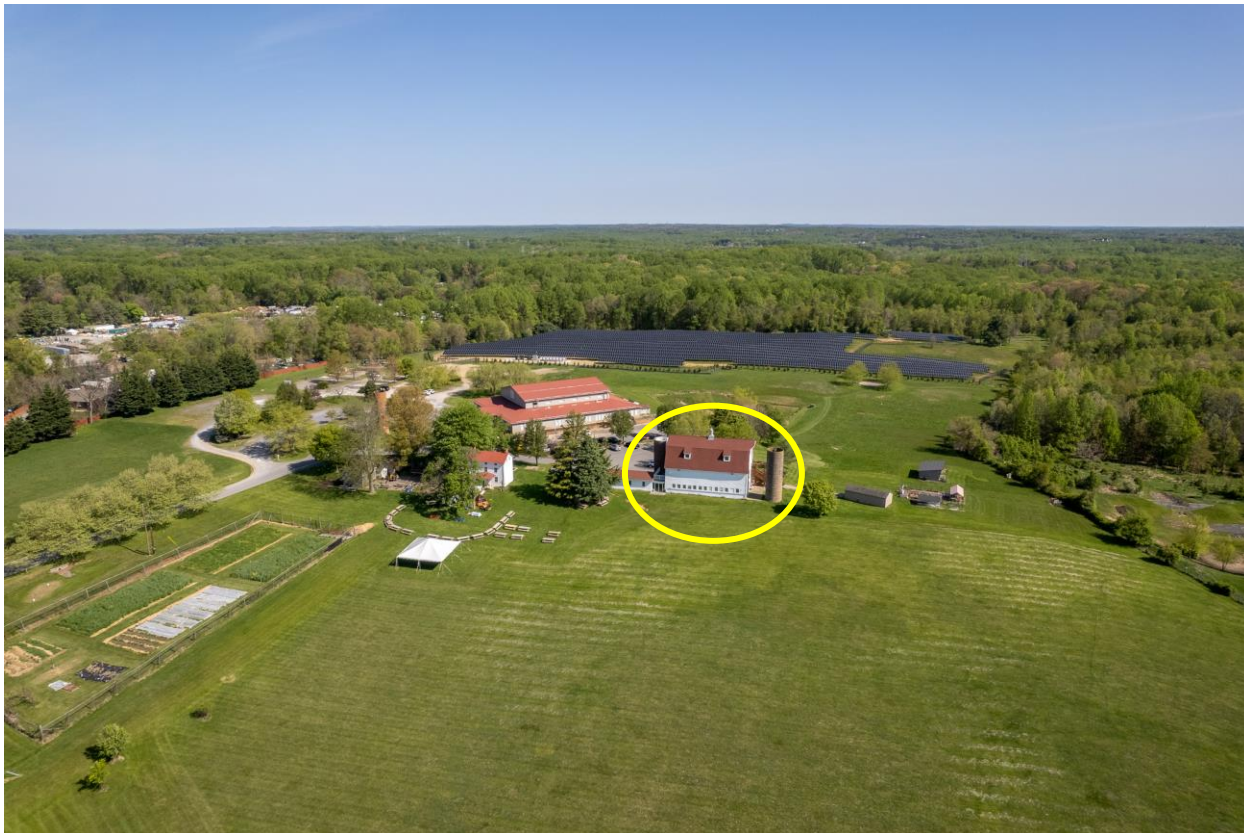
*Figure 5: Aerial photograph of the Spencer-Carr Master Plan site with the rehabilitated dairy barn and its silos circled in yellow.*

Staff finds that incorporating the usable silo bricks into a future project on site would be an appropriate use of the materials. As plans are developed, Staff recommends the applicant reach out to the Historic Preservation office as that work may require a HAWP.

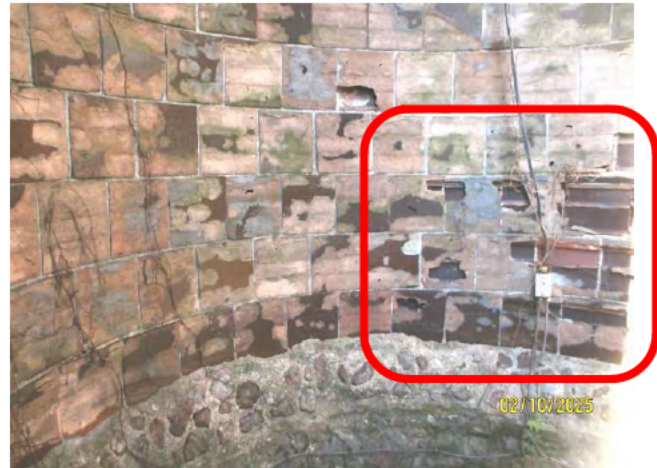
As referenced above, we observed crushing and deterioration of the terracotta masonry blocks at the inside rear face (opposite the front vertical opening) – see sample photograph at top right, with deteriorated/broken blocks circled in red. Around the exterior base of the silo, we observed a number of large cracks in the bricks; the largest of these cracks generally corresponds to the location of the damaged/deteriorated terracotta blocks within.

In our opinion, the broken terracotta blocks at the rear of the silo base can no longer support the weight of the structure. The terracotta is slowly crushing, and the brick layer at the base is distending/crushing outwards. Terracotta blocks are brittle (compared to brick or CMU block), and the condition will only continue to worsen until a collapse. At the front, since the steel and terracotta blocks are deteriorated along the edges of the vertical opening, there is little continuity left in the circular shape of the silo. That is to say, a circular structure is inherently strong; but the deterioration and damage at the front vertical opening has interrupted/broken the internal transmission of forces in the circular silo.

In the interest of safety, we must recommend that the silo be demolished and removed from the property, as soon as is feasible. Due to the brittleness and breaking of the terracotta block, and the significant damage/movement/cracking of the brick of the rear, we do not believe that the silo can be repaired in-place (such an endeavor would require temporarily bracing the silo, then replacing/rebuilding the brick and backup blocks in very small sections at a time; we fear the act of removing and replacing *any* portion would destabilize the entire base of the silo).

Once demolished, intact bricks may be reclaimed/reused for other purposes (either purely decorative or interlaid with new CMU blocks for new structural elements). Terracotta blocks should be outright discarded. In the meantime, we must recommend that access to the space around the silo be restricted.

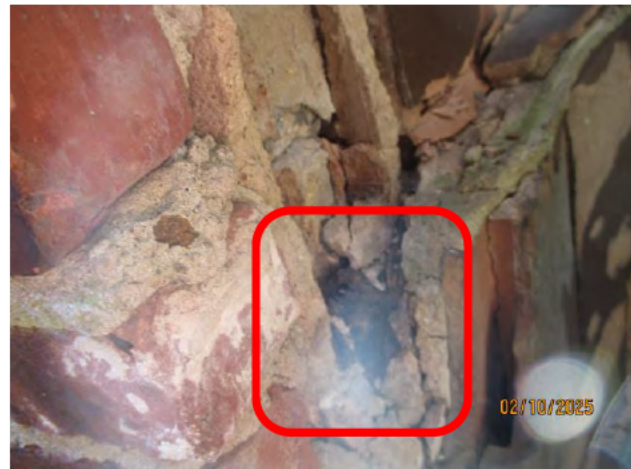
At the front vertical opening, we observed the edges/corners of the terracotta blocks to be similarly broken and deteriorated. Furthermore, the internal steel reinforcing lattices/ladders were observed to be completely deteriorated through in places – see sample photograph at bottom right, with deteriorated steel reinforcing circled in red. Some of the rungs in the vertical opening were also deteriorated through, and no longer engaging both sides of the opening.
