**MONTGOMERY COUNTY HISTORIC PRESERVATION COMMISSION**  
**STAFF REPORT**

| <b>Address:</b> | 19811 Darnestown Road, Beallsville | <b>Meeting Date:</b> | 11/12/2025 |
| <b>Resource:</b> | Darby House<br>Beallsville Historic District | <b>Report Date:</b> | 11/5/2025 |
| <b>Proposal:</b> | Demolition of accessory structure and construction of new shed. | | |

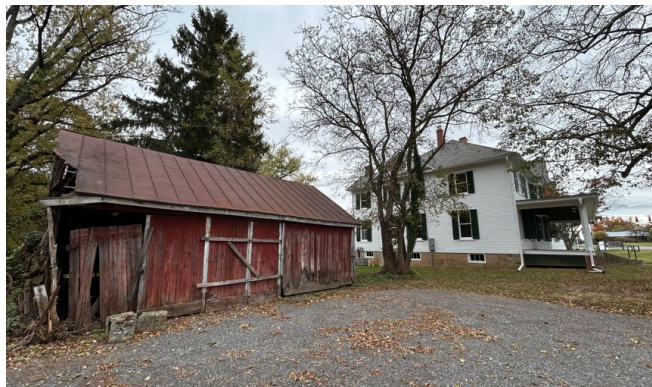
*Figure 6: The accessory structure proposed for demolition with the Darby house in the background (Left, October 2025, Historic Preservation office), and proposed shed (right).*

The north bay is severely structurally compromised. The sill plate, set on ground, has rotted, as have corner posts and stud bottoms, as well as siding, facia, and other elements. The bay doors have been secured shut, but they would be inoperable because of deterioration to most components. The man door providing access to this bay has also deteriorated and is inoperable (and open to the weather). A window ventilating the gable end is missing, so the building is open to the weather and a vulture was present inside the bay during the most recent site visit.

The front (west) elevation is clad in butted vertical boards. There is a largely rotted barn door that provides access to the south bay (plywood has been installed on the interior face of the door in an attempt to seal the building where the door's boards have rotted away); in the north bay there is a deteriorated plank, man-door and a set of double leaf barn doors. The hinge connection points to the door jambs have mostly failed and these doors do not function.

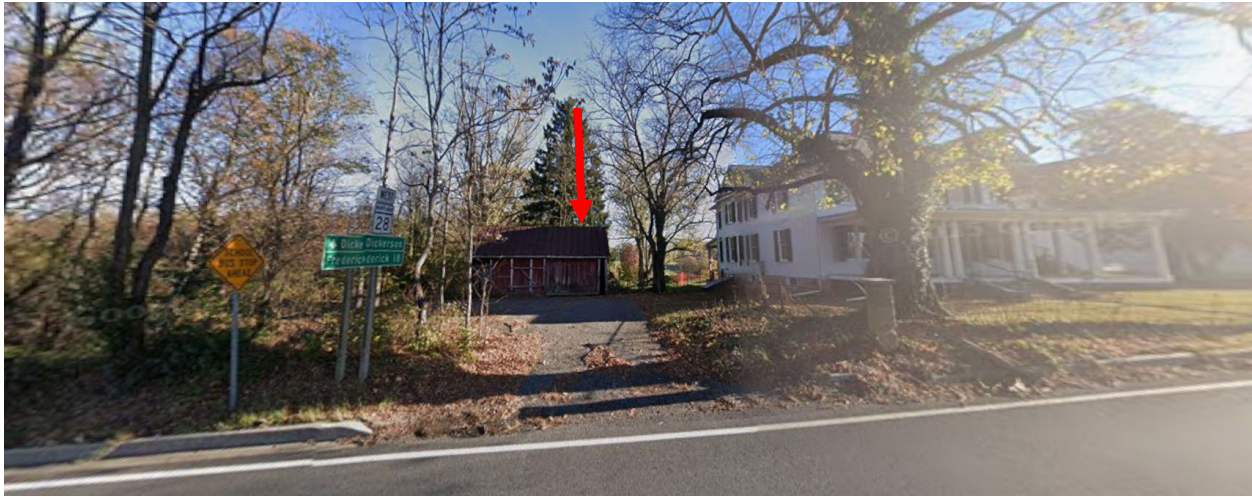
*Figure 8: Google Streetview image of the subject property from the driveway with a red arrow showing the location of the proposed shed. Staff recommends that the shed be placed farther from or behind the house, not to be immediately visible from the driveway entrance.*

Staff generally finds that the proposed 8-ft x 10-ft shed will not detract from the character of the historic resource, provided it is located in a less conspicuous location on the property than the end of the driveway where it is immediately visible upon entry to the property. Staff finds that, with that condition, the shed will be differentiated from but compatible in character with the historic resource, per *Standard 9* and Chapter 24A-8(b)(2) and will not impair the character of the surrounding historic resources or character of the district, per Chapter 24A-8(d). Staff notes that the application does not specify the corner materials for the shed but that painted wood or painted composite would be more appropriate and compatible with the resource than aluminum corners.

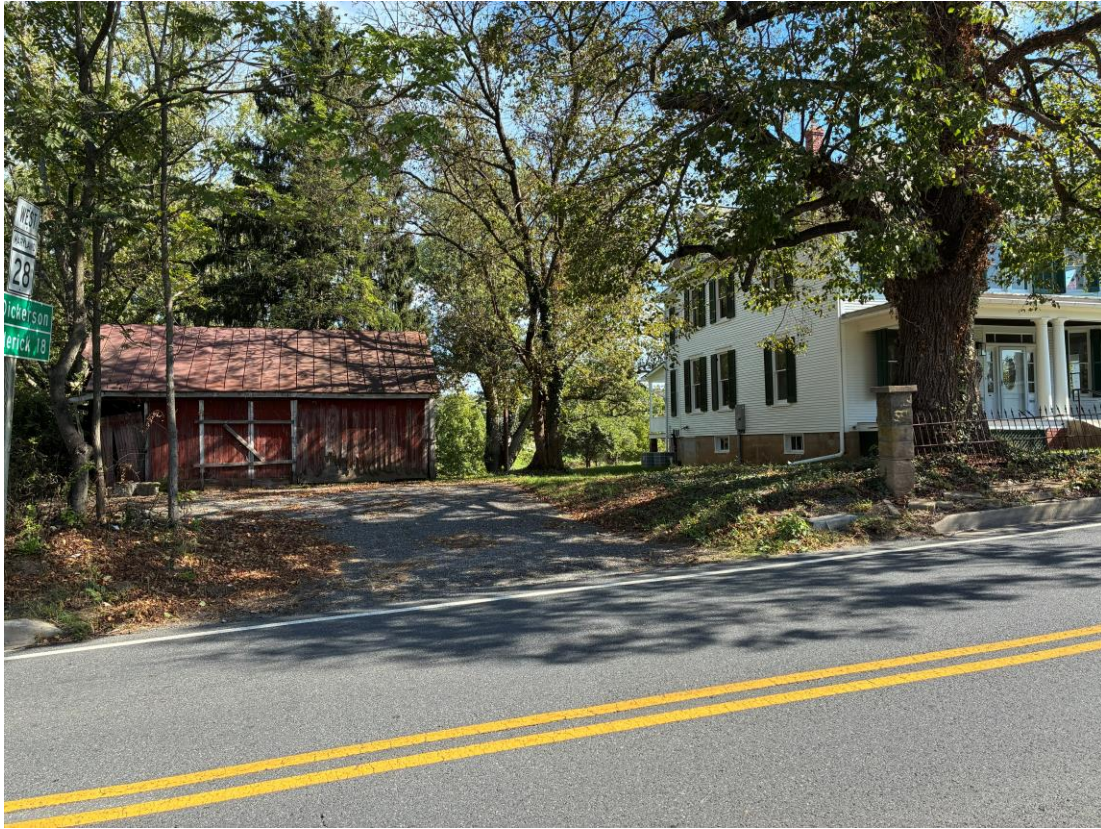
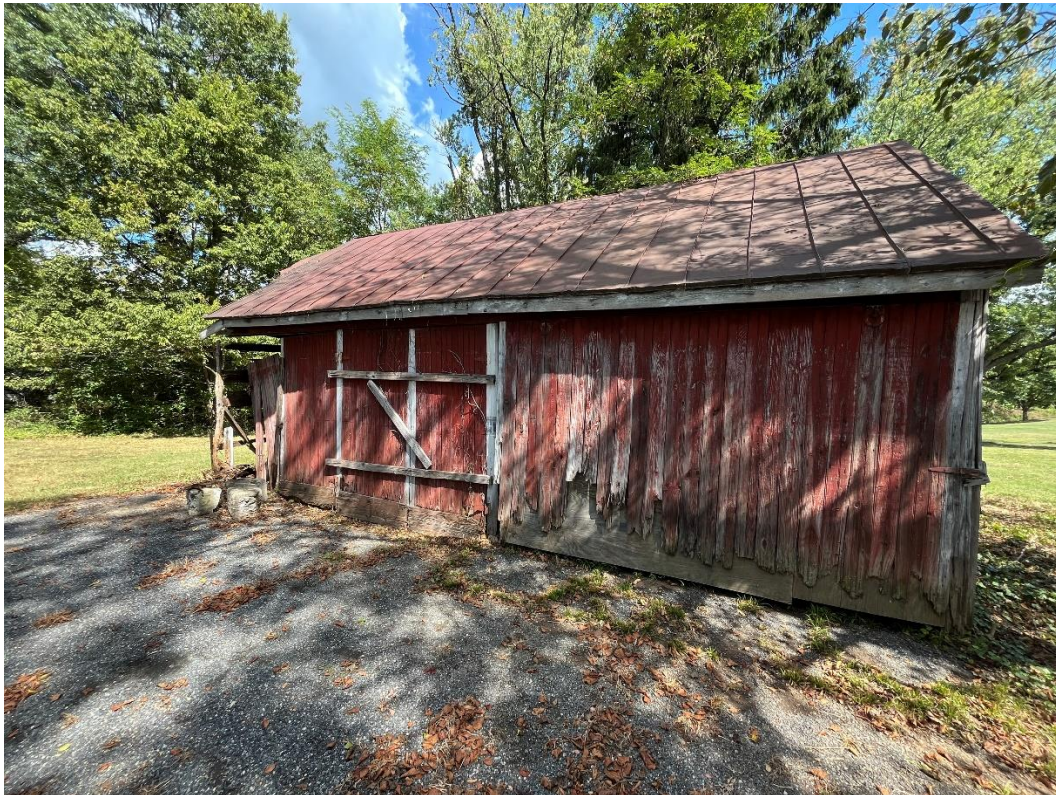
**Front (south) elevation:**

Note deterioration to sliding garage door. Boards are deteriorated; plywood added to rear for stability.

Note structural damage at southwest corner of front elevation: corner post and studs are missing, and roof is unsupported; sill is rotted.

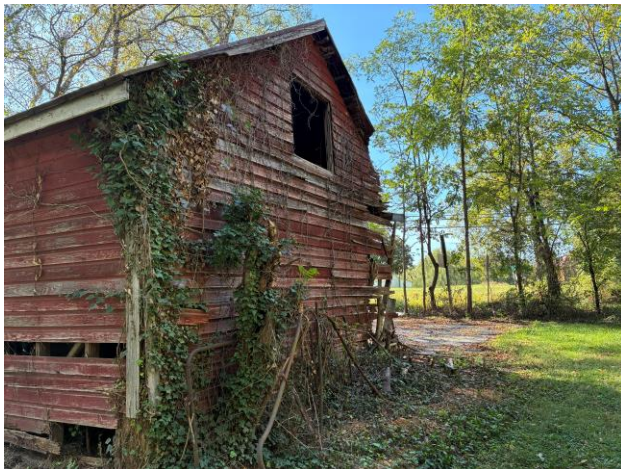
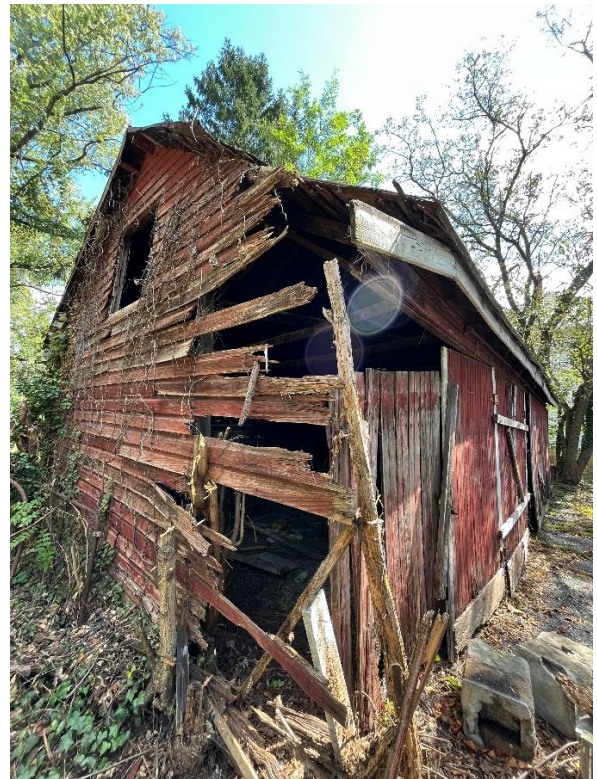
**Left side (west) elevation:**

Note missing window in gable;  
deteriorated siding, sill and structural  
members

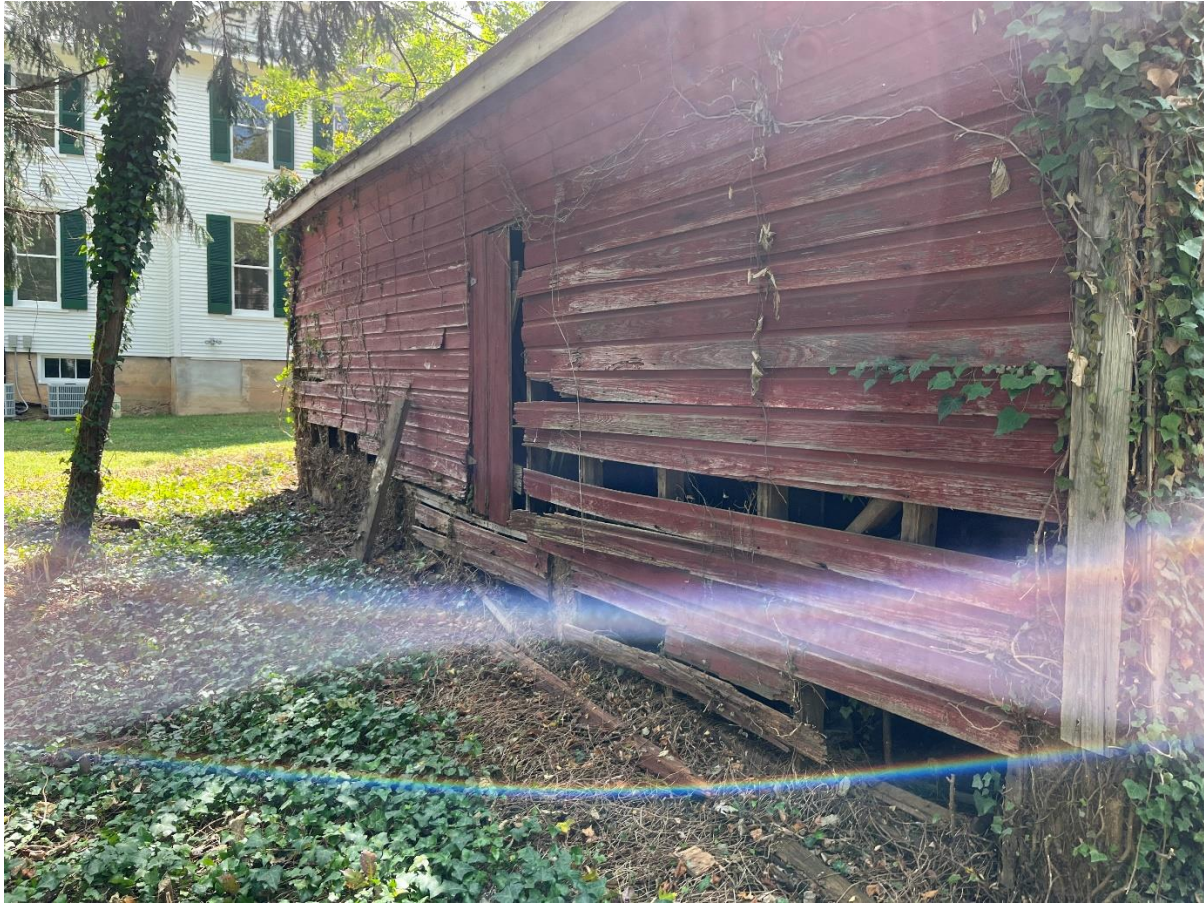
**Rear (north) elevation:**

Note missing and deteriorated siding, rotten sill

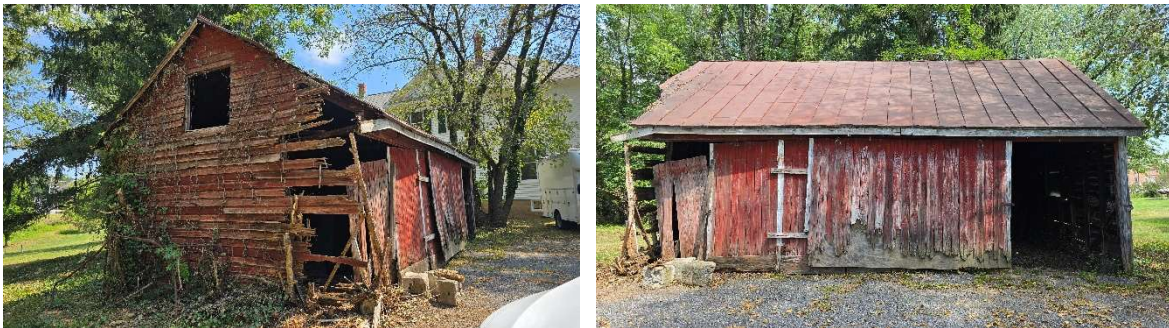
Figure 1 – Shed exterior

The shed structure has sustained significant deterioration over time due to termite activity and prolonged moisture exposure. The wall studs along all exterior walls exhibit advanced rot, particularly at their connections to the footing. The bottom plates of the walls are extensively decayed and have lost their structural integrity.

The footing is the only component that shows comparatively less deterioration; however, its depth and width are unknown and may not conform to current building code requirements.

Based on the observed conditions, the structure cannot be considered safe for occupancy or storage in its present state. There is a substantial risk of partial or complete roof collapse under severe wind loads or heavy snow accumulation.

Based on my observations, the shed structure is beyond repair in its current condition. After digging test pits to verify the width and depth, the footing is the only component that may be retained if a new, similar structure is to be constructed at the same location. All other wooden elements, including the walls and roof framing, have deteriorated to the point where complete replacement is necessary.
