Preliminary Consultation
MONTGOMERY COUNTY HISTORIC PRESERVATION COMMISSION
STAFF REPORT

Address:	25321 Frederick Road, Clarksburg	Meeting Date:	2/25/2026
Resource:	Master Plan Site #10/57 David Zeigler House	Report Date:	2/18/2026
Applicant:	Montgomery Parks (Catherine Stratton Treadway, Agent)	Public Notice:	2/11/2026
Review:	Preliminary Consultation	Staff:	Laura DiPasquale
Proposal:	Stabilization of frame main block, and demolition and reconstruction of log building section with fenestration modifications and dormer construction

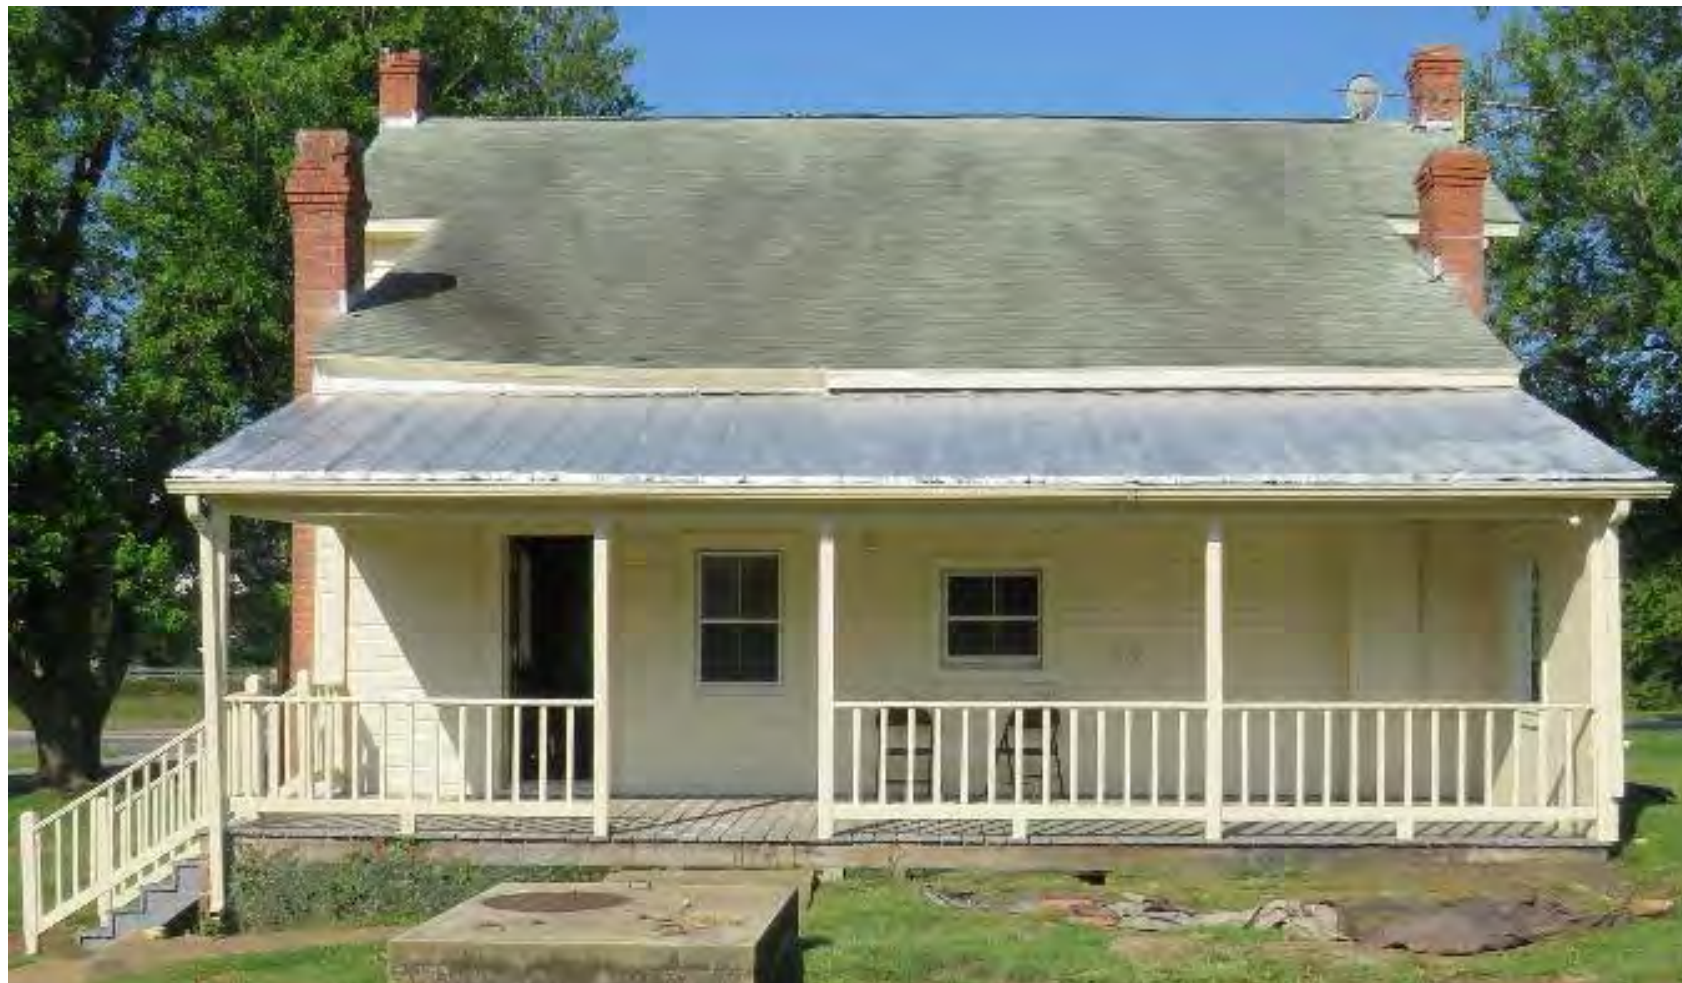
1. Rear elevation showing roof sagging and current window and door openings. This portion of the house and porch will be completely rebuilt except for the rear chimneys and porch wing wall. Window and door openings will be slightly modified to accommodate the new floor plan, see photos 3 & 4 below.

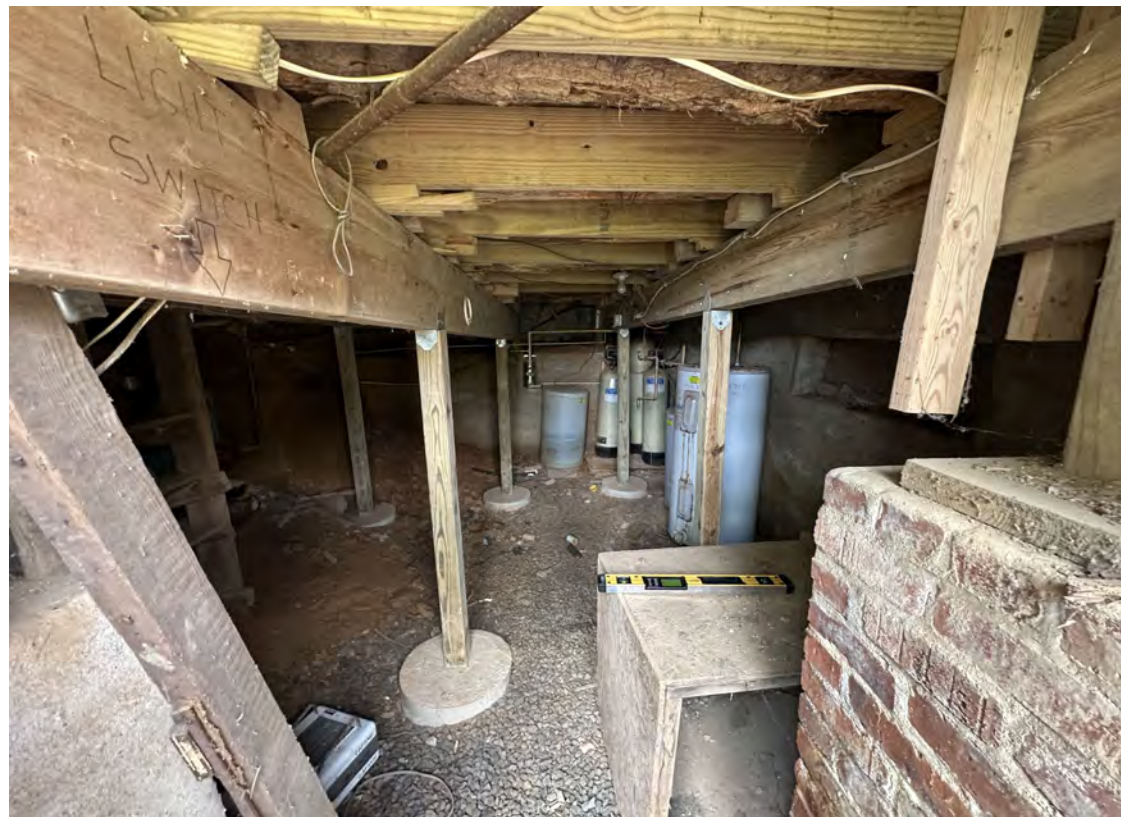
1. Basement Mechanical Space showing multiple layers of temporary supports and failing floor joists (photo by TEC, June 2025).

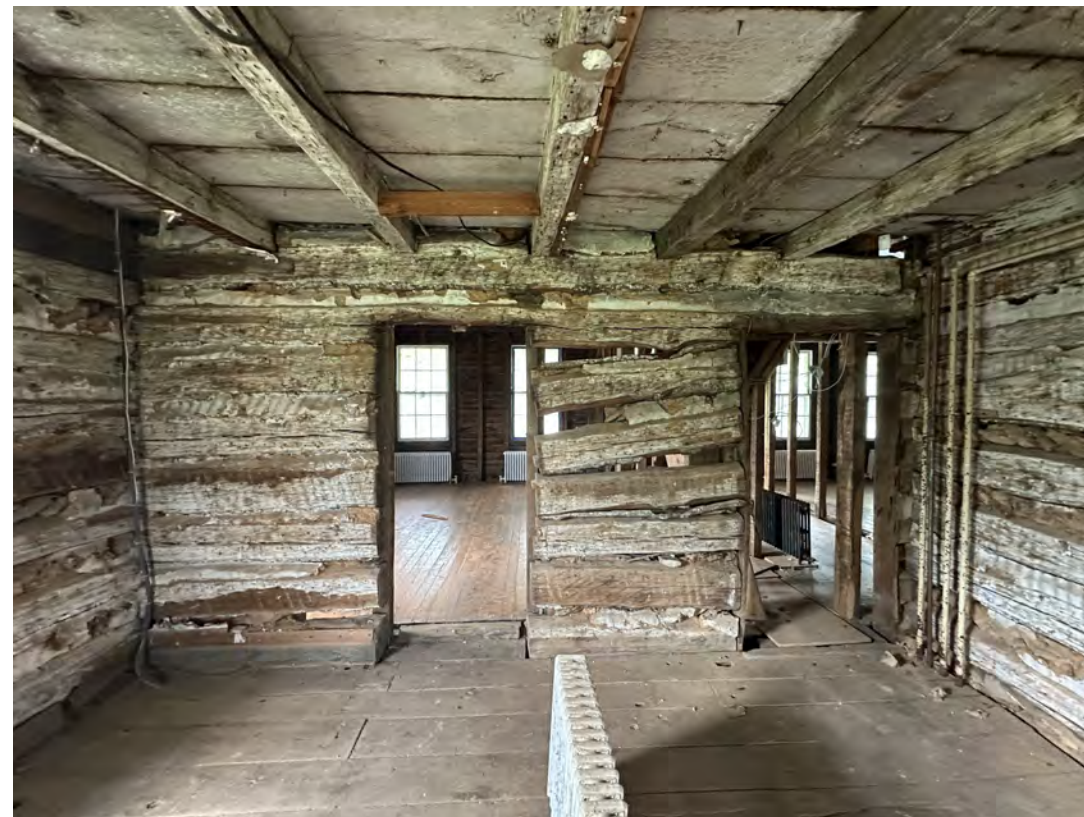
2. Deteriorated log walls failing to provide support for the floor above (photo by TEC, June 2025).

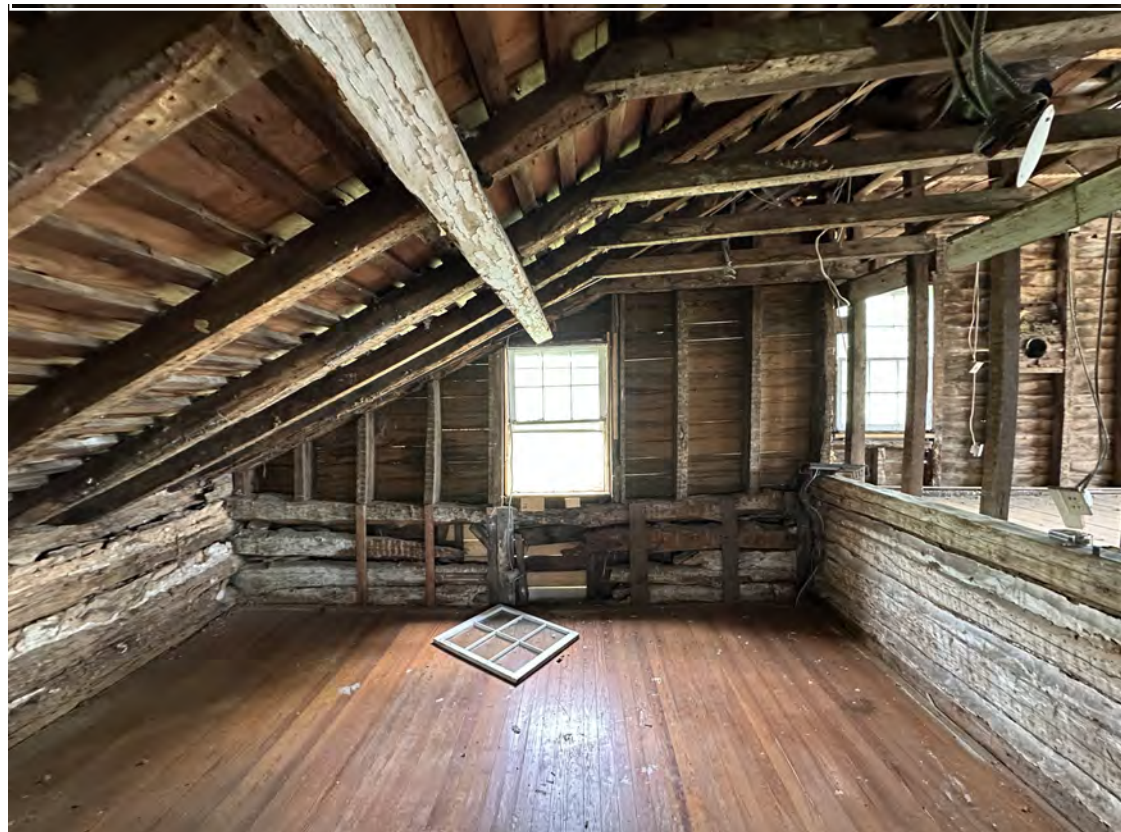
3. Primary roof beam rests unsupported on the window trim. Deteriorated log walls under the window and roof (photo by TEC, June 2025).

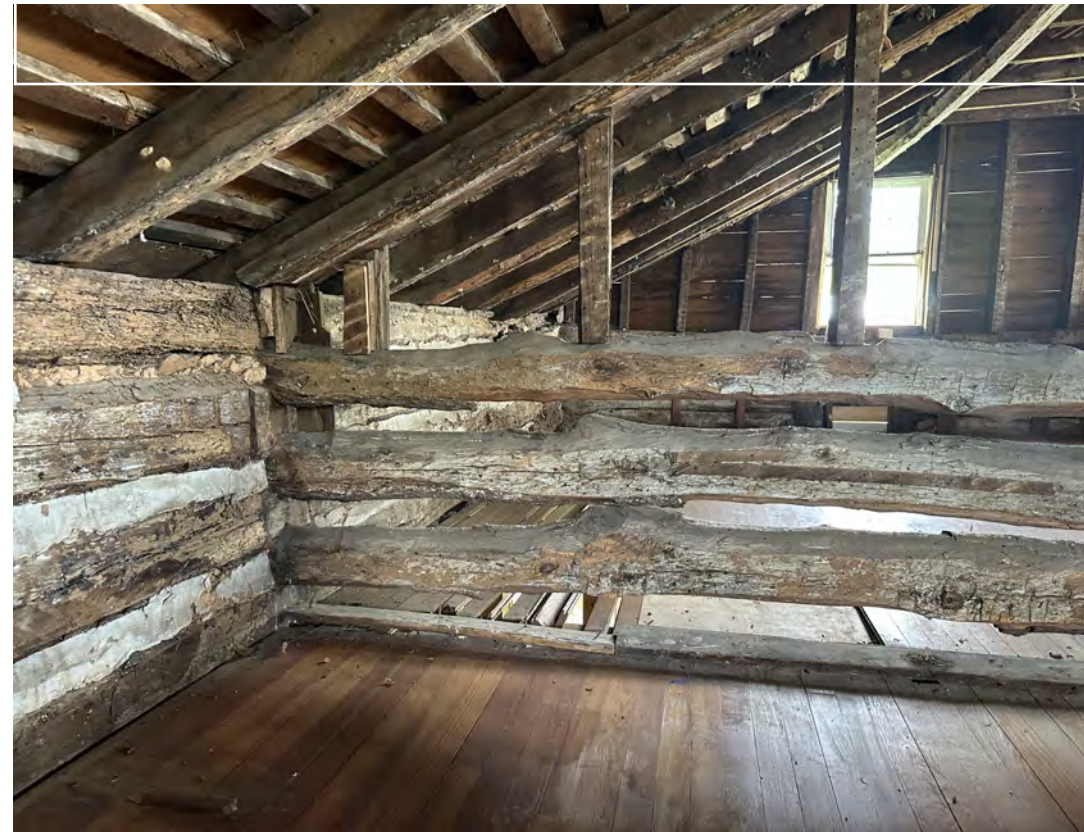
4. Failing log walls entirely ineffective in supporting the roof structure (photo by TEC, June 2025).

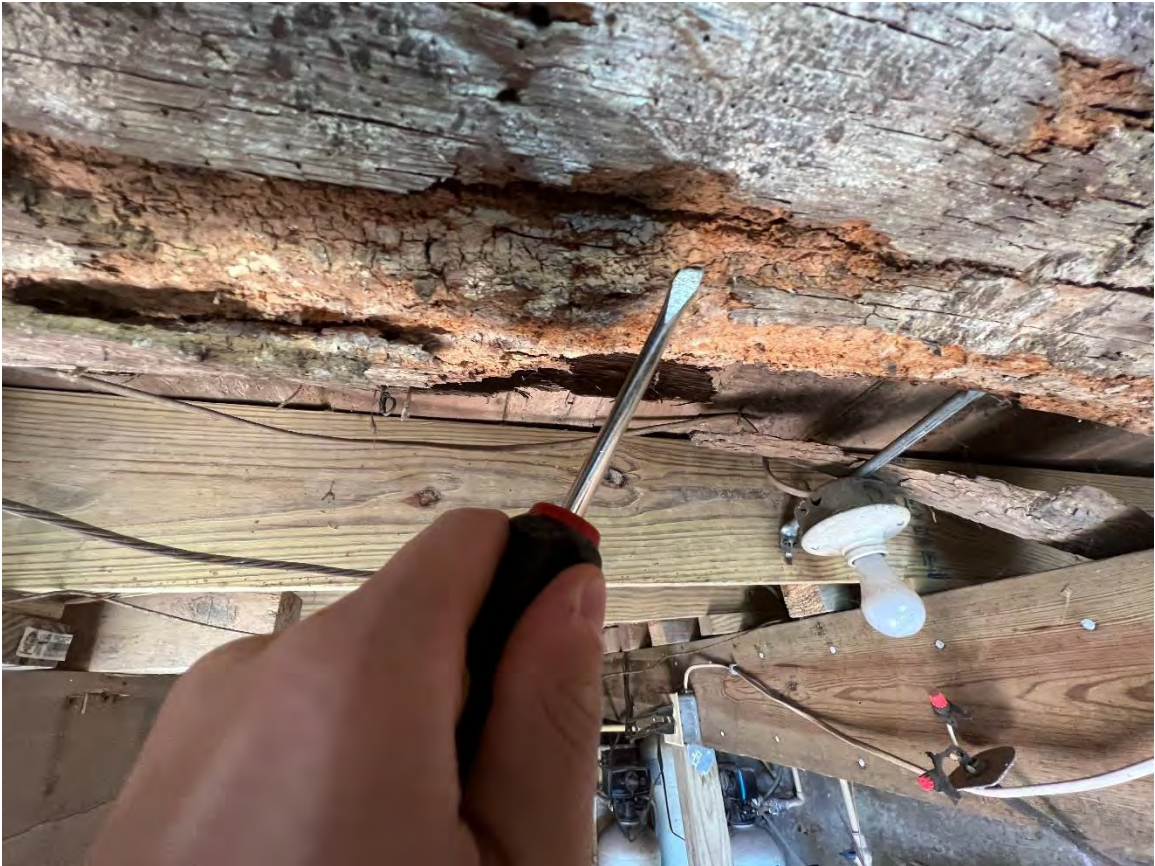
Photograph 4 – Typical poor condition of original log house first floor framing (logs).

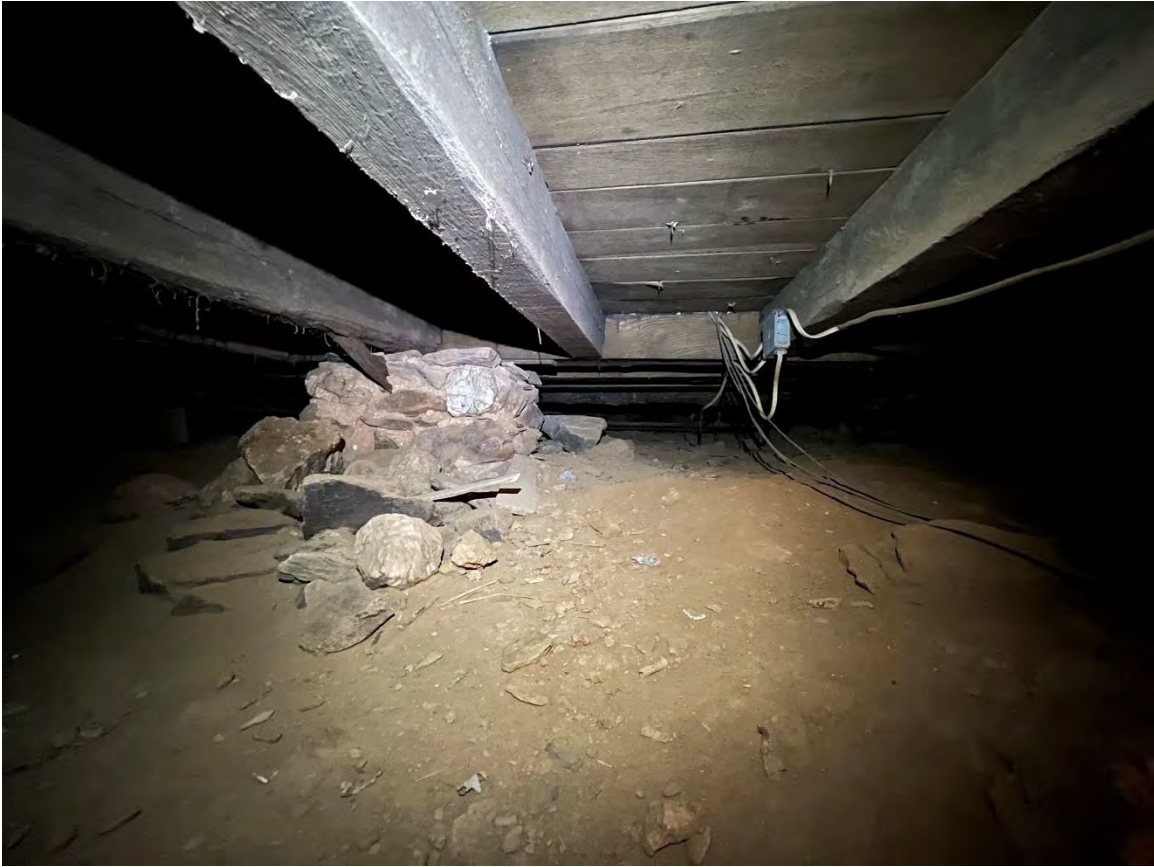
Photograph 9 – Typical deteriorated stone pier below addition.

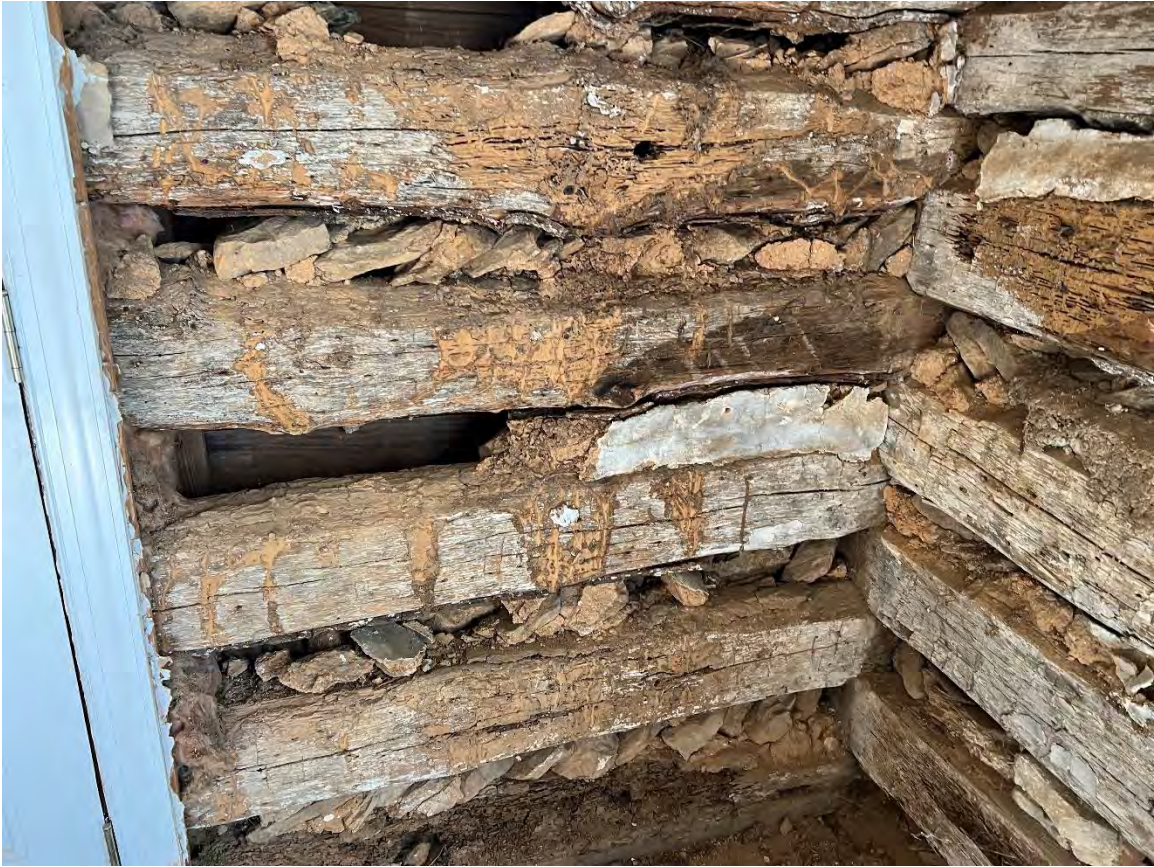
Photograph 11 – Typical poor condition of log walls within log house interior.

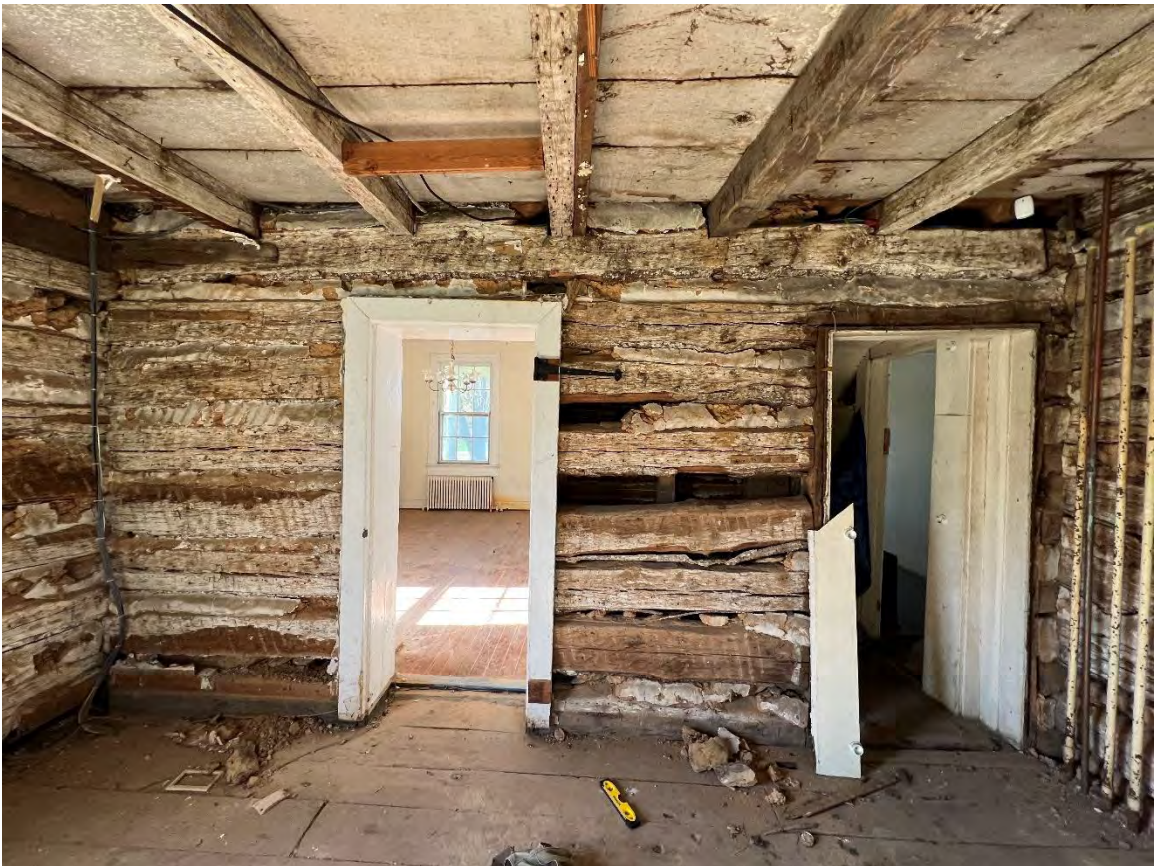
Photograph 12 – Typical rough openings are not square.

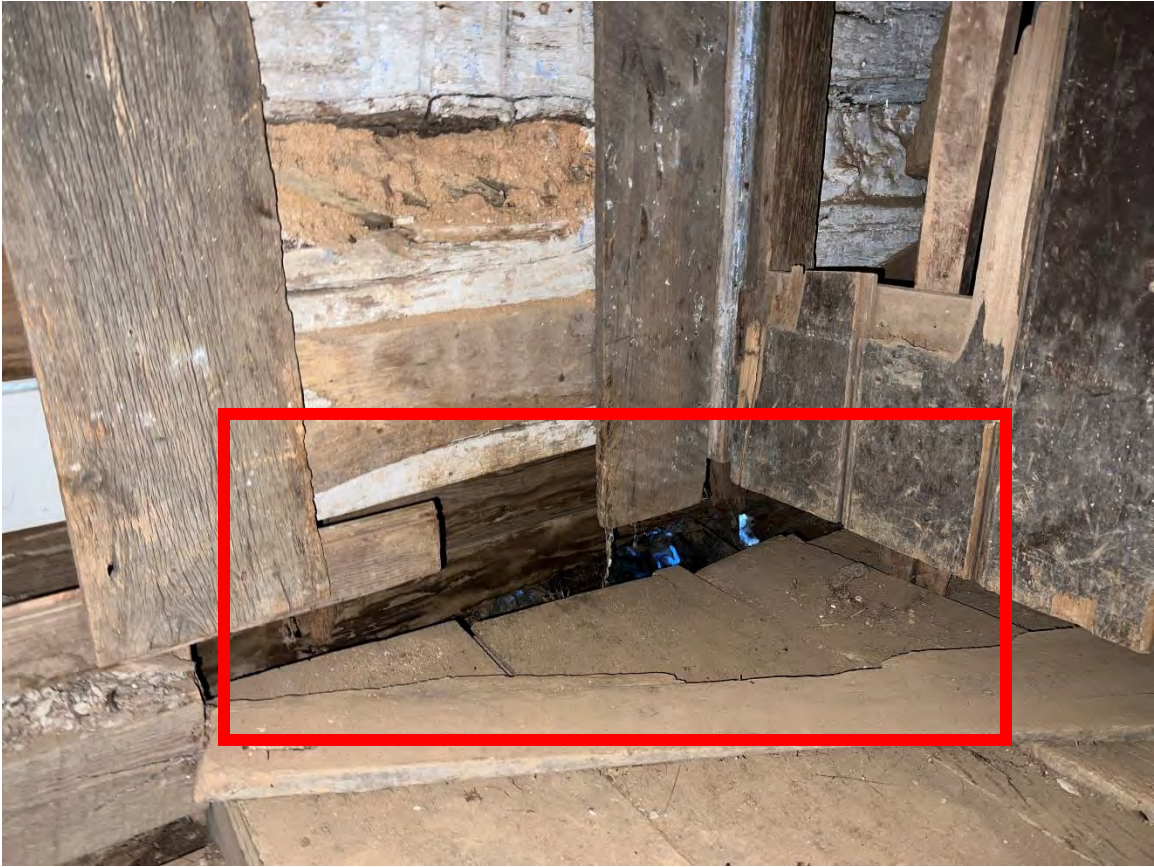
Photograph 13 – Deteriorated wood wall/floor framing at north end of Room 1D.

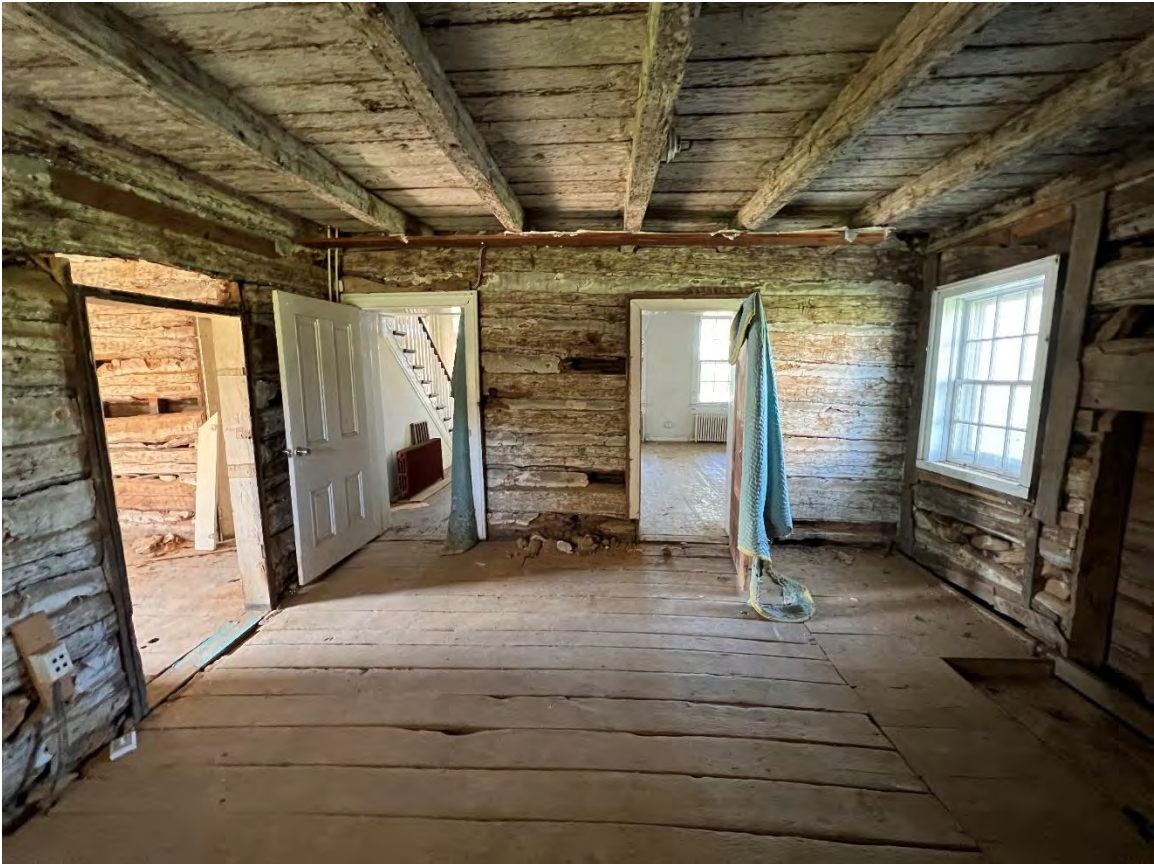
Photograph 14 – Large bow in floor in Room 1D.

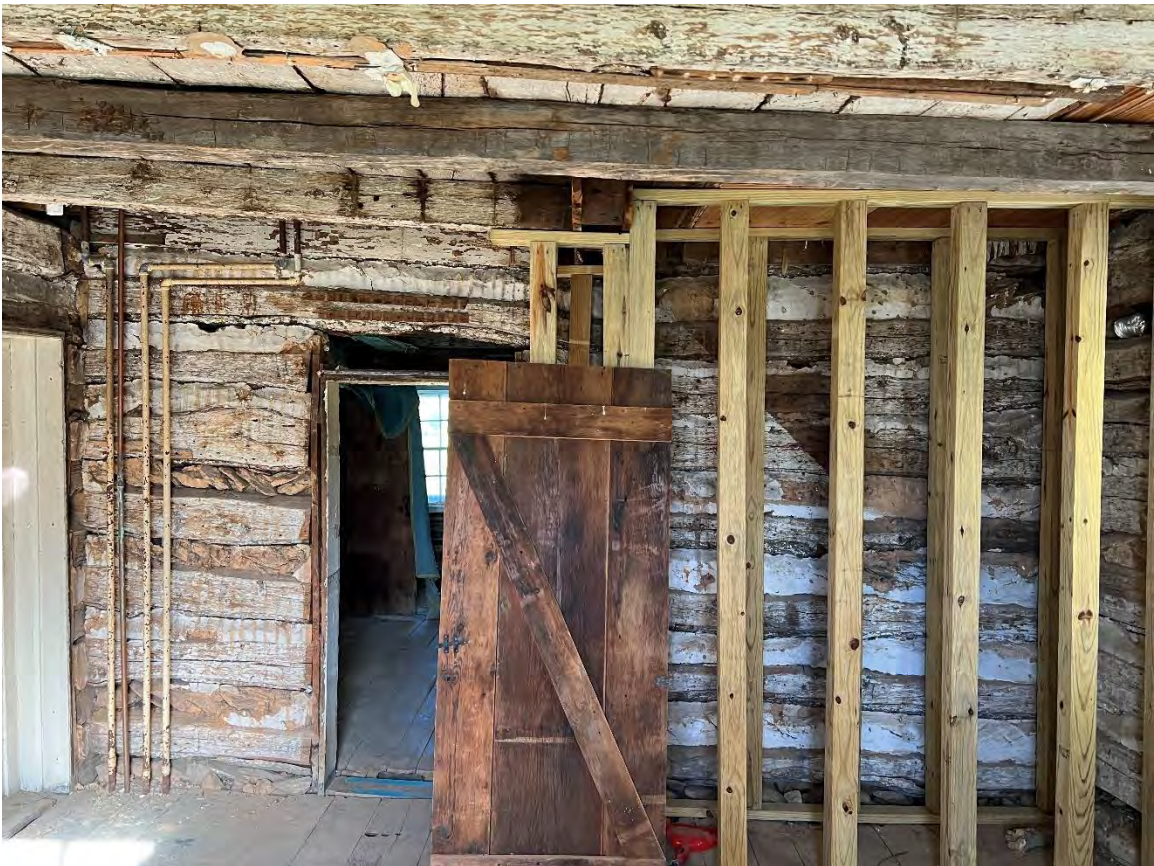
Photograph 16 – Temporary shoring installed in Room 1E.

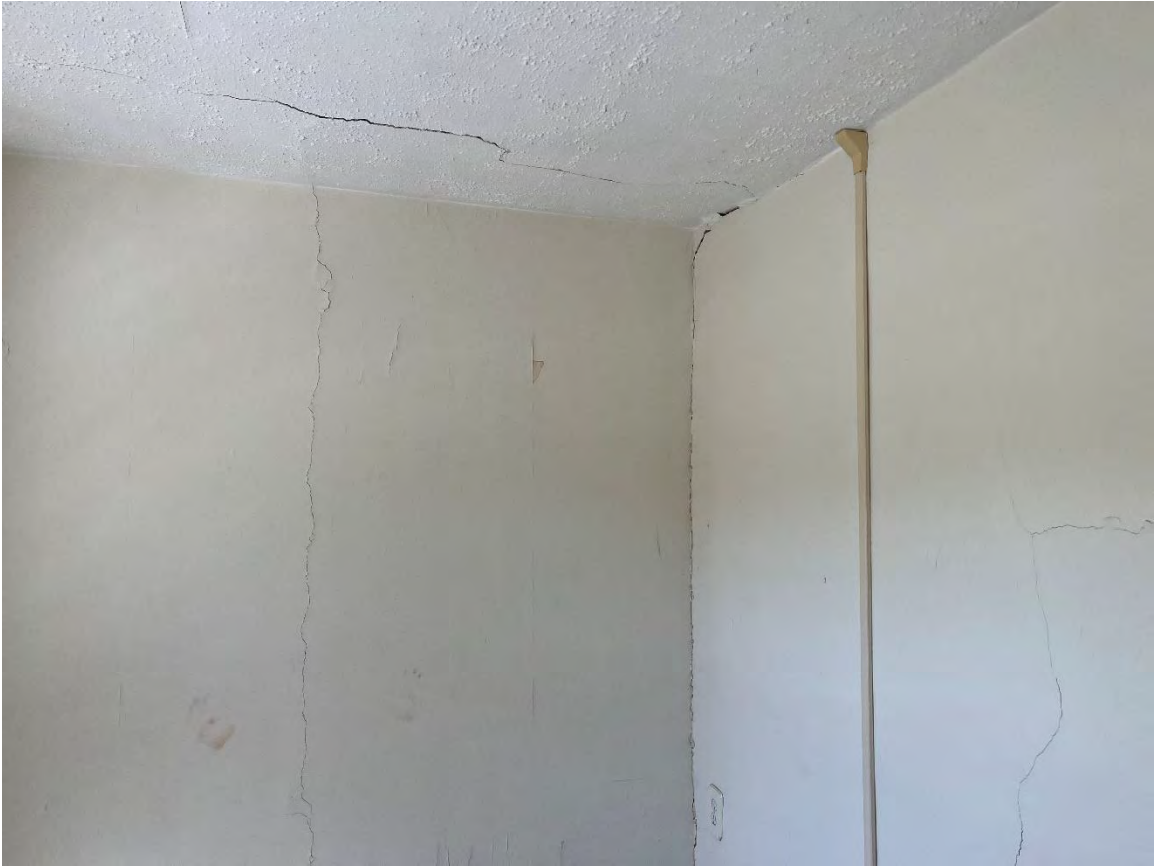
Photograph 17 – Typical cracks in interior wall/ceiling finishes.

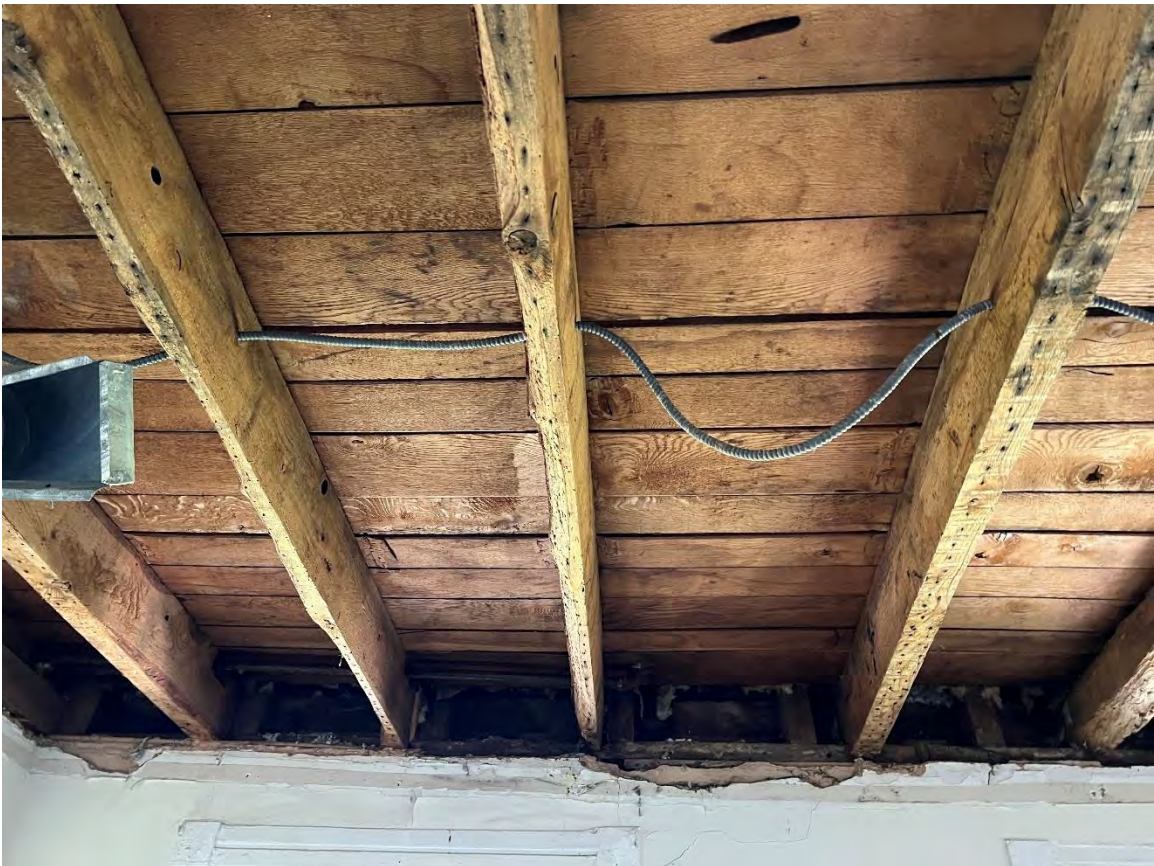
Photograph 18 - The floor joists supporting the upper levels were inconsistently sized with the widths ranging from four (4) inches wide to as narrow as one (1) inch wide.

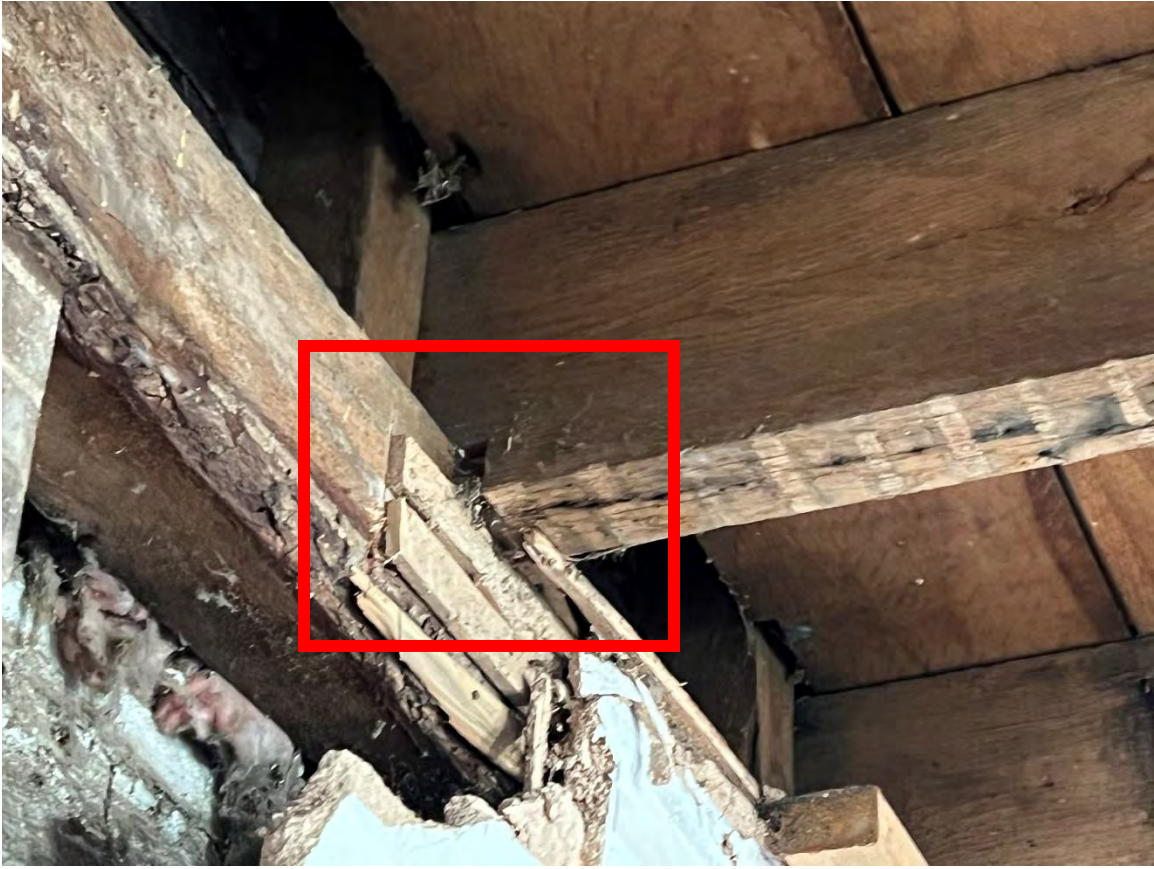
Photograph 19 – Typical notched floor joist.

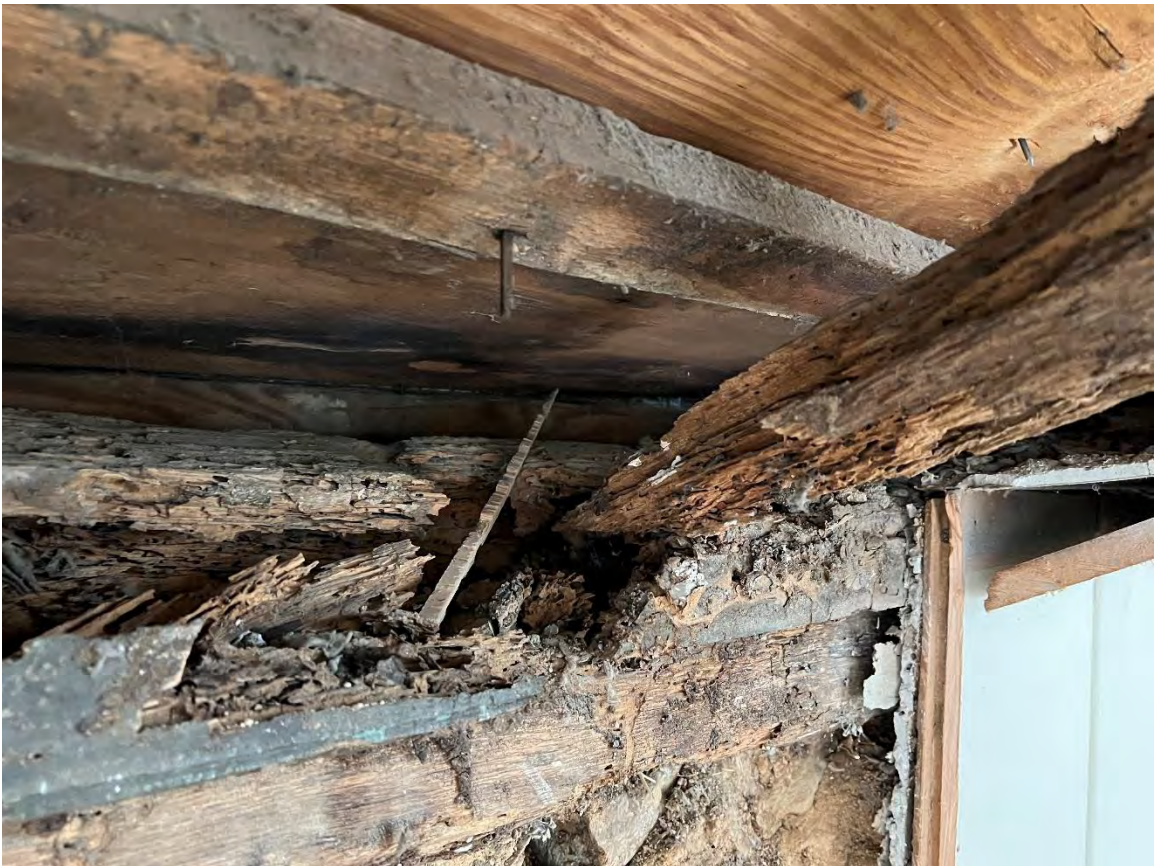
Photograph 22 – Typical severely deteriorated wood roof framing.

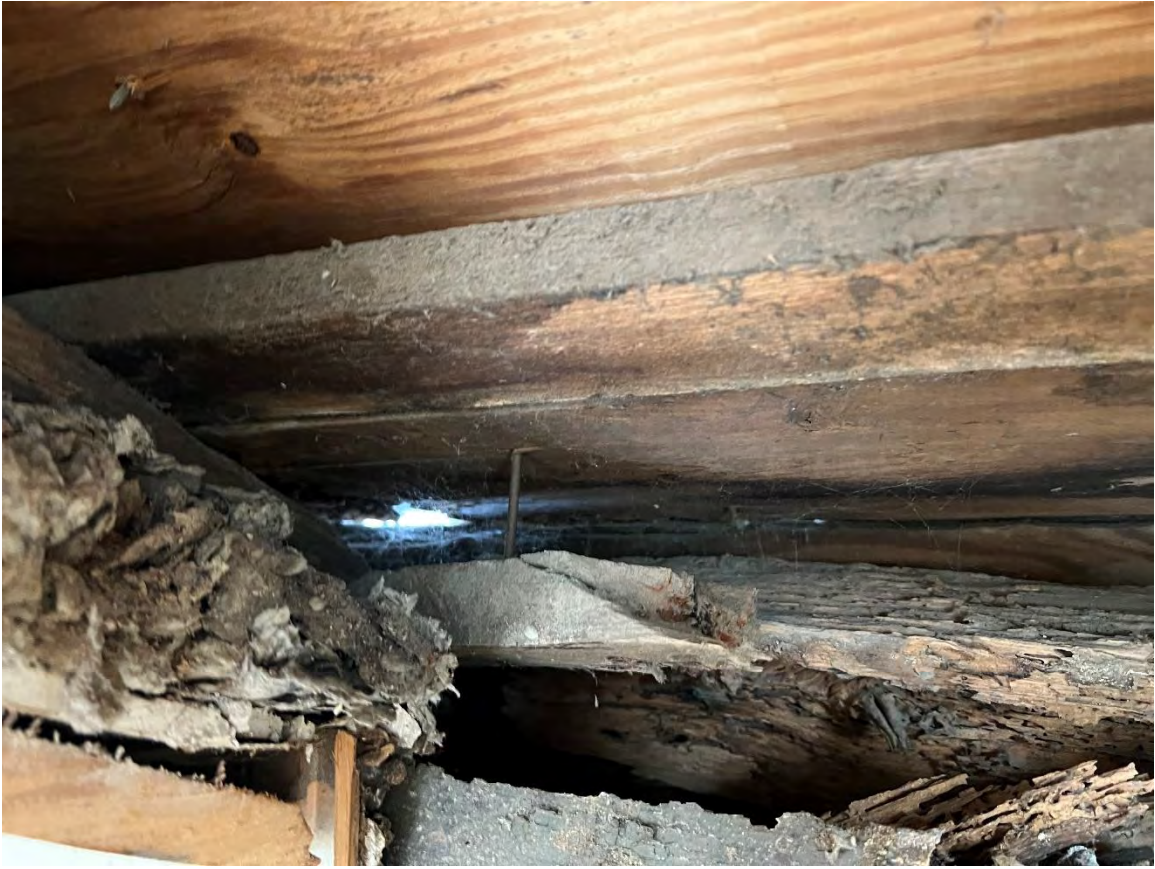
Photograph 23 – Typical severely deteriorated wood roof framing and daylight present.

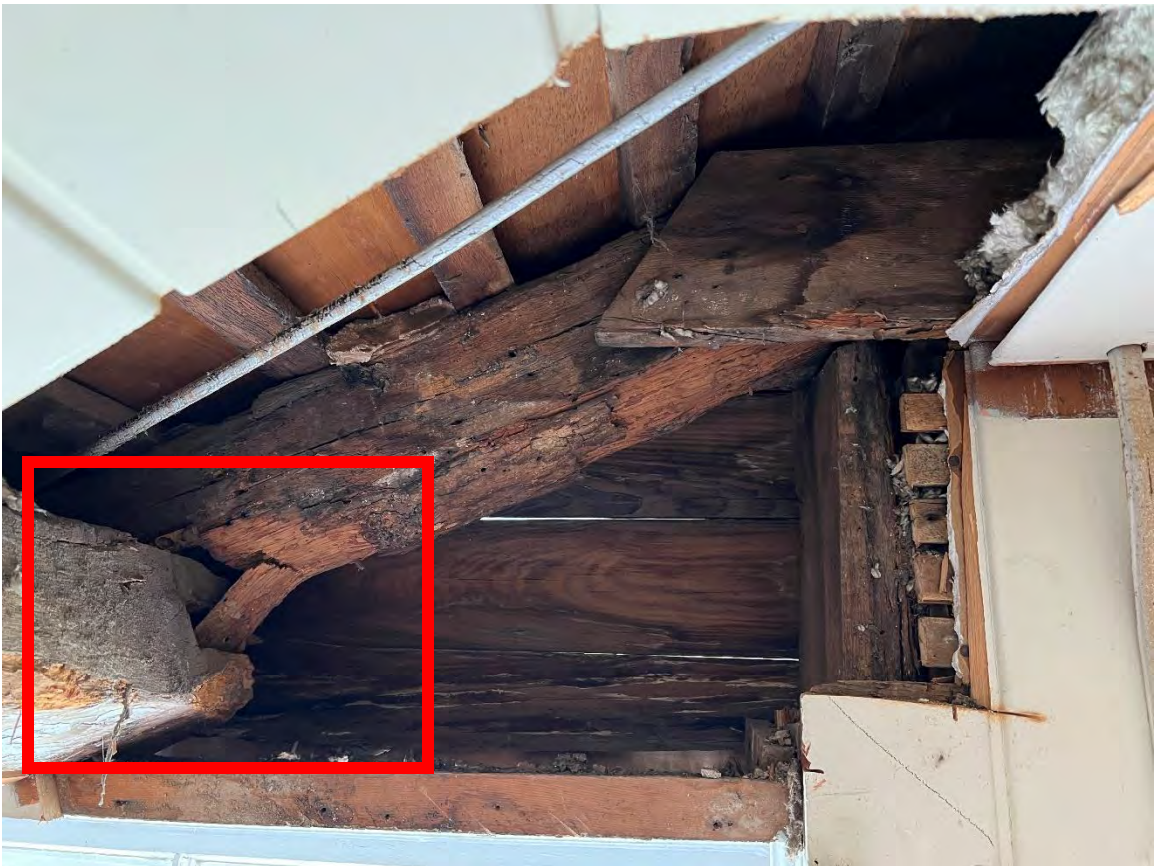
Photograph 24 – Failed connection between rafter and intermediate beam.

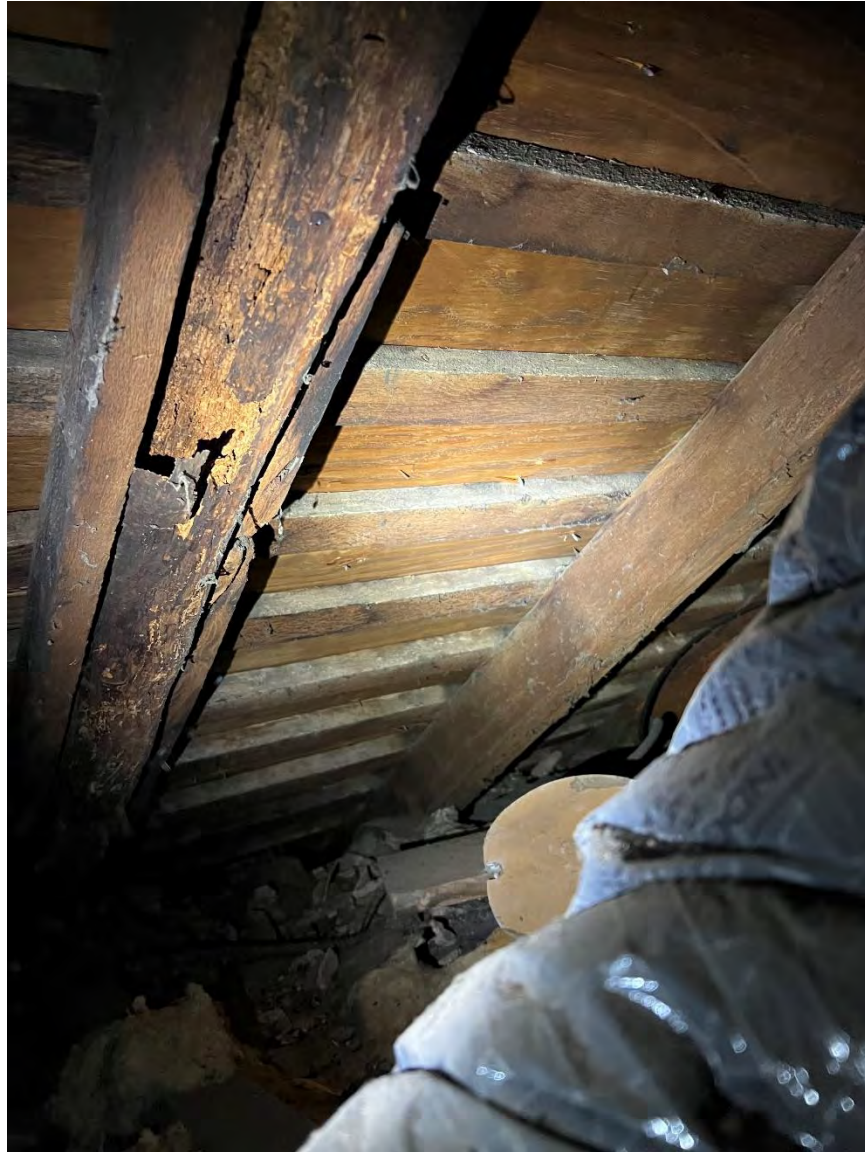
Photograph 25 – Typical severely deteriorated wood roof framing observed in attic space.

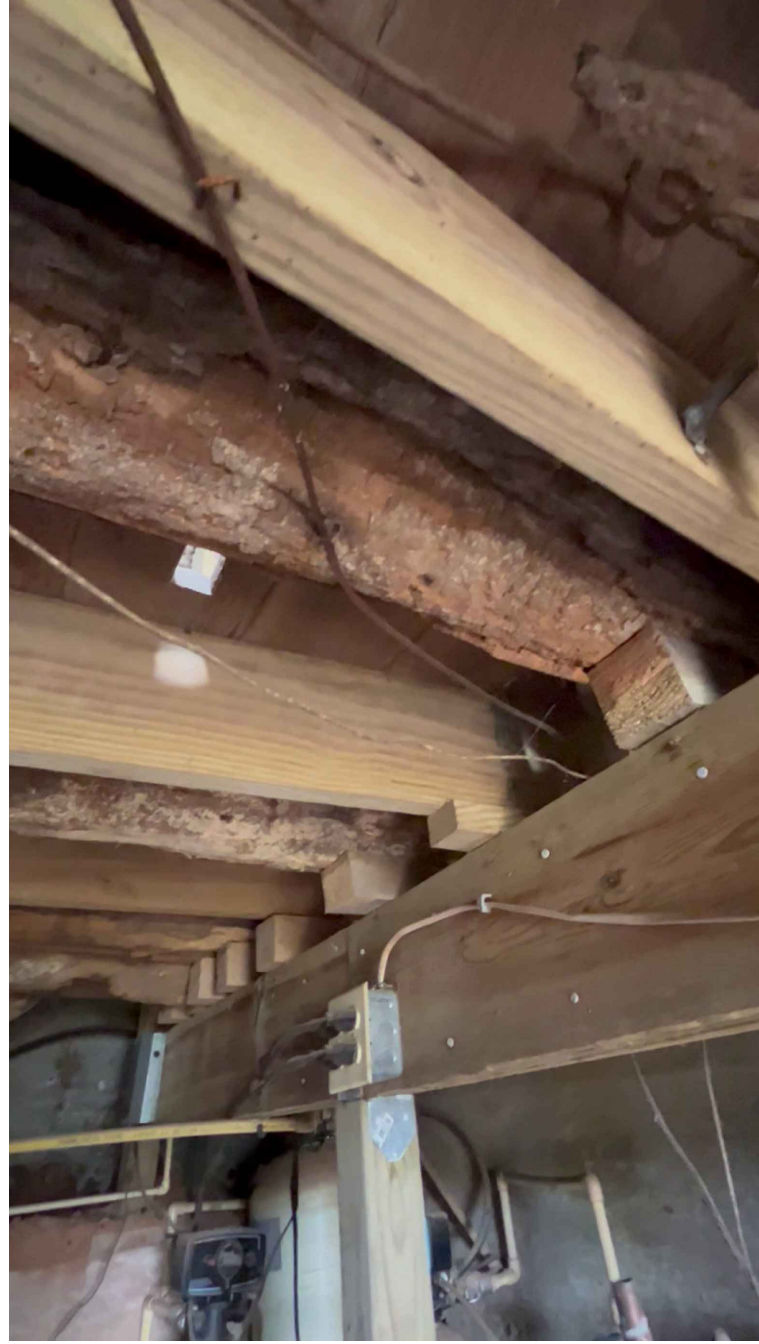
P34 LOG FLOOR BEAMS TURNED ON SIDE
