MONTGOMERY COUNTY HISTORIC PRESERVATION COMMISSION
STAFF REPORT

Address:	50 Elm Ave., Takoma Park	Meeting Date:	4/8/2026
Resource:	Contributing Resource Takoma Park Historic District	Report Date:	4/1/2026
Applicant:	Tamir Ezzat	Public Notice:	3/25/2026
Review:	HAWP	Tax Credit:	Partial
Case Number:	1148441	Staff:	Dan Bruechert
Proposal:	Retroactive Roof Replacement and Chimney Removal

FIELD REPORT

Inspected Site: 50 Elm Ave. Takoma Park, MD 20912	Purpose of Investigation: Structural review of tree impact TEC #: 25-191FH
Date of Site Visit: 16 July, 2025	Date Report Issued: 25 July, 2025
Report Prepared For: Tamir Ezzat, DDB Workshop	Persons Contacted: Christian Alvez, Insured Connor Sparks, Jenkins Restoration Ali Tolson, Jenkins Restoration

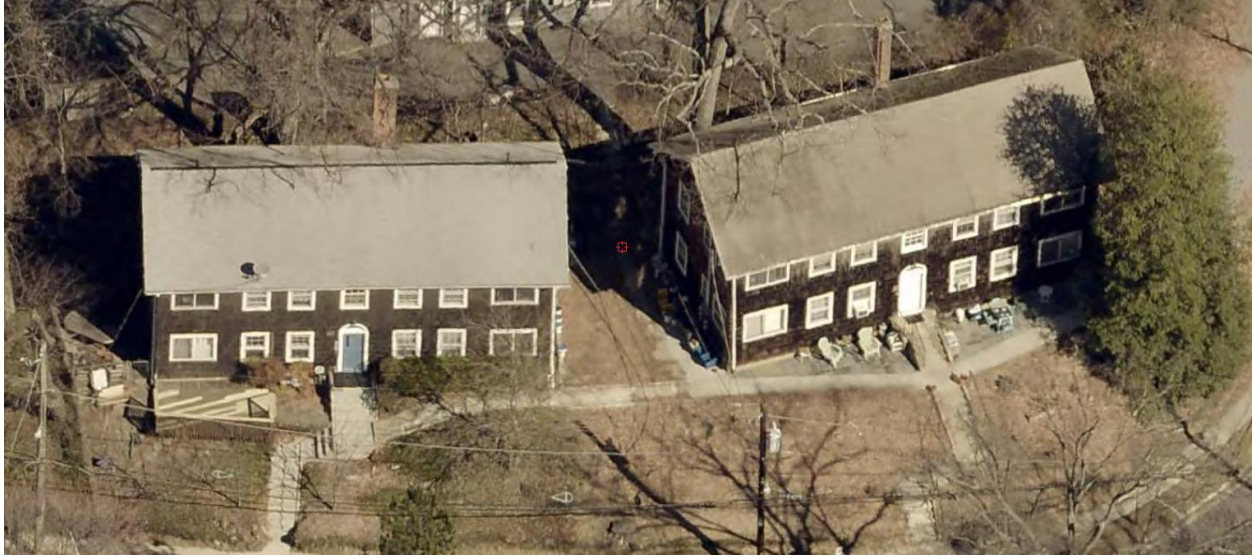
At the rear of the property, there is a brick chimney. Aerial photography shows the chimney was a brick rectangular chimney with a concrete cap. There does not appear to be decorative brickwork or a crown on the chimney. The chimney is a vestige from a furnace and water heater that were abandoned decades ago. The tree fall substantially damaged the chimney (see *Fig. 3*, below). Rather than reconstruct the chimney, the applicant proposes to demolish the chimney and repair the siding with matching wood shakes.

Figure 2: The subject property (left) and its twin showing the location and height of the chimneys.

The HPC has generally considered two primary factors when evaluating the appropriateness of removing chimneys. First, how significant is the chimney to the architectural character of the property, particularly when viewed from the public right-of-way? Second, how does removing the chimney impact the scale and massing of the historic building? Staff finds the chimney is not a significant architectural feature and was intended to serve a purely utilitarian function. The chimney is located at the rear of the building and lacks any ornamentation. Additionally, due to the rise in grade from Elm Ave., the chimney is only partially visible from the rear on Pine Ave. at a distance of approximately 150 ft (one hundred fifty feet). Staff further finds removing the chimney will not have a substantial impact on the massing of the building, as the chimney is an appendage at the rear that is only minimally visible from the right-of-way. Staff recommends the HPC approve the chimney removal under 24A-8(1), (2); and (d); *Standard #2*, and the Design Guidelines.

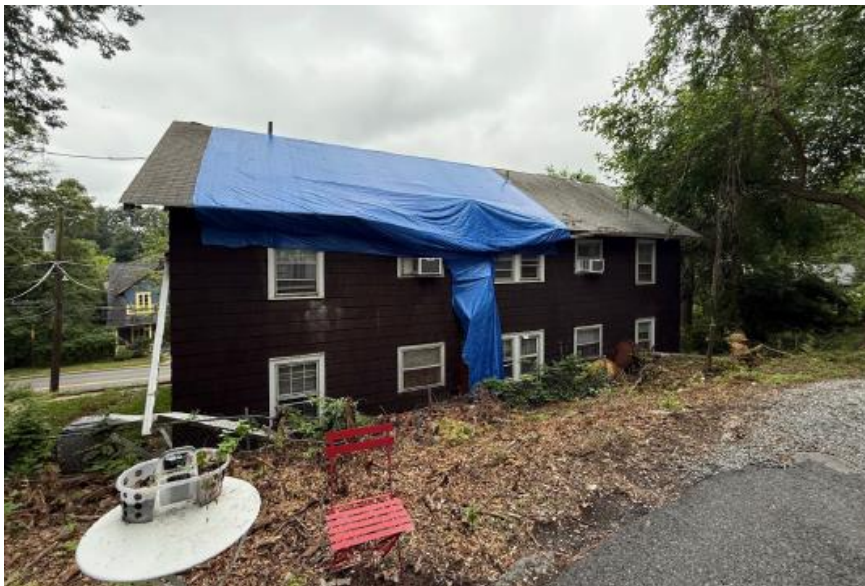
Figure 3: Rear elevation of the subject property showing the location of the chimney.

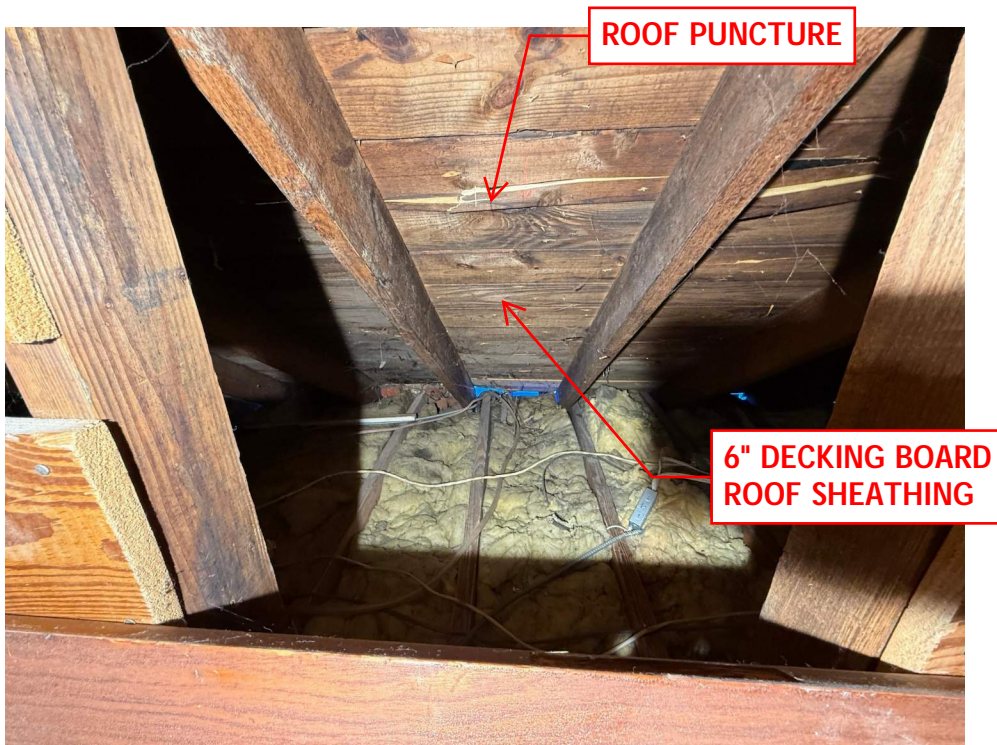
PHOTO 6: DAMAGED ROOF SHEATHING AND RAFTERS

- Punctures are present in the roof sheathing (Appendix A: Photo 6).

- Replace roof sheathing at roof penetrations in full board lengths.
- Replace all missing or damaged rafter tails on the north exterior wall (assume 10% of rafters and roof sheathing are damaged for pricing purposes).

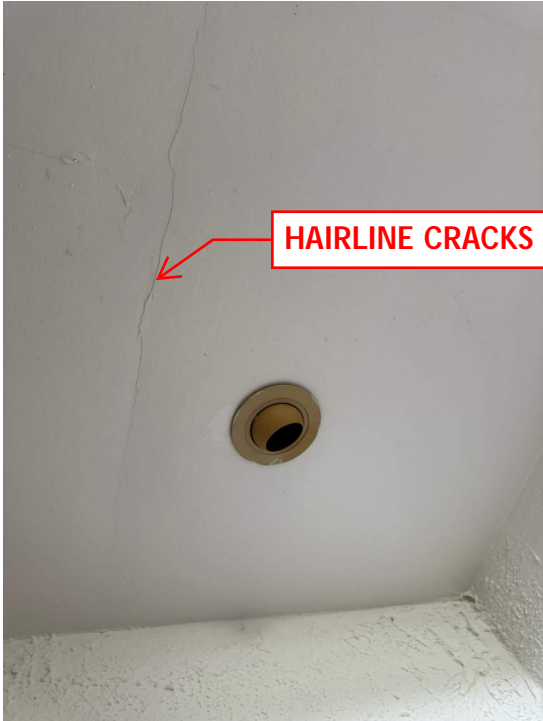
PHOTO 7: DAMAGED CEILING FINISHES AT 2ND LEVEL STAIRWELL

- Small cracks are present in the ceiling finishes on the second level stairwell (Appendix A: Photo 11).

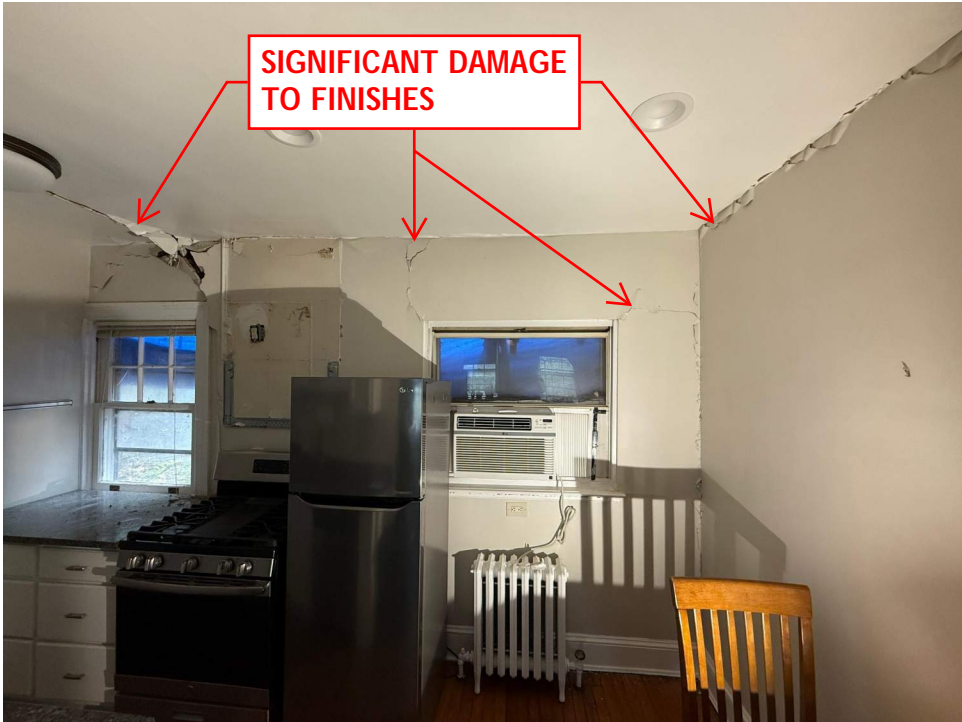
PHOTO 8: DAMAGED WALLS (UNIT 4)

- The North facing exterior wall and adjacent interior walls in the kitchen are compromised, with severe damage to the framing and finishes. Cracks are in the ceiling finishes (Appendix A: Photo 8, 9).
- Hairline cracks are in the finishes throughout the apartment (Appendix A: Photo 10).

- Replace the kitchen walls of unit 4 highlighted in red as shown in the 2nd Level Schematic (*Appendix B: Figure 1*).
- Remove finishes of walls highlighted in yellow as shown in the 1st Level Schematic and inspect the framing for racking or damage, focusing on the studs and top plates. Replace any cracked members (*Appendix B: Figure 2*).

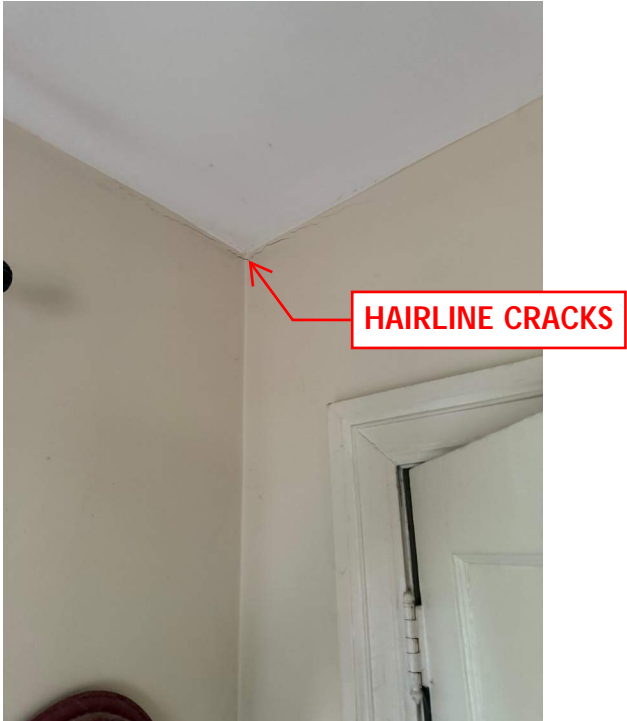
PHOTO 11: HAIRLINE CRACKS, TYPICAL (UNIT 3)

- Hairline cracks are in the finishes throughout the apartment (Appendix A: Photo 11).

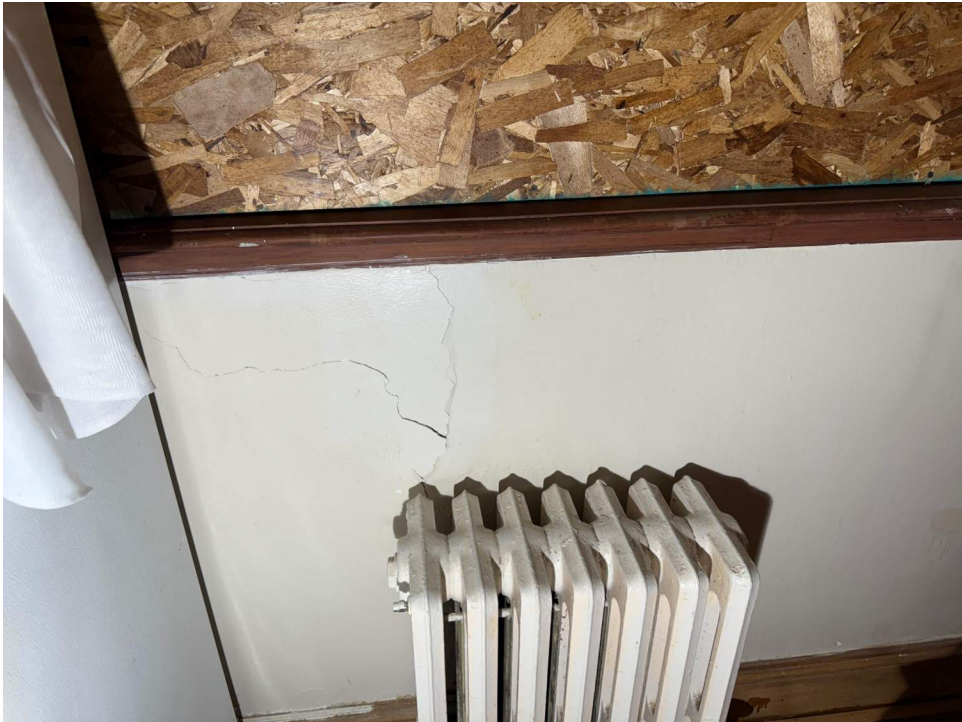
PHOTO 12: CRACKS IN NORTH EXTERIOR WALL (UNIT 2)

- Large cracks are in the finishes of the North exterior wall in the kitchen below one window (Appendix A: Photo 12).
- A large crack is in the finishes on the interior wall between the apartment and stairwell (Appendix A: Photo 13).
- A large crack is present in the east exterior wall in the office (Appendix A: Photo 14).
- Hairline cracks are in the finishes throughout the apartment (Appendix A: Photo 15).

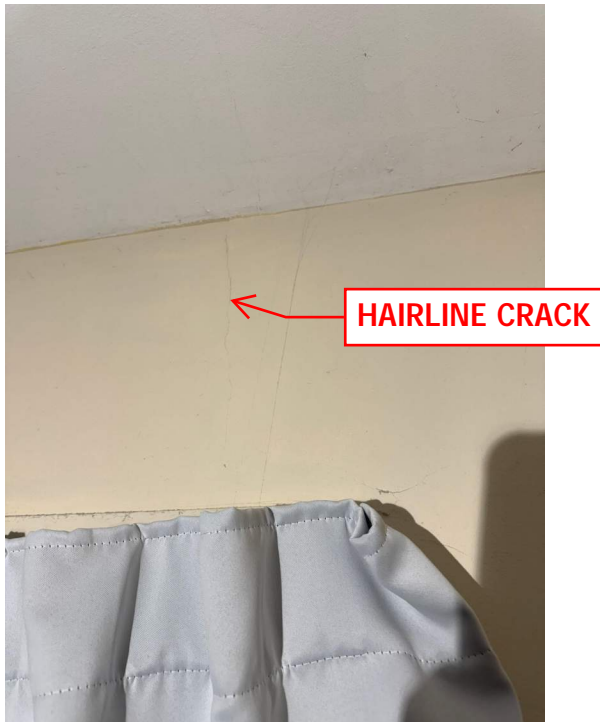
PHOTO 16: HAIRLINE CRACKS, TYPICAL (UNIT 1)

- Hairline cracks are in the finishes throughout the apartment (Appendix A: Photo 16).

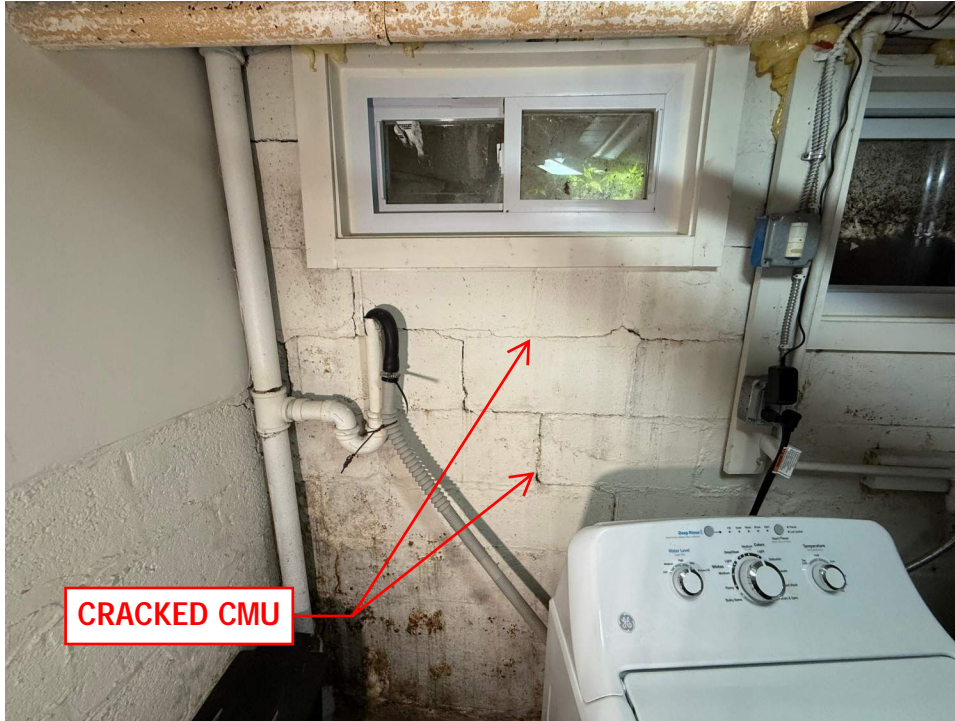
PHOTO 17: CRACKED AND DISPLACED NORTH CMU FOUNDATION WALL (BASEMENT)

- Cracks related to the impact are in the North facing CMU foundation wall. The wall is displaced and no longer plumb (Appendix A: Photo 17).
- Cracks unrelated to the impact are in the South facing CMU foundation wall (Appendix A: Photo 18).

- Replace approximately 6'-8' of CMU blocks cracked and displaced by the tree impact, highlighted in red on the north wall in the basement as shown in the Basement Level Schematic and repoint any damaged or cracked mortar joints (*Appendix B: Figure 3*).

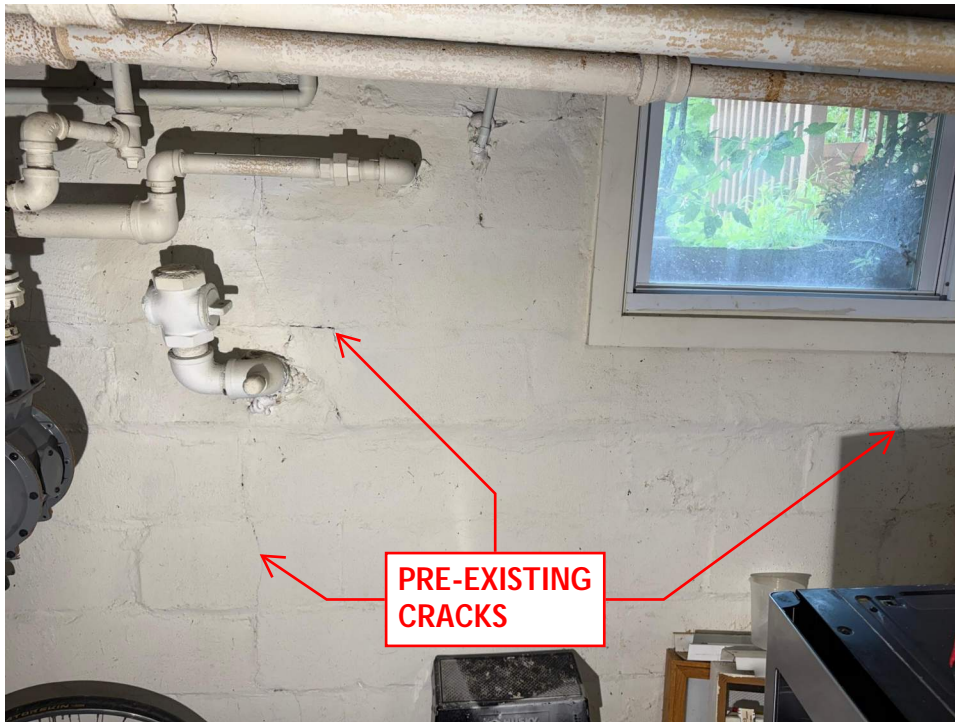
PHOTO 18: EXISTING CRACKS IN SOUTH CMU FOUNDATION WALL (BASEMENT)

Exterior elements such as roofing, gutters, fascia, soffit, and were also likely damaged, but were covered by tarp at the time of the site visit and as such their condition could not be accurately assessed. Cracks and displacement were observed in the CMU foundation wall of the basement in multiple areas; the owner pointed out pre-existing cracks in the south wall that were likely worsened by the impact. This damage should be repaired but is not part of this claim.

- Replace cracked and displaced CMU blocks as pointed out by the owner, highlighted in red on the south wall in the basement as shown in the Basement Level Schematic and repoint any damaged or cracked mortar joints (*Appendix B: Figure 3*).

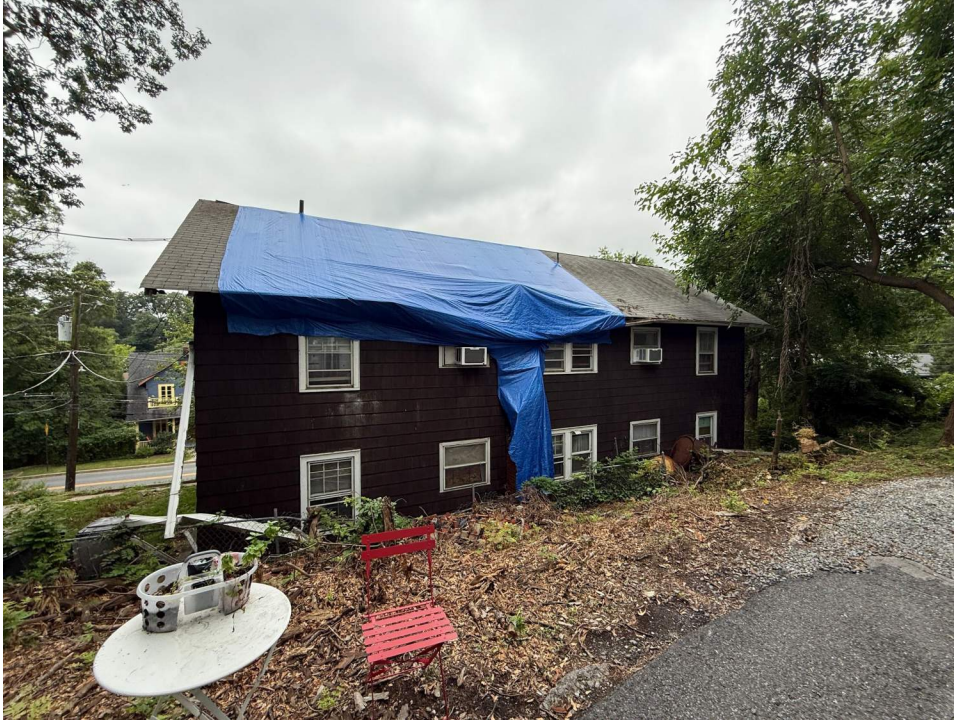
PHOTO 19: TARPS COVERING ROOF DAMAGE

- The damaged portions of the roof are currently covered by tarps (Appendix A: Photo 19).
- The chimney is damaged, with bricks surrounding its base (Appendix A: Photo 20).
- The timber retaining wall in the rear of the home is displaced (Appendix A: Photo 21).
