**MONTGOMERY COUNTY HISTORIC PRESERVATION COMMISSION**  
**STAFF REPORT**

<b>Address:</b>	4823 Dorset Ave., Chevy Chase	<b>Meeting Date:</b>	12/5/2018
<b>Resource:</b>	<b>Contributing Resource</b> (Somerset Historic District)	<b>Report Date:</b>	11/28/2018
<b>Applicant:</b>	John Stewart and Sharon Stoliaroff <b>(Adam Greene, Agent)</b>	<b>Public Notice:</b>	11/21/2018
<b>Review:</b>	HAWP	<b>Tax Credit:</b>	No
		<b>Staff:</b>	Dan Bruechert

**Case Number:** 35/36-18L

**PROPOSAL:** Accessory structure and hardscape alterations

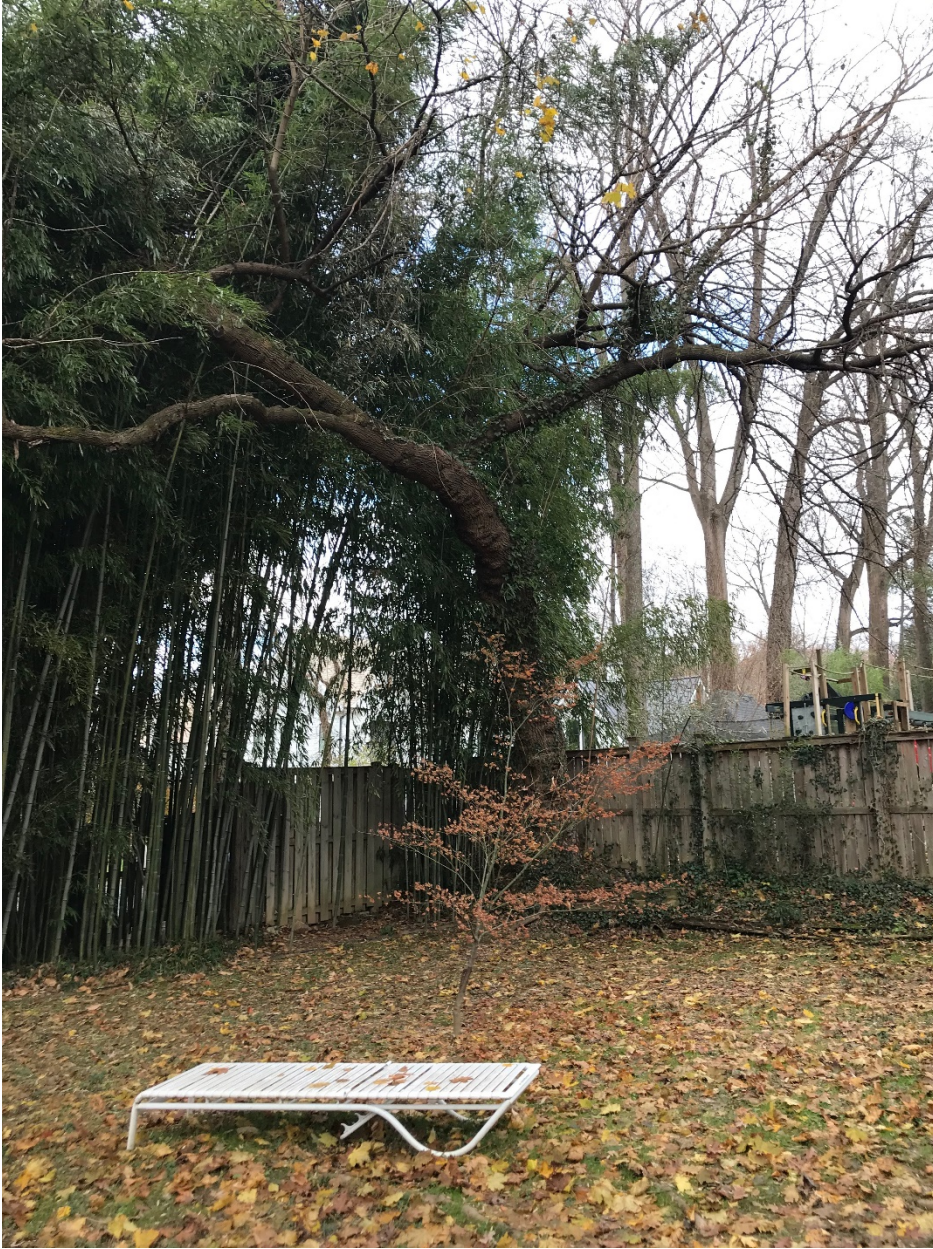
At the northeast corner of the property, the applicant proposes to remove a 30" (thirty inch) d.b.h. mulberry tree. While this tree is significant in size, it is set so far back from the street front that its removal will not impact the character of the site or surrounding district. In order to promote the mature tree canopy found throughout the district Staff recommends the HPC add a condition for approval that this tree may be removed provided the applicant plants an additional tree on the property.

*Figure 1: The 30" mulberry tree in the rear corner of the lot splits at the trunk. It is not visible from the public right-of-way.*

1. In order to promote the mature tree canopy found throughout the Somerset Historic District, one tree must be planted on the property.

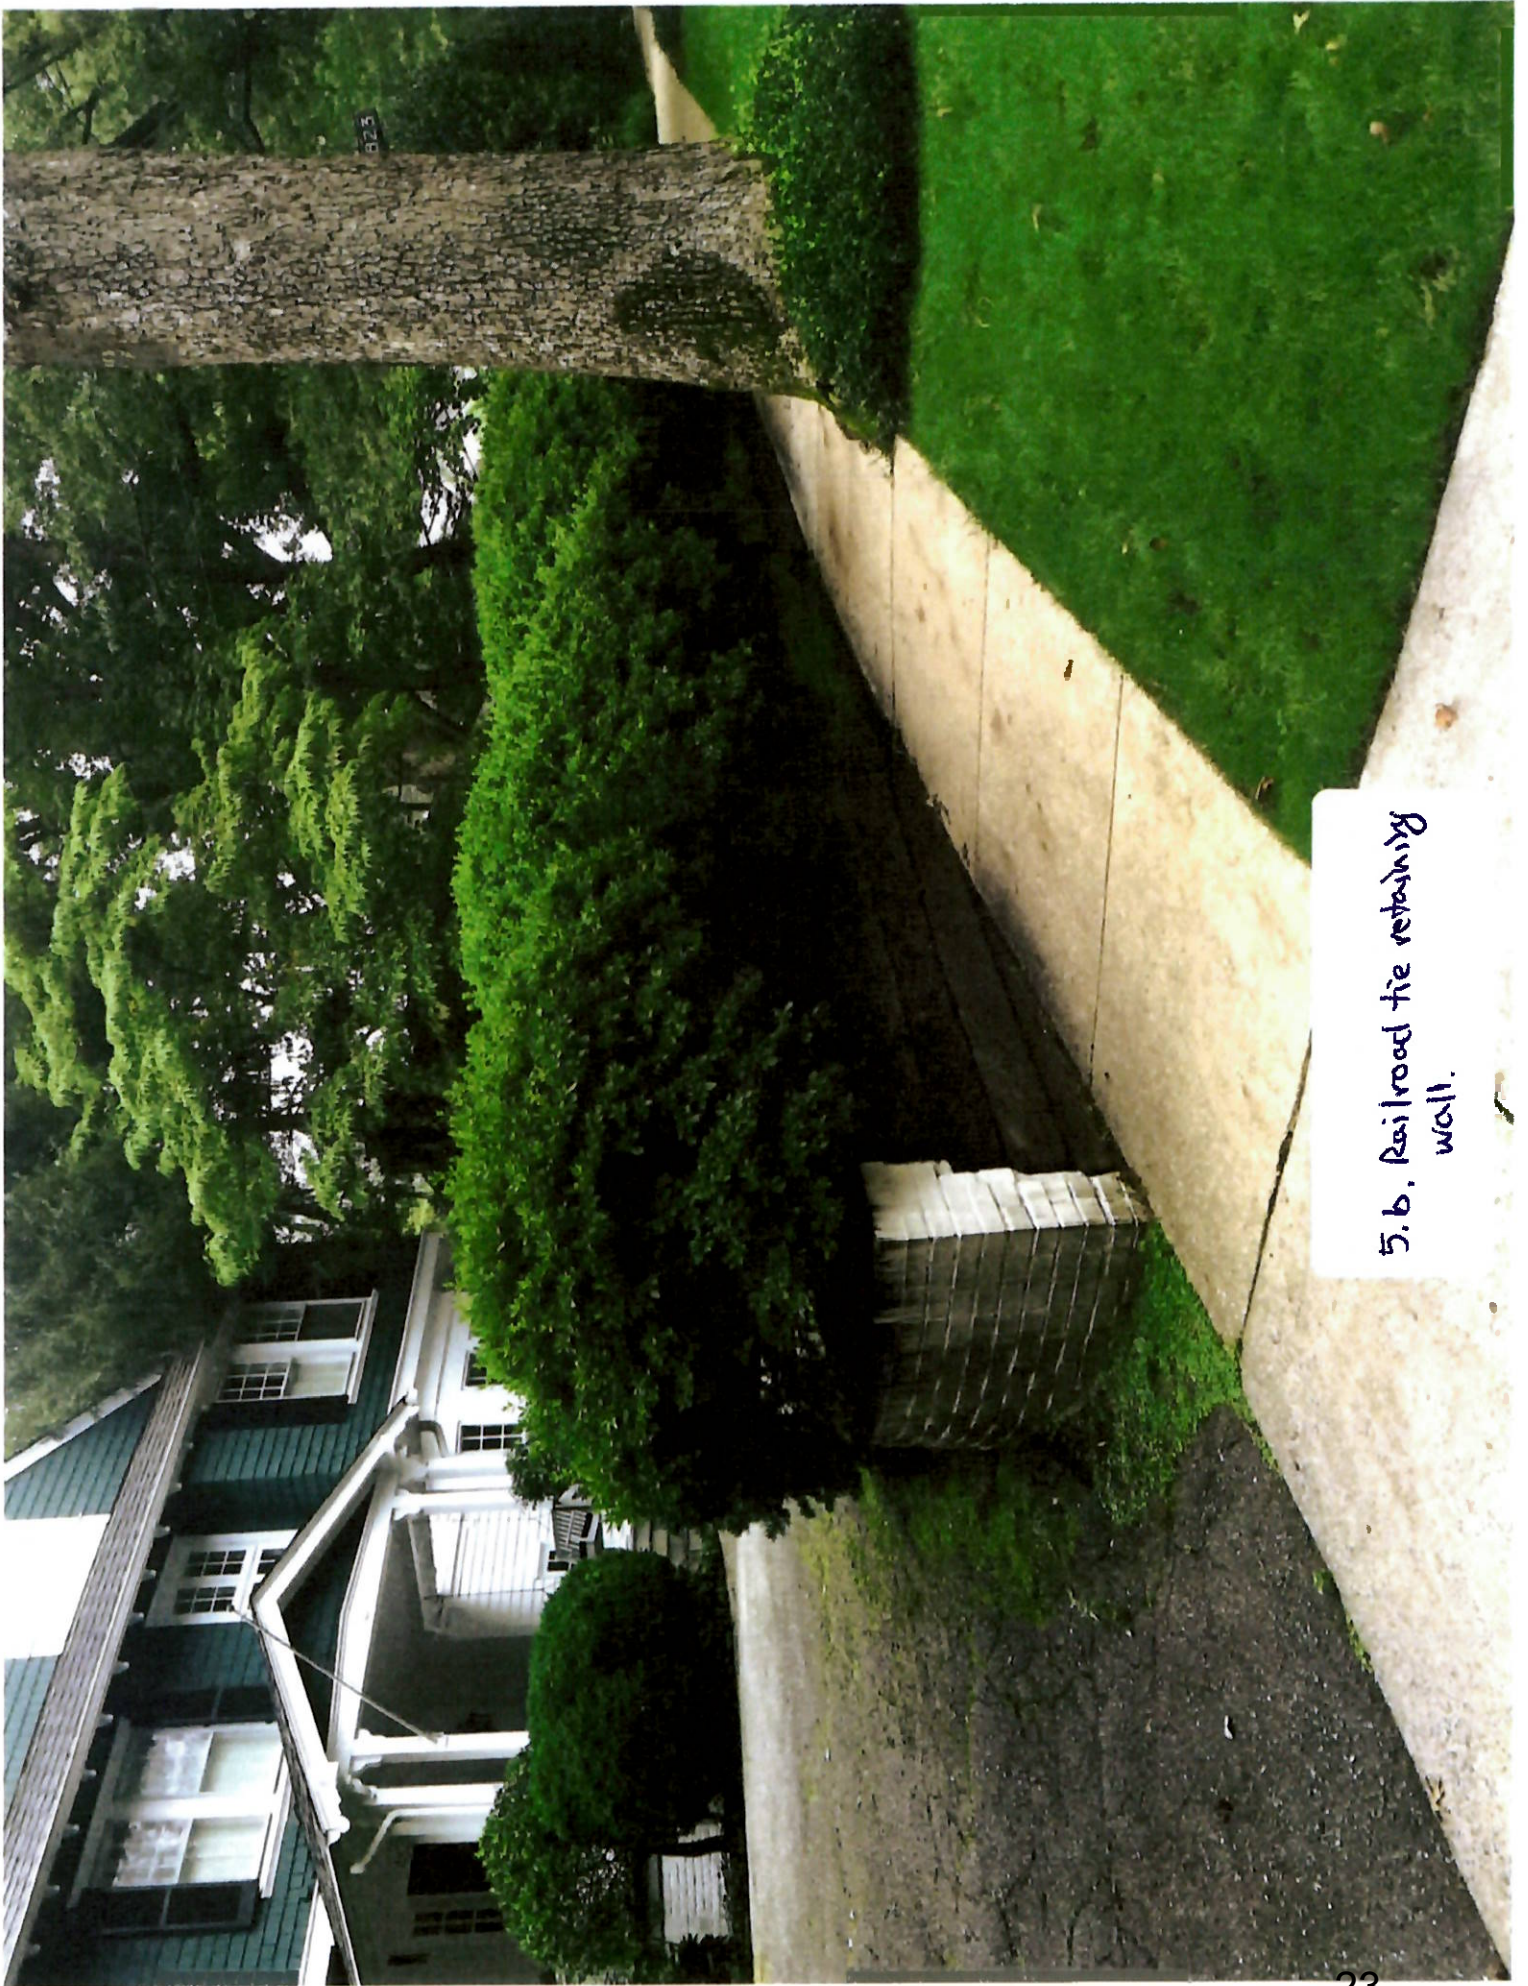
1. Replace the retaining wall between the shrubbery bed and the sidewalk on the south front of the property. The current wall, made of treated railroad ties, is failing. The new wall will be made of stone, generally to match other stone retaining walls in the neighborhood, including at 4824 Dorset.

5. b. Railroad tie retaining wall.

At the front, the applicant proposes to remove the existing railroad tie wall at the front and to replace it with a stone wall. The height of the wall will range from 12"-26" (twelve to twenty-six inches) to accommodate the change in grade. The asphalt drive and brick edging are cracked and failing, and the applicant proposes replacing them with cobblestone pavers in the drive with Belgian block edging. Staff finds that the proposed changes at the front are in keeping with the historic house and surrounding district and will provide more texture than modern asphalt or cement. Staff supports approval of the proposed changes at the front of the house.

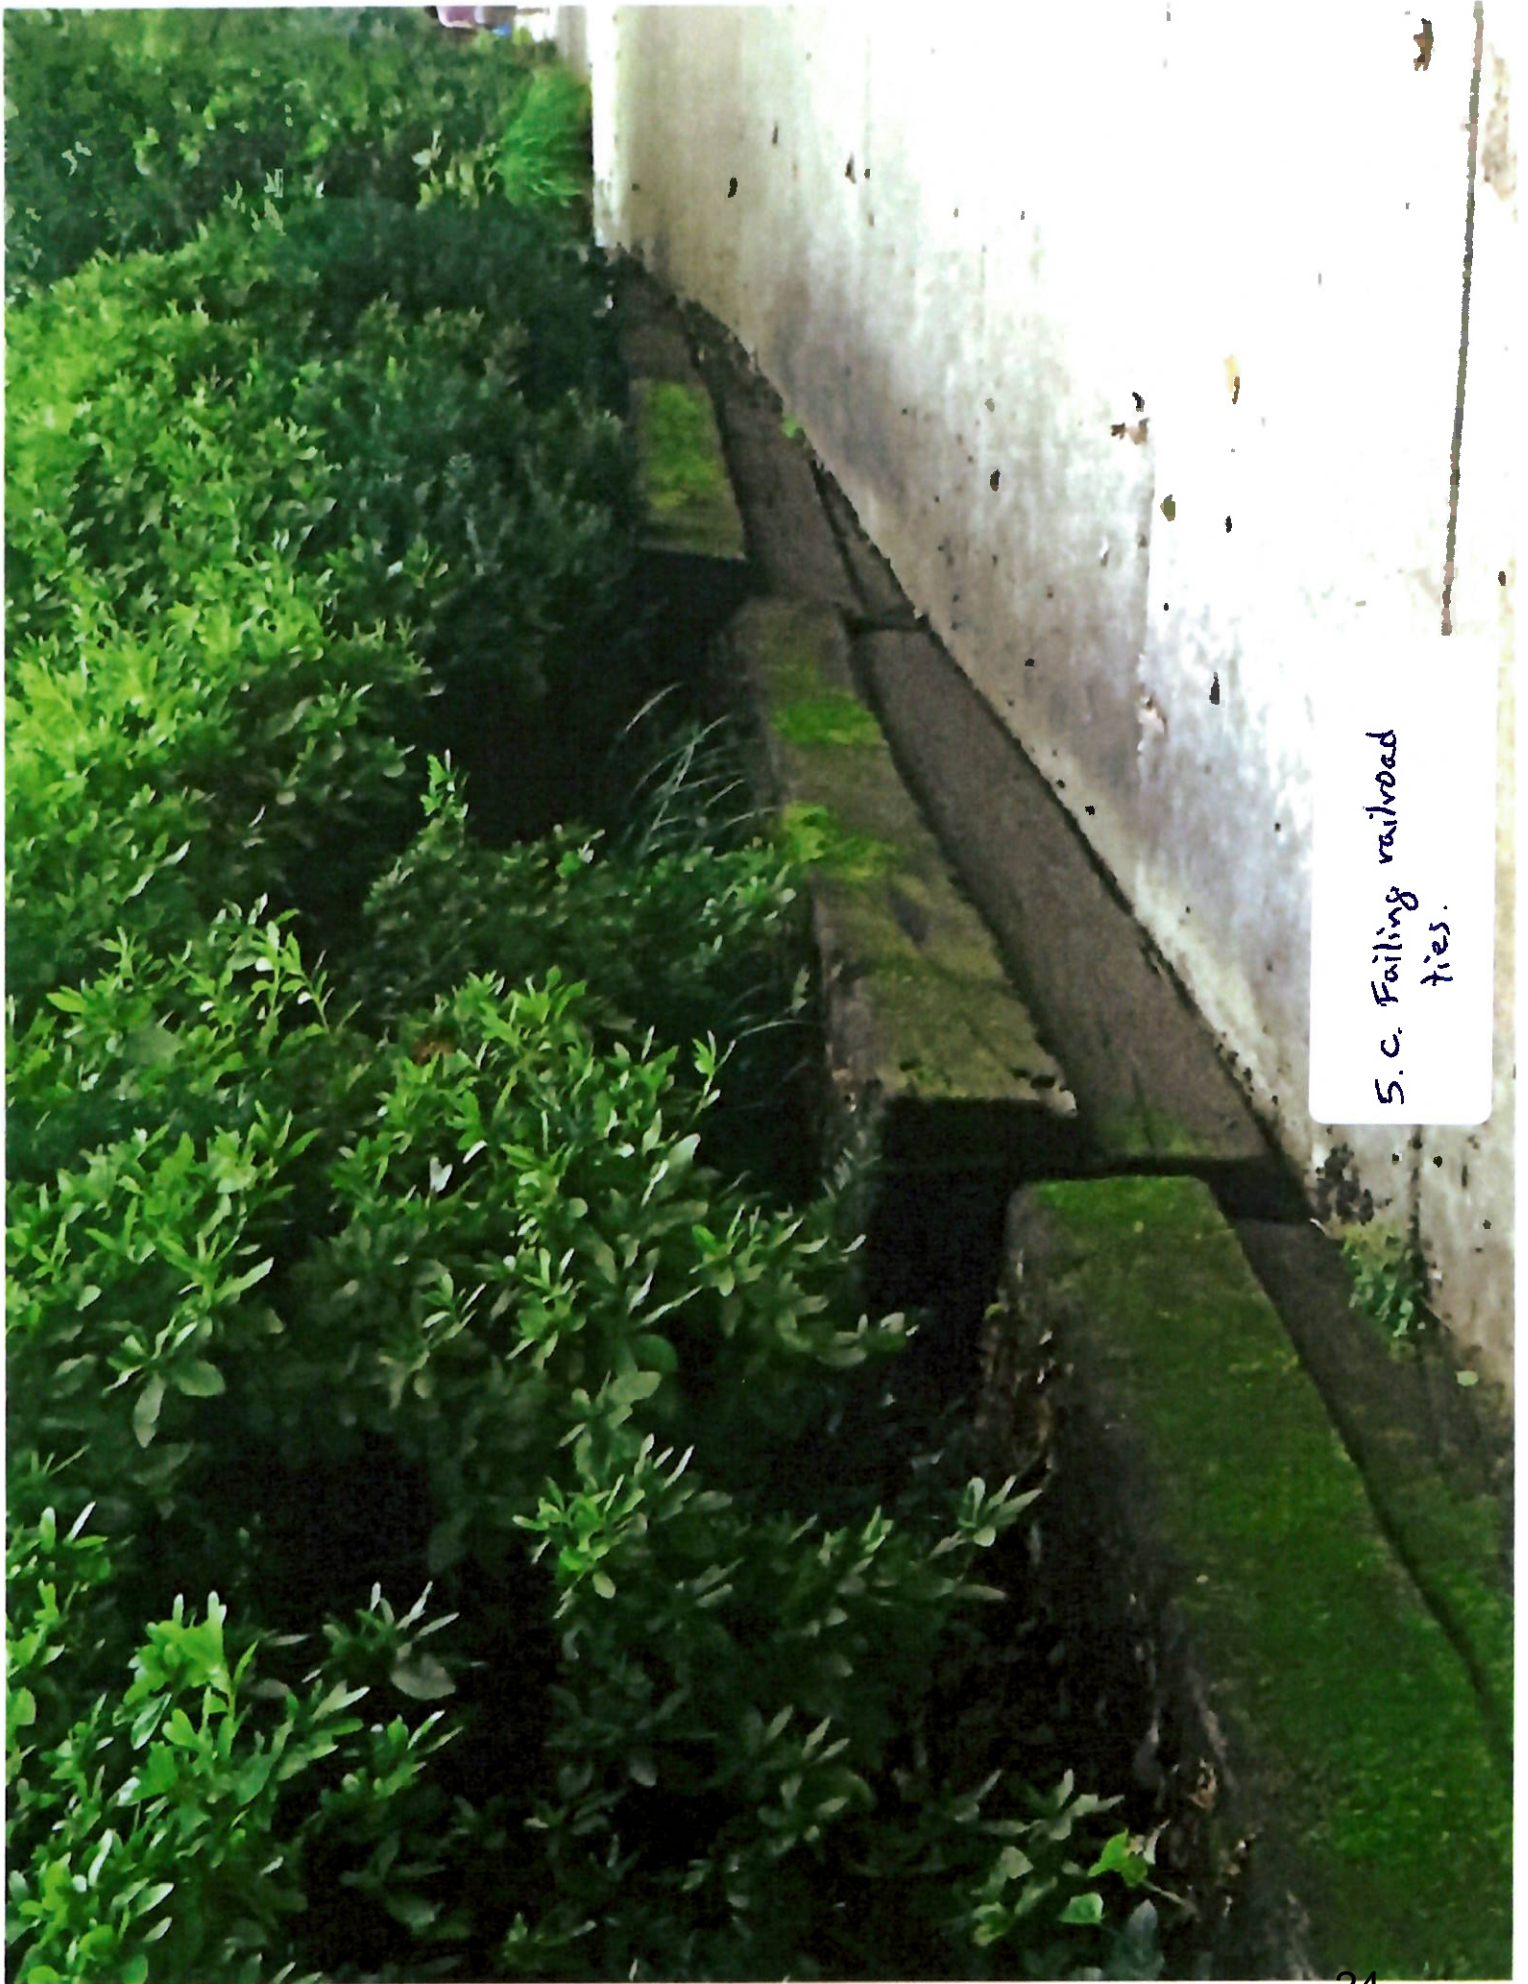
S. C. Failing railroad  
ties.

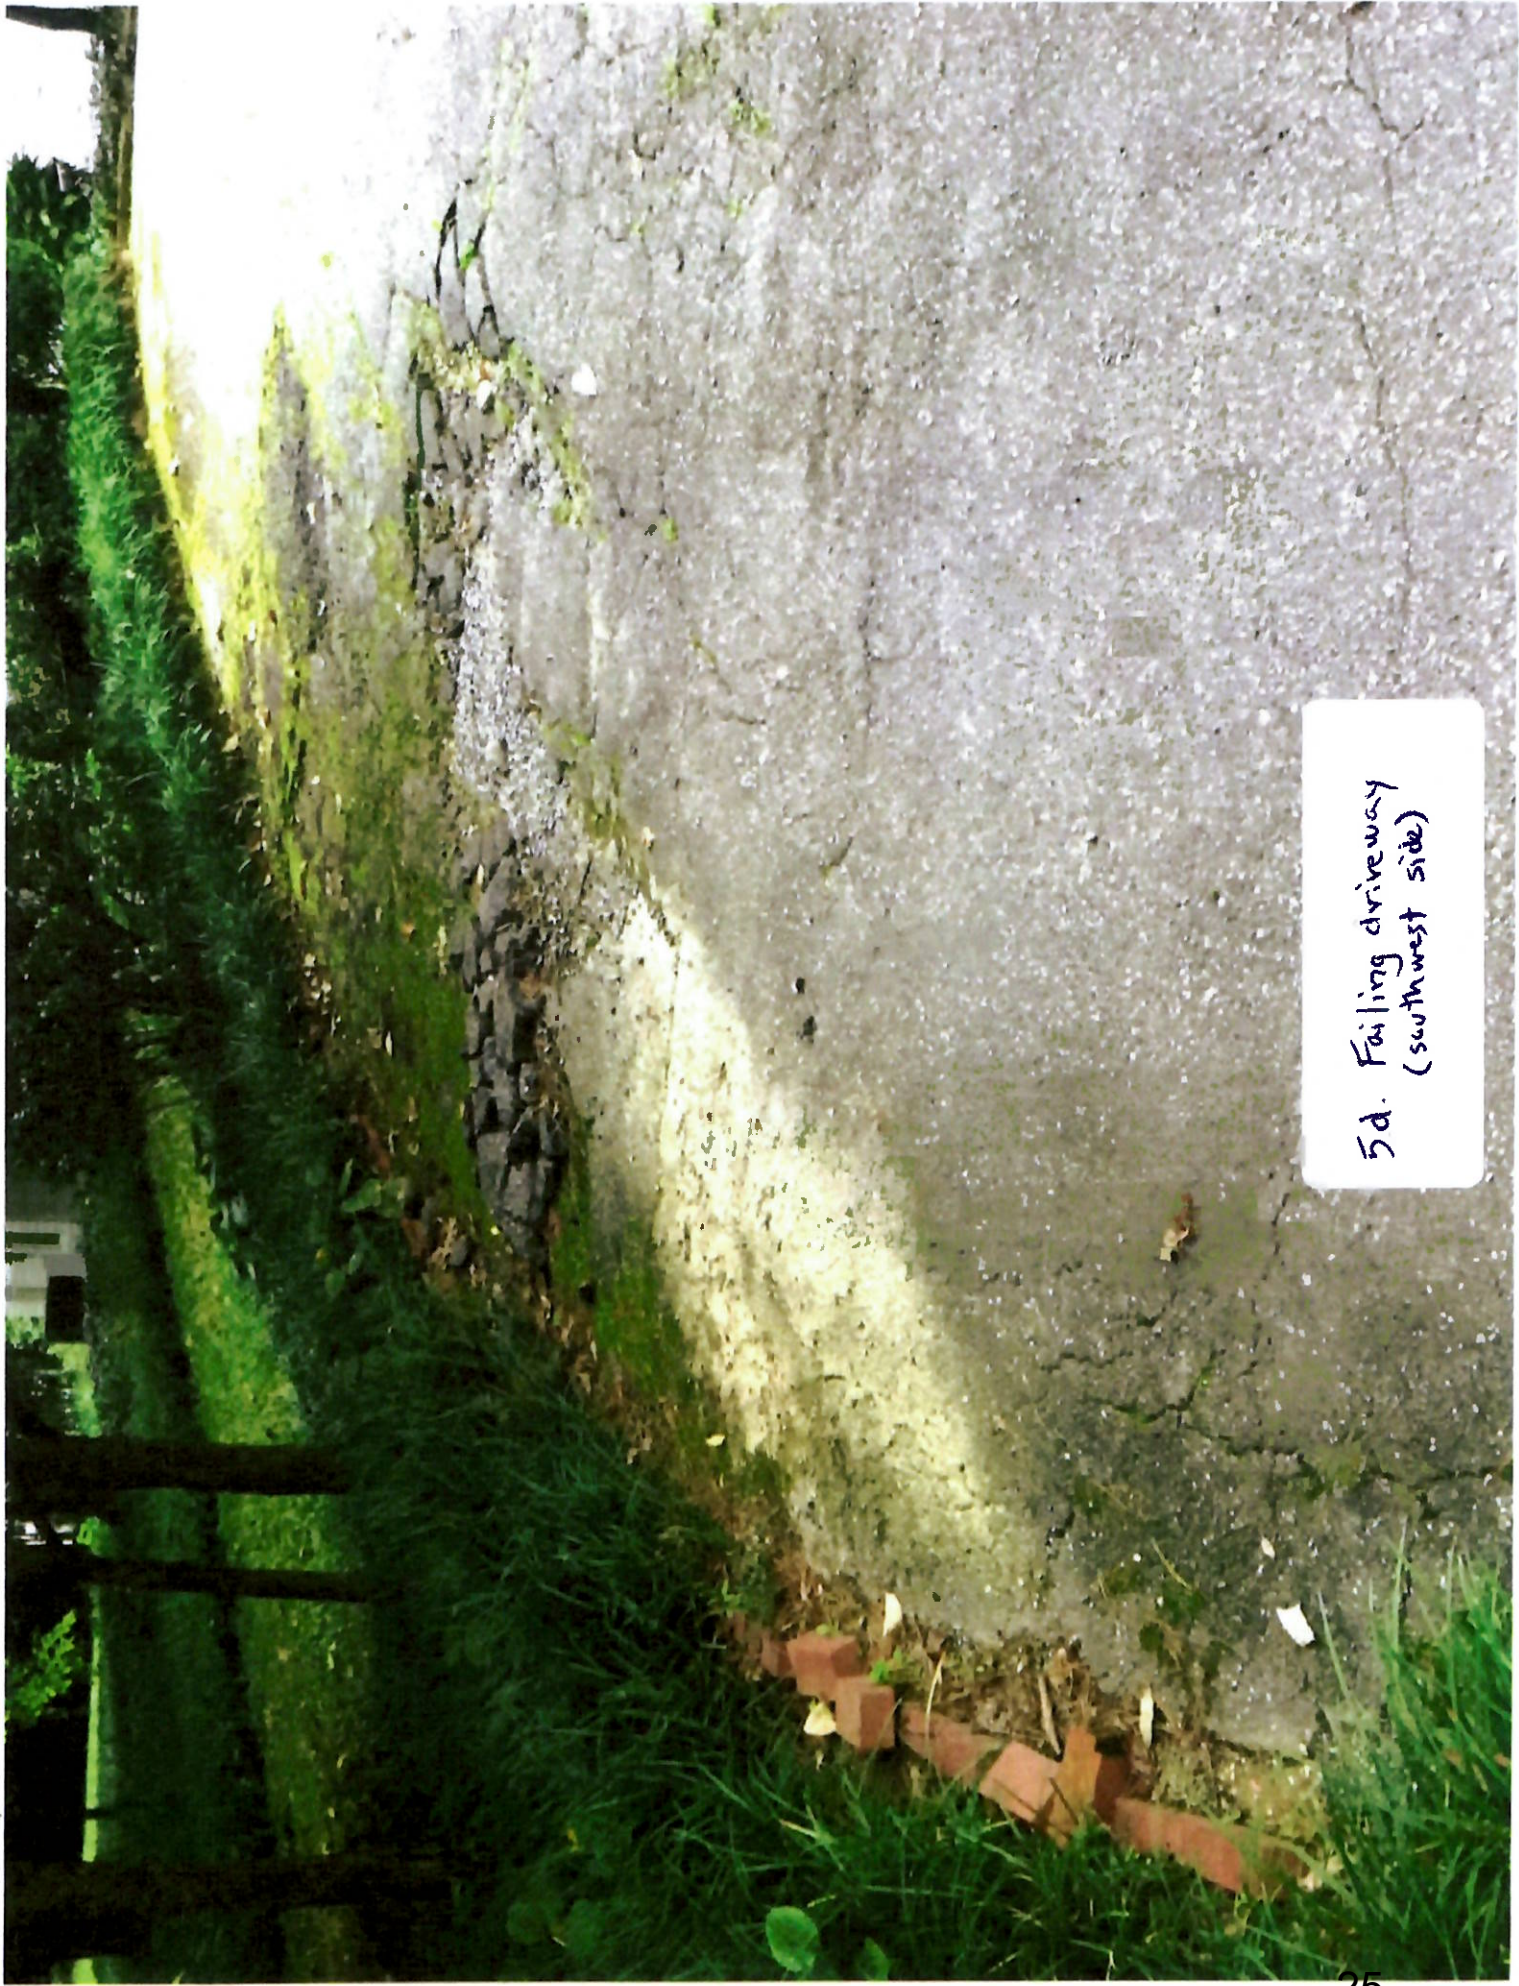
2. Replace the existing asphalt driveway that circles the south front and runs down the east side of the house. The asphalt is failing. The new driveway, within the same footprint as the current driveway, will be built of pavers and bordered by granite block. On the east side of the driveway, a buried vertical course of granite blocks will replace the buried diagonal brick edge that retains the slope from the neighbor's front yard. We will also replace the low brick wall between the driveway and the planting bed at the south front of the house with a low stone wall matching the one at the sidewalk. This wall will partially be moved closer to the house and partially reconfigured to accommodate existing dogwood trees.

5d. Failing driveway  
(southwest side)

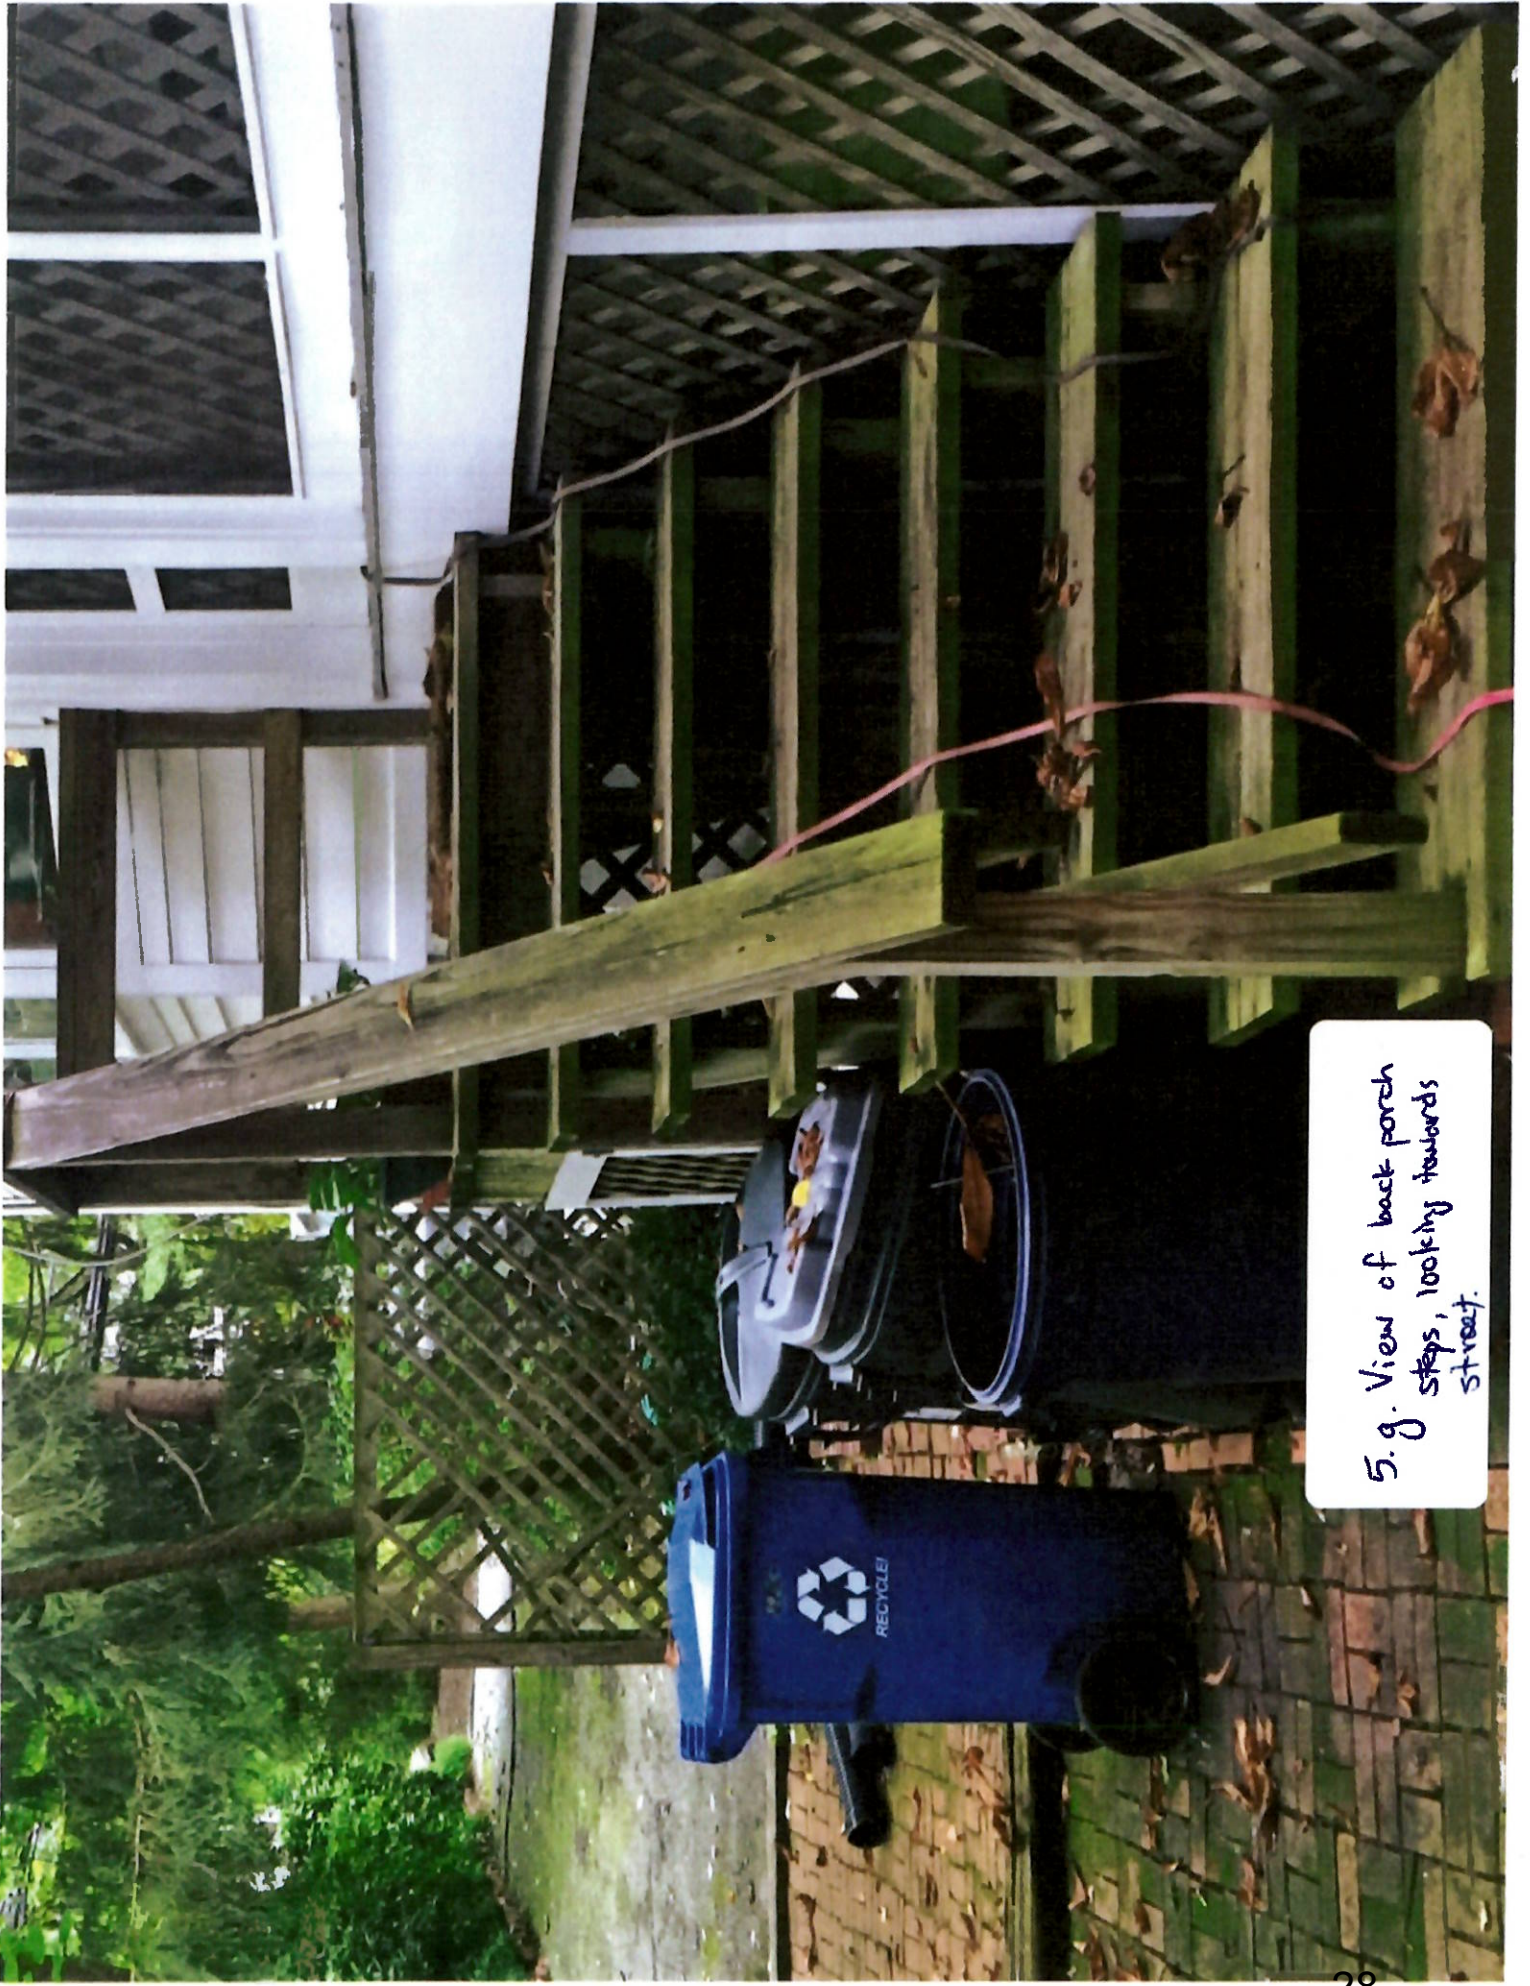
5. Replace and widen the landing and steps leading down from the back screened porch. These steps, which we understand were added at the same time the porch was built in about 1989 after a tree fell on a greenhouse there, are made of treated lumber, and the stairs' supports are splitting. The top landing will be expanded from 4' x 4' to 6' x 8', and the stairs will be widened and extended down onto the terrace. We will replace the unfinished treated lumber with Azek floors, steps, and railings, designed and painted to match the front porch. We will replace the existing door from the back porch onto the landing with an identical painted wooden door that opens outward instead of inward. We will replace the thin diagonal wooden lattice under the steps and under the back porch with cedar rectangular lattice to match the arbor and the equipment screens.

5.g. View of back porch  
steps, looking towards  
street.

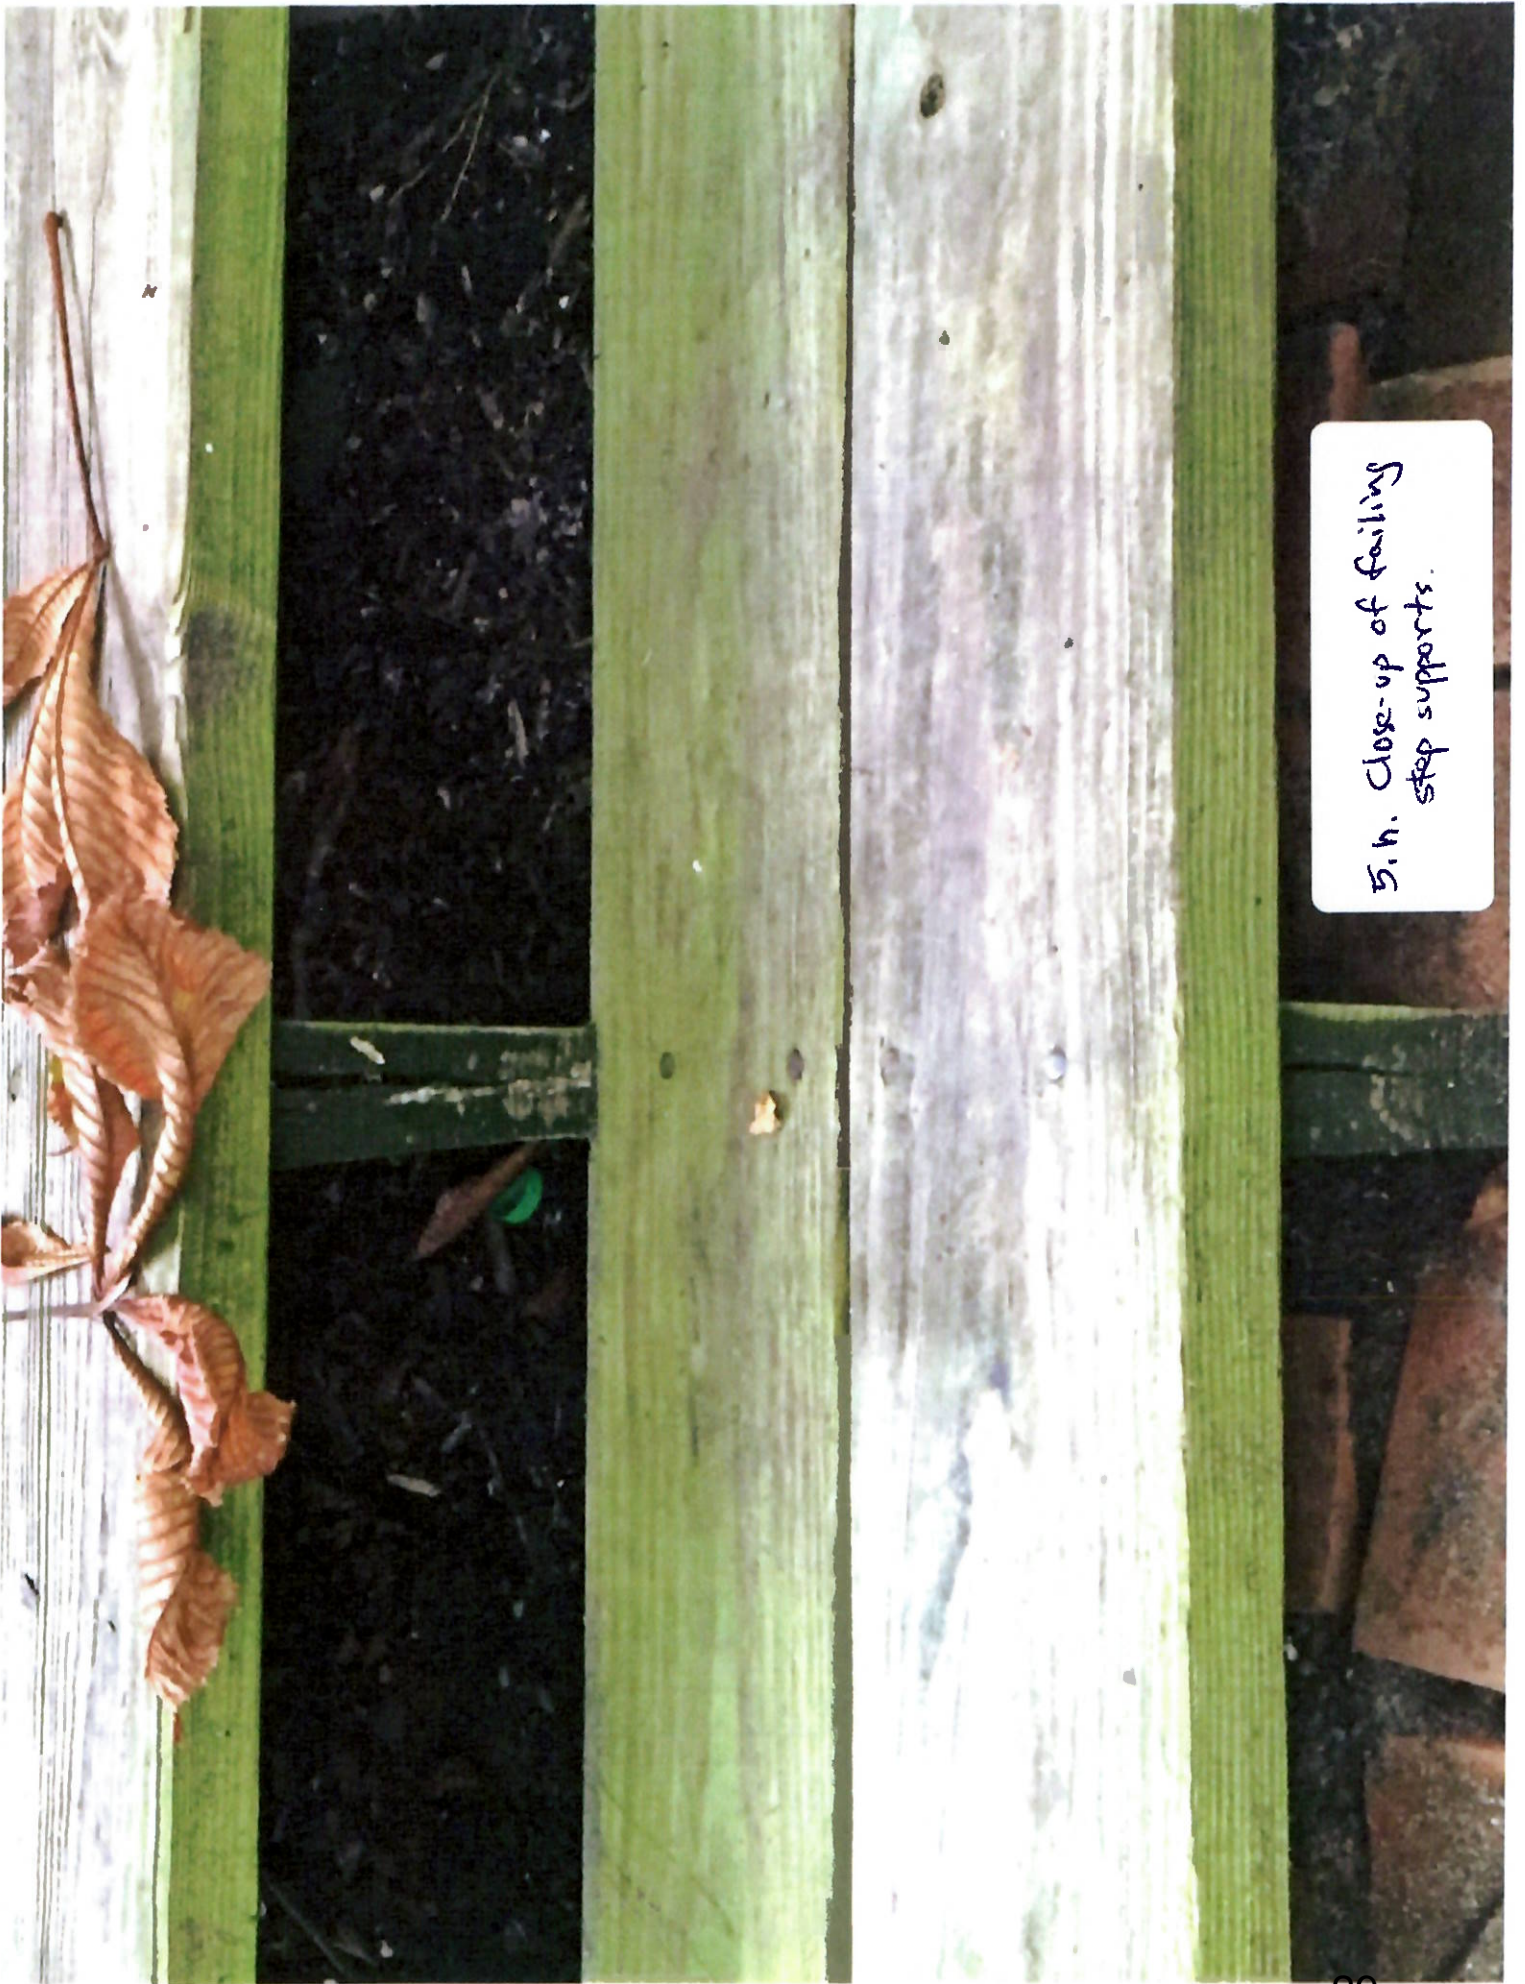
5. h. Close-up of failing  
step supports.

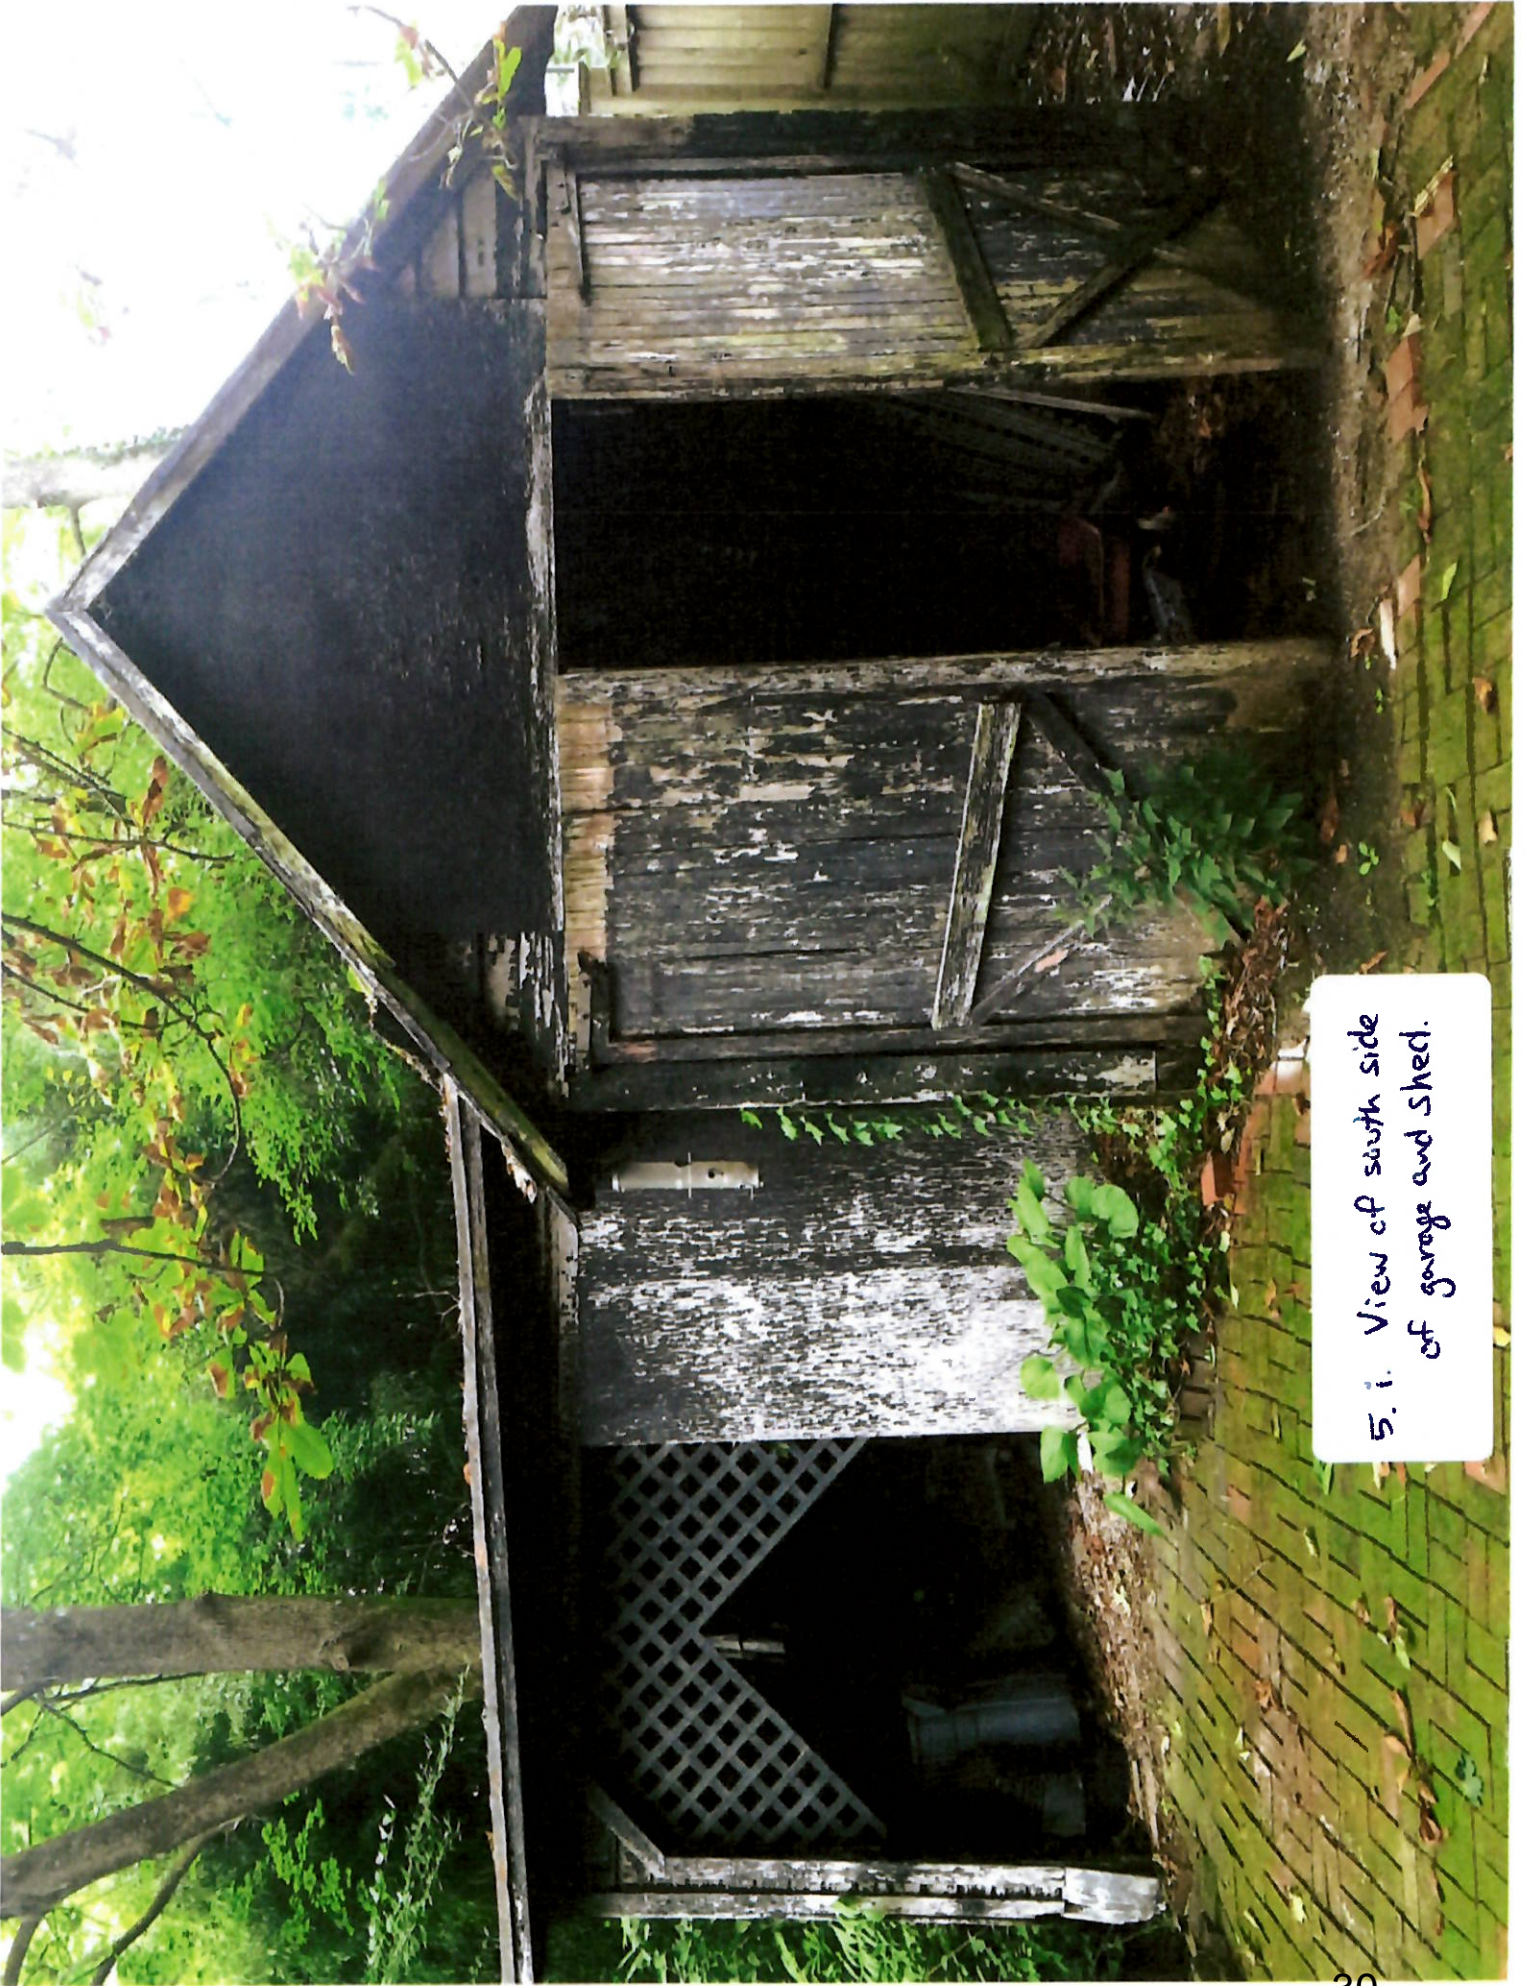
In the rear of the lot, there is a one-bay, front-gable garage with a combination of clapboard and shiplap siding. To the left of the garage is an open shed with a pent metal roof and wood siding. The garage appears to have been constructed either contemporary to or shortly after the construction of the historic house. The shed appears to have been a later construction. Both structures have been repaired piecemeal over the years and lack much of their historic integrity. The applicant proposes to remove both of these structures. Staff finds that these structures are likely historic. Staff further finds that the condition of these structures has degraded significantly and that a significant portion of the historic materials have been replaced over the years. The removal of these features will not significantly impact the historic character of the house or the surrounding district, and, therefore, Staff recommends approval of the demolition of the garage and attached shed.

6. Remove the old garage and shed at the back of the brick patio. This structure, which conveyed to us "as is" in 1992, is rotted and in very poor shape. It is clear that an extension that was added to the front of the old garage and the shed added on the side were amateurishly built, and are failing. The foundations of the entire structure are rotted and it may collapse. The reconfiguration of the garage and addition of the brick patio allowed rainwater to wash down into the garage. We will be undergrounding the downspouts along the driveway and extending them to an outflow in the back yard in order to avoid this runoff.

5. i. View of south side of garage and shed.
