**MONTGOMERY COUNTY HISTORIC PRESERVATION COMMISSION**  
**STAFF REPORT**

<b>Address:</b>	4823 Dorset Ave., Chevy Chase	<b>Meeting Date:</b>	12/5/2018
<b>Resource:</b>	<b>Contributing Resource</b> (Somerset Historic District)	<b>Report Date:</b>	11/28/2018
<b>Applicant:</b>	John Stewart and Sharon Stoliaroff <b>(Adam Greene, Agent)</b>	<b>Public Notice:</b>	11/21/2018
<b>Review:</b>	HAWP	<b>Tax Credit:</b>	No
		<b>Staff:</b>	Dan Bruechert

**Case Number:** 35/36-18L

**PROPOSAL:** Accessory structure and hardscape alterations

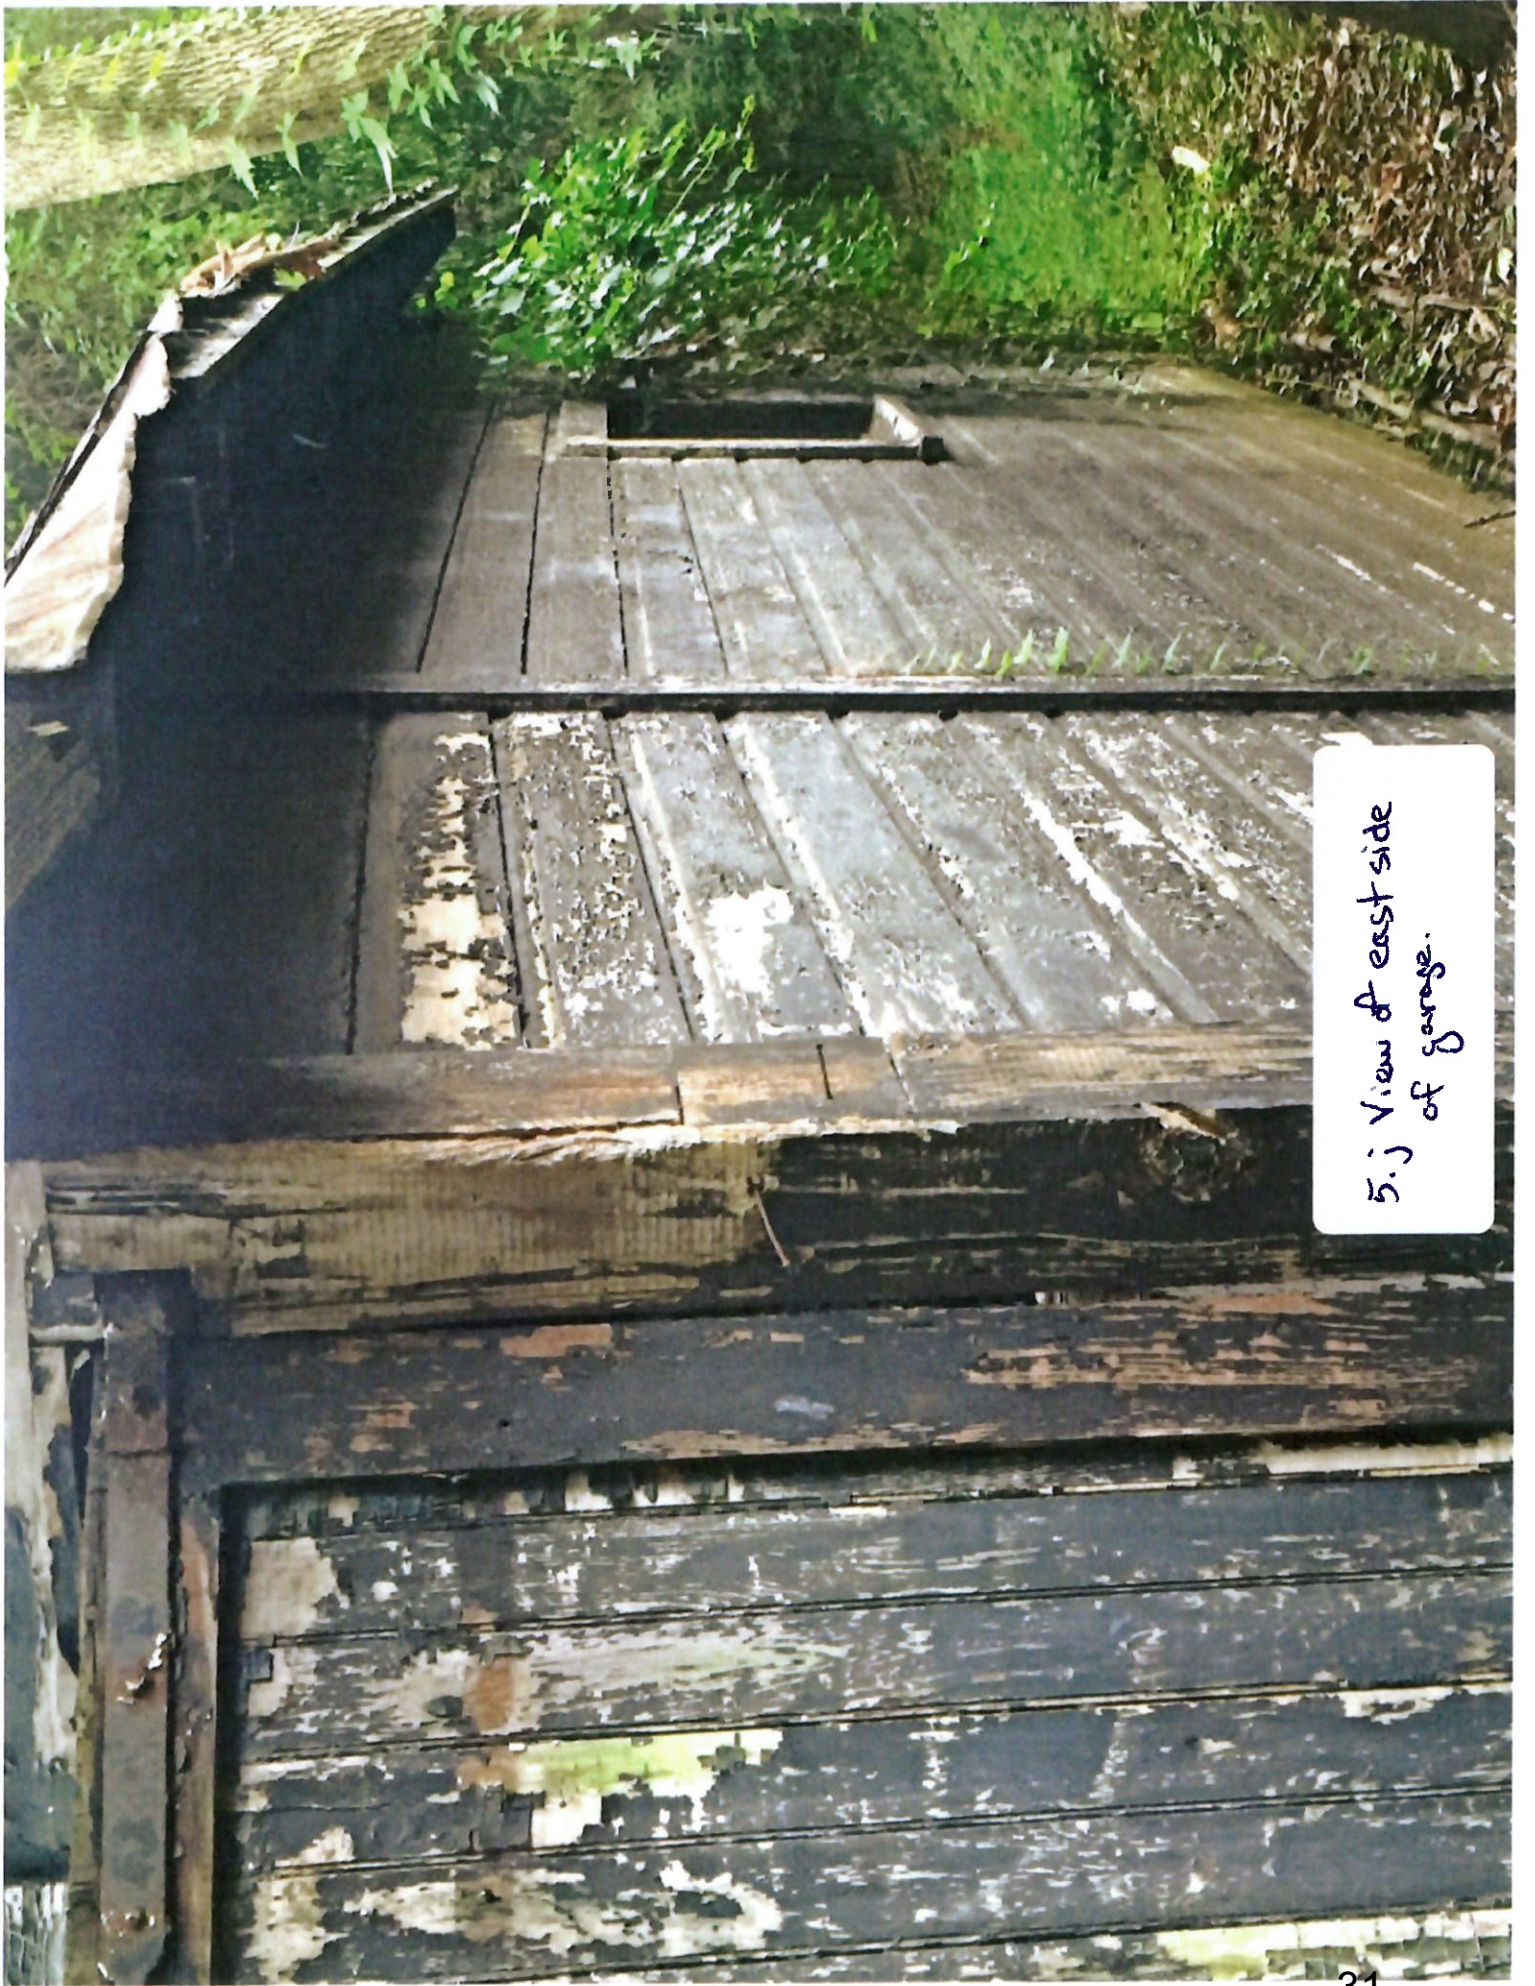
5.j View of east side of garage.

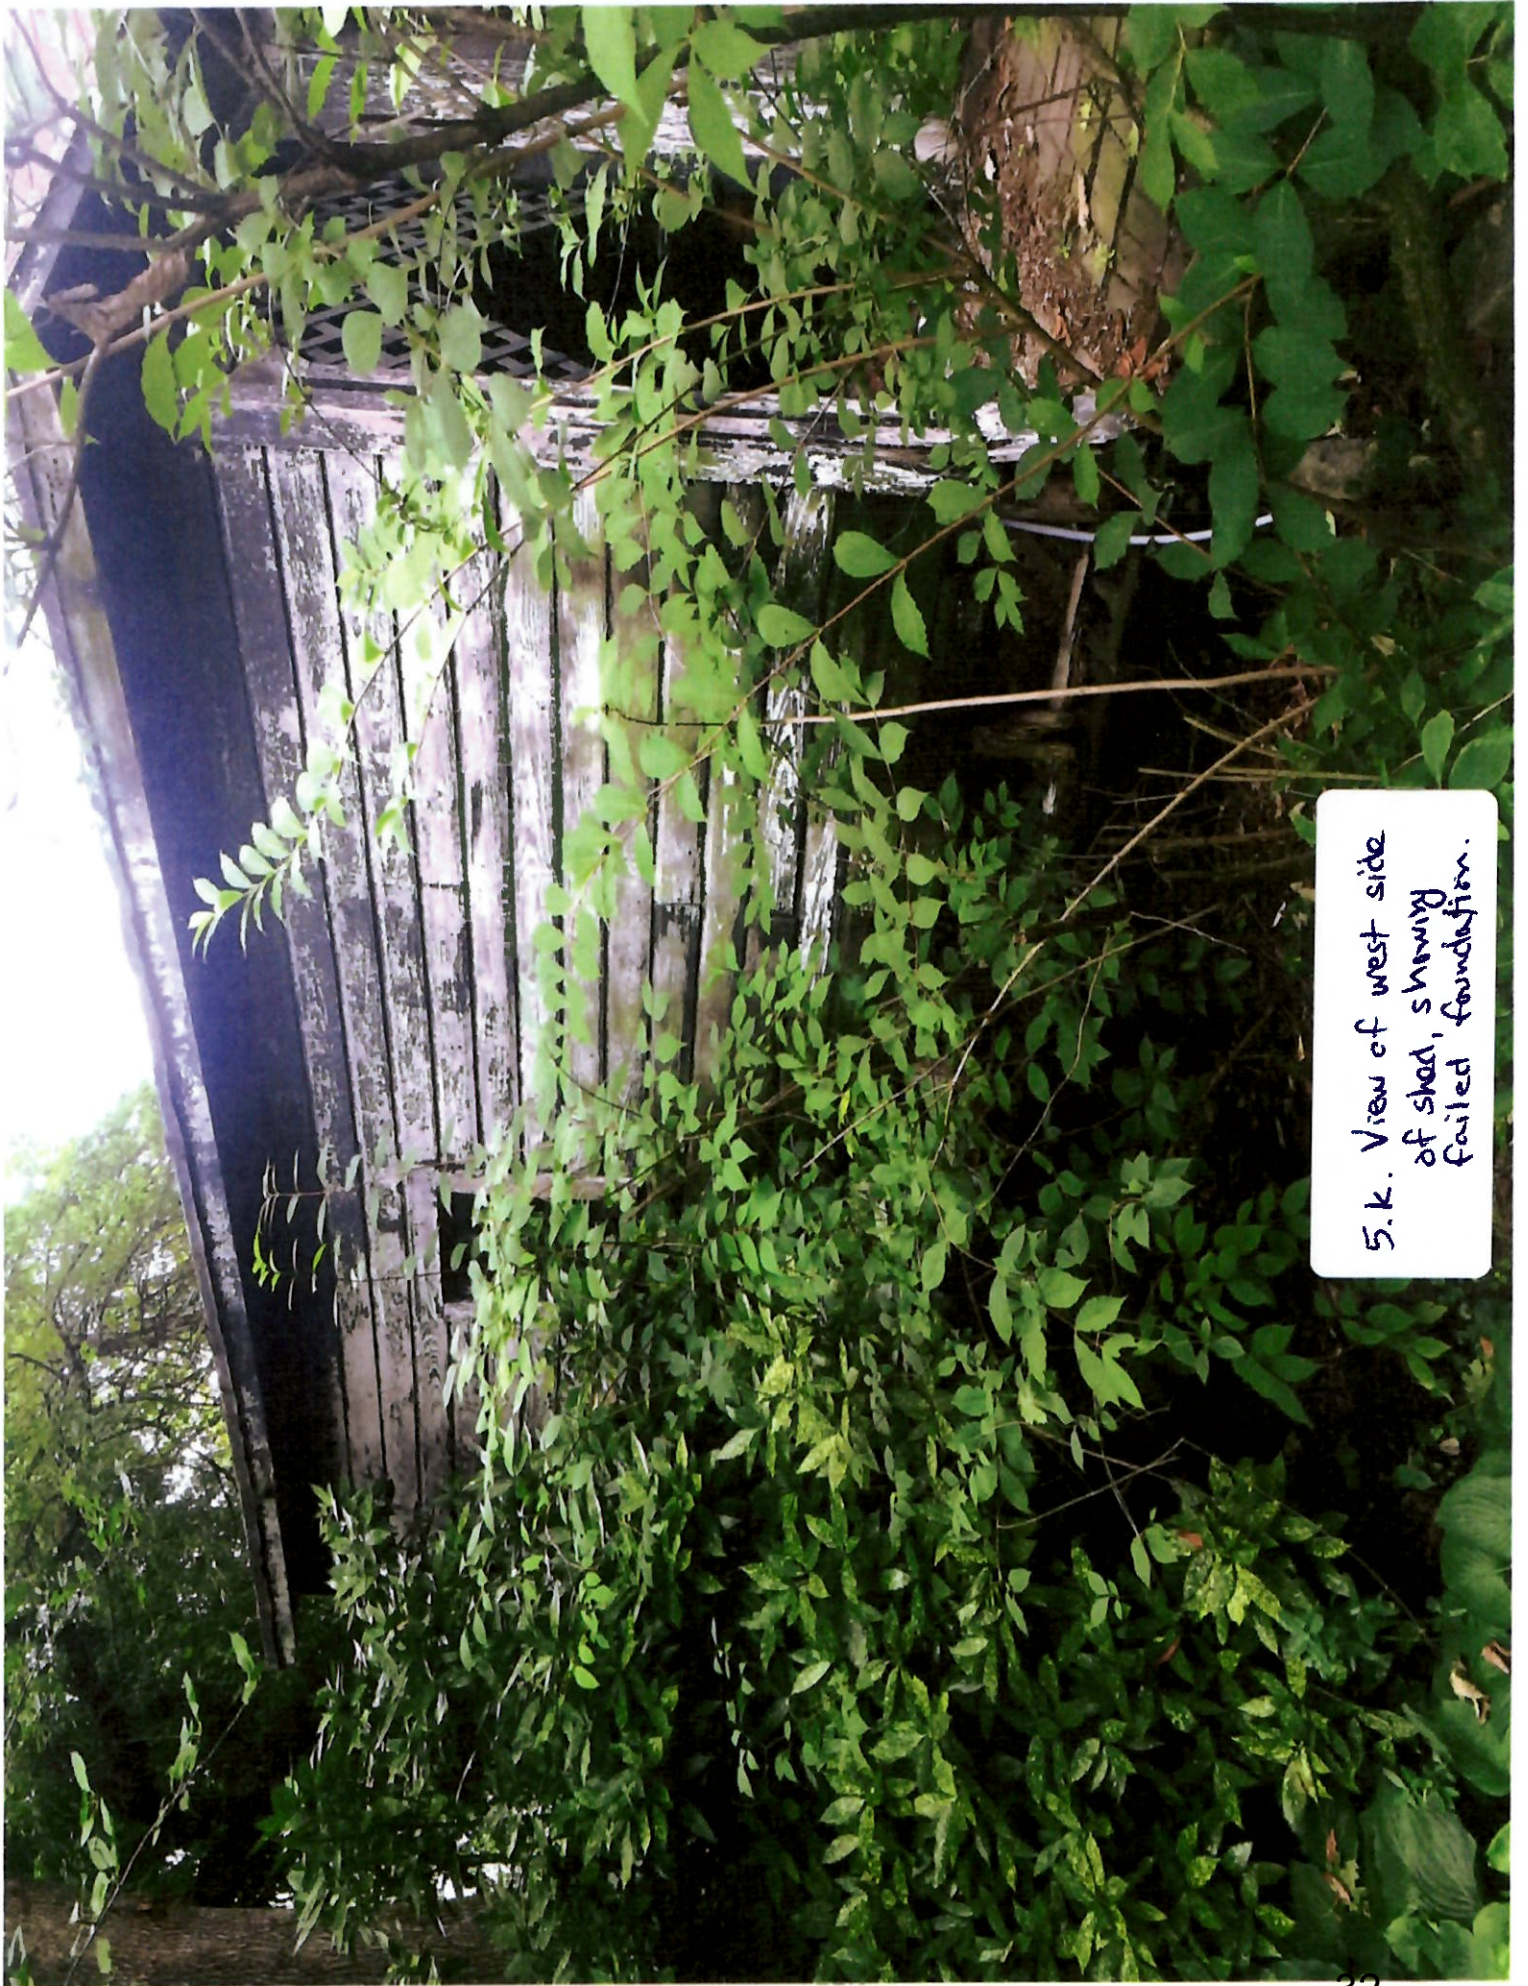
6. Remove the old garage and shed at the back of the brick patio. This structure, which conveyed to us "as is" in 1992, is rotted and in very poor shape. It is clear that an extension that was added to the front of the old garage and the shed added on the side were amateurishly built, and are failing. The foundations of the entire structure are rotted and it may collapse. The reconfiguration of the garage and addition of the brick patio allowed rainwater to wash down into the garage. We will be undergrounding the downspouts along the driveway and extending them to an outflow in the back yard in order to avoid this runoff.

5.k. View of west side of shed, showing failed foundation.

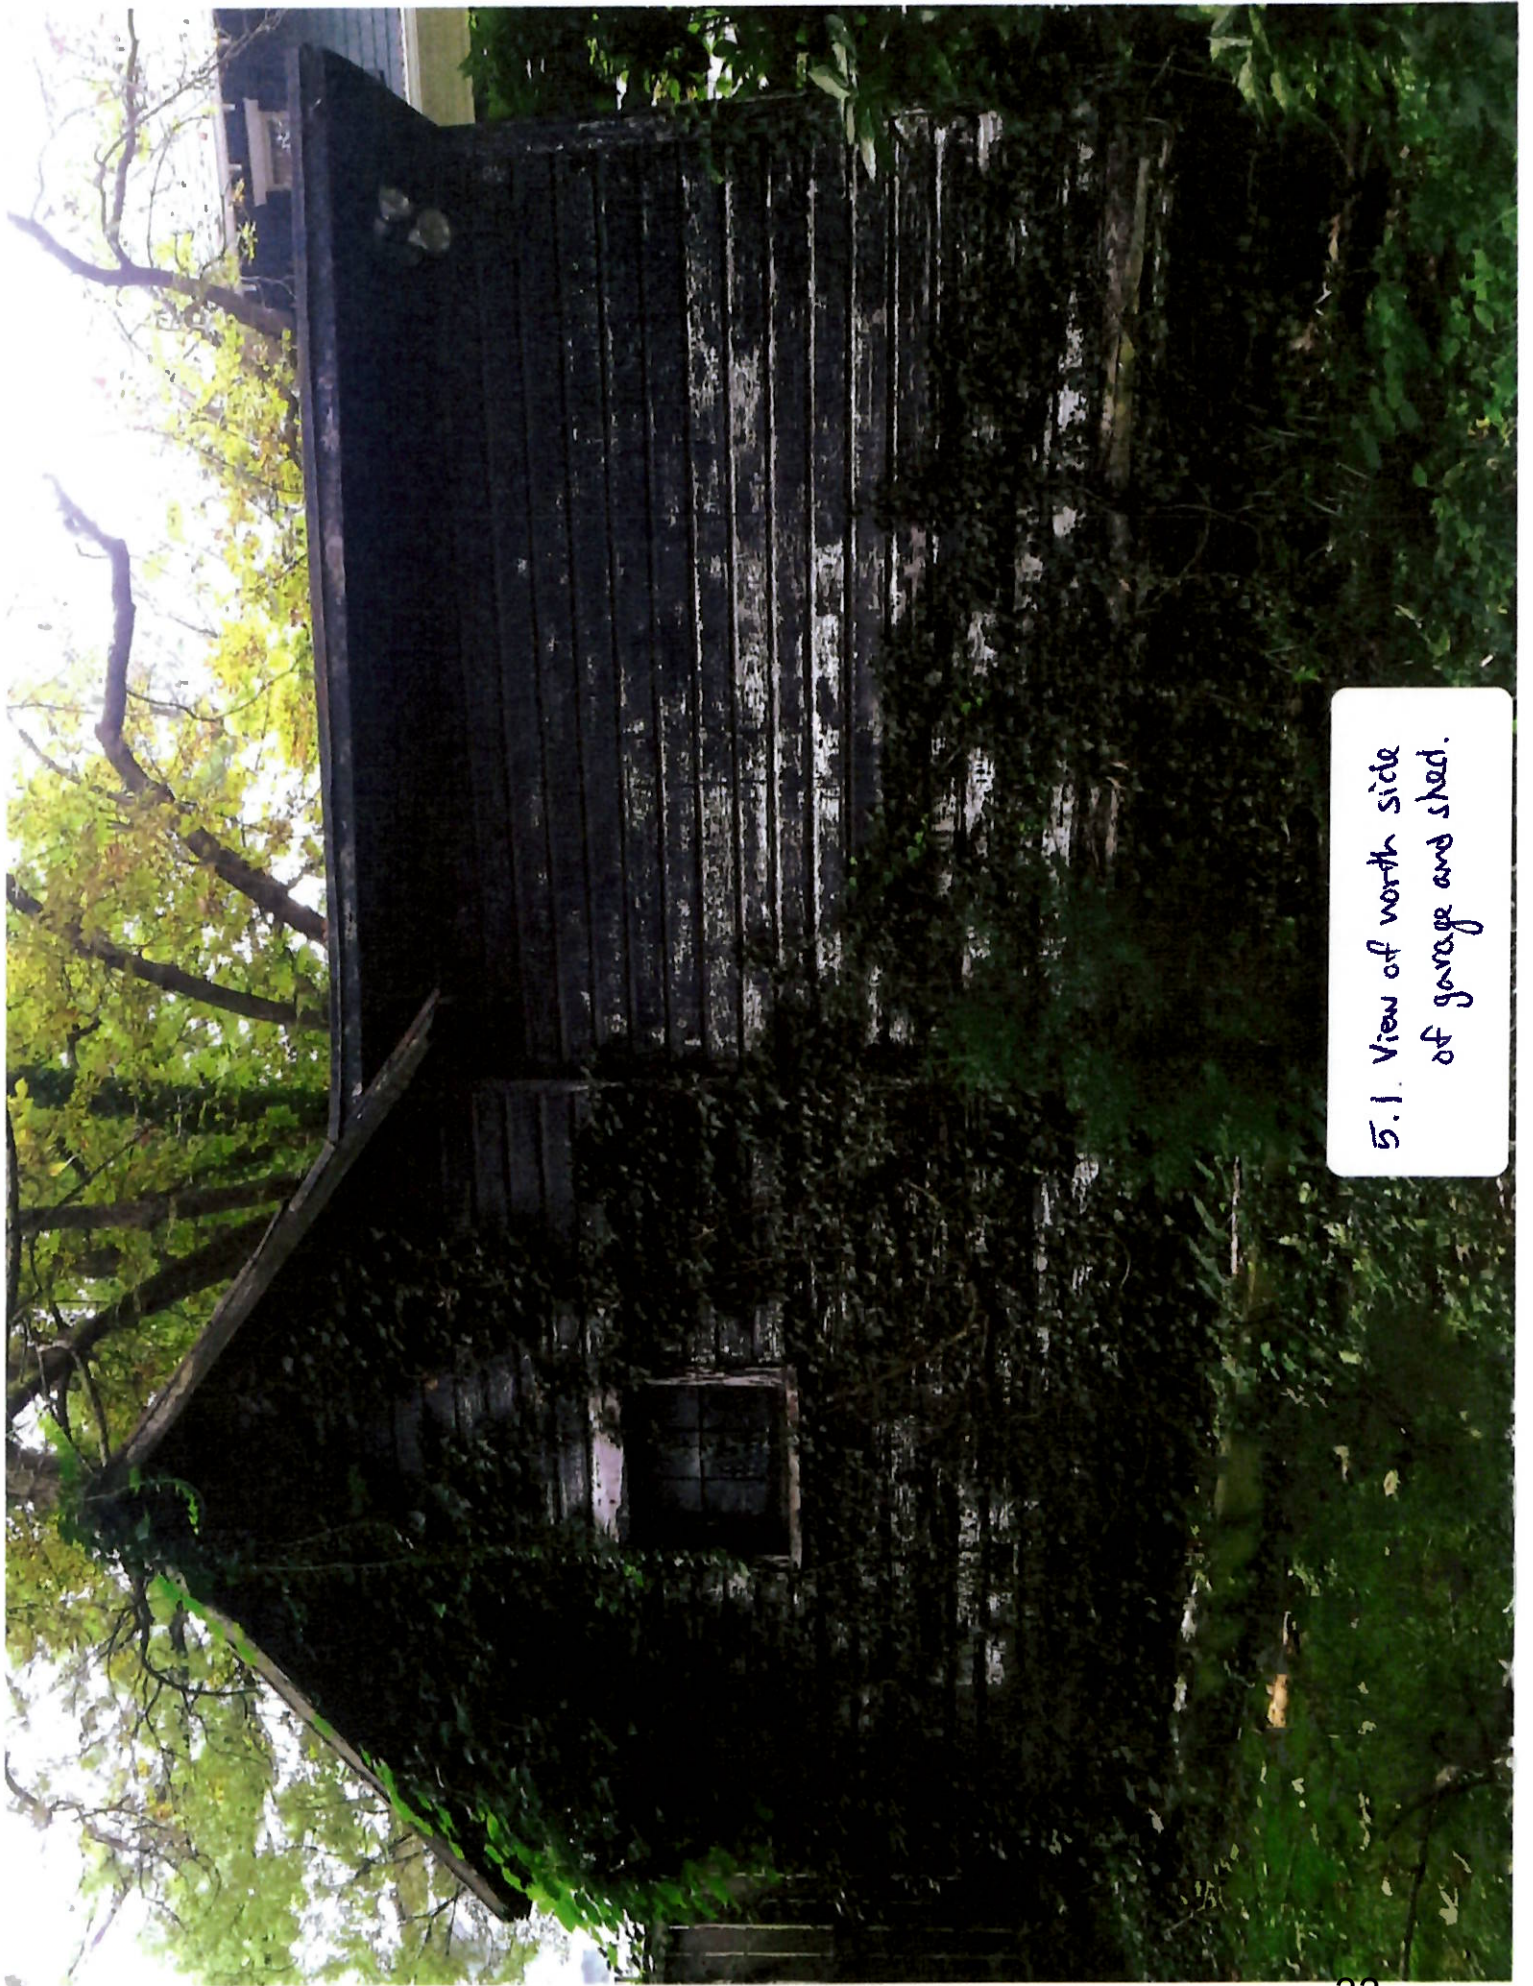
5.1. View of north side of garage and shed.

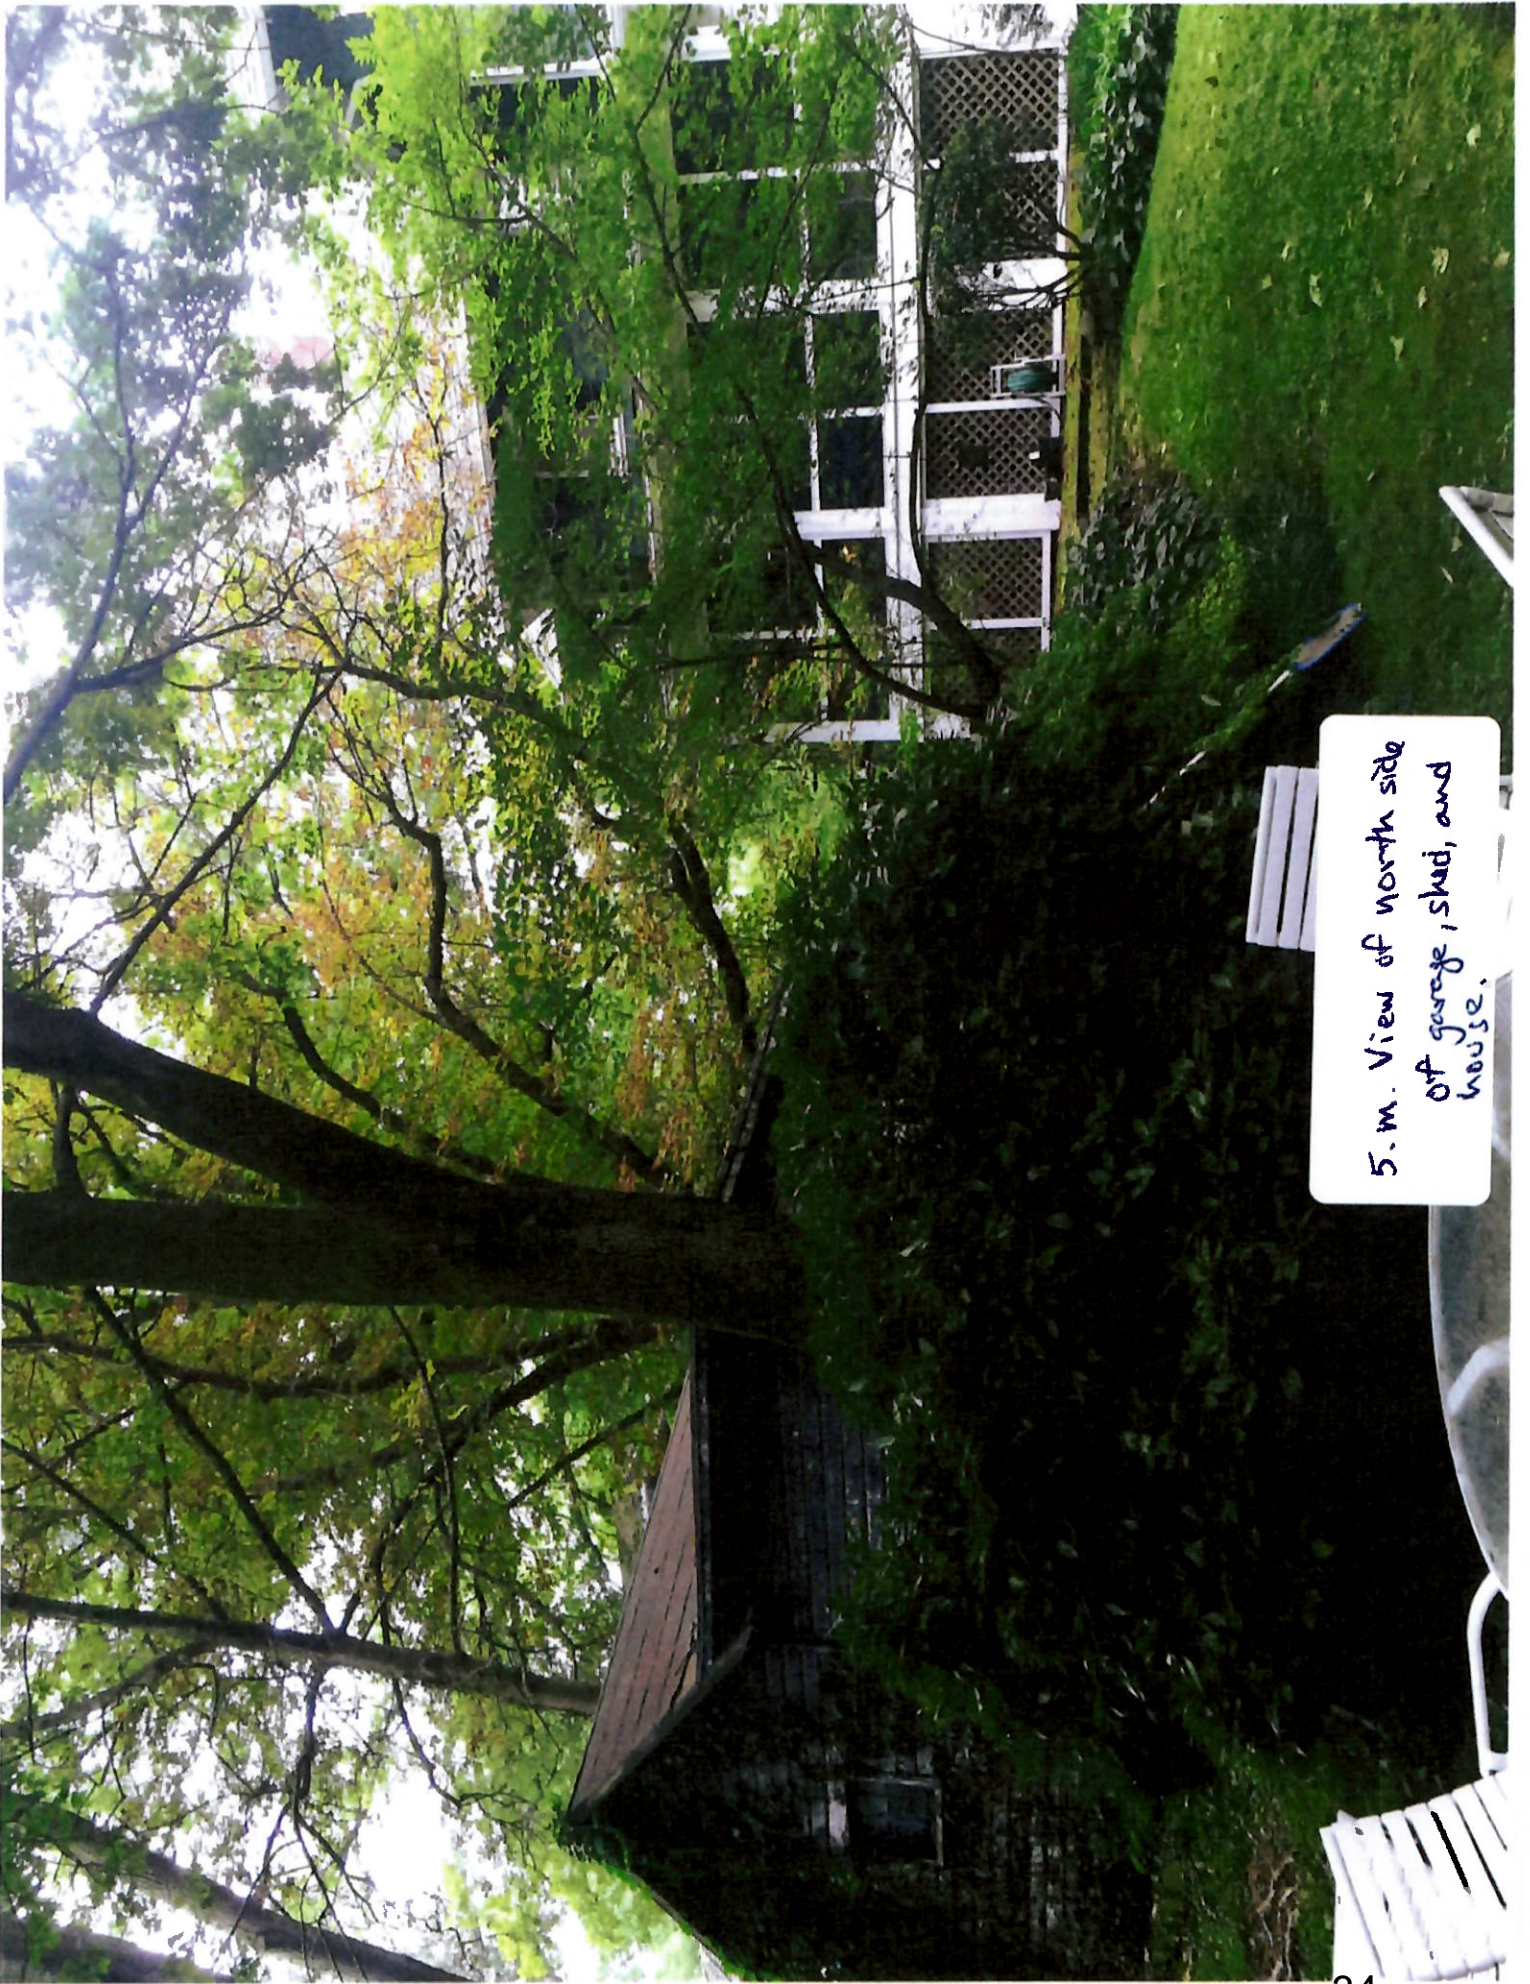
5.m. View of north side  
of garage, shed, and  
house.
