Pedestrian Road Safety Audit

Middlebrook Road

From Father Hurley Boulevard to Waring Station Road

December 2017

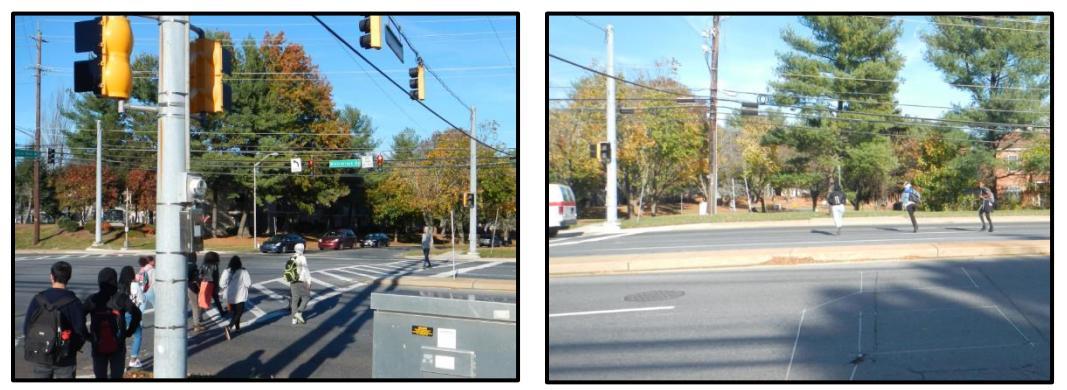
At multiple locations along the corridor, pedestrians were observed crossing outside of marked crossings or during the Don't Walk phase of the pedestrian signal. Additionally, conflicts between turning vehicles and pedestrians crossing during the Walk phase were observed. The audit team recommends coordination with the MCDOT Pedestrian Safety Coordinator and Seneca Valley High School to increase pedestrian education about where and when to cross and recommends that signal phasing changes, such as protected left-turn phases or Leading Pedestrian Intervals (LPIs), be evaluated where turn conflicts are present.

Left: Pedestrian crosses during Don't Walk phase. Right: Pedestrian crosses outside of marked crosswalk. Figure 11: Examples of Pedestrian-Vehicle Conflicts

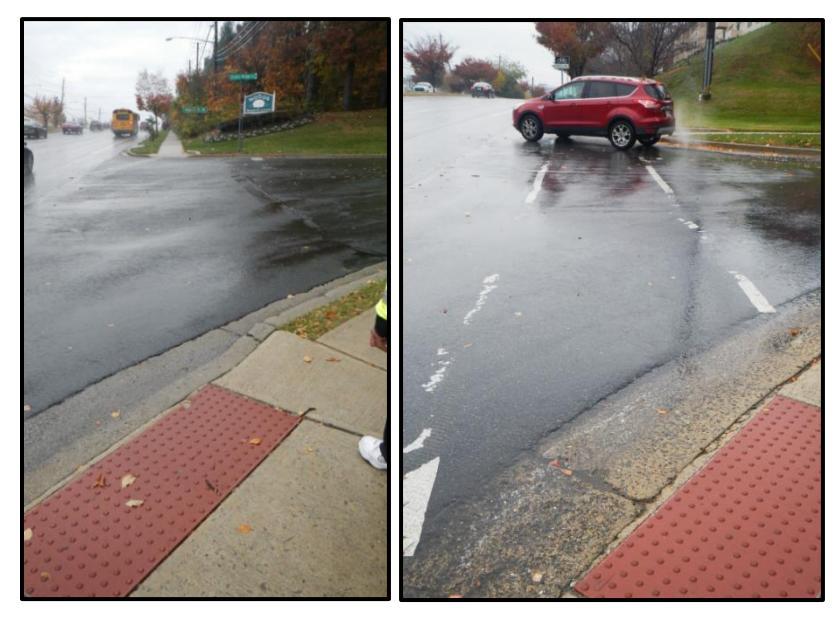
A number of issues related to pedestrian facilities were observed during the audit. Examples include lack of crosswalk markings across side-streets, faded crosswalks, and no Accessible Pedestrian Signals (APS) at some intersections.

Left: No marked crosswalks across side streets. Right: Crosswalk markings are faded. Figure 12: Examples of Pedestrian Facility Issues

The audit team identified a number of suggestions to improve the condition of the existing pedestrian facilities including, but no limited to, the installation of crosswalks across all side-streets, restriping pavement markings for crosswalks and stop bars along Middlebrook Road, and installing APS where applicable.

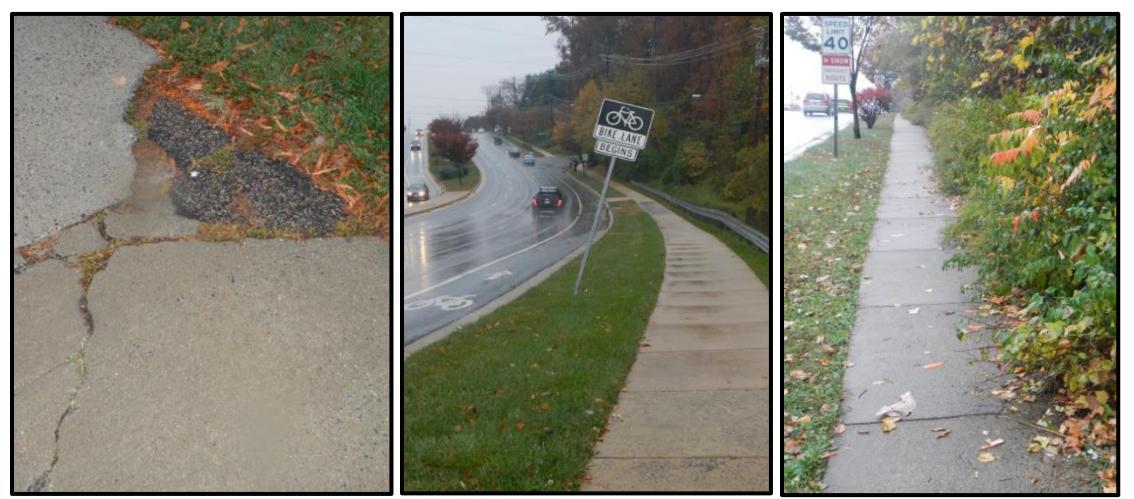
A number of conditions were observed that may contribute to pedestrian safety issues that could be resolved through maintenance improvements. Such issues include signs that are damaged, sidewalk that is damaged or overgrown with vegetation.

Left: Damaged sidewalk on the south side of Middlebrook Road. Center: Sign is leaning east of Great Seneca Highway. Right: Overgrown vegetation greatly reduces sidewalk width. Figure 13: Examples of Maintenance Issues

The audit team recommends that all damaged or missing signs be replaced and that all foliage along the sidewalk be trimmed to maintain the full available width of walkable space. The condition of the sidewalk should be assessed along Middlebrook Road and the feasibility of repairs should be evaluated.
