**EXPEDITED**  
**HISTORIC PRESERVATION COMMISSION STAFF REPORT**

<b>Address:</b>	3924 Baltimore St., Takoma Park	<b>Meeting Date:</b>	3/14/18
<b>Resource:</b>	Primary-One Resource Kensington Historic District	<b>Report Date:</b>	3/7/18
<b>Review:</b>	HAWP	<b>Public Notice:</b>	2/28/18
<b>Case Number:</b>	31/06-18C	<b>Tax Credit:</b>	n/a
<b>Applicant:</b>	Adeline Vanderver	<b>Staff:</b>	Dan Bruechert
<b>Proposal:</b>	Accessory Structure Removal

December 15<sup>th</sup>, 2014

Re: Garage

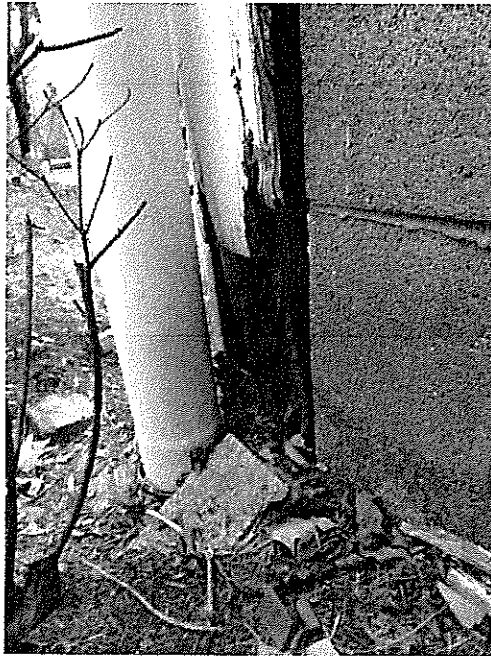
The wood at the northwest corner of the garage has rotted (see photo 8) and two of the three garage doors are rotting and in danger of losing their glass (see photo 9).

Photo 8  
Rotten lumber
