Preliminary Consultation
MONTGOMERY COUNTY HISTORIC PRESERVATION COMMISSION
STAFF REPORT

Address:	7306 Maple Ave., Takoma Park	Meeting Date:	3/27/19
Resource:	Contributing Resource Takoma Park Historic District	Report Date:	3/20/19
Applicant:	Amit and Anjali Patel	Public Notice:	3/13/19
Review:	Preliminary Consultation	Staff:	Dan Bruechert
Proposal:	Partial Demolition and Building Addition

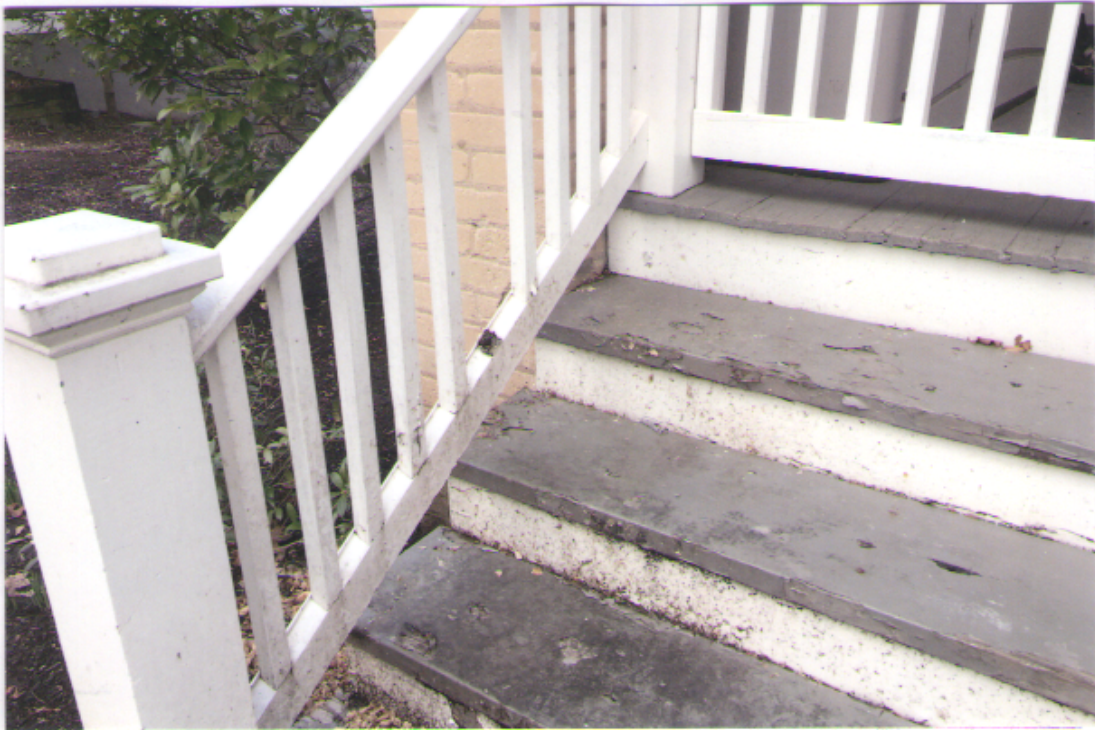
Front porch: The railing, steps, and parts of the flooring of the existing front porch are rotting and the lattice gate under the porch that allows access to the gas meter is broken. Furthermore, the wiring on the front light shorts quickly, the roof is in need of replacement and the ceiling fans are rusting. As part of this project, the porch railing and floorboards and under-porch access gate will be rebuilt in kind, the exterior electric lines will be rewired and brought up to code, and the porch light and electric fans will be replaced. The roof will be replaced in-kind, and the entire porch will be repainted. To the extent portions of the existing porch are salvageable, they will be retained.

Detail: FRONT PORCH BROKEN RAILING

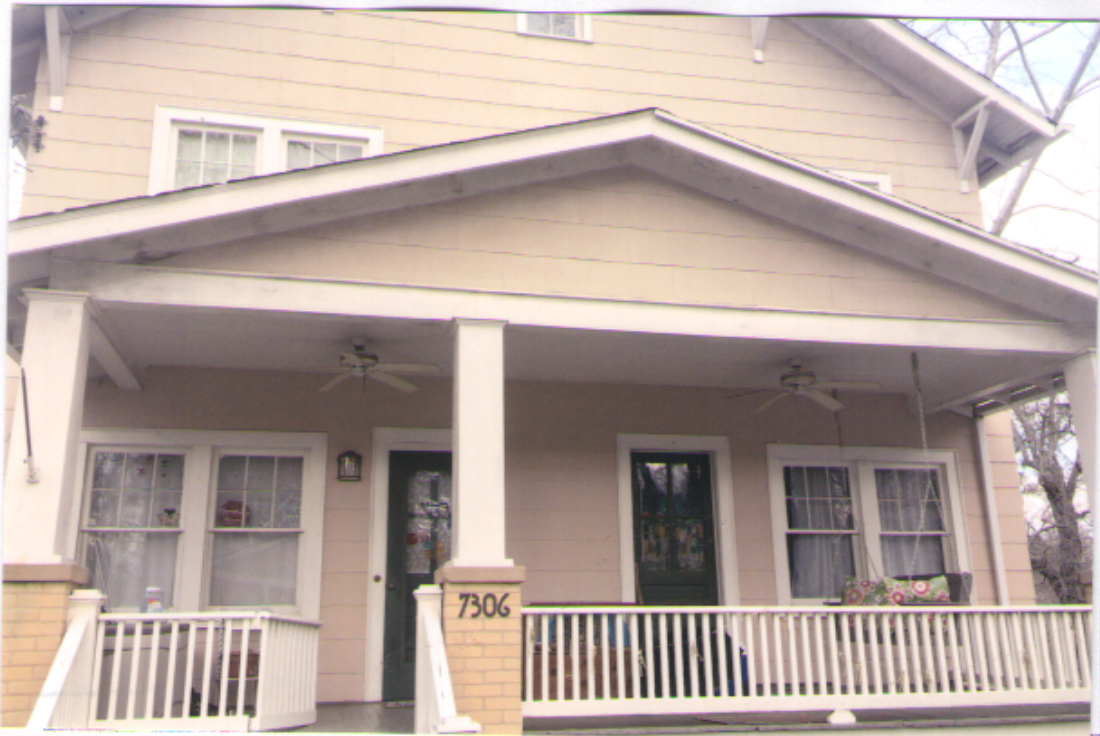
Detail: FRONT PORCH ^{REHAB} ~~ROOF~~ EXISTING WINDOWS & DOORS REHAB

Doors and windows: The interior of the home is energy inefficient. The original doors and windows at the front and north/south sides of the house will be

rehabilitated, including by repainting, replacing broken sashes, and adding weather stripping.

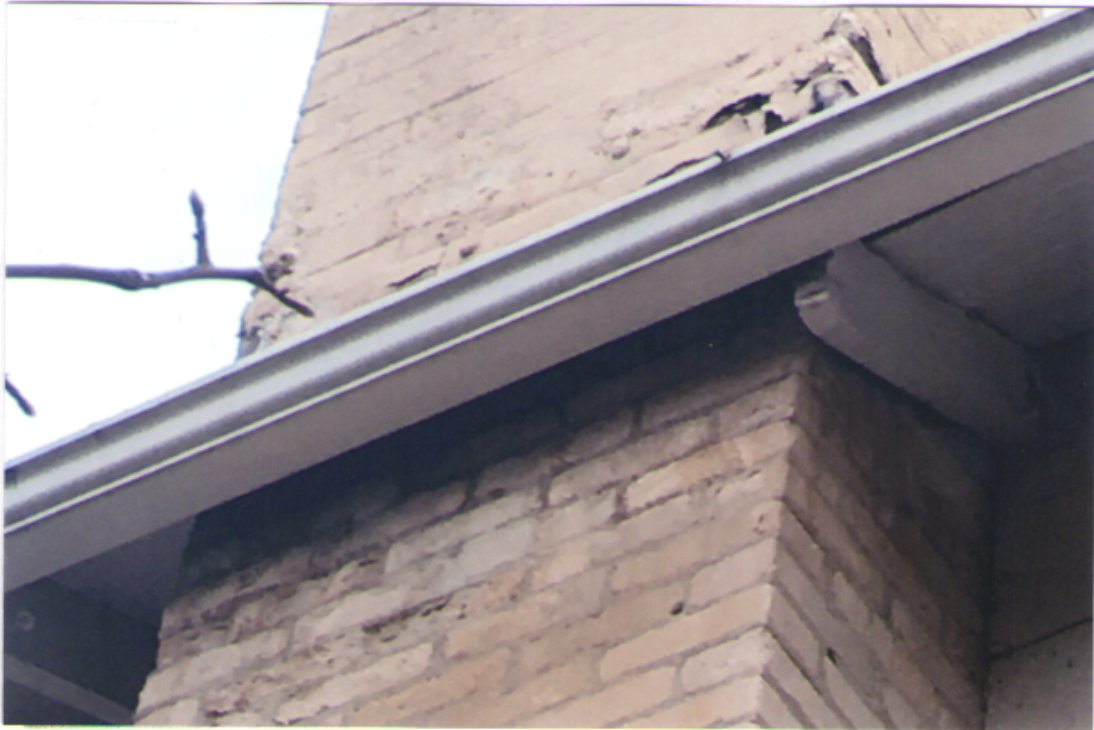
Roof and chimney: The roof is at nearing the end of its useful life, and has broken down in parts allowing a slow intrusion of water into the second floor bathroom and the northeastern corner bedroom. Moreover, the exposed rafters close to the chimney appear to be rotting and the chimney bricks and mortar are deteriorating, likely due to the roof's condition. The roof and affected rafters will be replaced in kind. The chimney will be repointed or, as necessary, rebuilt, and new flashing will be installed where the chimney meets the roofline.

Detail: CHIMNEY DETERIORATING, BROKEN EAVE

Much of this work is eligible for the County Historic Preservation Tax Credit. If the chimney needs to be rebuilt, Staff recommends the applicant consult with Staff to ensure that the work will be an in-kind replacement and will not require a HAWP.

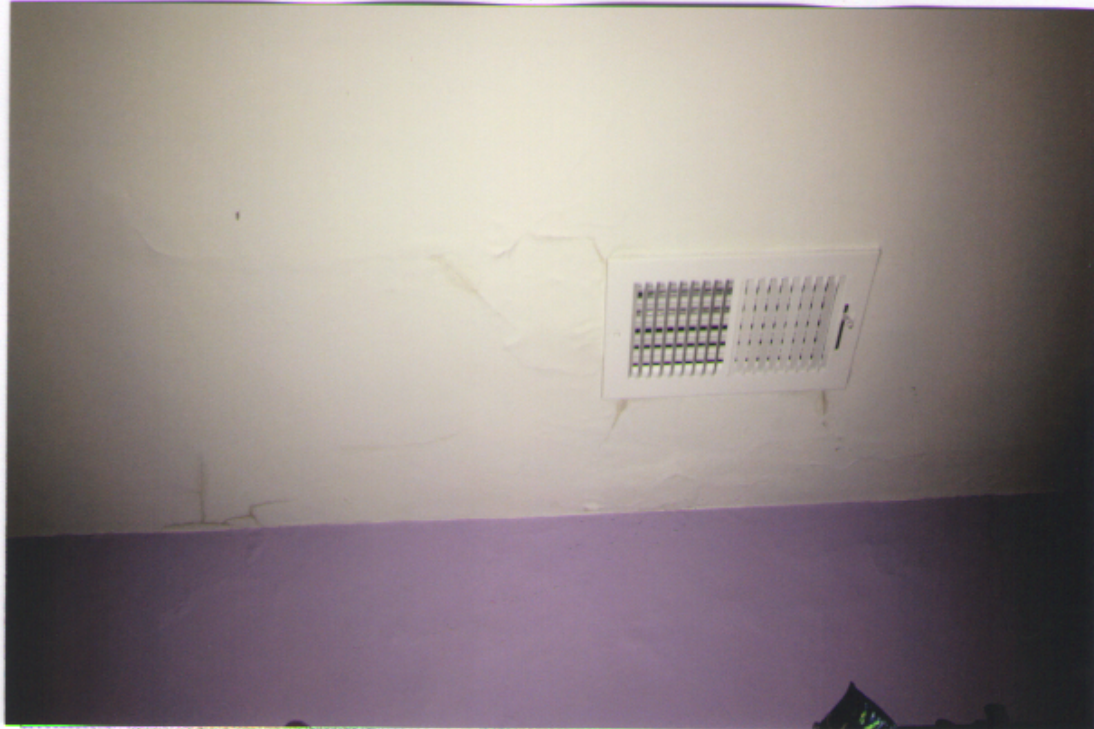
Detail: INTERIOR WATER DAMAGE FROM ROOF, NEAR CHIMNEY

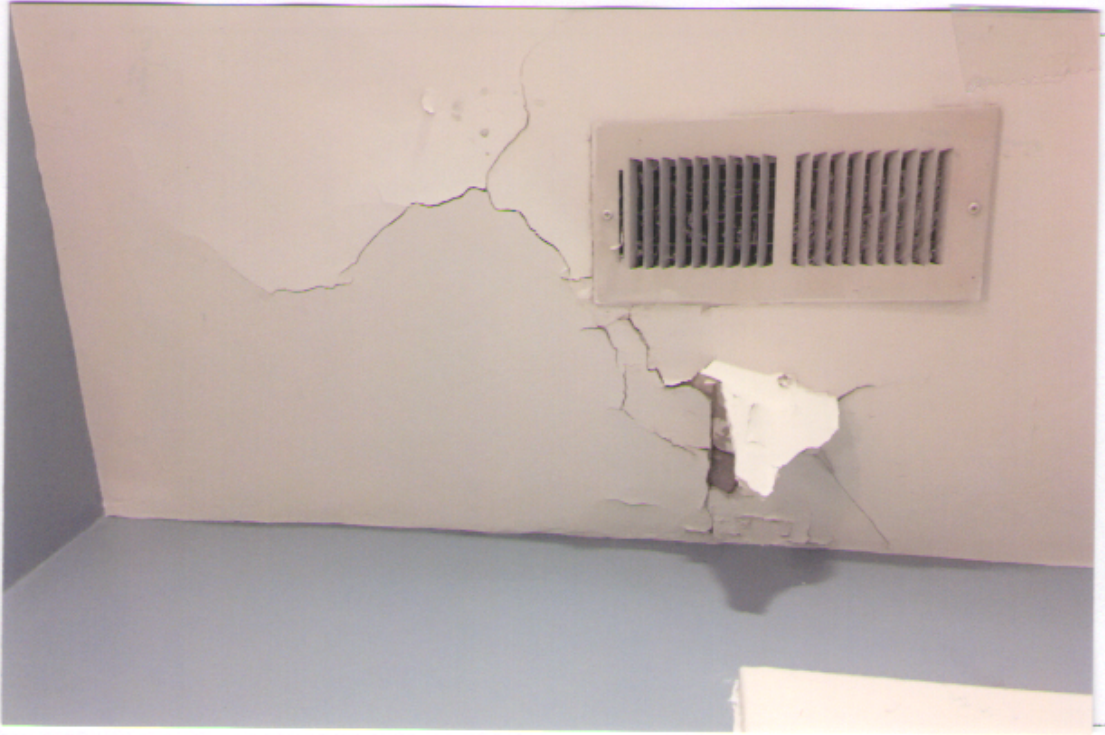
Detail: 2ND FLOOR REAR INTERIOR DAMAGE

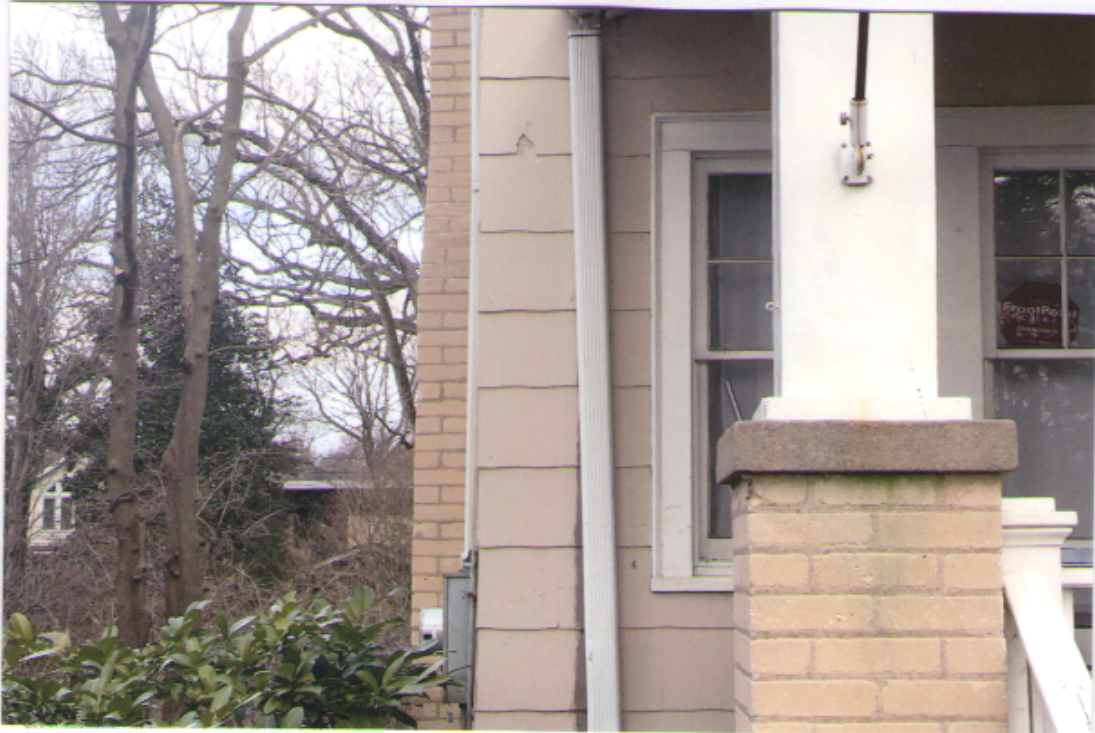
Gutters and downspouts: The current drainage systems is breaking apart and in places does not direct water away from the home, which has caused cracking in the interior walls and may have caused damage to the foundation. The gutters and downspouts will be replaced with materials that are substantially similar and in keeping with the historic character of the house, and will include drain covers that prevent leaves from entering. The drain covers will not be visible from the street.

Detail: BROKEN DOWNSPOUTS

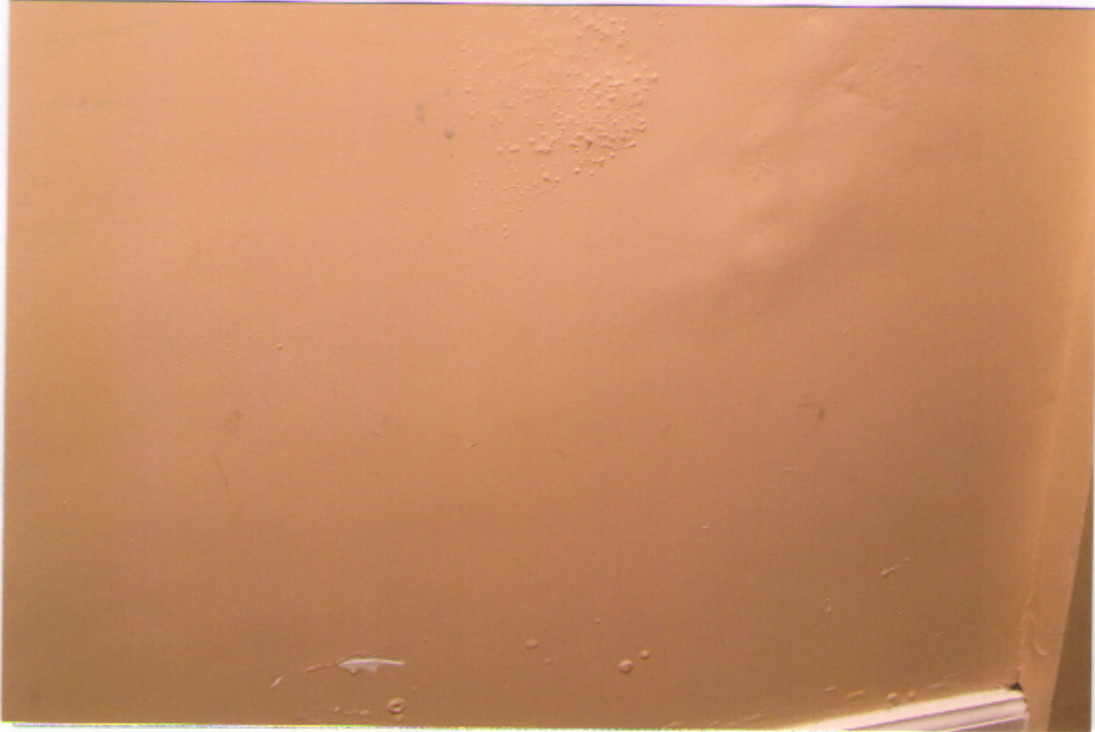
Detail: INTERIOR BASEMENT WATER DAMAGE FROM DOWNSPOUTS

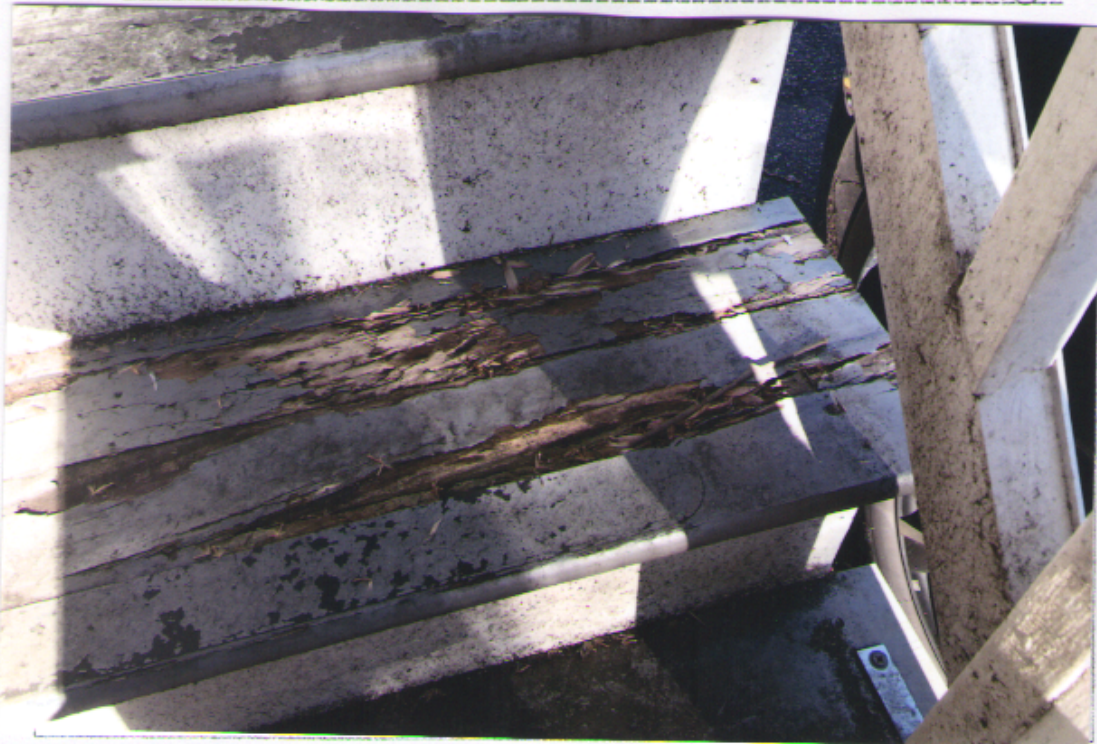
The side porch stairs and railing are rotting and the roof has reached the end of its useful life. Under the porch, the cinder-block support columns are leaning and the lattice doors do not close properly. With the exception of the back railing (discussed further below), each of these components will be rehabilitated or replaced in-kind. Because the ground slopes downwards at that location, the supports may need to be augmented with concrete in order to level them appropriately.

Detail: SIDE PORCH BROKEN/ROTTING STEPS

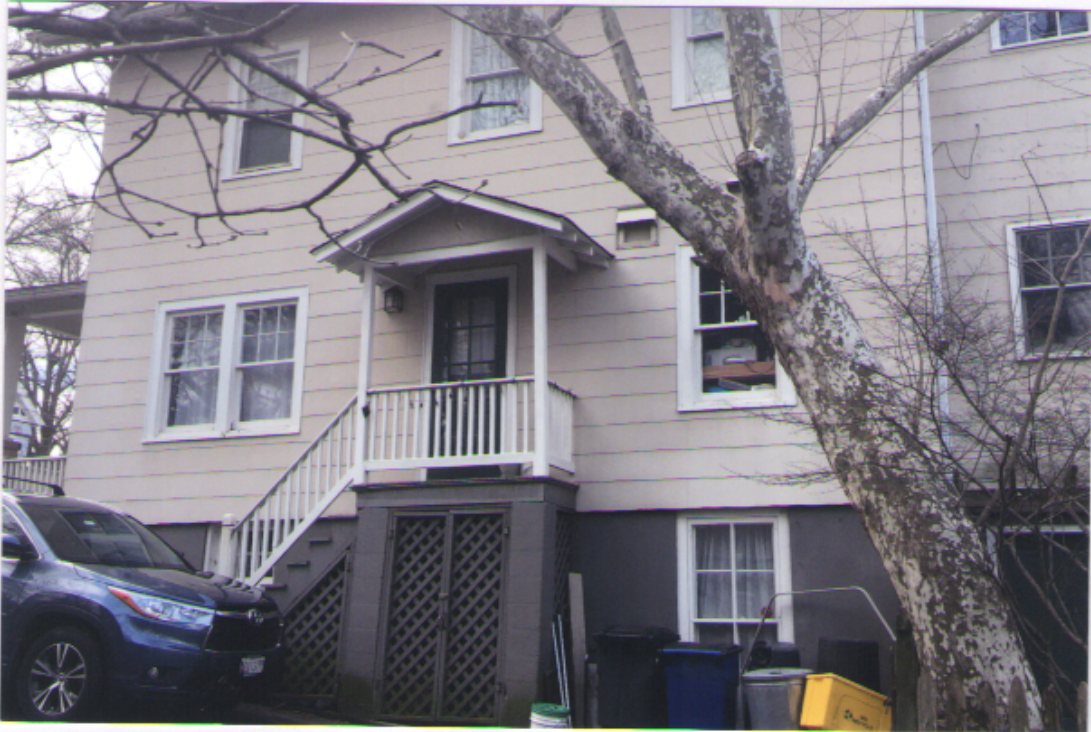
Detail: SIDE PORCH + SUPPORT TO BE REHABED, BACK RAILING REMOVED
PORCH TO BE EXTENDED, ROOF TO REMAIN

North Side: The back railing of the north-side small porch will be removed. The porch will be extended along the side of the house to connect to the new covered back porch. A new roof will be built over the extension. There will be a minimal impact, if any, to the historic district as the existing porch stairs and roof will be retained and repaired. Additionally, because the ground slopes downward at that location, only a small portion of the porch extension will be visible from certain limited locations on the public right of way. Additionally, we will be installing a Level 2 car charger underneath the existing side porch. This will not be visible from the public right-of-way as it will be enclosed in the lattice gate.

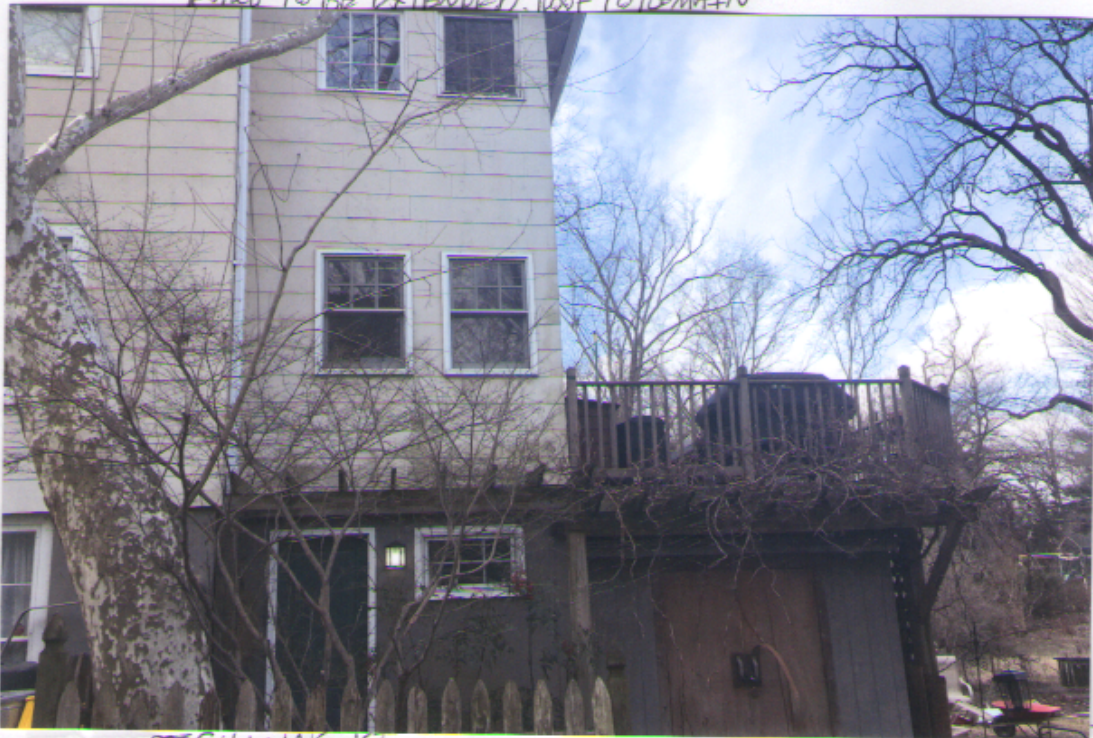
Detail: EXISTING IS +
NO FLOOR ADDITION, BACK DECK + STONE DECK
UNDER DECK TO BE REMOVED. (NORTH VIEW)

Rear: The existing first and second floor additions, 1st floor closet, back deck, and the shed under the deck will all be removed. The existing additions were originally porches that were constructed on unknown dates, and were enclosed and finished also on unknown dates. The existing closet was added to the house at an unknown date and is structurally unsound as it was attached to the 1st floor at the back of the house with no support to anchor it to the ground. The extension will consist of a new room on the basement level that will provide structural support to the levels above. The room will connect to the existing structure through an existing door. The existing structural support underneath the 1st and 2nd floor additions that are being removed will remain in place. The first floor addition will consist of a kitchen and dining room, and an attached covered deck. A new storage unit will be constructed under the back deck. A new master bedroom, bathroom, and closet will

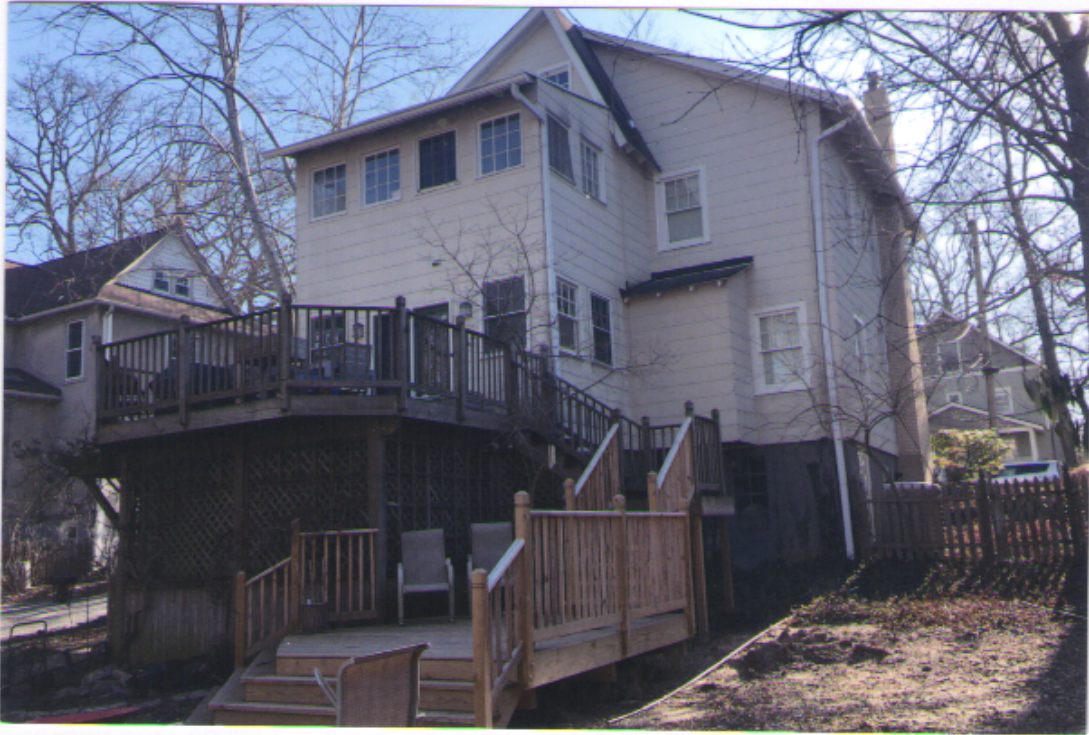
Detail: REAR 1ST+2ND FLOOR ADDITIONS, 1ST FLOOR CLOSET, BACK DECK
TO BE REMOVED (SOUTH SIDE VIEW)

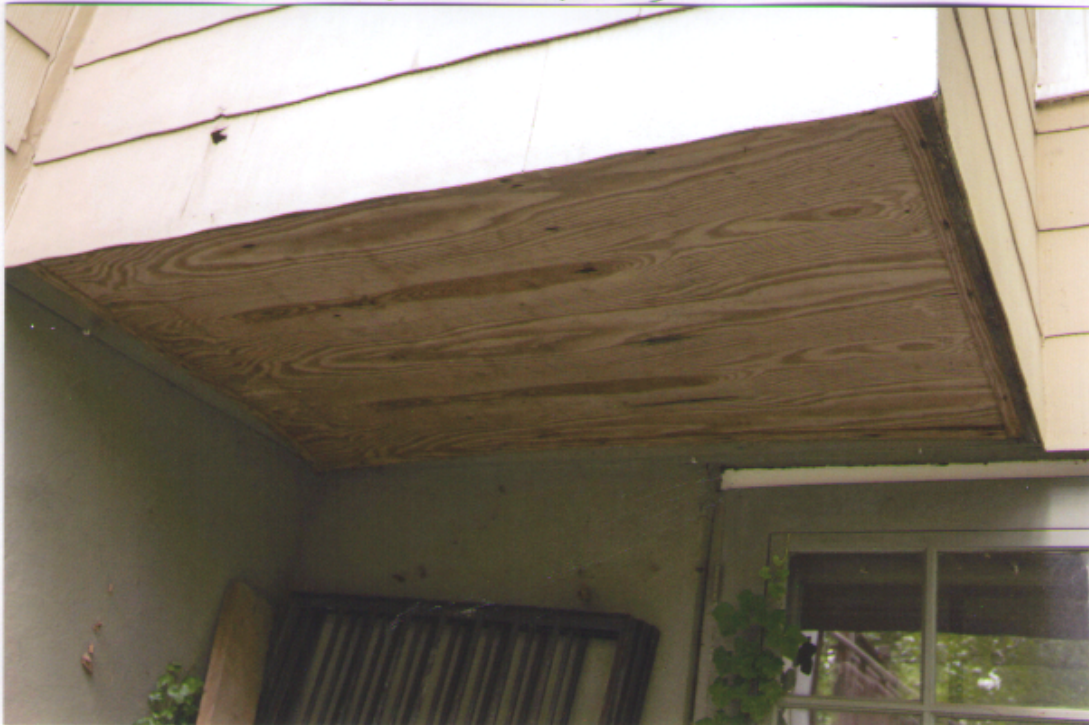
Detail: 1ST FLOOR WITH NO LOWER SUPPORT
CLOSET
