# MONTGOMERY COUNTY HISTORIC PRESERVATION COMMISSION STAFF REPORT

**Address:** 7312 Willow Ave., Takoma Park **Meeting Date:** 5/21/2019

Case Number: 37/03-19U Staff: Dan Bruechert

**PROPOSAL:** Porch Alterations, fence construction, hardscape alteration

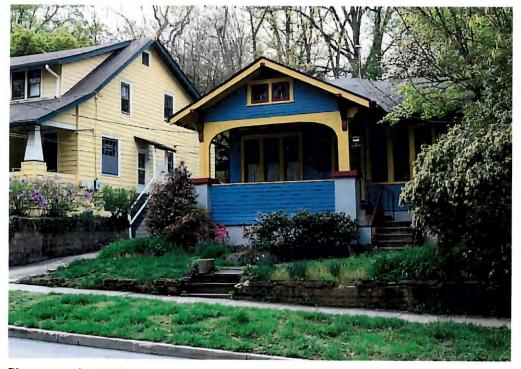
The existing porch has been heavily modified from its original configuration (photo attached). The front-loading stairs have been relocated to the sides, the columns have been covered, and the projecting beams were removed. The application indicates that these changes were part of a renovation conducted in 1956. The applicant proposes to expose the columns and install new projecting beams that will match the historic appearance. There is a historical basis for this work and Staff finds that it is appropriate and completes a step toward partially restoring the house's historic appearance.

The original front-facing porch entrance was closed and a concrete landing and stairs were built where the porch floor was located as shown in Figure 2. A wrought iron railing was installed on the landing and stairs. In addition, circular fillets were placed on the insides of the two front porch posts. As part of this work, it is believed the front yard was regraded and a rusticated cinder block retaining wall (Figure 3) was built along the sidewalk.

Figure 2—7312 Willow Avenue showing existing front porch and stairs.

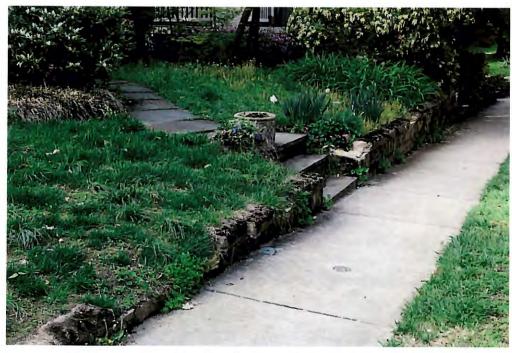
The owners propose removing the deteriorating rusticated cinder block retaining wall (Figure 3). The wall has a number of significant cracks (Figure 4) and, in places, overhangs the sidewalk.

Figure 3—Rusticated cinder block wall along sidewalk

The applicant also proposes to remove the degraded block retaining wall along the front of the property and regrade the property. The blocks are textured concrete and are typical of many site walls and foundations found throughout Takoma Park. The images shown in the applicant and confirmed in a site visit confirms to Staff that the wall has degraded beyond repair and needs to be removed. Rather than replacing the wall with a new wall, the applicant proposes re-grading approximately the front 5' (five feet) of the front yard. There surrounding streetscape shows a variety of solutions to addressing the grade along Willow Ave., from parged retaining walls, to dry-laid stone, to grading, to raw CMU blocks. Staff finds that the applicant's proposal is consistent with that variety and Staff supports the re-grading as consistent with the existing environmental setting, per the *Design Guidelines*.

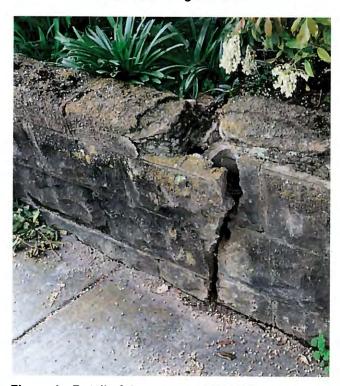
Figure 4—Detail of damage to rusticated cinder block wall

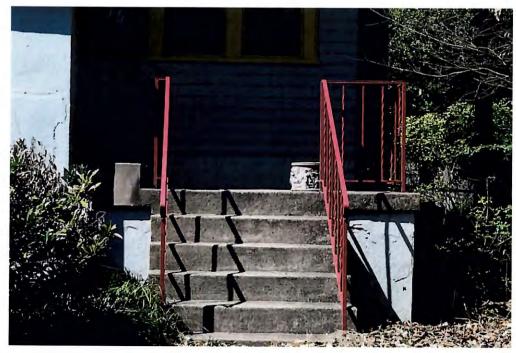
The applicant further proposes to replace the existing, iron, hand rail with a simply detailed Azek handrail. Staff finds that the iron is not in keeping with the historic character or appearance of the house and its removal will not impact the historic character. The proposed railing material should be compatible with the historic house and surrounding streetscape. Staff finds that the proposal should utilize traditional materials, with finishes and aging that is consistent with traditional materials. This is all the more significant in this location, because the material is on the first floor at the front of the house and will be more visible from the right-of-way and will be physically touched on a daily basis. Staff finds that the appropriate material is wood. Staff recommends the HPC add a condition for approval that the front railing be constructed out of wood. Staff can confirm that this condition has been met upon submission of permit drawings.

Figure 6-Porch landing with iron handrail and balusters

1. The proposed porch railing needs to be constructed out of wood, not the proposed Azek. Permit drawings submitted for review need to satisfy this condition.

The owners also propose replacing the steel railing and balusters on the concrete landing (Figure 6) with a design more appropriate to the bungalow style of the house (Figure 7).

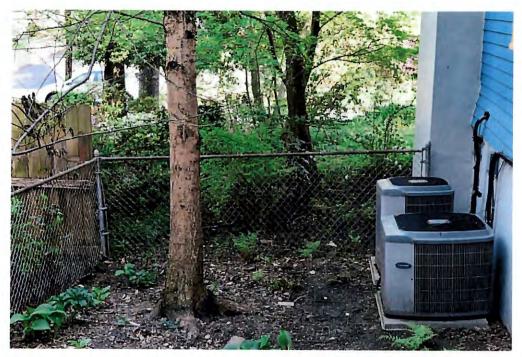
Currently, there is a 4' (four foot) chain link fence surrounding the property. The applicant proposes removing the section of chain link to the right of the house and proposes a new 4' 6" (four-foot, six inch) board-on-board fence with a slightly taller gate with a decorative pediment above. This fencing will match the fence installed in 2008, adjacent to the driveway. This fence exceeds the typical requirement that fences be no more than 48" (forty-eight inches) in front of

Figure 8—Chain link fence from backyard, looking to front yard

The owners are also proposing to replace the front-facing section of the chain link fence (Figure 8) on the northeast side of the property with a wooden fence and gate. The fence and gate would use the same construction used for the driveway fence (Figure 9).

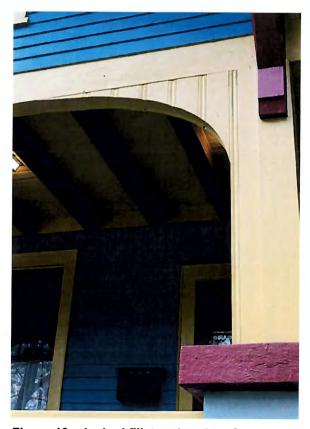
Figure 10—Arched fillet on interior of porch post

In addition to the landscaping, the project includes the removal of the filleted inserts (Figure 10) on the inside of the front porch posts and replacing the projecting beams removed from the gable as part of the 1956 remodeling. This work is shown in the Proposed Front Elevation Drawing. Three beam ends (Figure 11) removed during the remodeling can be used to design and fabricate replacement beam ends.
