MONTGOMERY COUNTY HISTORIC PRESERVATION COMMISSION STAFF REPORT

Address: 5605 York Ln., Bethesda Meeting Date: 6/12/2019

Greenwich Forest Historic District

PROPOSAL: Demolition and new construction

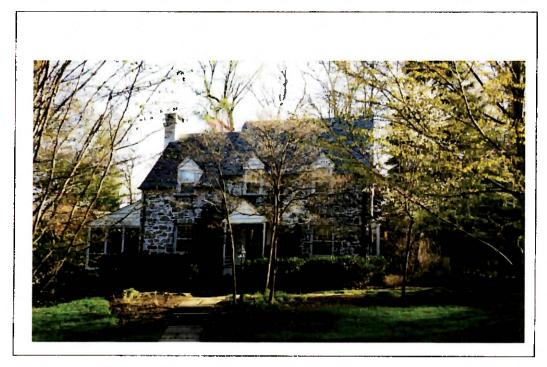
Detail: _____ View of front of house (southwest-facing) showing screened porch at left

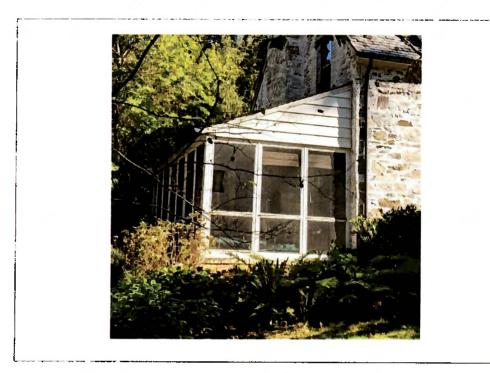
Detail:______View of front of porch (southwest-facing)

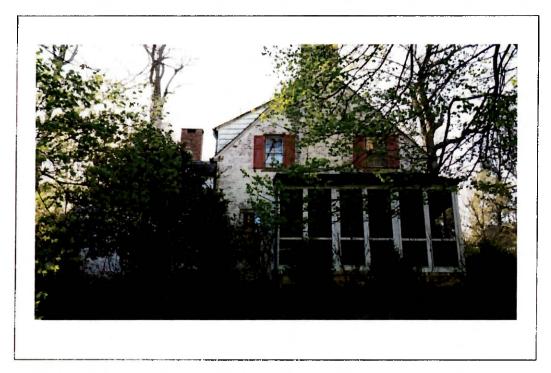
Detail: View of side of porch (northwest-facing elevation)

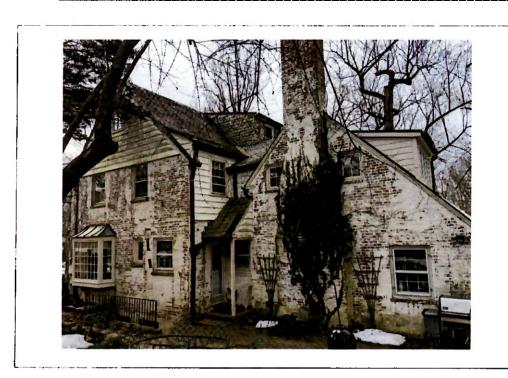
Detail: View of east-facing elevation showing side porch and entrance to basement door

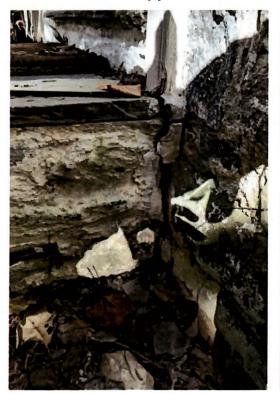
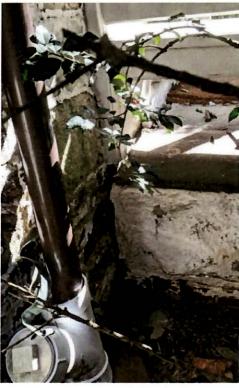
Appendix 1. Front porch

1. Renovation of the front porch (see Figure 2 and detailed photos, Appendix 1). This small porch has a concrete/masonry foundation which has fallen away from the foundation of the main house, causing tilting of the pillars and roof. Rain gutters no longer drain properly due to this tilting. Wooden pillars and fascia boards have rotted. The previous owners installed vinyl siding over all the original ship-lap on gable-ends. The proposed renovation would replace the foundation and all woodwork and roof structures found to be beyond repair. Vinyl siding would be removed and the underlying siding re-finished or replaced if found to be beyond repair. The renovated porch would have the same footprint, dimensions and architectural details as the original, including flagstone steps with stone risers and ship-lap siding on the gable end. A new slate roof and copper gutters and downspouts would be installed to match the rest of the house. Wooden exterior trim would be replaced with painted redwood and siding would be replaced with wooden clapboards milled to match the original ship-lap profile.

Failure of connection between foundations of house and porch

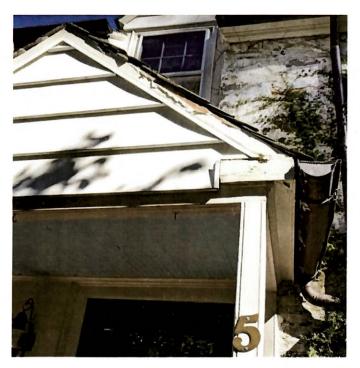
Deterioration of wood roof members

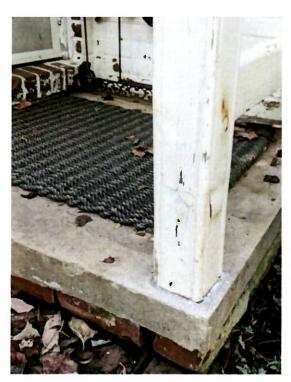
Deteriorating Dutchman installed at base of pillar

2. Repair of the side porch (see Figure 3; and detailed photos, Appendix 2). This small porch has a concrete/masonry foundation that has not deteriorated other than the surface of mortar joints. However, the pillar and woodwork have deteriorated beyond the point of repair. Several rooves converge above this porch and the existing copper flashing and gutters leak into the interior during heavy rains. The porch's side gable has vinyl siding over the original wooden ship-lap siding and adjacent trim and roof flashing. Vinyl siding would be removed and necessary repairs made to flashing and trim. Until demolition begins it is impossible to know how much of the existing structure and siding cannot be repaired and must be replaced. The proposed repair would not alter the size, configuration and style of the existing porch. A new slate roof and copper gutters and downspouts would be installed to match the rest of the house. Wooden exterior trim would be replaced with painted PVC. If new siding is needed, the original ship-lap siding would be replaced with Hardie planking if available with the original ship-lap profile. If unavailable, wooden siding milled to match the original will be used.

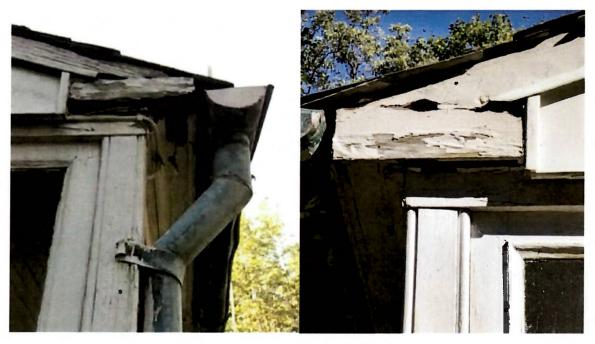
Appendix 3. Screened porch

Deterioration of roof members

3. Partial replacement of the existing screened porch to convert it to a study (See Figure 4 and detailed photos, Appendix 3). This porch has a concrete/masonry foundation that has not deteriorated, but its roof and woodwork has rotted beyond repair. The owners propose to use the existing foundation and construct a new structure that would be used as a study. The existing shed roof with slate tiles will be replaced with a hipped roof covered with standing seam copper. The replacement roof will reflect the roof of a dining room bay window on the opposite side of the house. Copper hipped rooves are found on front and side porches as well as bay windows on several other contributing properties in the Greenwich Forest Historic District (e.g., 7825 Overhill Road). Windows in the new study would be true divided light configured to be consistent in design and scale with the eight-over-eight and six-over-six windows visible from the right-of-way in front of the property. The existing doorway to the living room would be retained and a new door installed. No exterior doorways would be added. Trim and molding will be PVC that matches the existing house.

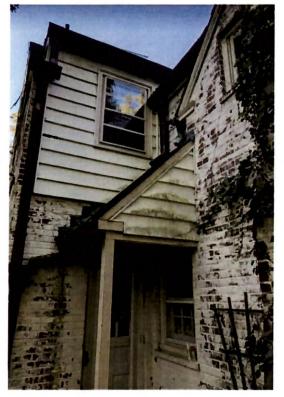
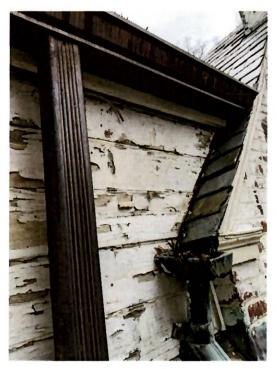
Appendix 4. Removal of vinyl siding

Vinyl siding on and above side porch

Original ship-lap siding below vinyl siding

- 4. Removal of all vinyl siding. The vinyl siding installed by the original owners will be removed to reveal the original wooden ship-lap siding (see Appendix 4). If the original siding is found to be rotted beyond repair, new Hardie Plank with the same ship-lap design would be used to replace it. If unavailable, wooden siding milled to match the original ship-lap profile will be used.

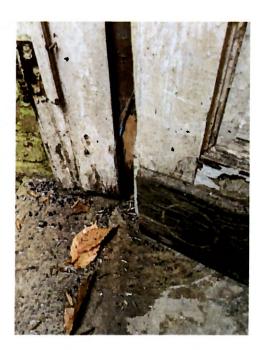
However, 70 years of basement flooding has led to serious deterioration of the bottom of the basement door and doorframe. Wood rot is extensive and the doorframe is no longer firmly attached to the surrounding masonry walls. Weatherstripping has deteriorated or been destroyed in the bottom part of the doorframe.

Bottom of right-hand doorframe (as viewed from interior), showing patch installed over rotted door panel and deterioration of wooden doorframe and copper weatherstripping

The basement door, doorframe and weatherstripping will be removed and replaced with synthetic material that matches originals in size, detail and color. The use of synthetic building material is permissible under the Greenwich Forest Historic Guidelines in areas not visible from the public right-of-way in front of a property.

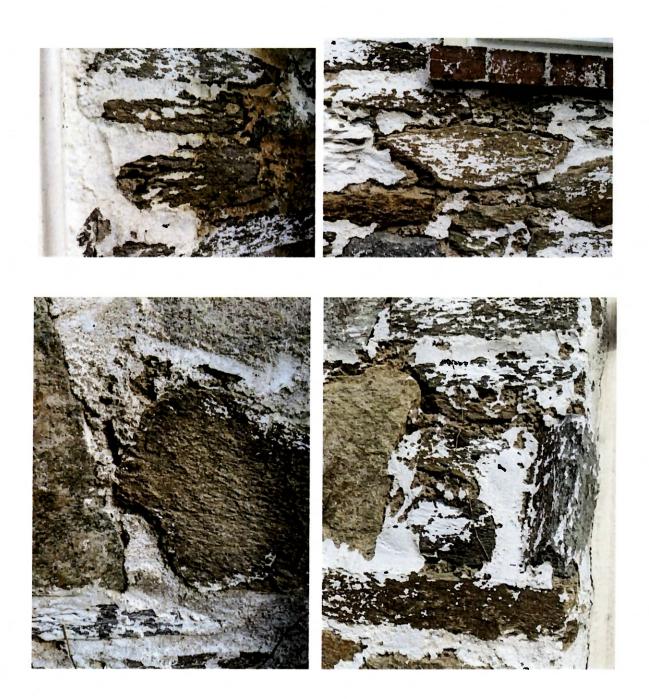
Appendix 6. Masonry re-pointing of stone façade

Weathering of mortar around porous stone on front façade.

Regarding the proposed masonry repointing, staff finds that this work constitutes routine maintenance, but that the applicants should ensure that the composition of the new mortar is consistent with the existing. A mortar mixture with an inappropriate (i.e., "too hard") composition will result in significant damage to the historic house within a short period of time. The existing mortar should be tested, and the test results and composition of the proposed mortar should be shared with staff before repointing commences.

6. <u>Masonry re-pointing of stone façade</u> (see detailed photos, Appendix 6). The front face of the house is covered with several different species of decorative stone. Some species are more porous than others and severe weathering has taken place around the more porous stones. Weathered areas around porous stones will be repointed using mortar that matches the current color of original mortar.
