EXPEDITED
HISTORIC PRESERVATION COMMISSION STAFF REPORT

Address:	16 Oxford St., Chevy Chase	Meeting Date:	9/11/2019
Resource:	Contributing Resource Chevy Chase Village Historic District	Report Date:	9/4/2019
Review:	HAWP	Public Notice:	8/28/2019
Case Number:	35/13-19MM	Tax Credit:	Yes
Applicant:	Matthew and Melissa Leggett	Staff:	Dan Bruechert
Proposal:	Siding Restoration and New Shutters

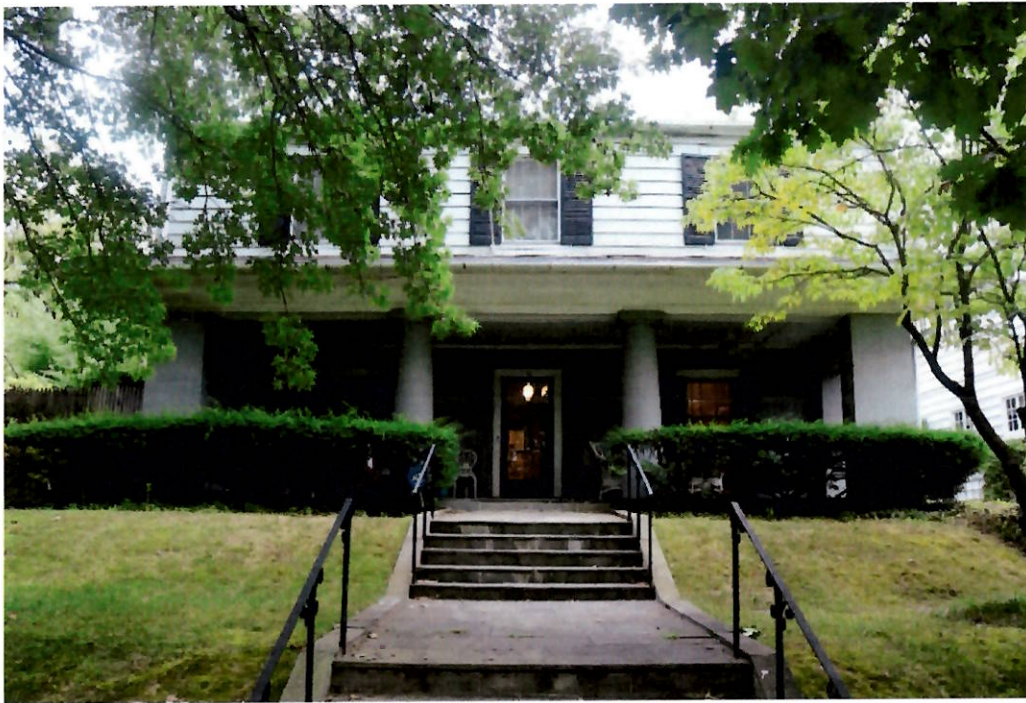
Photo 1. 08/05/19. Front (north) elevation. Project area. As viewed from Oxford Street. Opposite 33 Oxford Street.

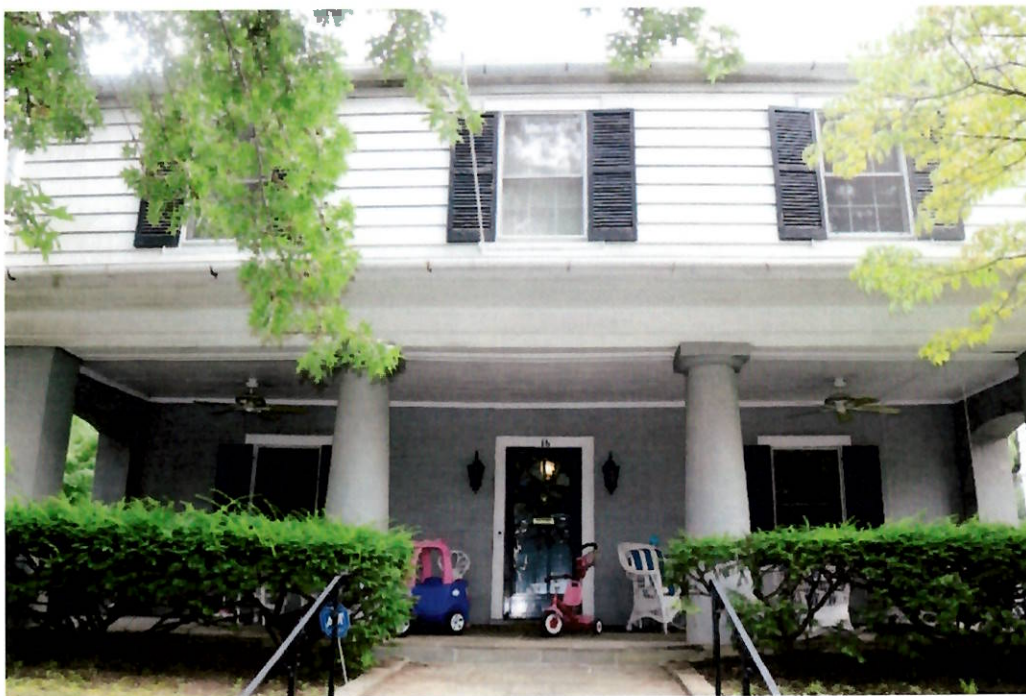
Photo 2. 08/05/19. Front (north) elevation. Project area. Center close-up showing aluminum siding to be removed; shutters to be restored and painted; wood porch ceiling, trim, and molding to be repaired and painted; stucco to be repaired and painted; aluminum gutters to be repaired.

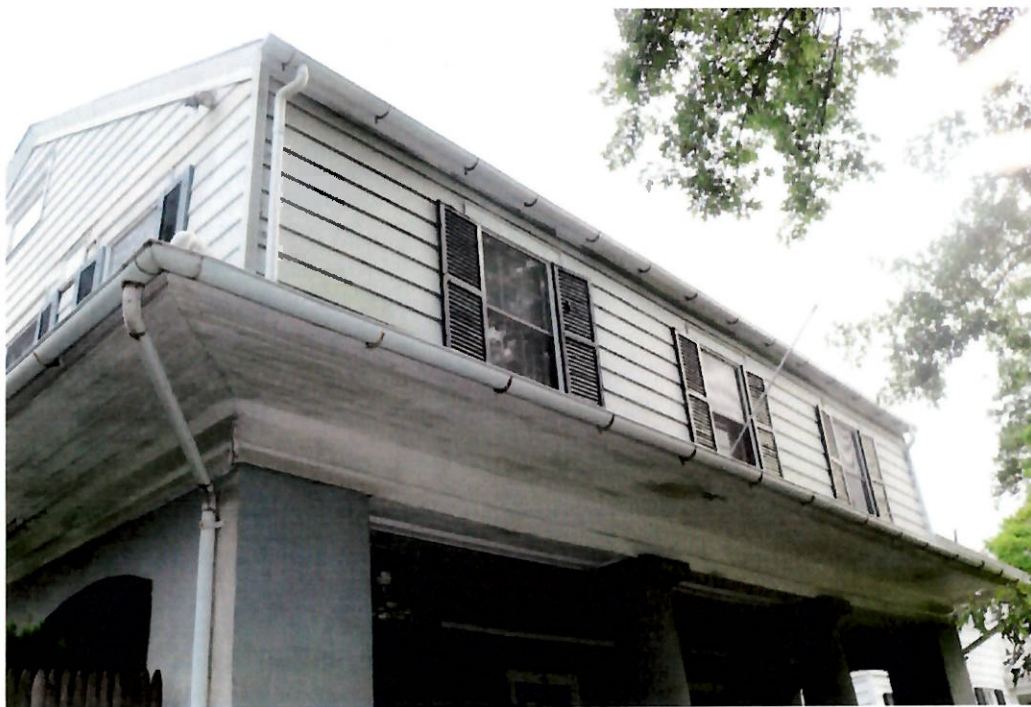
Photo 3. 08/05/19. Front (north) elevation. Project area. Left close-up showing aluminum siding to be removed; shutters to be restored and painted; wood porch ceiling, trim, and molding to be repaired and painted; stucco to be repaired and painted; aluminum gutters and downspouts to be repaired.

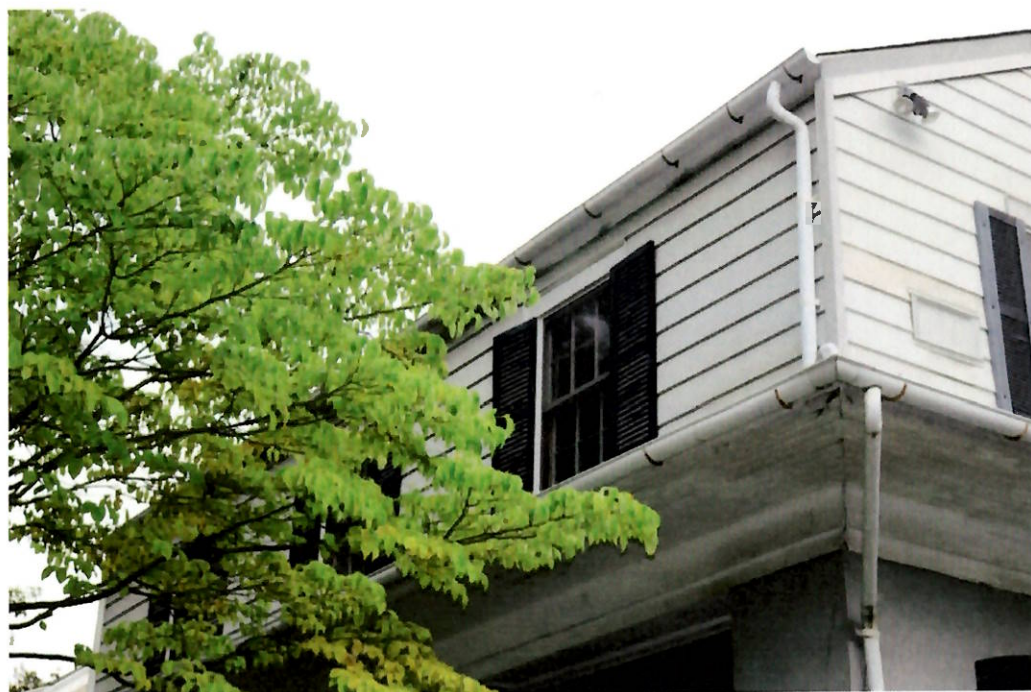
Photo 4. 08/05/19. Front (north) elevation. Project area. Right close-up showing aluminum siding to be removed; shutters to be restored and painted; wood porch ceiling, trim, and molding to be repaired and painted; stucco to be repaired and painted; aluminum gutters and downspouts to be repaired.

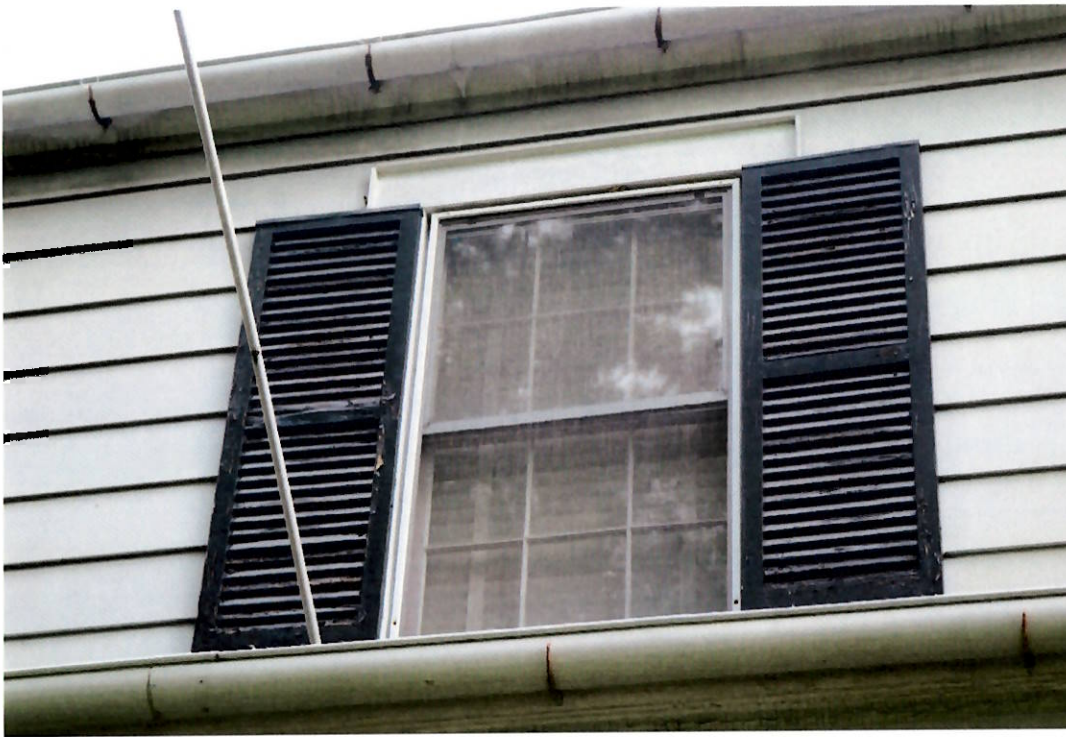
Photo 5. 08/05/19. Front (north) elevation. Project area. Detail of shutter to be restored and painted.

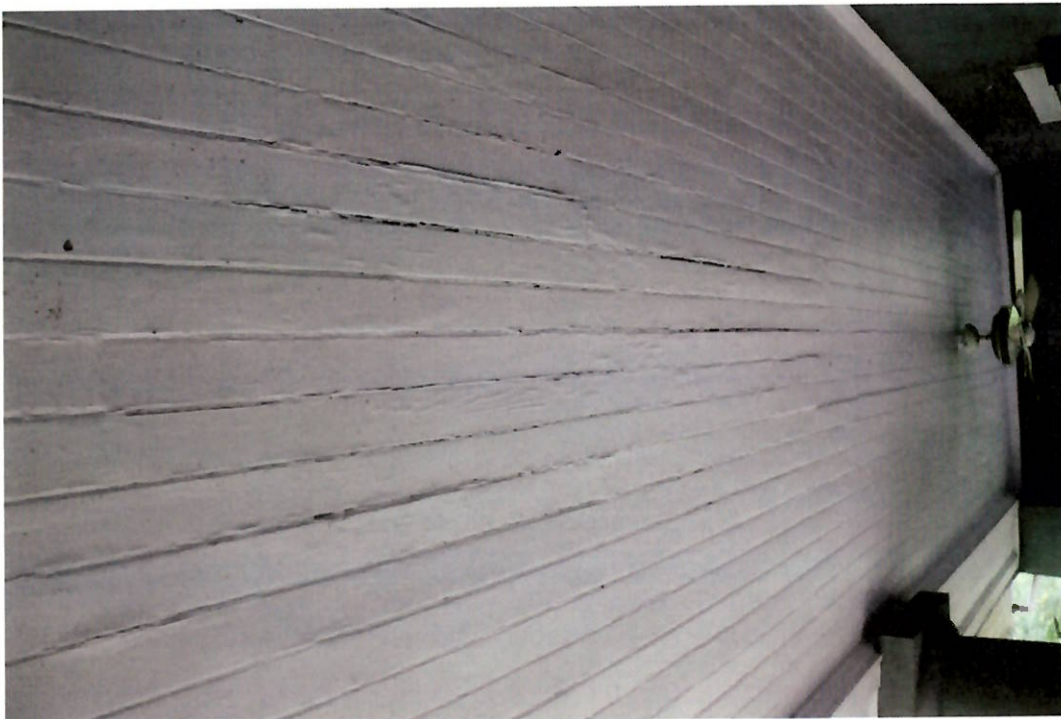
Photo 6. 08/05/19. Front (north). Project area. Porch. Detail of wood porch ceiling, trim, and molding to be repaired and painted.

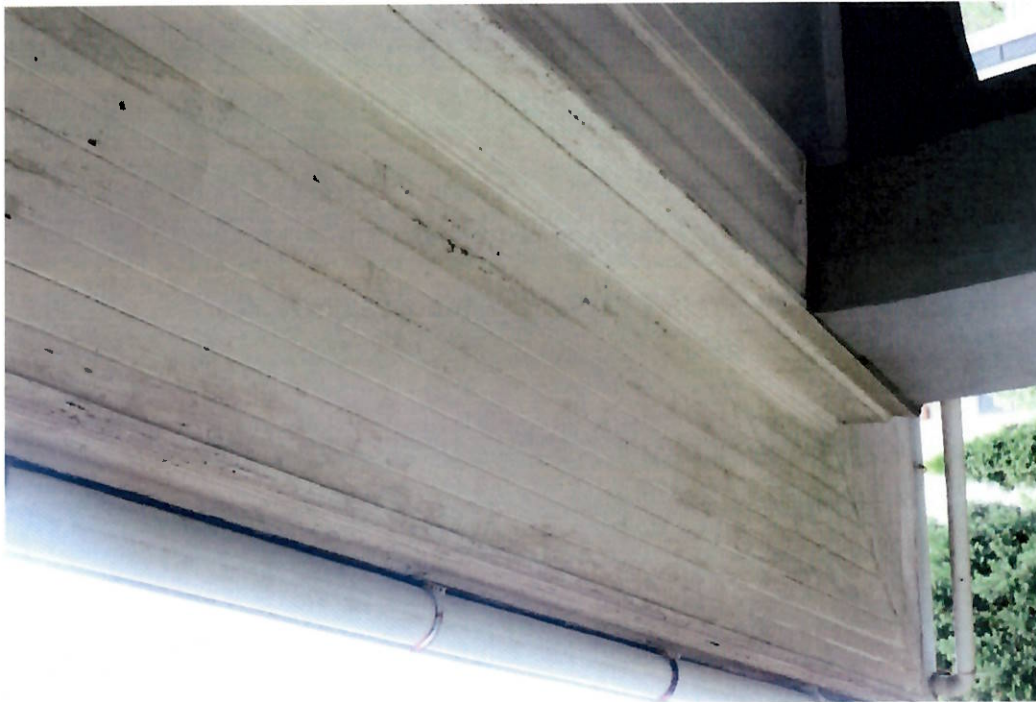
Photo 7. 08/05/19. Front (north). Project area. Porch. Detail of wood porch ceiling, trim, and molding to be repaired and painted; aluminum gutters and downspouts to be repaired.

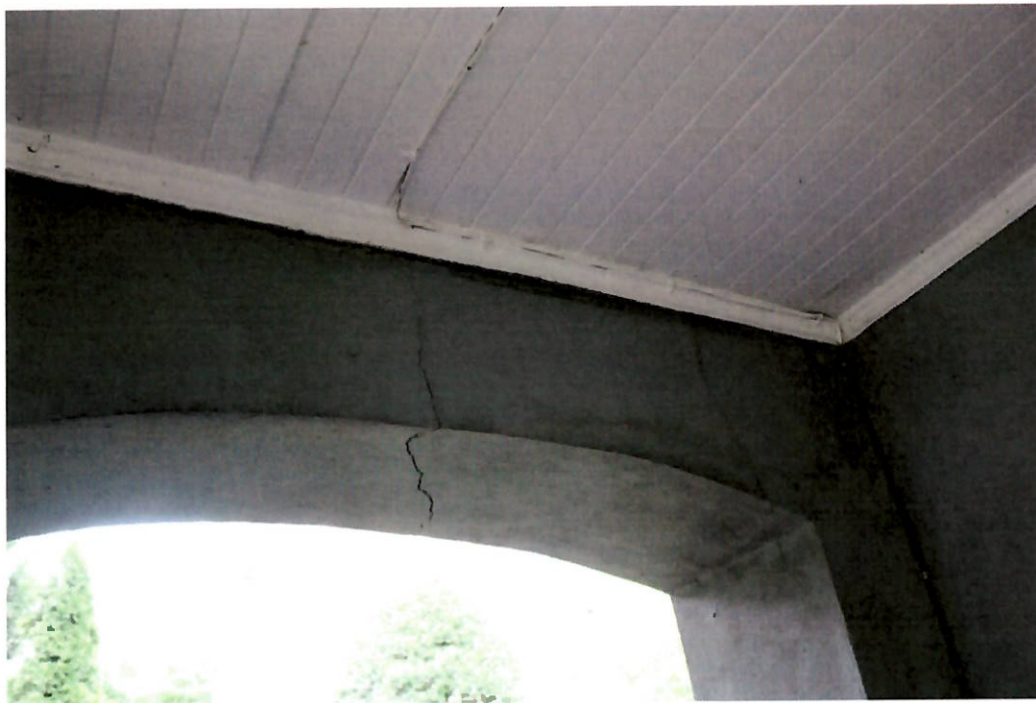
Photo 8. 08/05/19. Front (north). Project area. Porch. Detail of stucco to be repaired and painted.

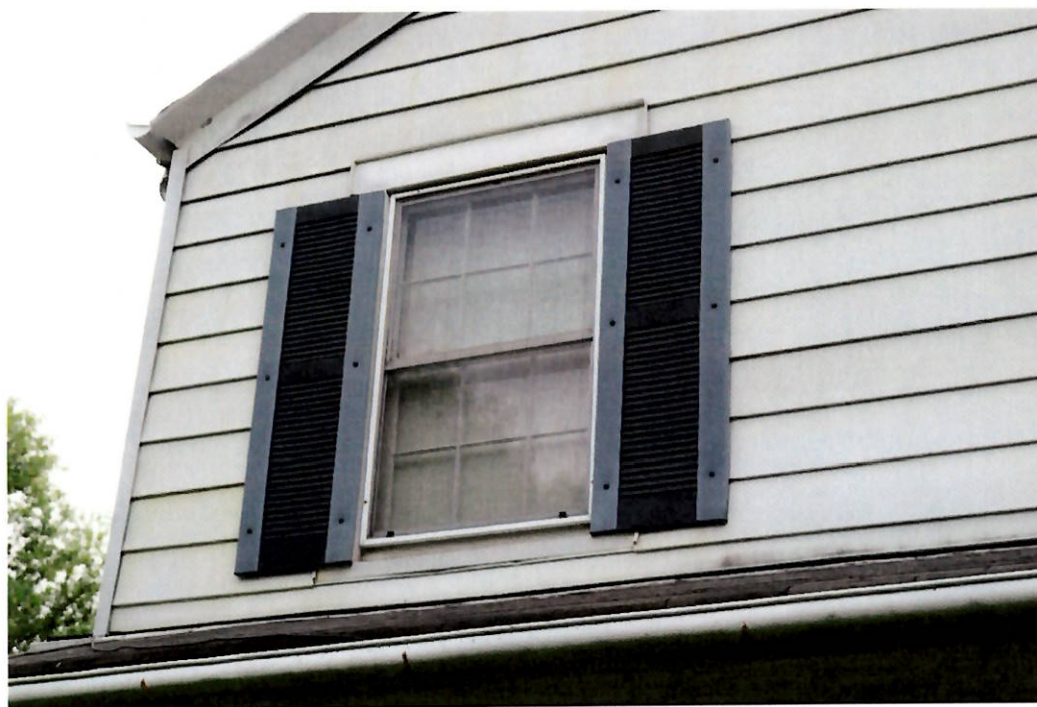
Photo 10. 08/05/19. Side (east) elevation. Project area. Left close-up showing aluminum siding to be removed; non-original shutters to be replaced and painted; aluminum gutters to be repaired.

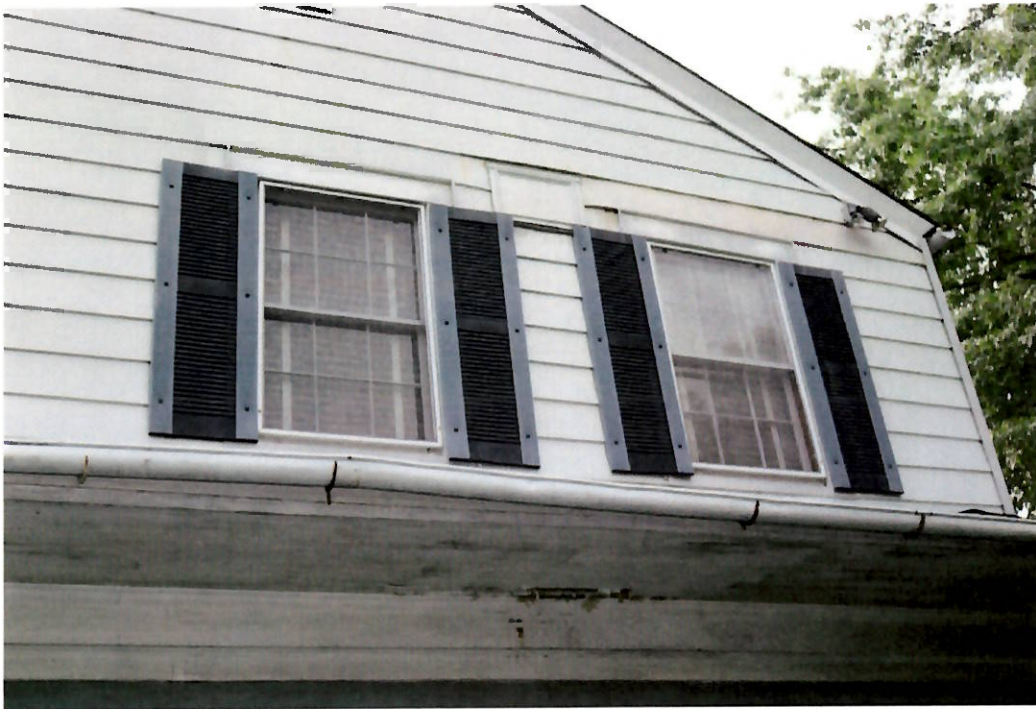
Photo 11. 08/05/19. Side (east) elevation. Project area. Right close-up showing aluminum siding to be removed; non-original shutters to be replaced and painted; wood ceiling, trim, and molding to be repaired and painted; aluminum gutters to be repaired.

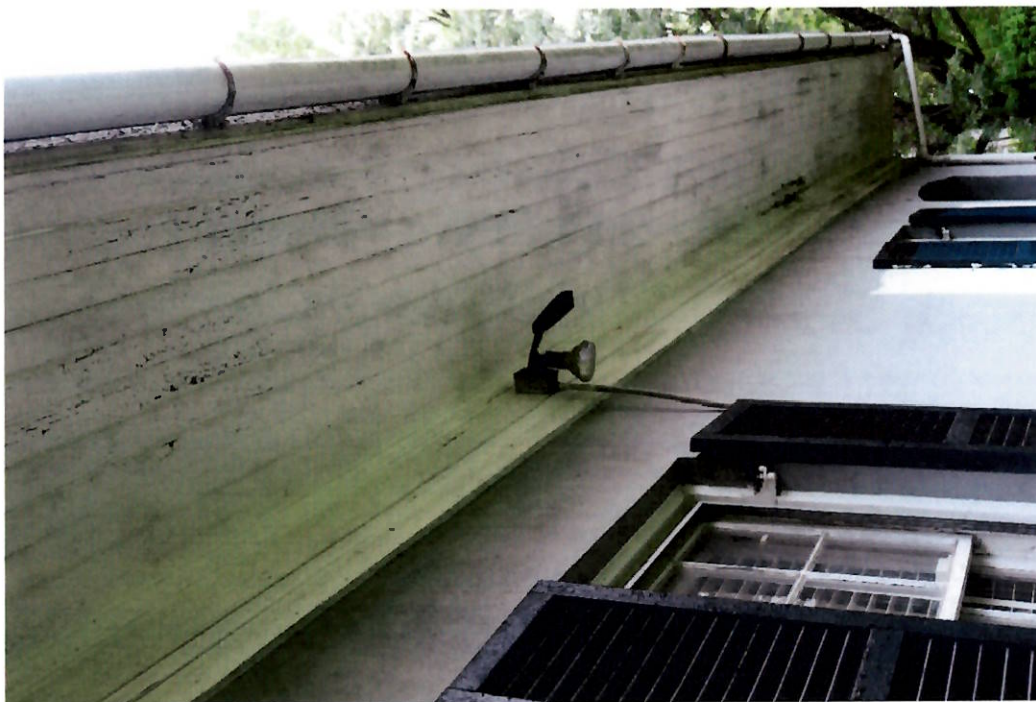
Photo 12. 08/05/19. Side (east). Project area. Detail of shutters to be restored and painted; wood ceiling, trim, and molding to be repaired and painted; stucco to be repaired and painted; aluminum gutters and downspouts to be repaired.

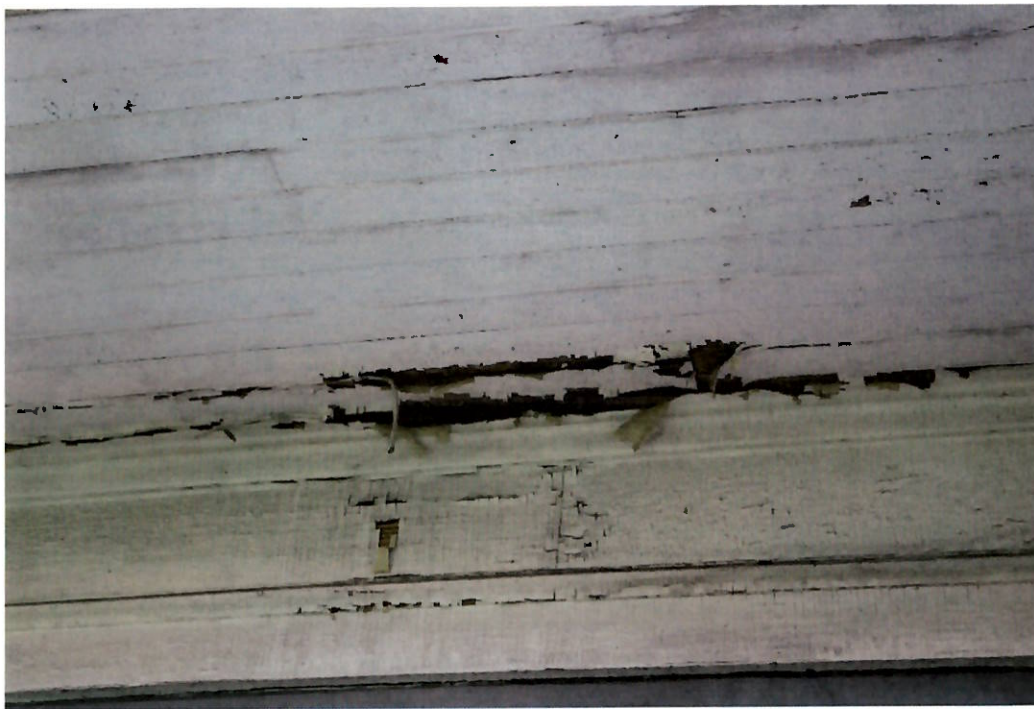
Photo 13. 08/05/19. Side (east). Project area. Detail of wood ceiling, trim, and molding to be repaired and painted.

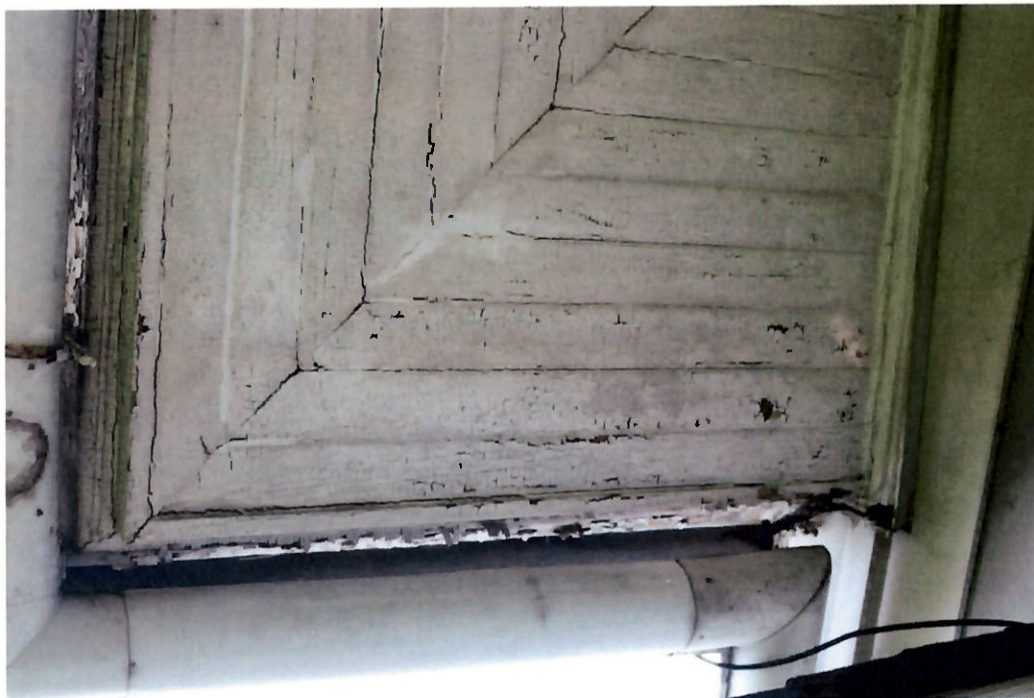
Photo 14. 08/05/19. Side (east). Project area. Detail of wood ceiling, trim, and molding to be repaired and painted; aluminum gutters to be repaired.

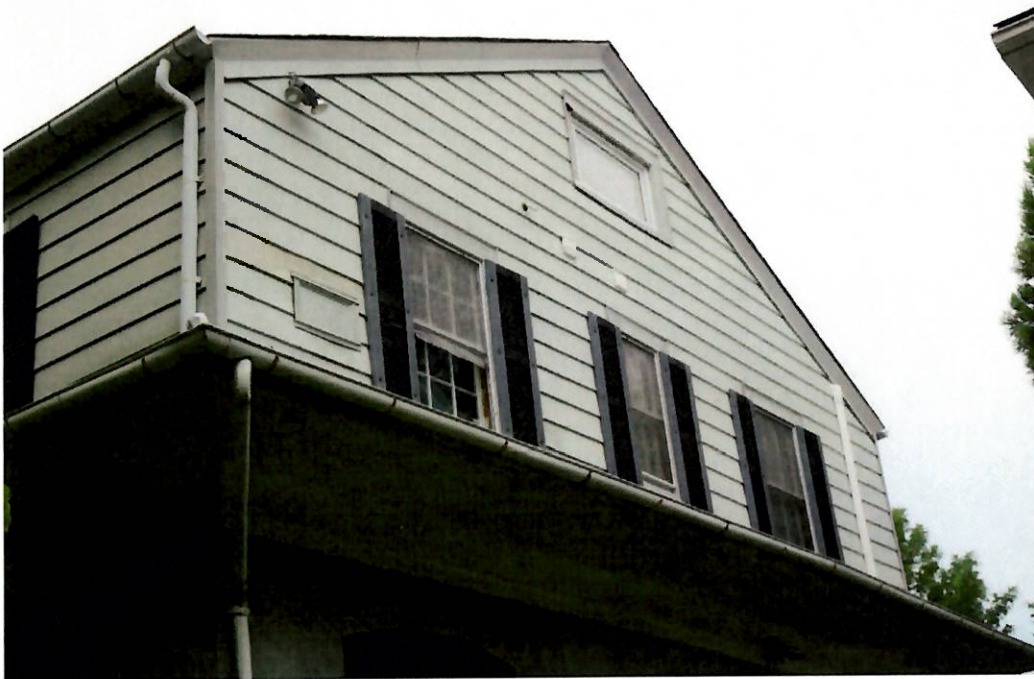
Photo 16. 08/05/19. Side (west) elevation. Project area. Center close-up showing aluminum siding to be removed; non-original shutters to be replaced and painted; wood ceiling, trim, and molding to be repaired and painted; stucco to be repaired and painted; aluminum gutters and downspouts to be repaired.

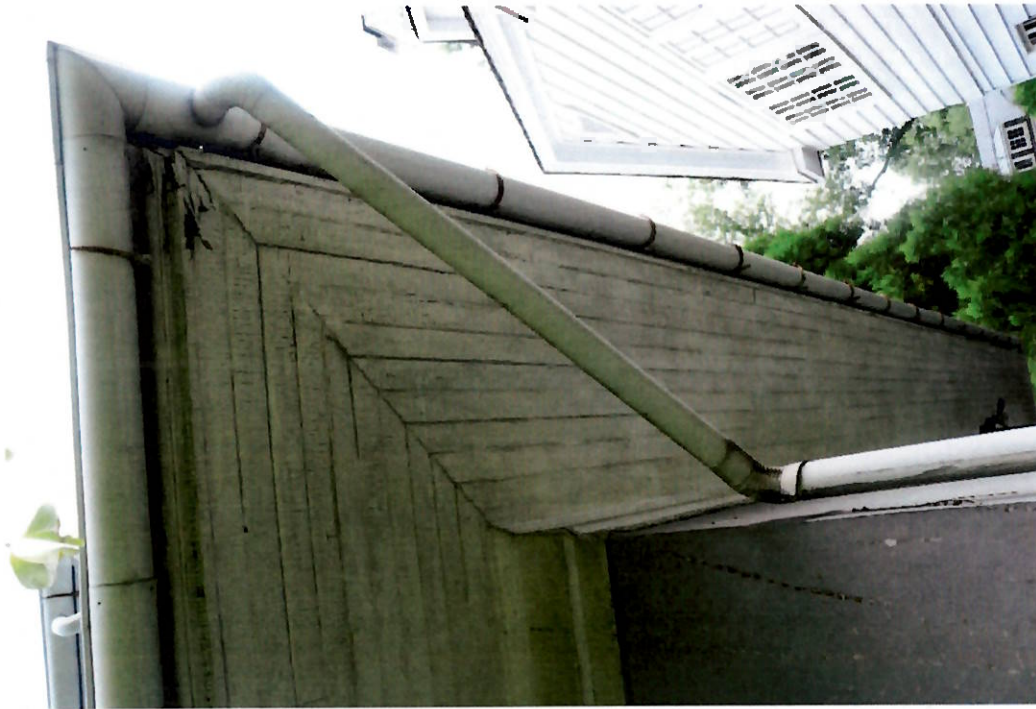
Photo 17. 08/05/19. Side (west). Project area. Detail of wood ceiling, trim, and molding to be repaired and painted; stucco to be repaired and painted; aluminum gutters and downspouts to be repaired.

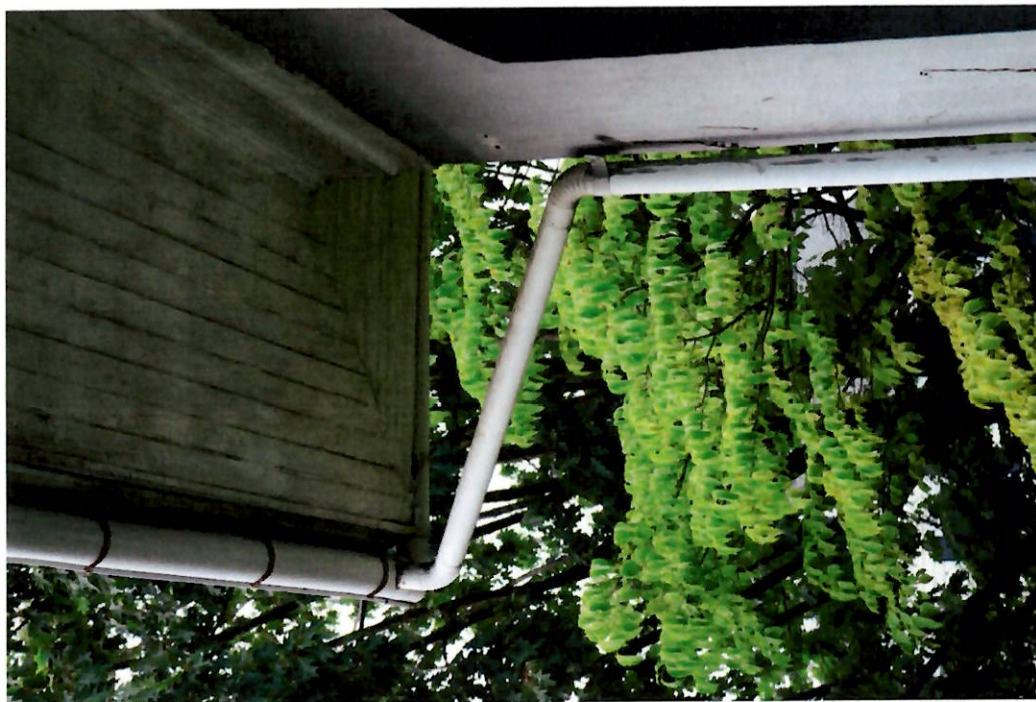
Photo 18. 08/05/19. Side (west). Project area. Detail of wood ceiling, trim, and molding to be repaired and painted; stucco to be repaired and painted; aluminum gutters and downspouts to be repaired.

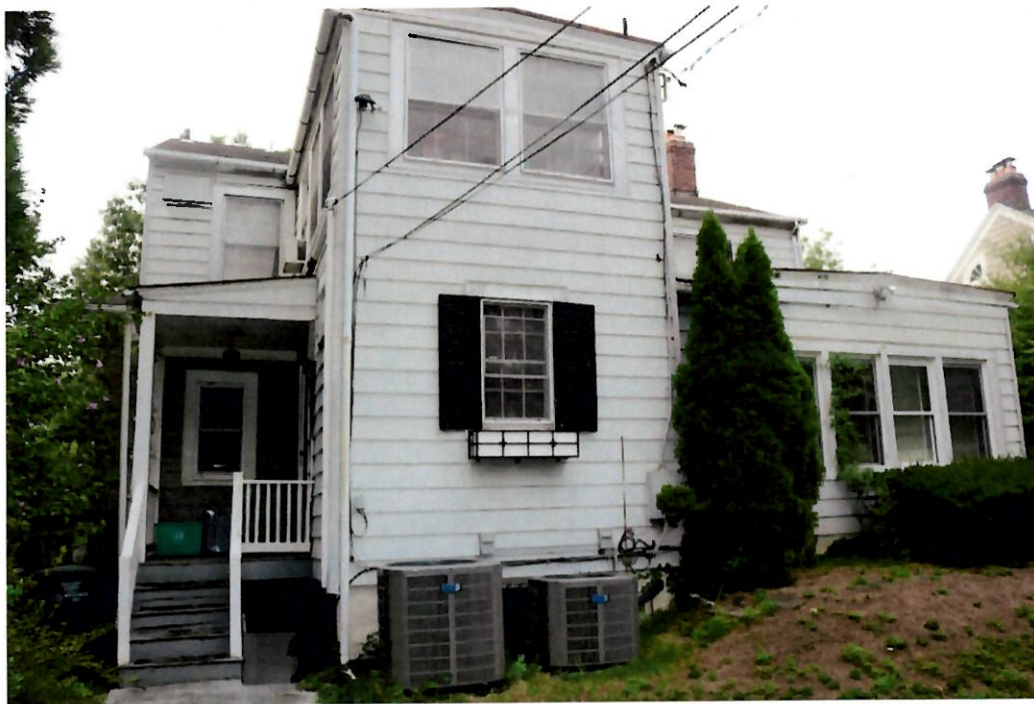
Photo 20. 08/05/19. Back (south) elevation. Project area. Left close-up showing aluminum siding to be painted; shutters to be painted; wood ceiling, trim, and molding to be painted; aluminum gutters and downspouts to be repaired.

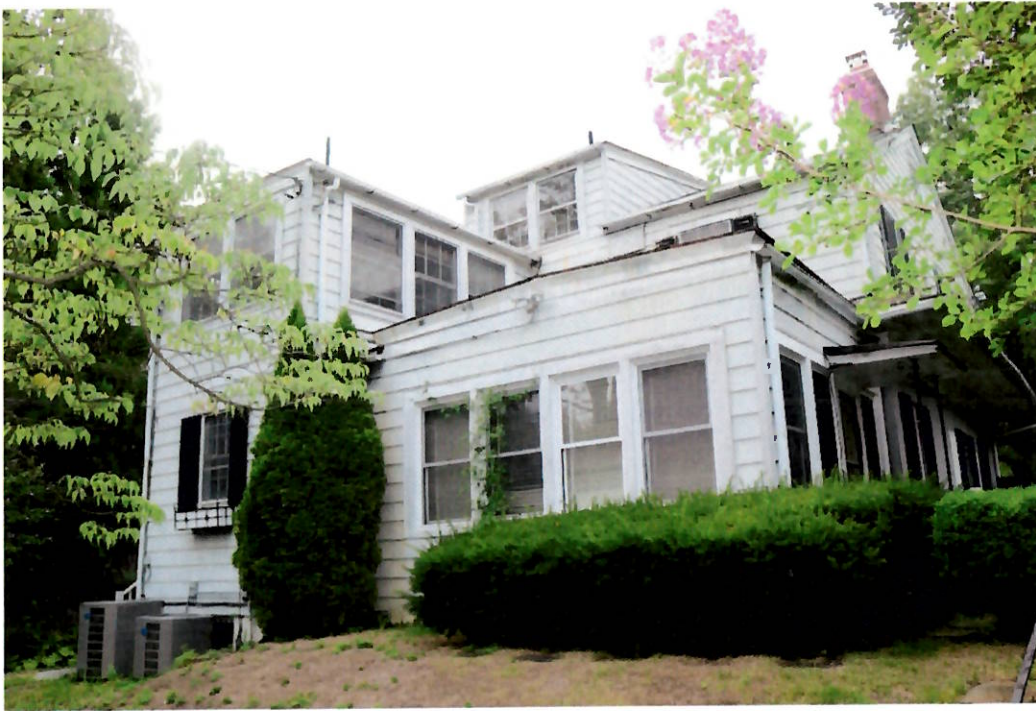
Photo 21. 08/05/19. Back (south) elevation. Project area. Right close-up showing aluminum siding to be painted; shutters to be painted; aluminum gutters and downspouts to be repaired.

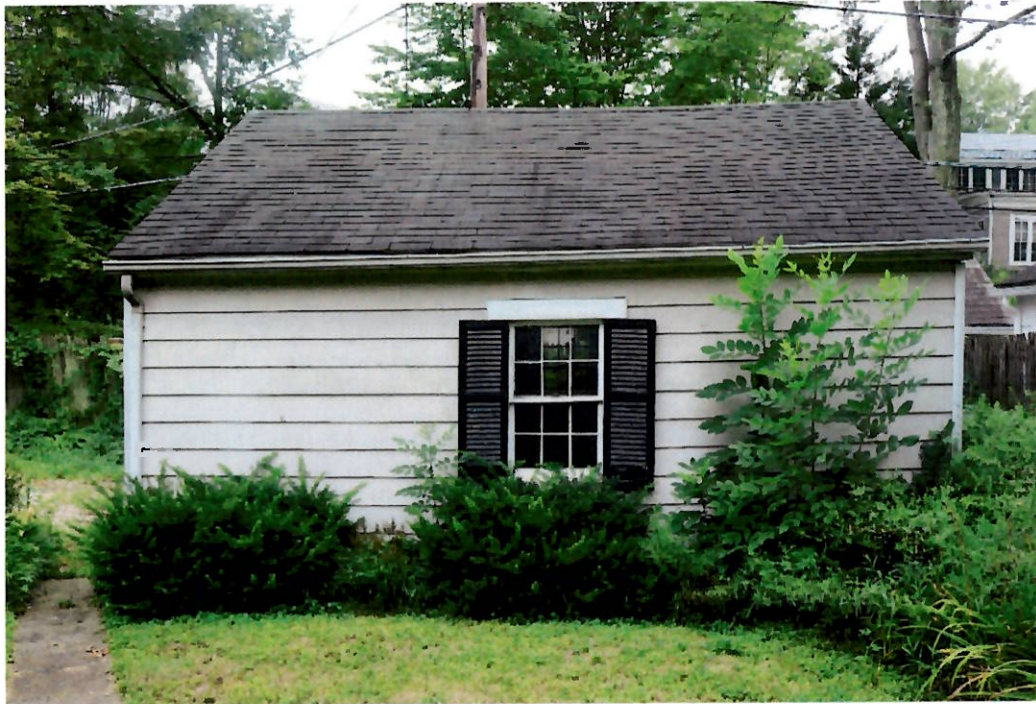
Photo 23. 08/05/19. Backyard (south). Garage. Project area. Close-up of north side of garage showing aluminum siding to be removed; shutters to be restored and painted; aluminum gutters and downspouts to be repaired.

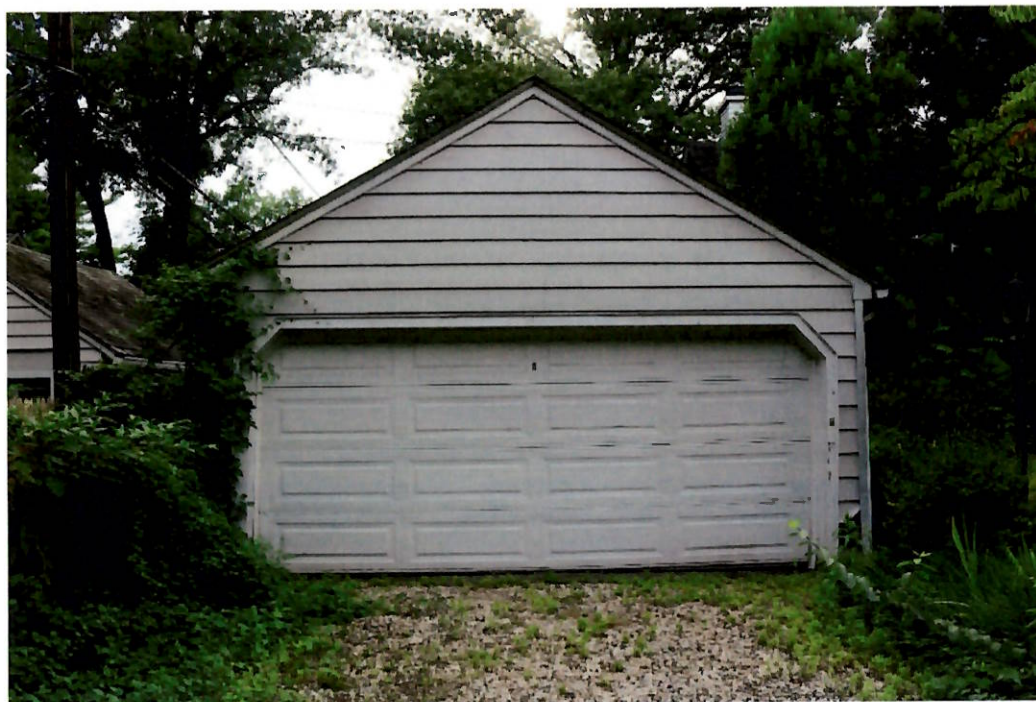
Photo 24. 08/05/19. Backyard (south). Garage. Project area. Close-up of east side of garage showing aluminum siding to be removed; aluminum gutters and downspouts to be repaired.

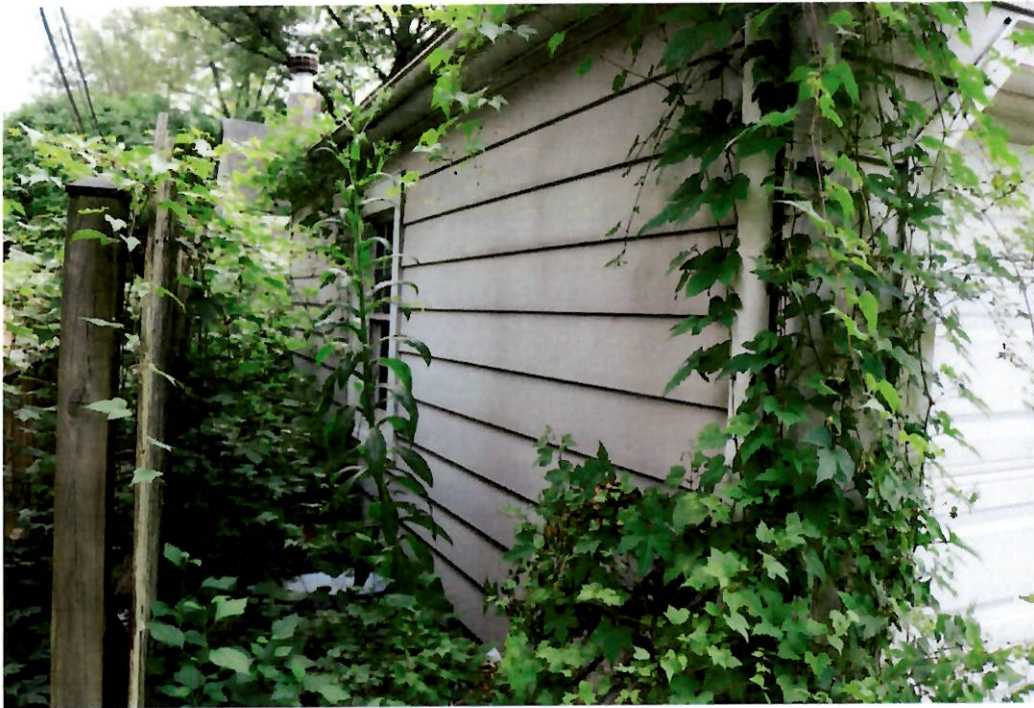
Photo 25. 08/05/19. Backyard (south). Garage. Project area. Close-up of south side of garage showing aluminum siding to be removed; aluminum gutters and downspouts to be repaired.

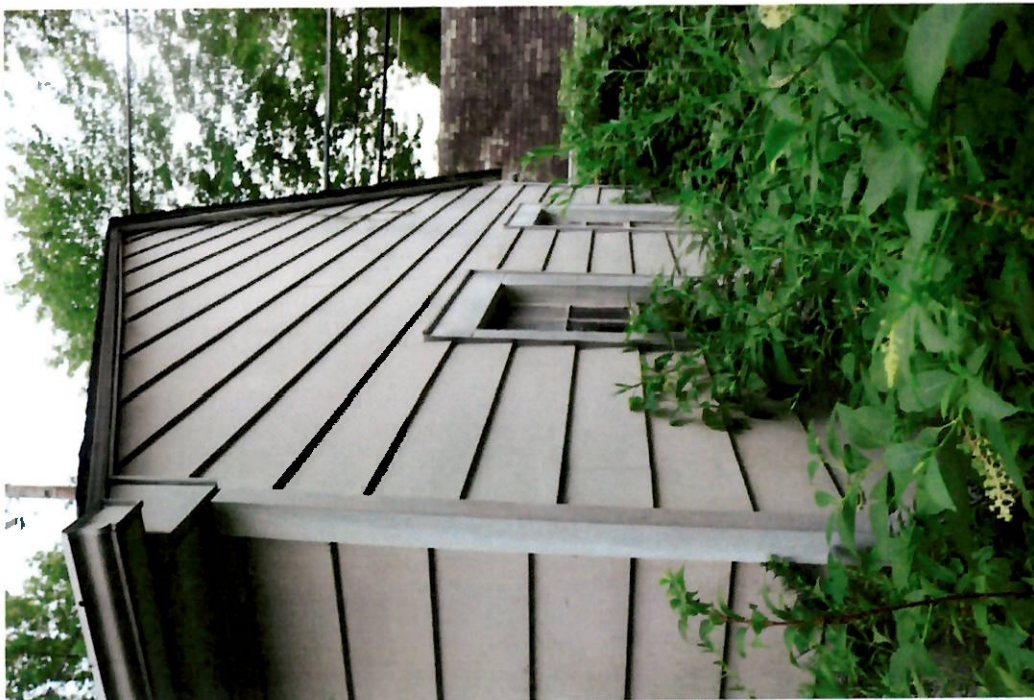
Photo 26. 08/05/19. Backyard (south). Garage. Project area. Close-up of west side of garage showing aluminum siding to be removed; aluminum gutters and downspouts to be repaired.
