MONTGOMERY COUNTY HISTORIC PRESERVATION COMMISSION
STAFF REPORT

Address:	5904 Cedar Parkway, Chevy Chase	Meeting Date:	2/12/2020
Resource:	Outstanding Resource Chevy Chase Village Historic District	Report Date:	2/5/2020
Applicant:	David O'Neil & Laura Billings (David Jones, Architect)	Public Notice:	1/29/2020
Review:	HAWP	Tax Credit:	n/a
Case Number:	35/13-20E	Staff:	Dan Bruechert
Proposal:	Window Replacement

Billings O'Neil Residence HAWP Revision 2

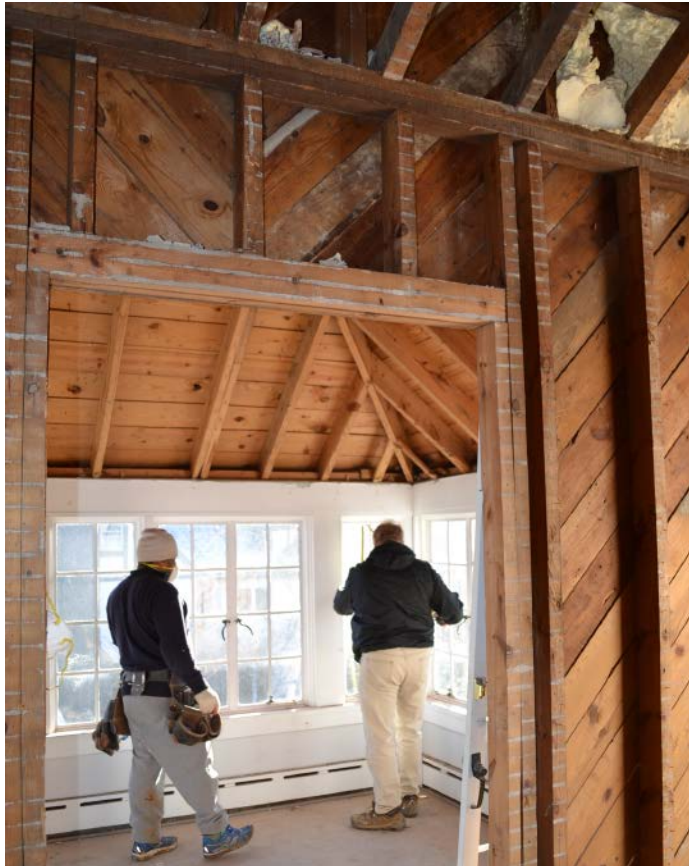
6. Study Entrance

The evidence that the second floor is also an altered space is even more convincing. First, the framing of the door opening and roof rafters is much brighter and does not match the rest of the exposed framing. Second, the wire lath and stucco were crudely cut off of the wall before being covered with drywall, showing that their appearance had been altered. Third, the interior wall construction is not consistent with the masonry walls on the first floor. Fourth, the casement windows are paired eight-light casement windows instead of the ten-light wood casement windows installed in the first floor.

We have evidence that this room was added at a later date. All of the framing in this room is newer than that in the rest of the house, evidenced by a clear difference in color (photo 6, 7). The steel windows do not match the other windows in the house (photo 8, 9).

The existing steel windows are in disrepair, have been modified in places and do not operate. We propose to replace these with wood framed windows with similar pattern.

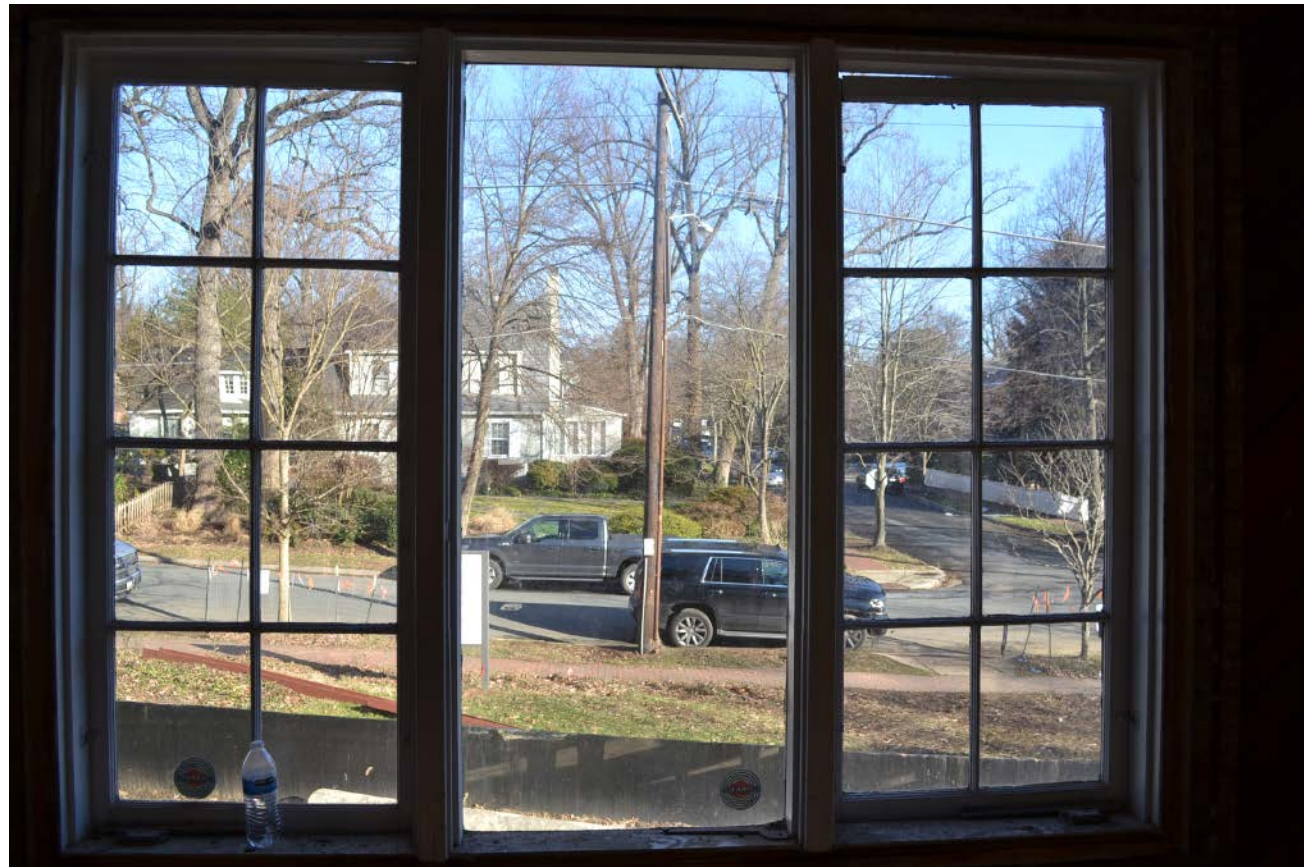
10. Dining Room Interior

The original approved plans call for replacing the center sash. However, after further inspection, the two flanking sashes are rotted and will not close fully (photo 10). We propose to replace this window with a custom unit to match the existing details and frame dimensions.

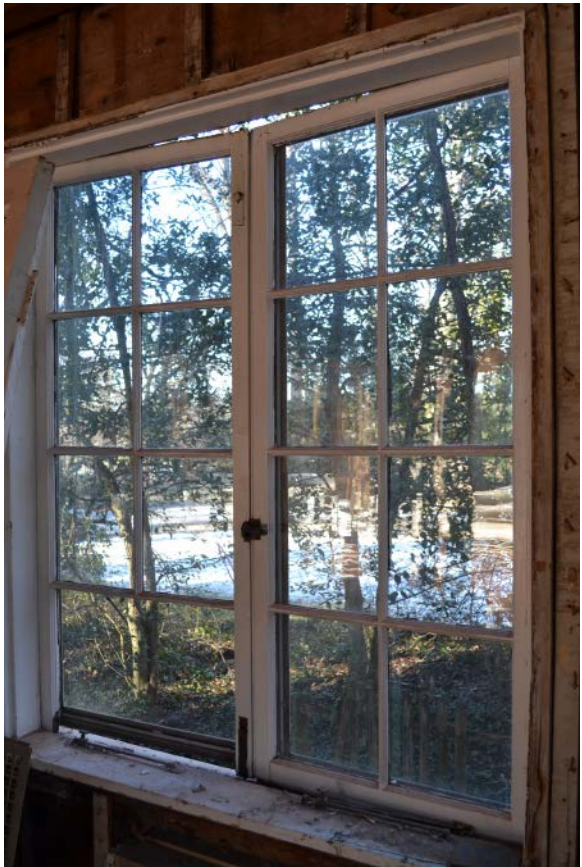
11. Living Room Interior

This window is rotted and will not operate (photo 11). We propose to replace with a custom unit to fit the opening and match the details of the Living Room window on the east elevation.

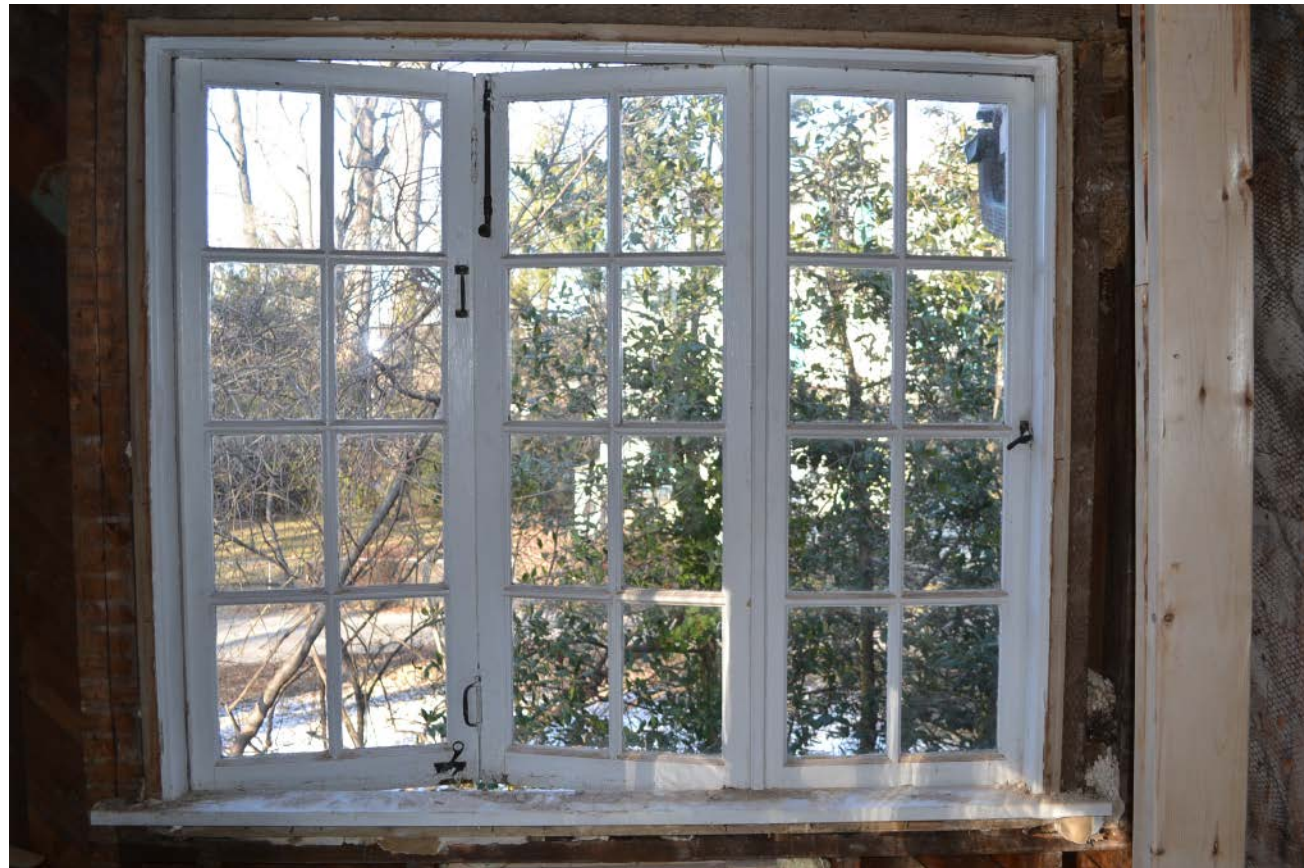
12. Bedroom 1 Interior

This window is rotted and will not operate (photo 12). We propose to replace with an operable window to match.

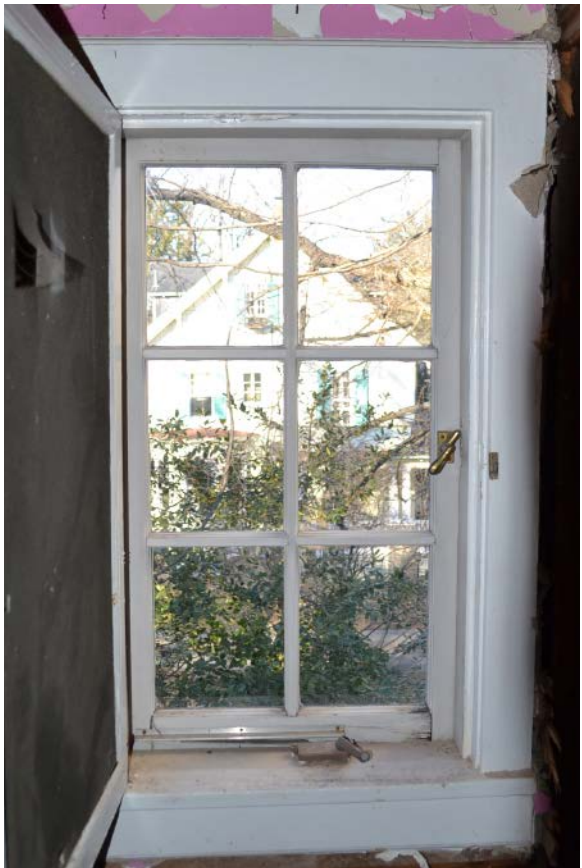
13. Bath 3 Interior

This window is rotted and cannot open without failing (photo 13). We propose to replace with an operable window to match.
