MONTGOMERY COUNTY HISTORIC PRESERVATION COMMISSION
STAFF REPORT

Address:	10201 Menlo Ave., Silver Spring	Meeting Date:	9/9/2020
Resource:	Vacant Lot Capitol View Park Historic District	Report Date:	9/2/2020
Applicant:	Minter Farnsworth	Public Notice:	8/26/2020
Review:	HAWP	Tax Credit:	n/a
Case Number:	31/07-20F	Staff:	Dan Bruechert
PROPOSAL:	Tree Removal

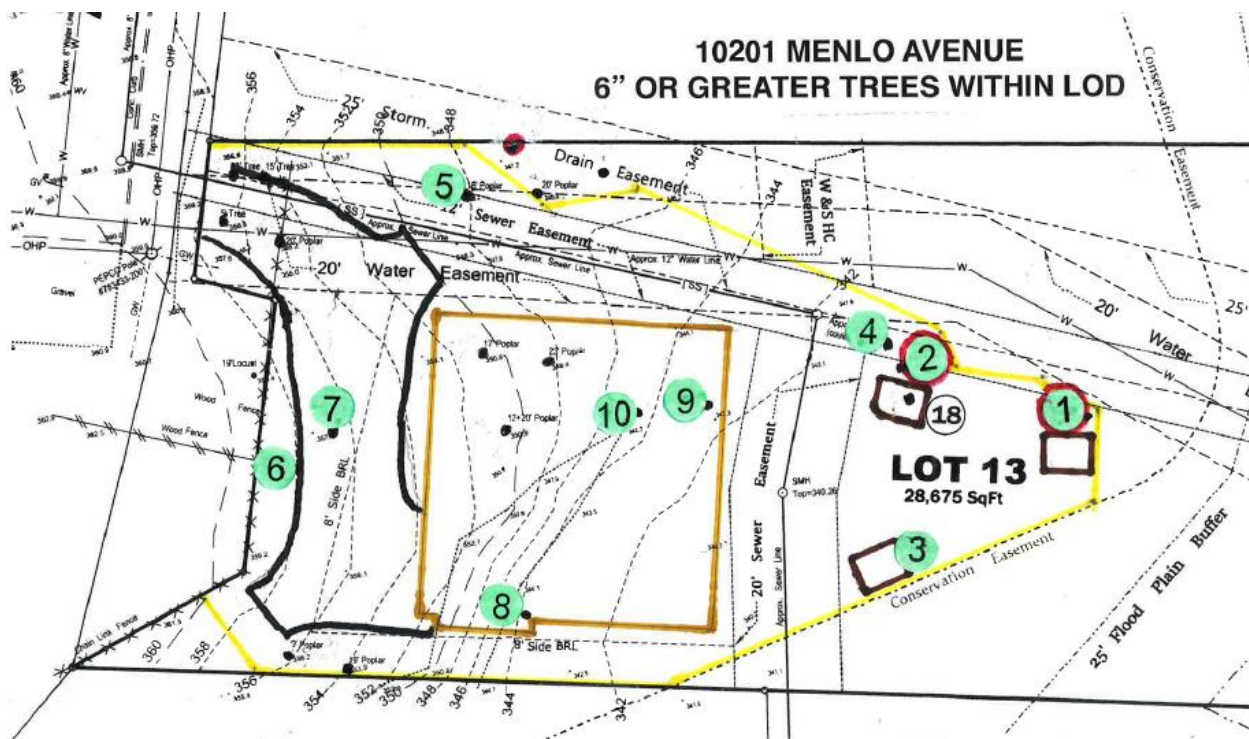
Figure 2: Partial site plan showing the location, size, and species of the proposed tree removal.

Trees identified as 8, 9, and 10 are all within the footprint of the approved house. The applicant asserts that two of the trees were smaller than 6” d.b.h. when the 2017 Prelim was submitted; and the third tree was obscured by bamboo and missed by the applicant’s arborist. Regardless of the tree growth and the omission by the arborist the trees exceed 6” and require a HAWP. In April 2019 the HPC agreed with Staff’s finding that the only location a house could be placed on the lot (due to the restrictions of the conservation easement and several utility easements along with zoning requirements) is the location of the approved house. For the HPC to not approve the tree removal would frustrate the approved HAWP and Staff finds would violate 24A-8(b)(5), depriving the applicant of the reasonable use of the property. Staff recommends the HPC approve the removal of trees 8, 9, and 10 of the submitted tree survey.

Trees 6 and 7 are in or immediately adjacent to the proposed driveway. Due to the unique layout of this lot, with the only access point to Menlo Ave. at the northwestern corner of the lot, Staff finds the driveway can not be located in any other location on the site. Staff finds that trees 6 and 7, like the trees discussed above, need to be removed so that the site has vehicular access. Staff recommends the HPC approve the removal of trees 6 and 7 under 24A-8(b)(5). Staff also notes that tree 6 is identified in ‘poor health’ and while it is not a hazard yet if its health continues to degrade its removal will be required as a hazard without the HPC’s approval.

Trees 1, 2, 3, and 4 are located to the rear of the lot and are not visible from the right of way. Trees 1 and 2 will be retained in their location. Tree 3 is in the location of one of the three proposed dry wells on the site and is one of the trees the applicant identified as less than 6” at the time of the original submission. Tree 4 is a 10” d.b.h. spruce tree that is in poor health due to a spider mite infestation. Staff finds that tree 3 is barely above the 6” threshold and is in a location that is not visible from the public right-of-way. Its removal will not impact the historic character of the site or the surrounding district. Additionally, tree 3 is in the location of one of the proposed drywells. While this dry well could be relocated, that would expand the limits of disturbance and increase the potential erosion on site. Tree 4 is in poor health and only has needles at its crown. Staff finds that this tree will likely continue to degrade and become a hazard. Staff recommends the HPC approve the removal of trees 3 and 4 under 24A-8(b)(2), (4), and (5).

Tree 5 is a Tulip Poplar that the applicant contends was less than 6” d.b.h. at the time of the original submission. Based on the soft wood and quick growth of the species, Staff concludes this was likely the case. The location of this tree is near the turn-around for the previously approved driveway and in the middle of the approved timber terraces. In Staff’s discussions with the applicant, the applicant identified the approved on-site re-grading and terracing as a method to limit runoff and erosion into the creek; a concern voiced by many members of the community in the various Preliminary Consultations, HAWP hearings, and administrative appeals. Staff recommends the HPC approve the removal of Tree 5 under 24A-8(b)(2) and (d).

Staff recommends that the Commission **approve** the HAWP application under the Criteria for Issuance in Chapter 24A-8(b)(1), (2), (4), (5) and (d), having found that the proposal will not substantially alter the exterior features of the historic resource and is compatible in character with the district and the purposes of Chapter 24A;

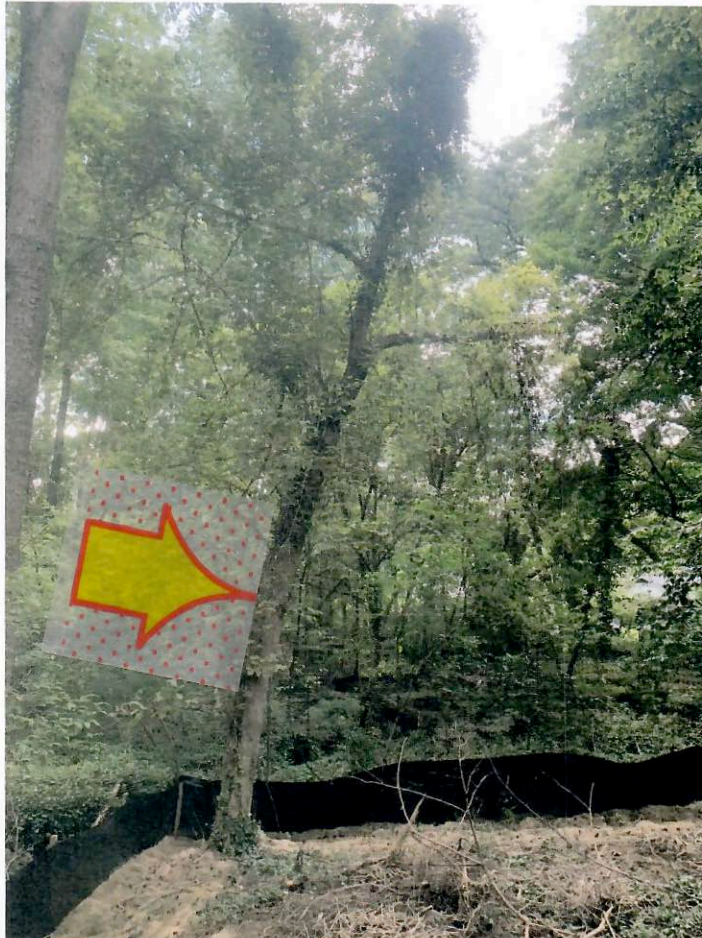
TREE #1
12.5" Boxelder
Plan is to save this tree

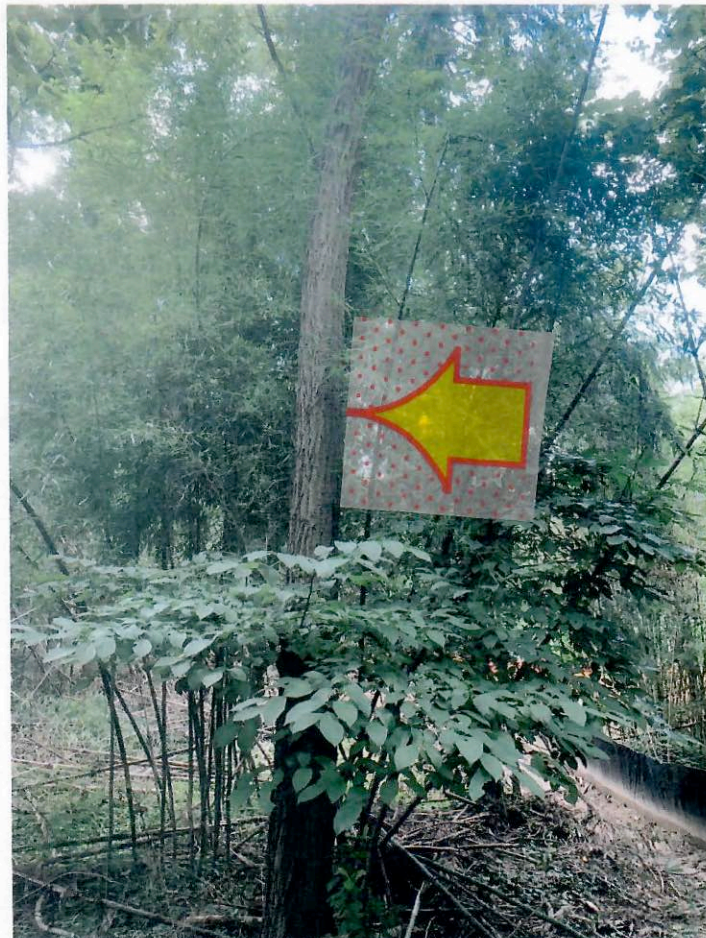
TREE #2
12" Black Locust
Plan is to save this tree

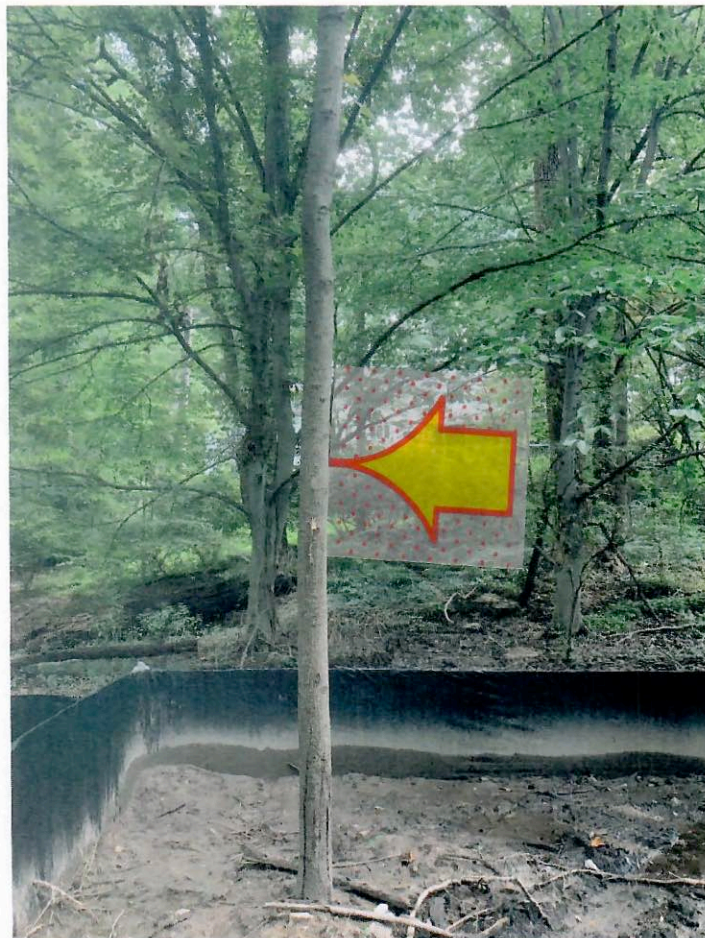
TREE #3
6.25" Tulip Poplar
Not planning to save - Dry well location
Encroaching into the area of replanting a willow oak

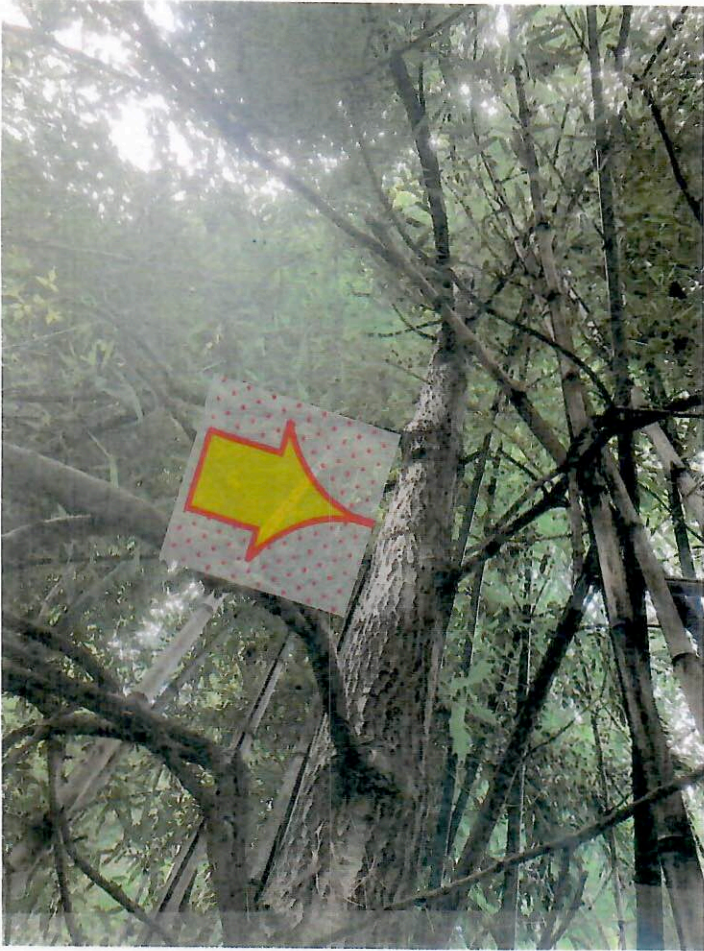
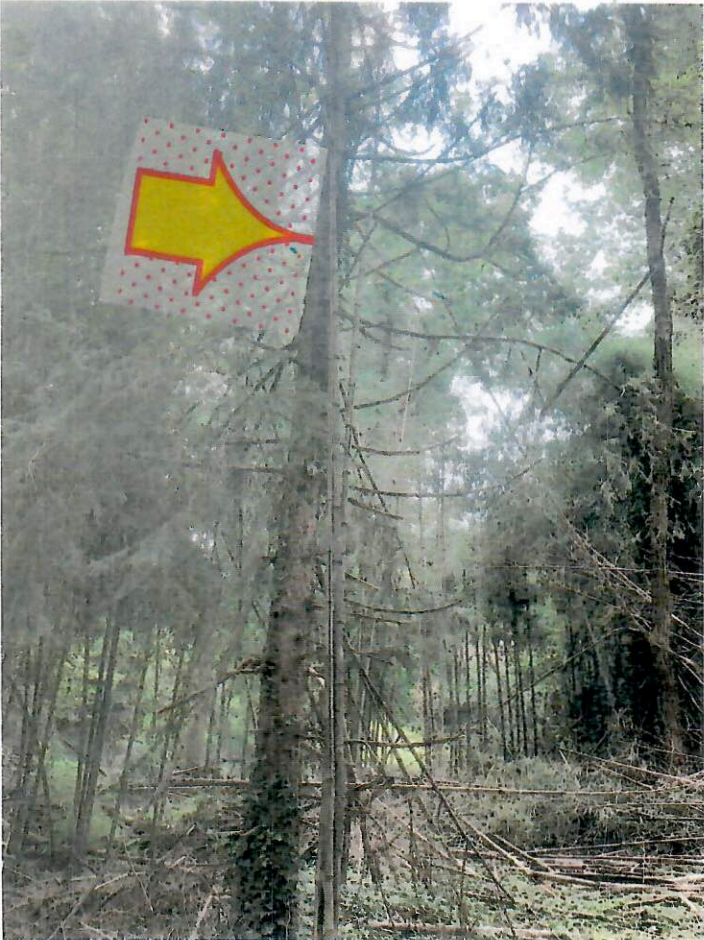
TREE #4
10" Spruce
Not planning
to save due to
poor health
Needlecast and
Spider Mites

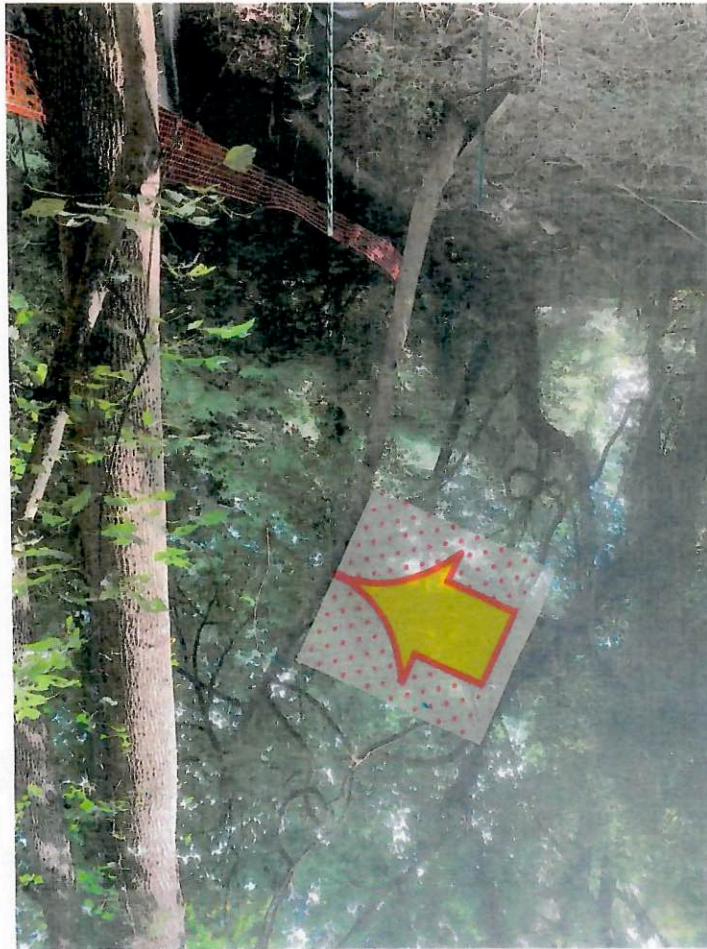
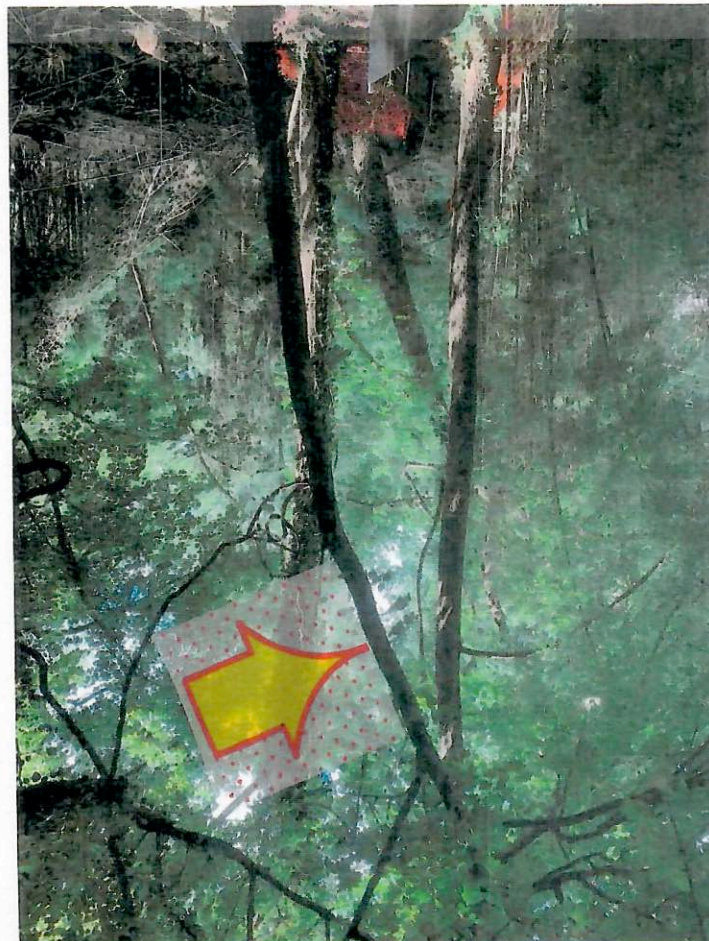
TREE #5
8.5" Tulip Poplar
6" on 2017 NRI
Not planning to
save due to
leaning over
neighbor's
property and
in fill area for
driveway

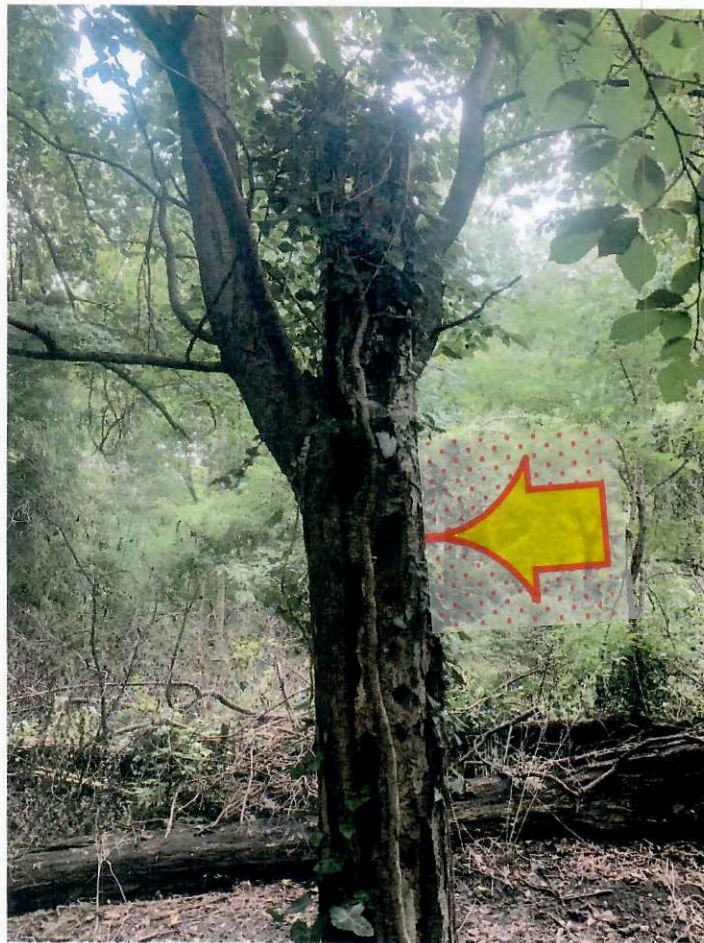
TREE #6
8" Maple
Not planning to save
due to poor health
and within driveway

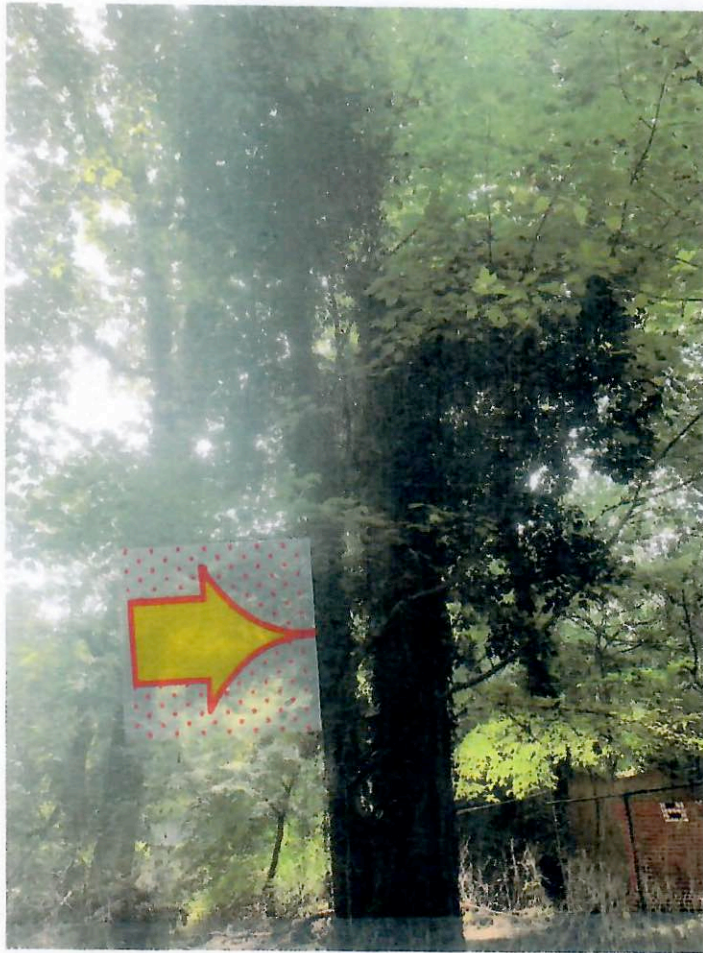
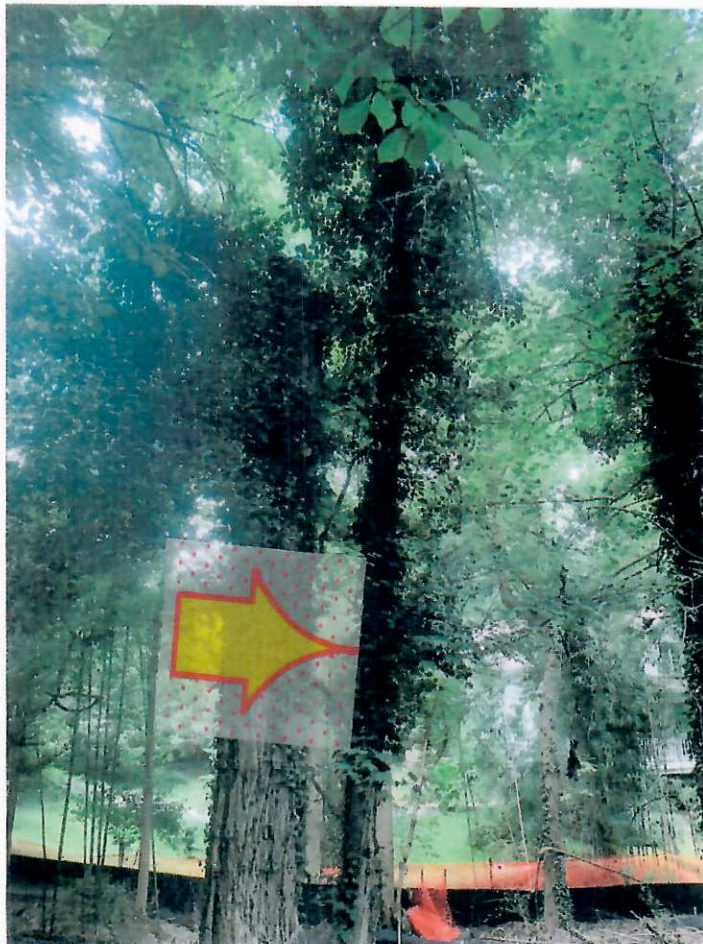
TREE #7
7" Maple
6" on 2017 NRI
Not planning to
save due to
location within
the driveway

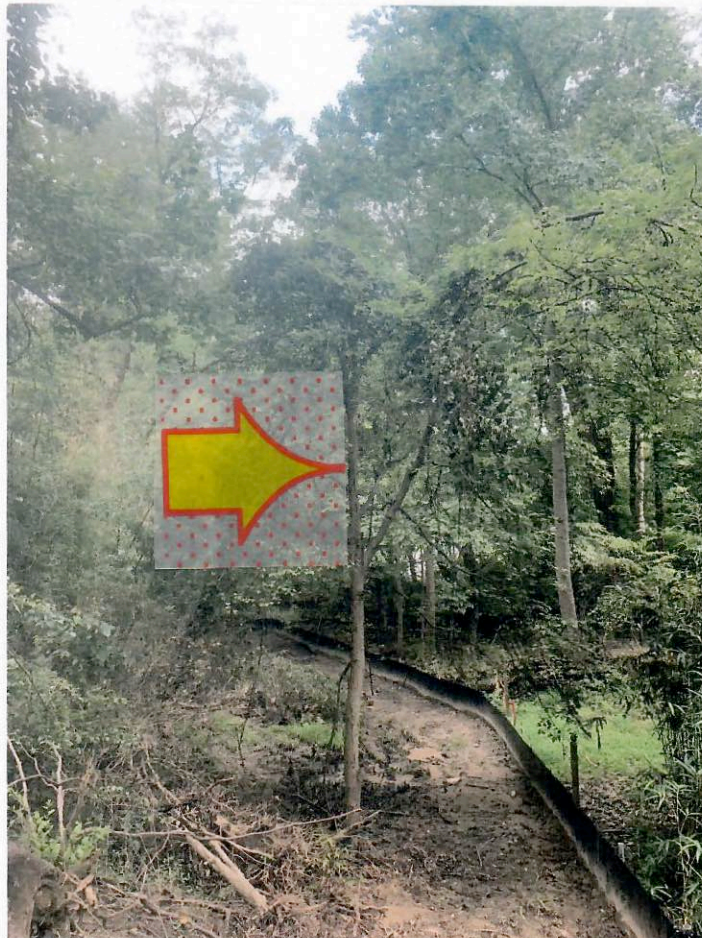
TREE #8
9" Maple
Not planning to save
due to location
within the house, deck and
retaining wall construction

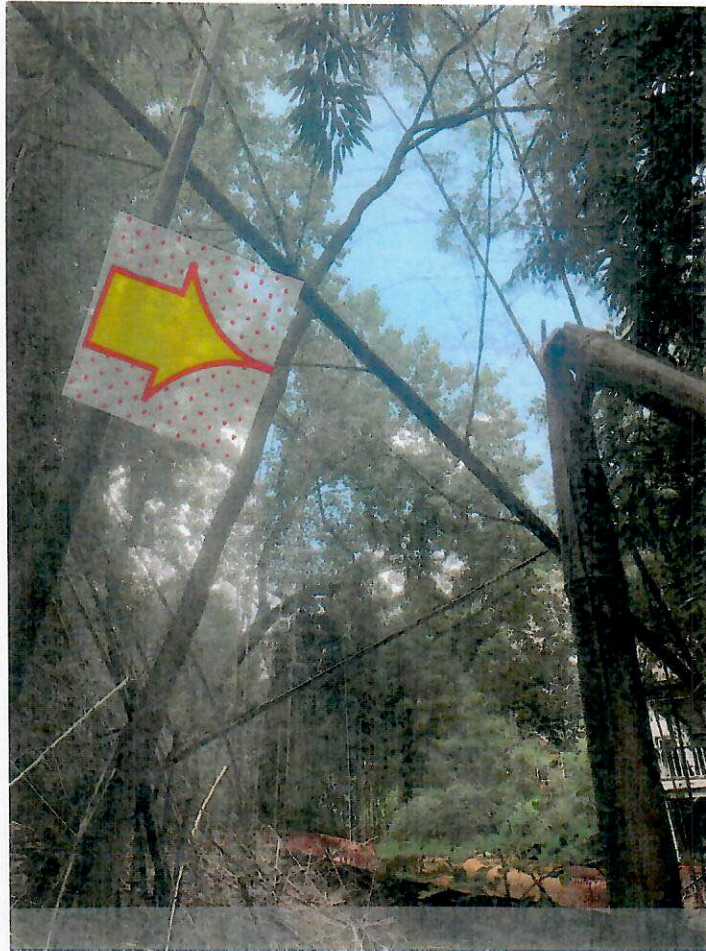
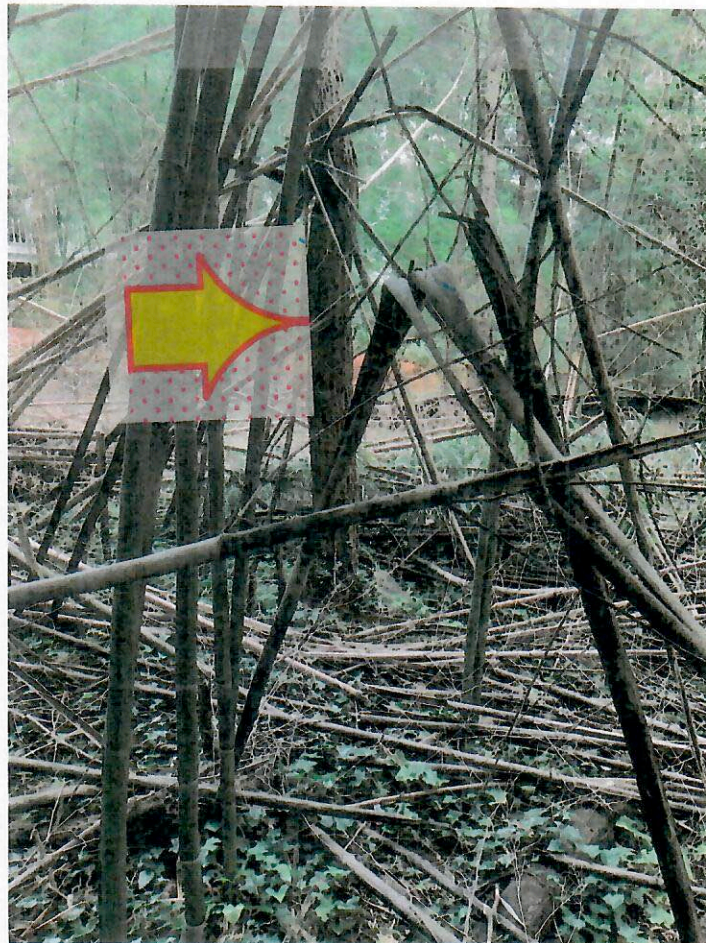
TREE #9
10.5" Black Locust
Not planning to
save due to
leaning toward
neighbor's house
and within the
house, deck and
retaining wall
construction

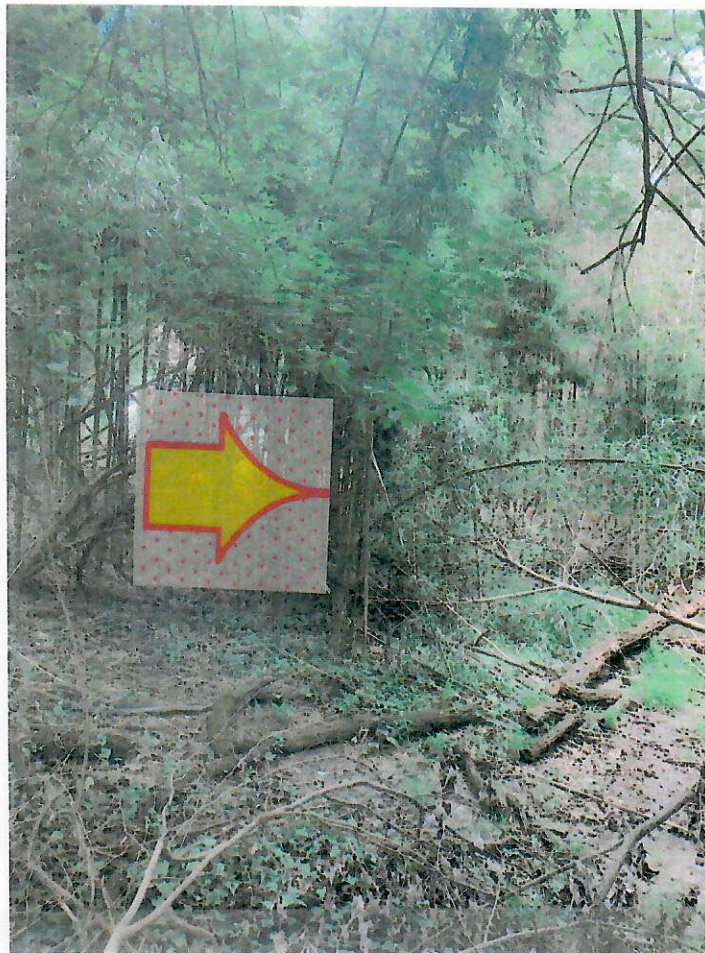
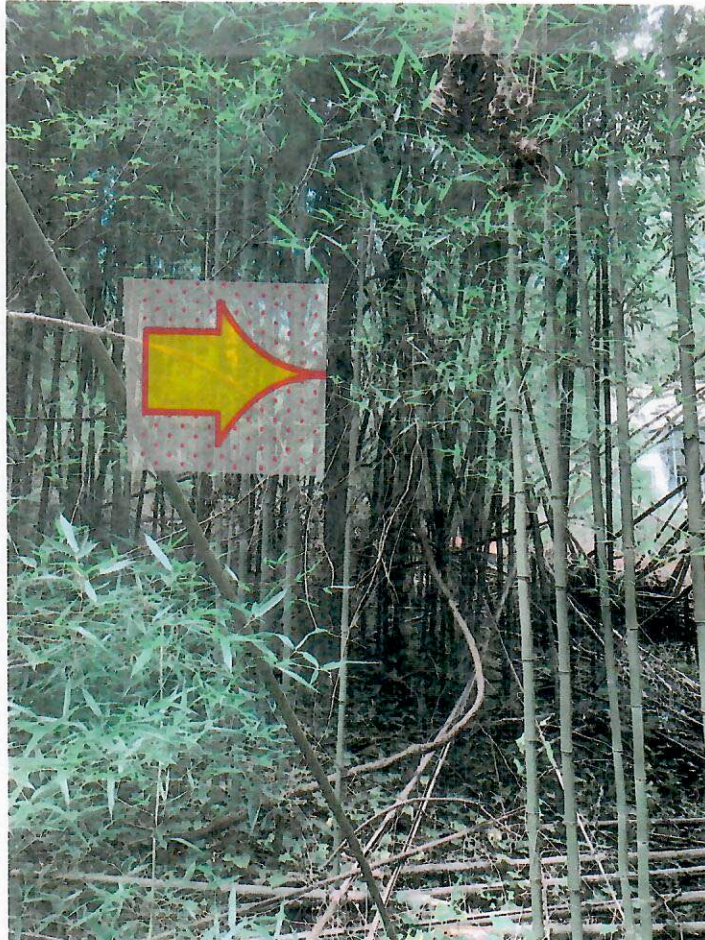
TREE #10
8" Oak
6" or less at
2017 HAWP
Not planning
to save due to
within the
house, deck
and retaining
wall construction
