**EXPEDITED**  
**MONTGOMERY COUNTY HISTORIC PRESERVATION COMMISSION**  
**STAFF REPORT**

<b>Address:</b>	2805 Linden Ln., Silver Spring	<b>Meeting Date:</b>	3/24/2021
<b>Resource:</b>	Swiss Chalet; National Park Seminary Historic District	<b>Report Date:</b>	3/17/2021
<b>Applicant:</b>	Heidi Lunasin	<b>Public Notice:</b>	3/10/2021
<b>Review:</b>	HAWP	<b>Tax Credit:</b>	n/a
<b>Permit No.:</b>	943635	<b>Staff:</b>	Dan Bruechert
<b>Proposal:</b>	Hardscape Alteration and Gutter Installation

# Project 1 – Gutter Addition on North Side

## Project 2 – Addition of Walkway to House

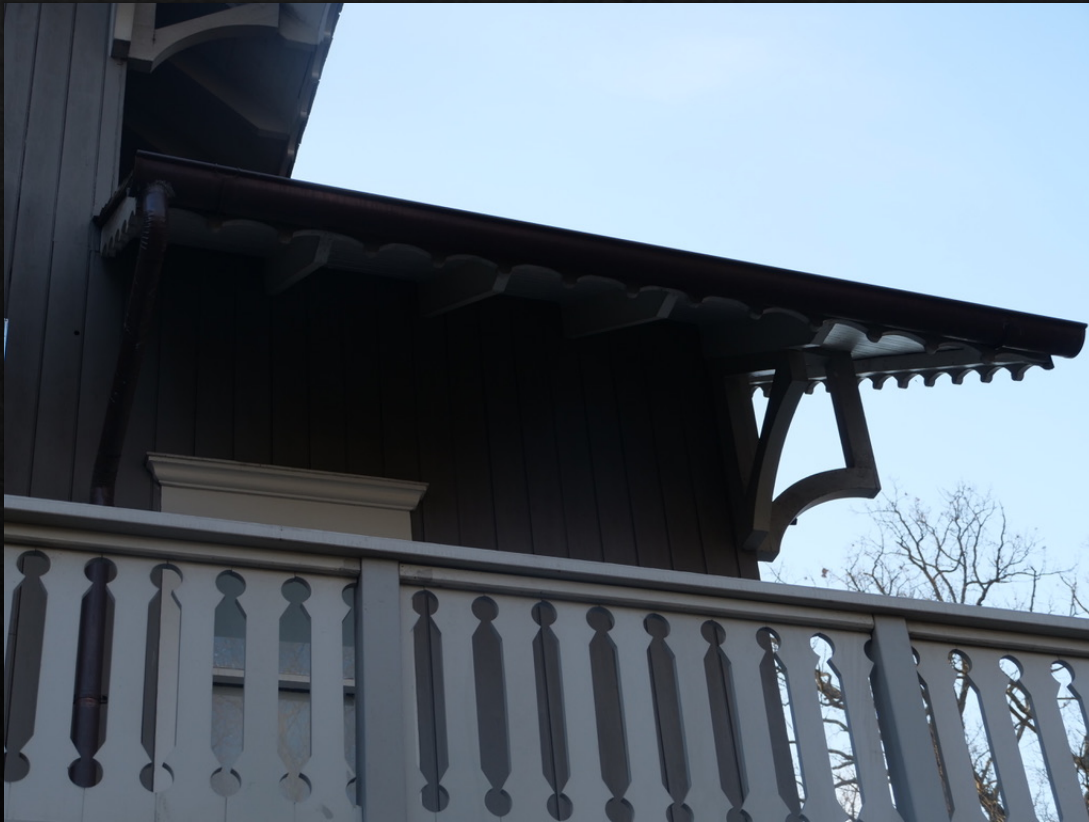
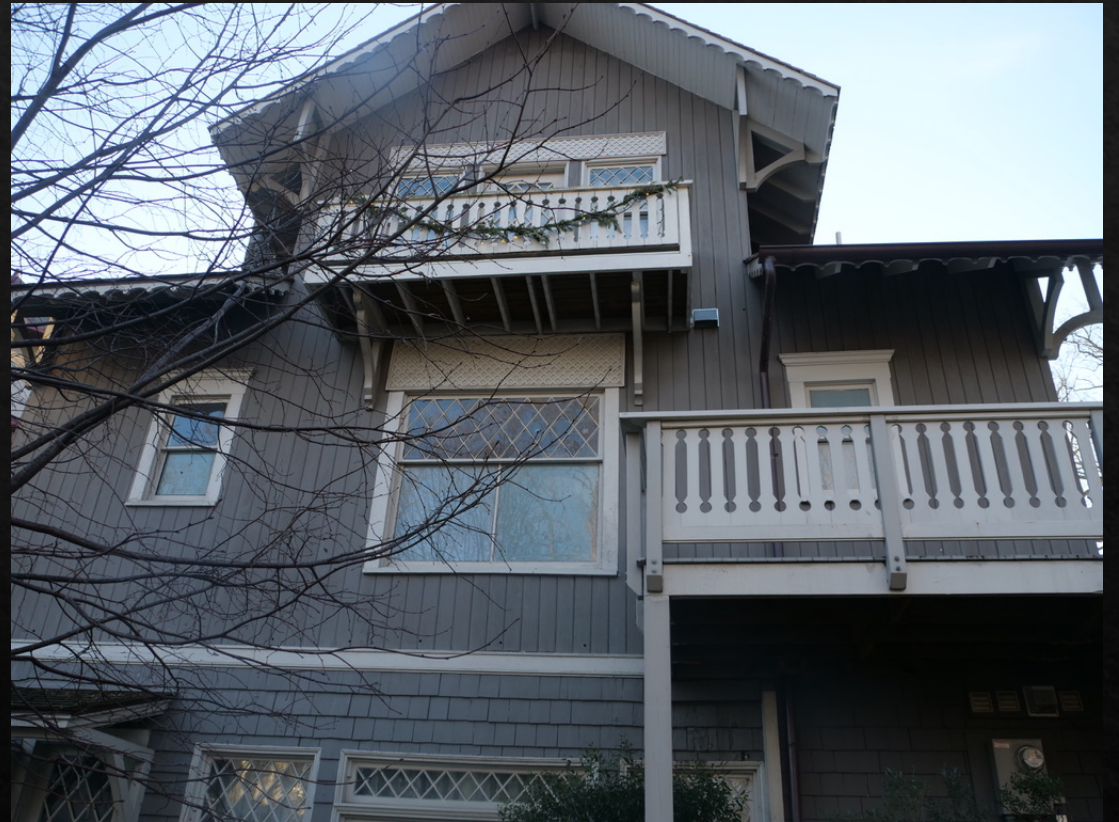
Gutters are positioned almost completely around the lower roof. Just one section on the North side does not include a gutter.

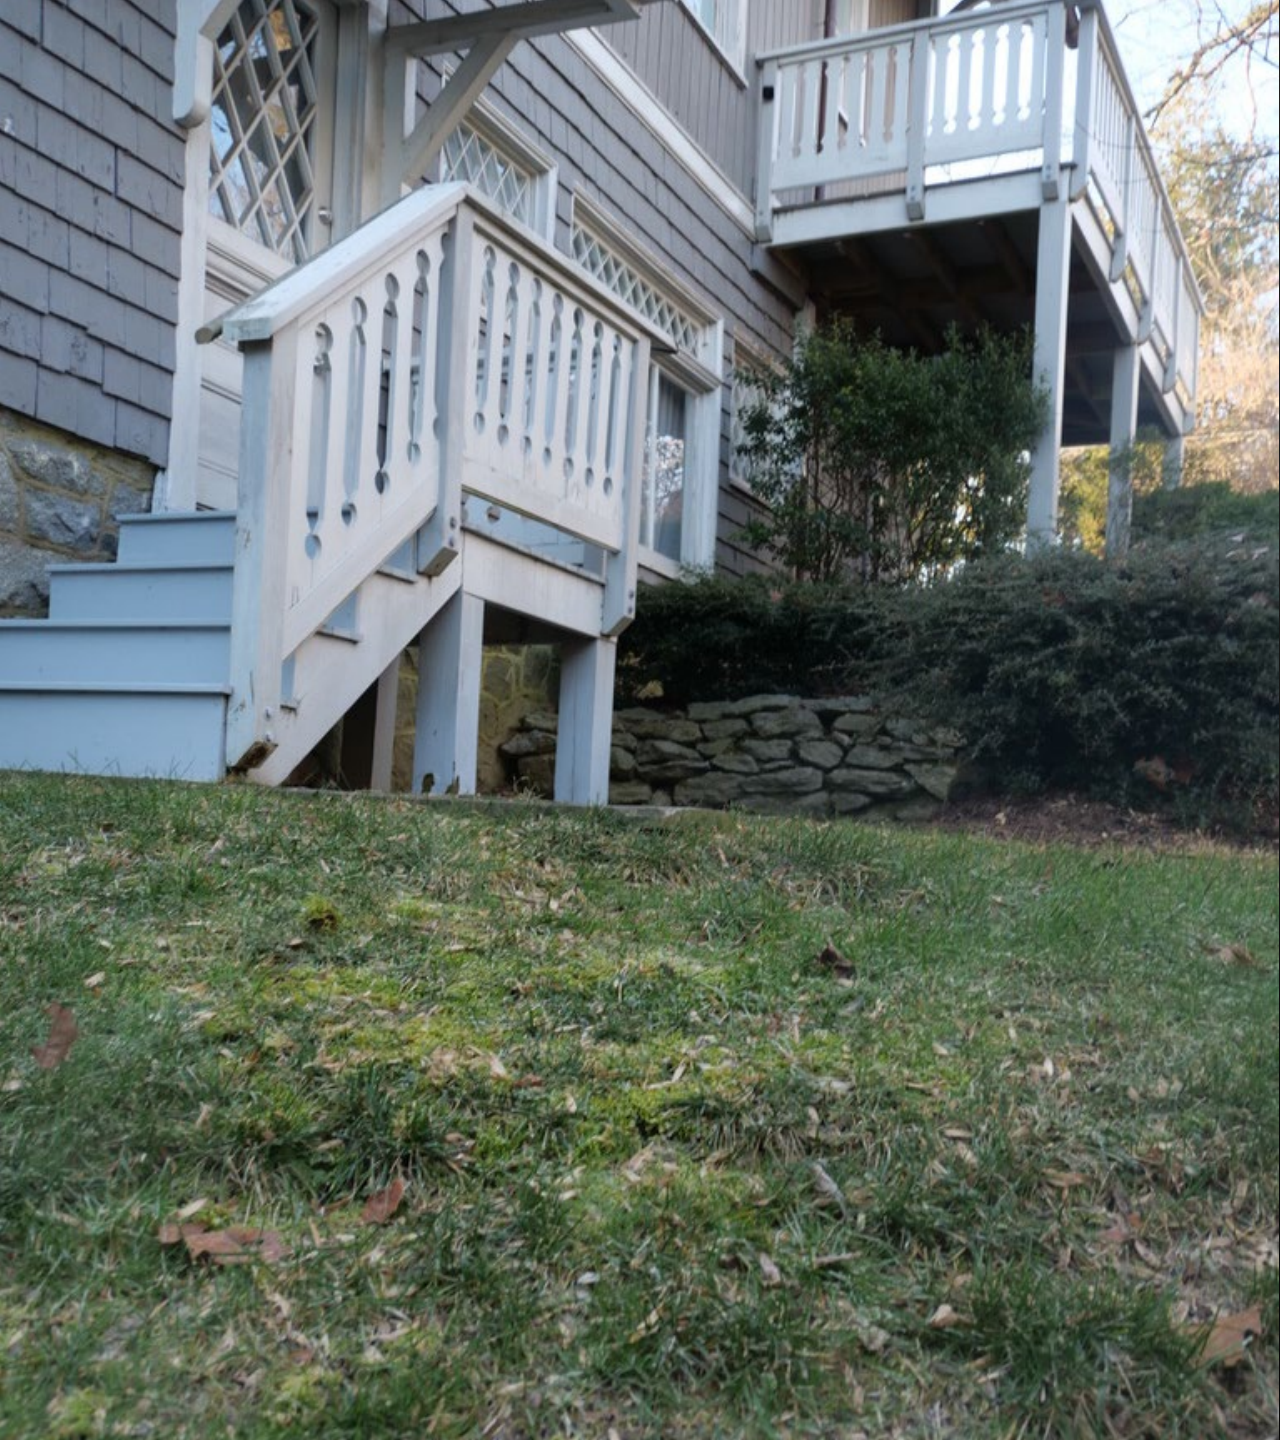
Due to the extreme amount of water coming off both the upper and lower roofs at this point significant erosion is occurring in this area causing the pavers installed by the previous owner to sink. Over time this may affect the stairs connected to the house as well.

- ◇ Significant erosion is occurring on the North Side of the house
- ◇ Landscapers from the National Park Seminary HOA continually tear up the grass due to the area being wet

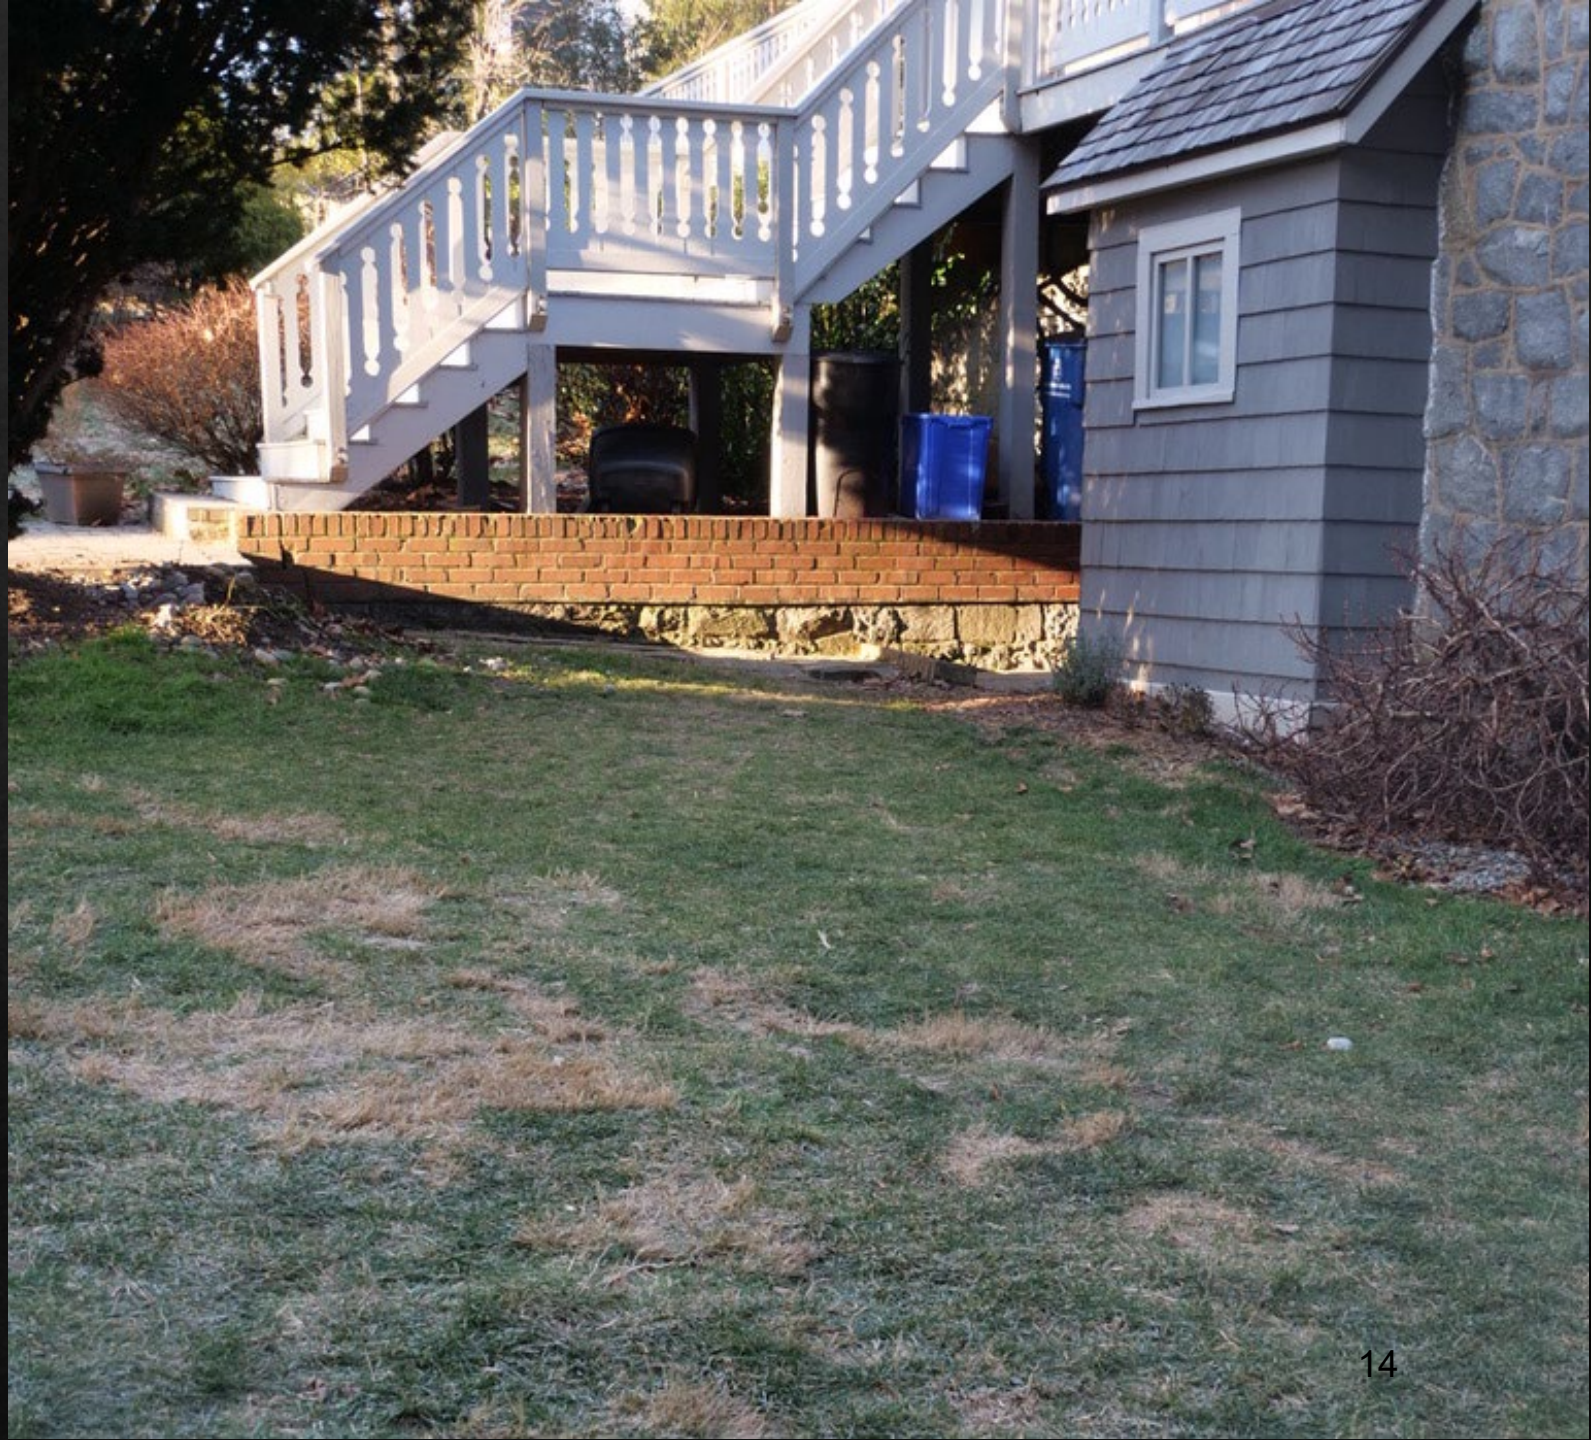
- ◇ There is no paved or stone walkway to enter the house from any sidewalk.
- ◇ This means all people entering the house have to walk across the grass, mud, snow, or ice to reach any door on the property from a sidewalk.
- ◇ Further, the sloping towards the house in this area appears to be causing water intrusion into the crawl space during significant rain events.

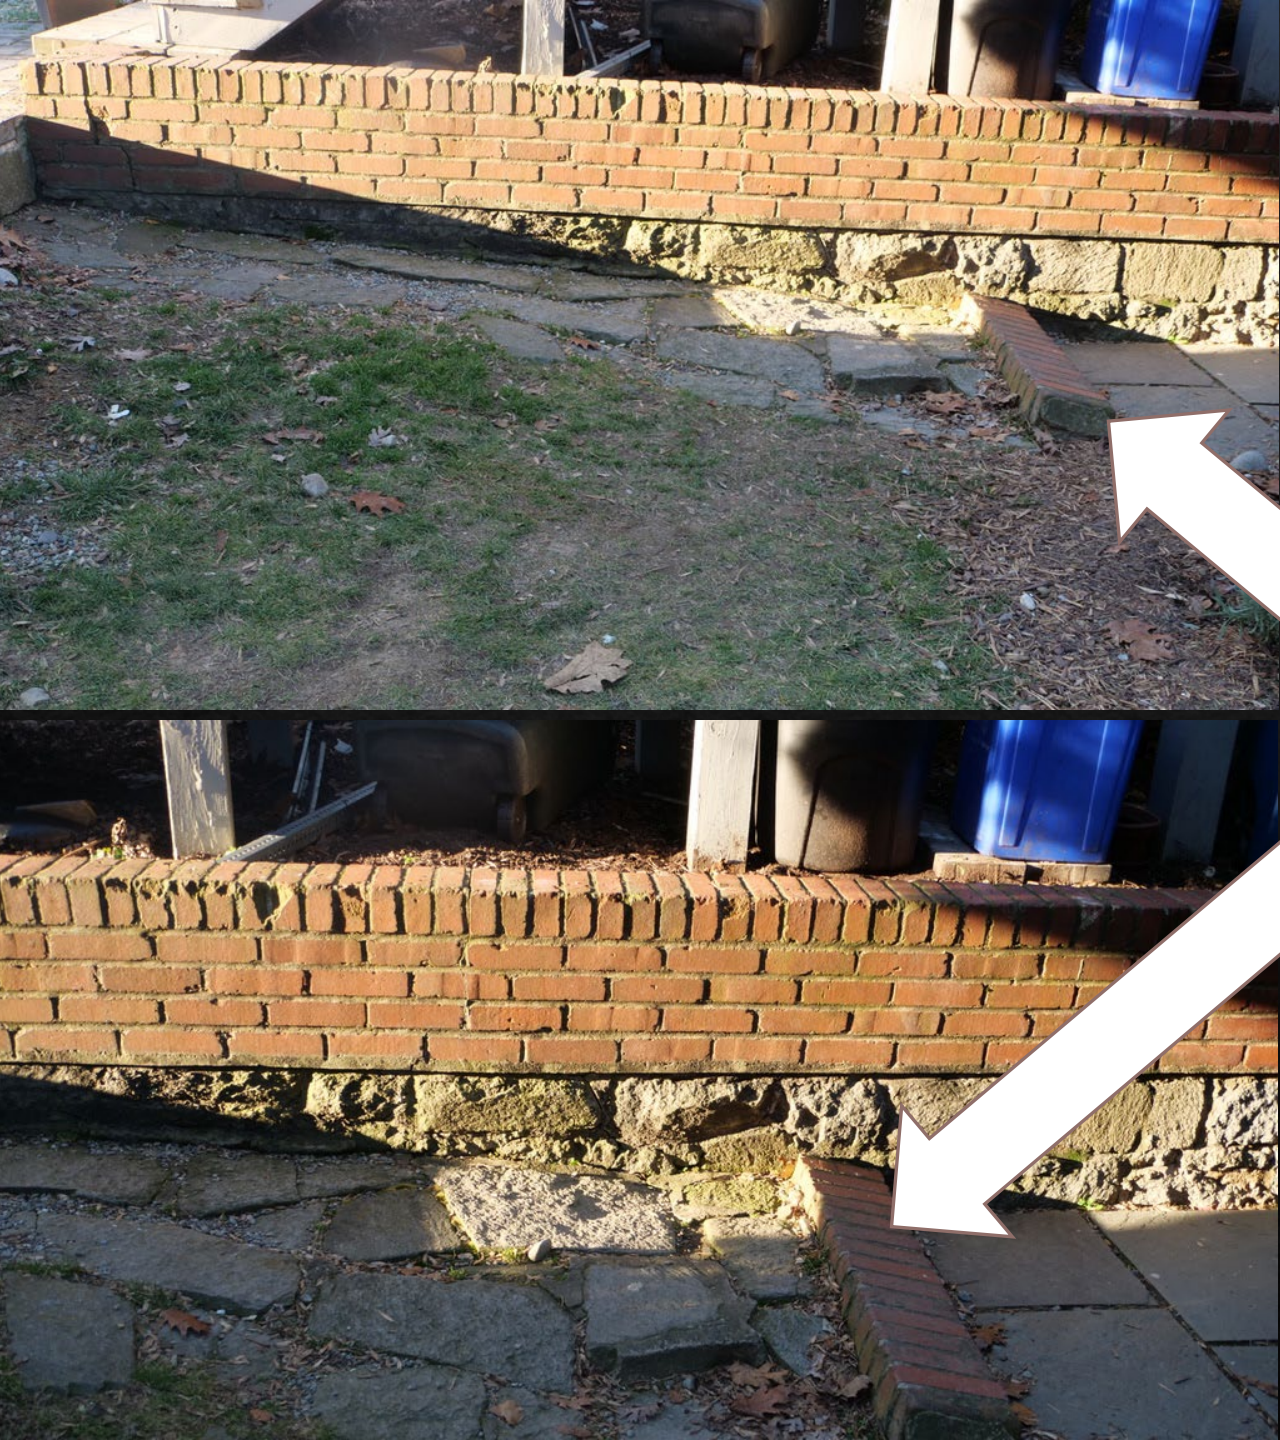
- ❖ Further, the access to the house is uneven stones are not flush, in fact, there is a differential of at 3-4”.
- ❖ There is also a small brick retaining wall in the middle of the stone pathway that exists that has proven to be rather dangerous for people walking (I have fallen twice).
- ❖ We are proposing excavating this area to be at the same elevation of the door to eliminate this uneven surface and remove the small brick retaining wall.

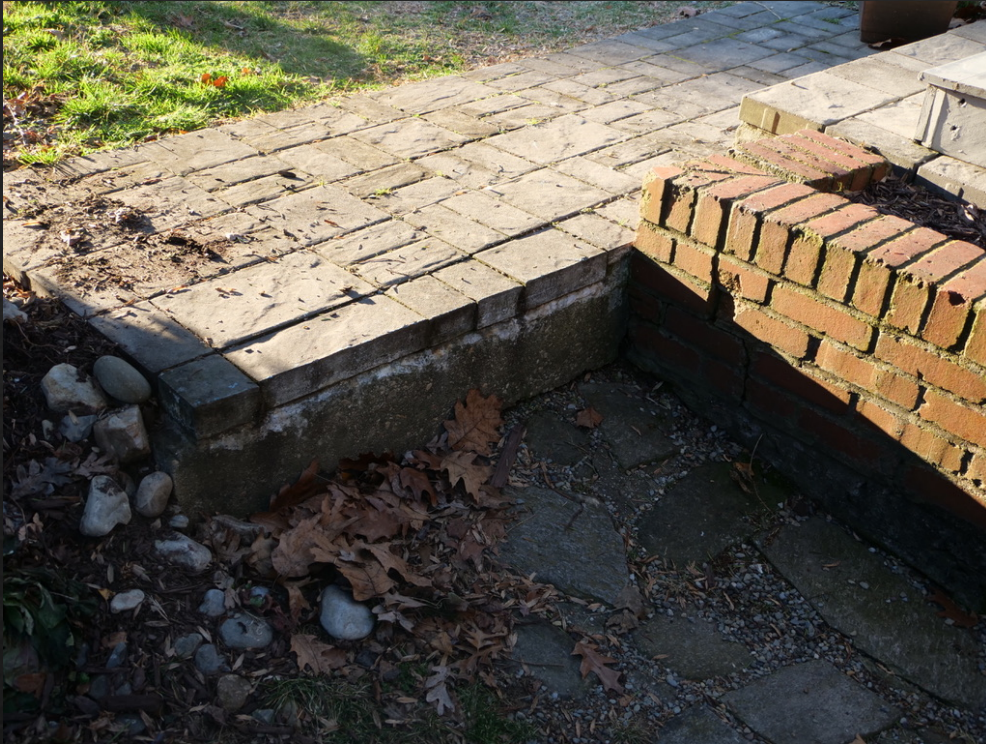
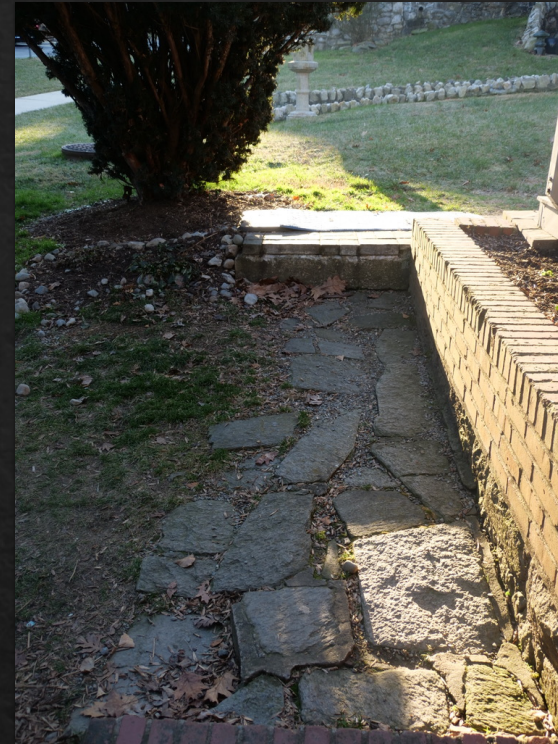
As can be seen in these images the existing stone pathway is extremely uneven and the stair at near the small existing patio (positioned on an old concrete slab by previous owner) is uncomfortably high and without a railing which makes it very uncomfortable and dangerous for guests or visitors.

The uneven and high step from the upper patio will be replaced with 2 stairs down to a lower patio made from the material listed on the purchase order as 640059 ROCK, STEPS BLUE BROWN - 4'WD. 6-7" RISE 16" TREAD and shown in the picture on the right.

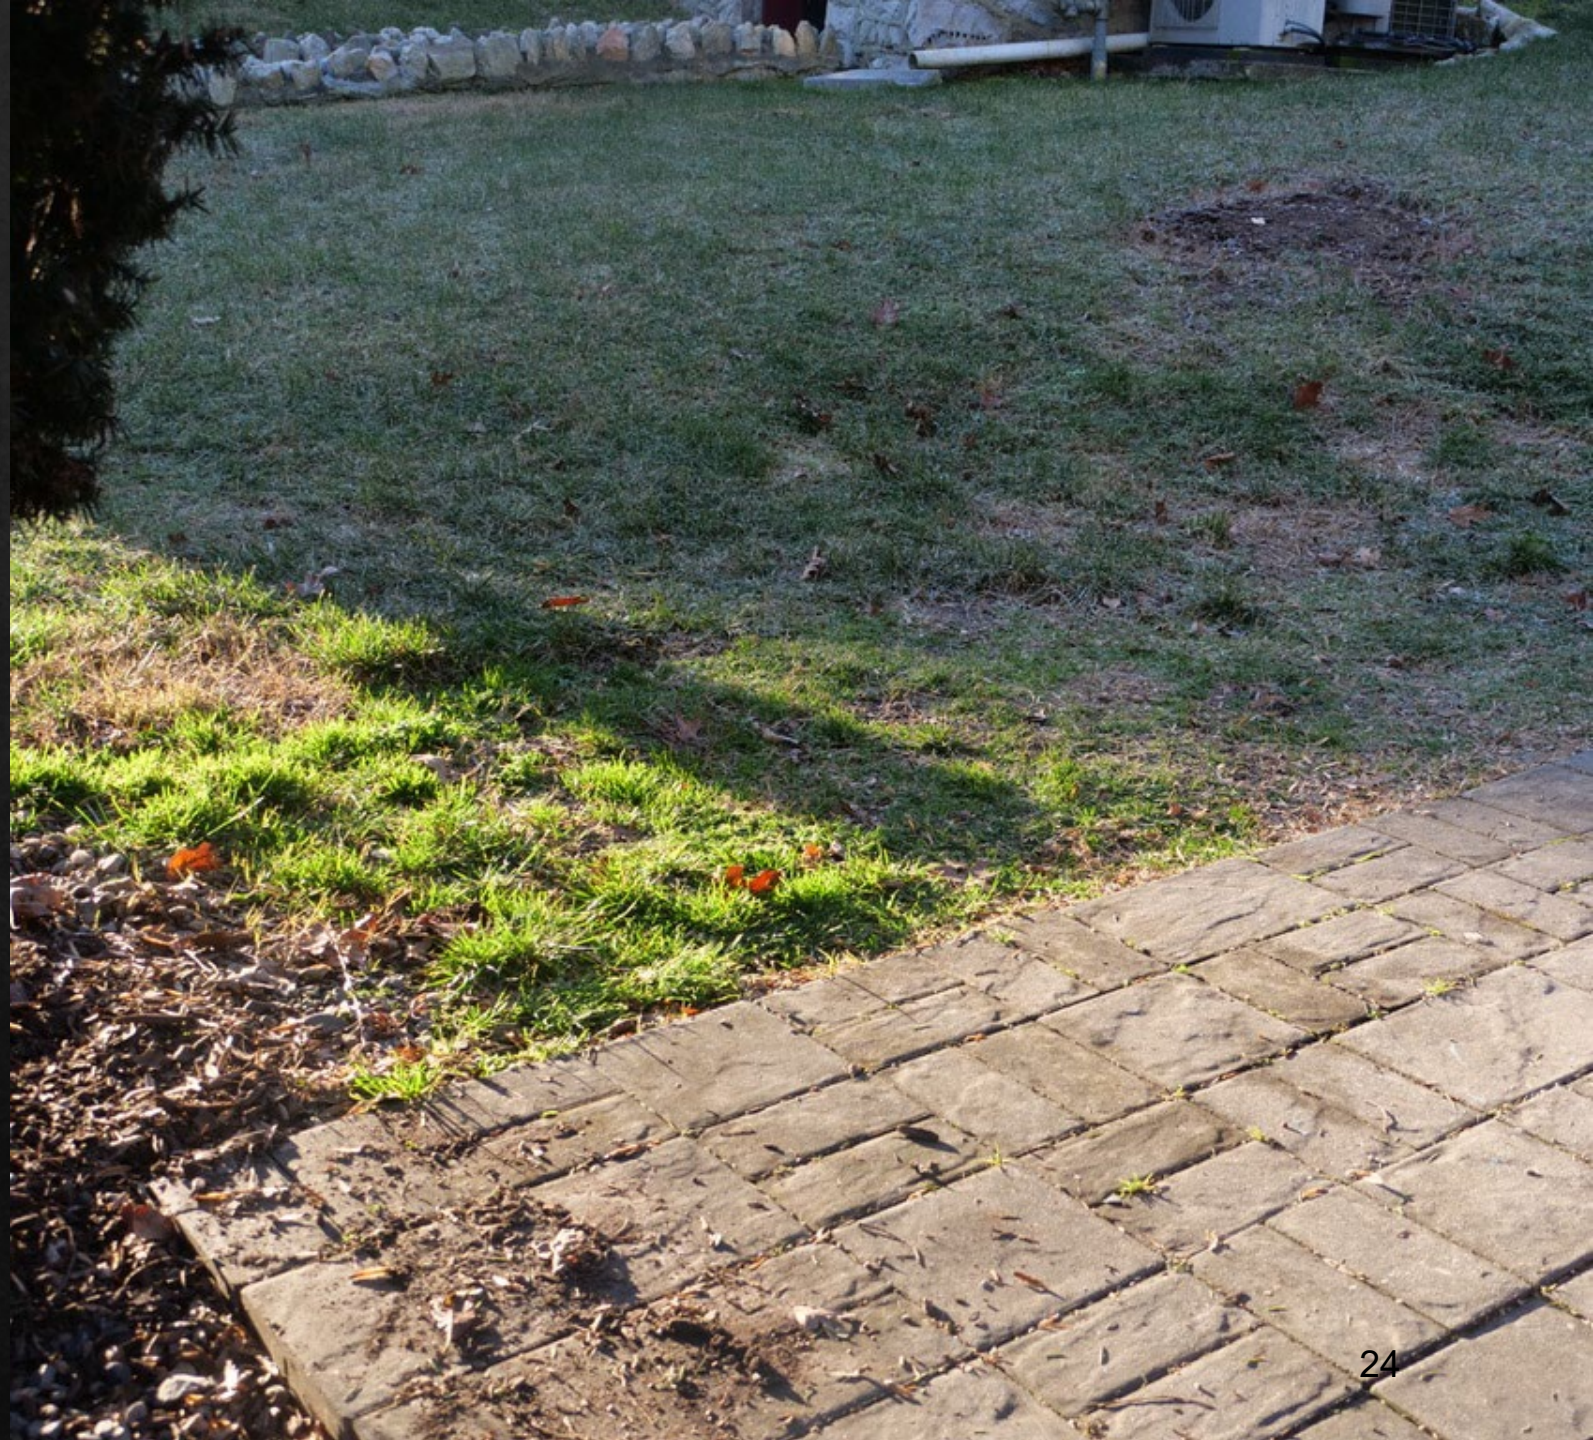
- ◆ Concrete pad extends into the yard at least 3 more feet.
- ◆ We are continually adding soil and grass seed in an attempt to keep grass growing but during heavy rains it washes away and the soil is less than 1 inch deep here.

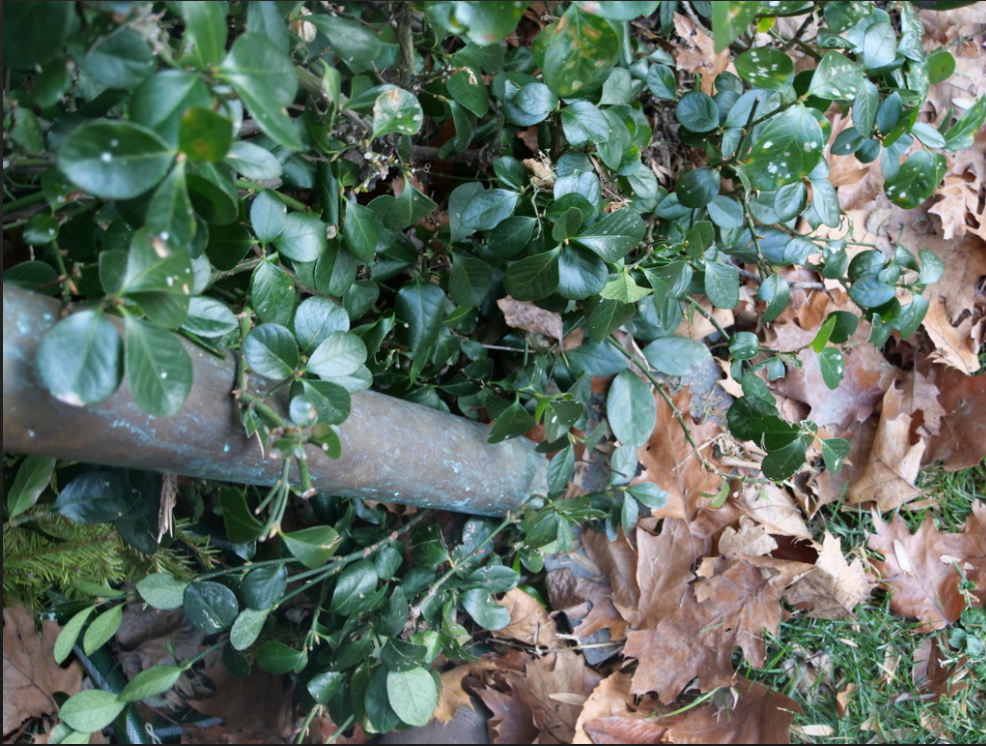
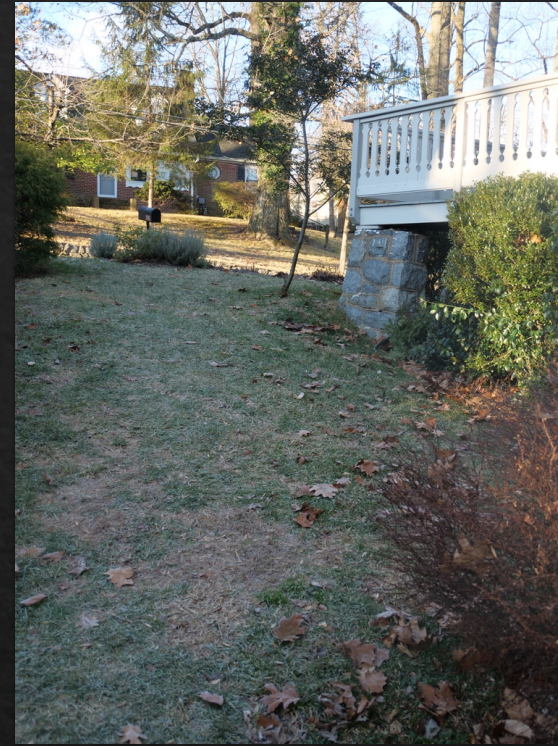
Due to slope of the yard and the fact that the gutters were placed directly into the dirt by the previous owner during heavy rain storms we have a large amount of water sitting behind the existing retaining wall. We will add drains to mitigate this problem.
