MONTGOMERY COUNTY HISTORIC PRESERVATION COMMISSION

Address:	9923 Sutherland Rd., Silver Spring	Meeting Date:	11/17/2021
Resource:	Contributing Resource Polychrome Historic District	Report Date:	11/10/2021
Applicant:	Alicia Gilbert	Public Notice:	11/3/2021
Review:	HAWP	Tax Credit:	n/a
Case No.:	967878	Staff:	Dan Bruechert
Proposal:	Front Door Replacement

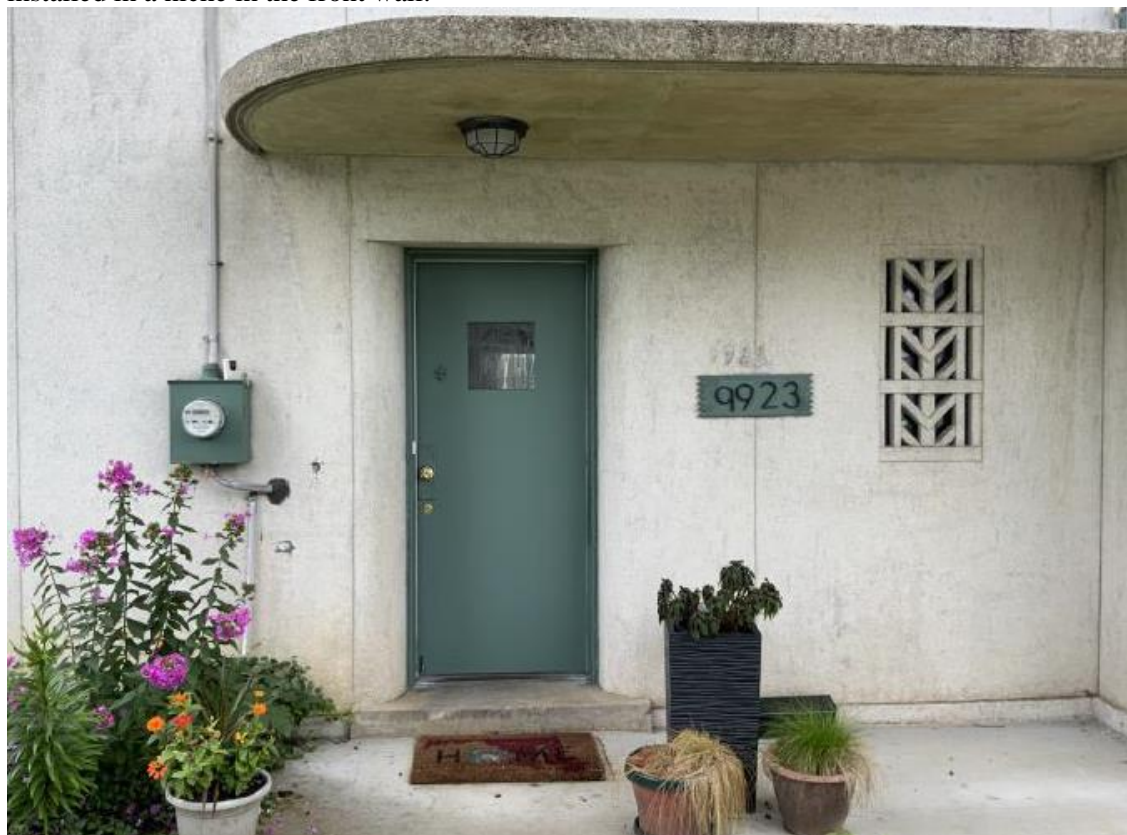
Figure 2: Front door of the subject property.

The existing front door is a wood, flat panel door, with a small single square window (see below), installed in a niche in the front wall.

The front door appears to be original based on Staff's review of HP photos, site visits, and the condition of the other Polychrome houses. The simple design would have been selected so that it does not detract from the house's decorative concrete walls. Unlike the windows, which were selected to align with decorative features on the walls, it appears the door was selected to visually recede and not distract from the house's highly decorative elements.

The door and jamb have degraded over the years and there are gaps between the door and the jamb to the point that light is visible in the gaps between (see the application). Staff finds the door has degraded beyond repair and that a replacement door is appropriate.

The applicant proposes to install a smooth fiberglass three-lite door to fit the existing opening. The door will be painted to match the house's architectural elements.

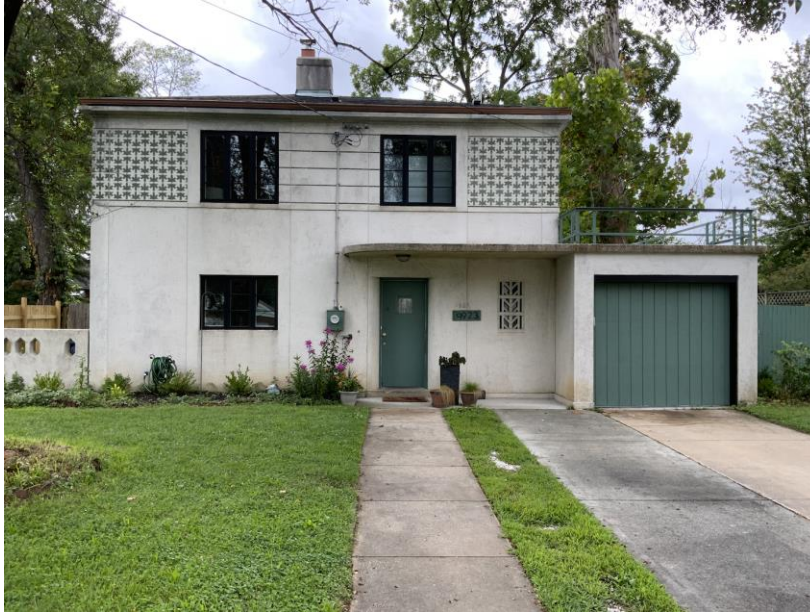
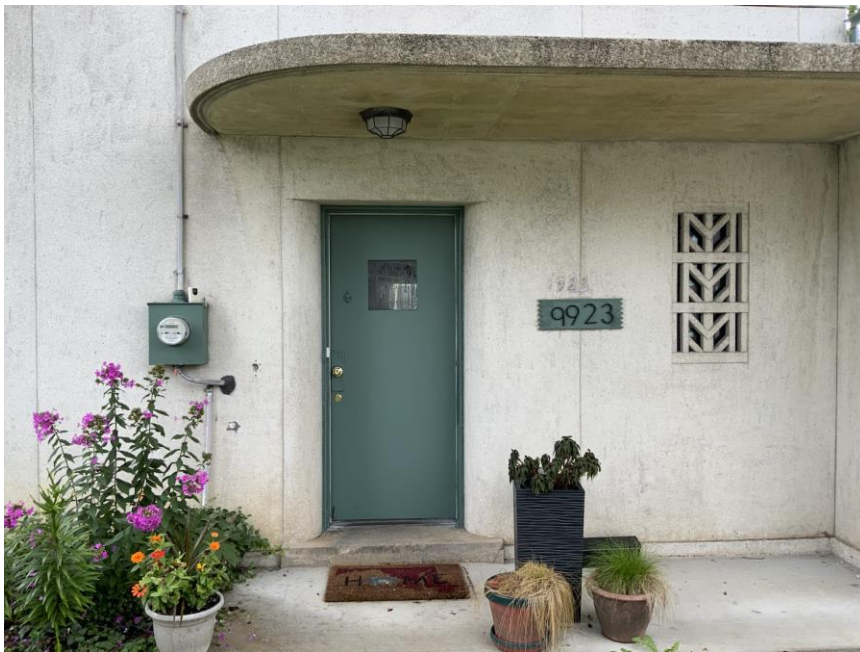
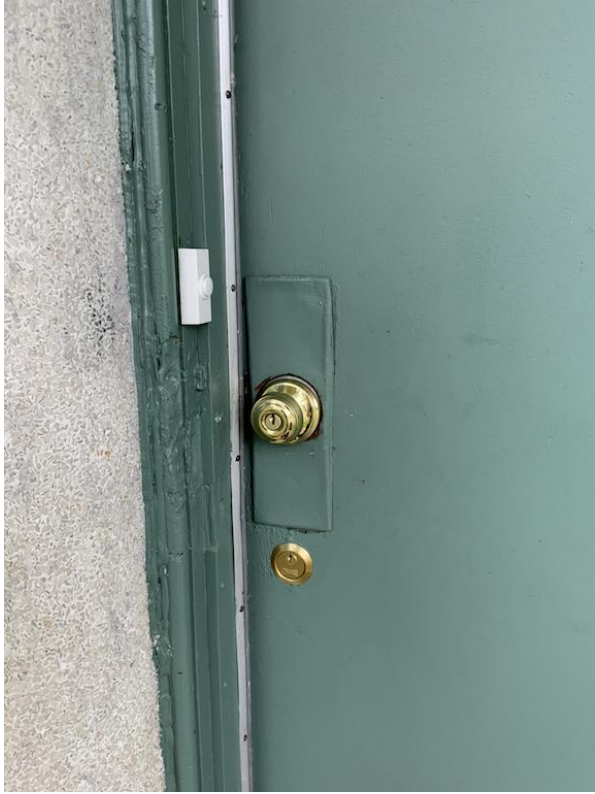
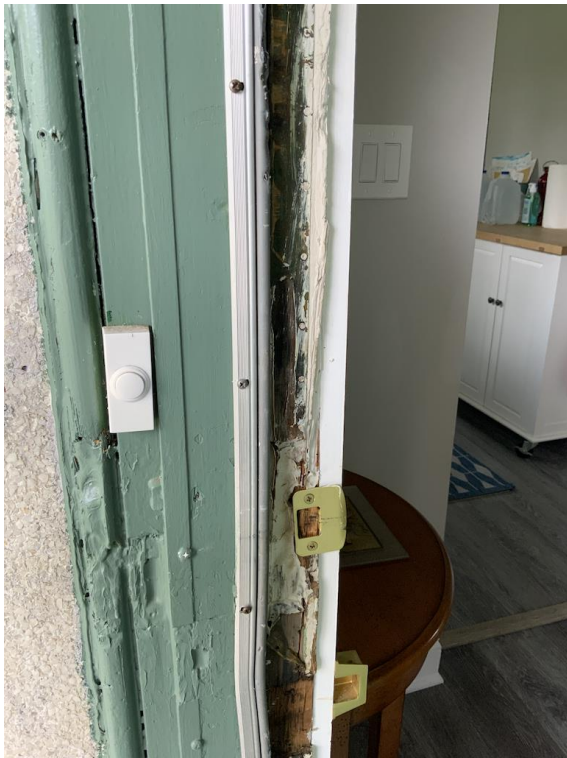
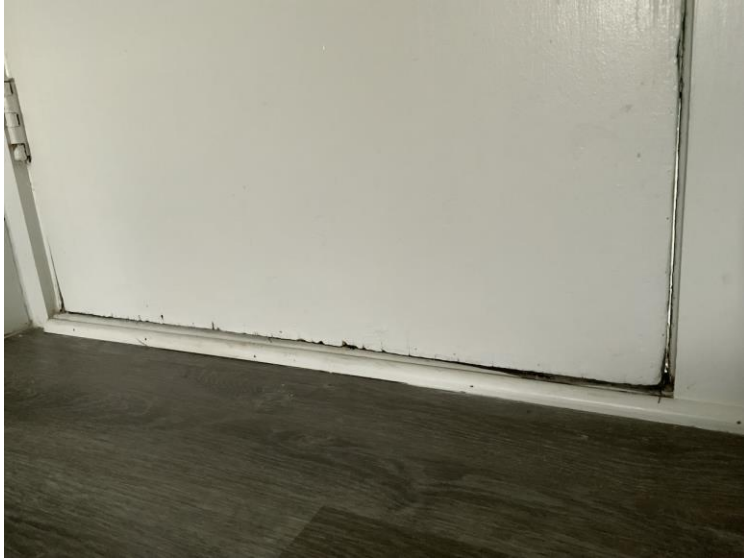
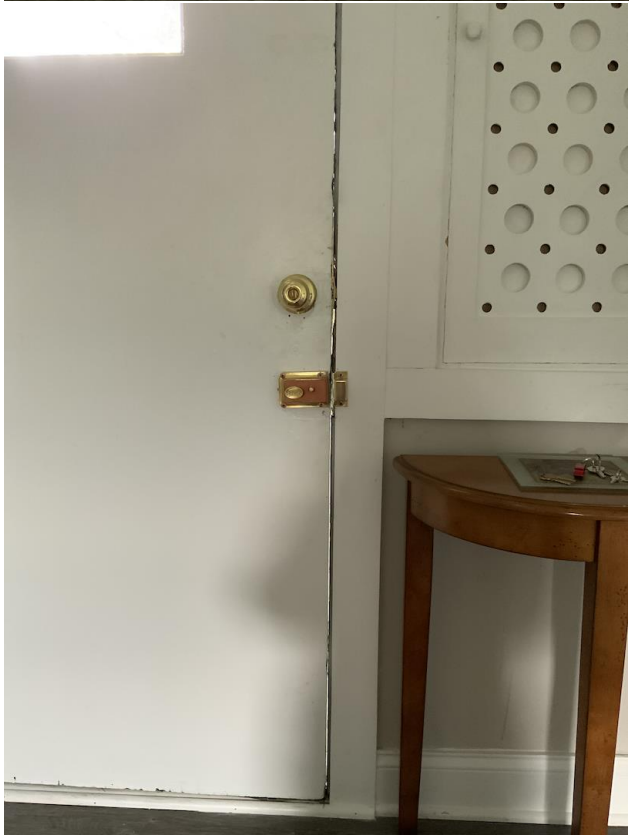
Photos of current door:

The front door, in its current condition, is deteriorating and leaks at the bottom during driving rain storms. There are large gaps between the door slab and door frame. The door knob and lock set are not secure. There is little wood left in the door jamb to allow repair of the weather stripping or to install a more secure door handle and deadbolt lock.

The current condition of the front door at 9923 Sutherland Rd is deteriorating and leaks at the bottom during driving rainstorms. There are large gaps around the door and the lock is not secure. There is no more wood left on the jamb to repair the weather-stripping or install another door handle or lock.

The proposed work will be performed by a licensed contractor, Ace Home Services (MHIC # 74289). The old door and door frame will be removed. The new door and frame will be installed. The door will be painted black to match the windows or green to match the maple leaf mosaic pattern.
