MONTGOMERY COUNTY HISTORIC PRESERVATION COMMISSION STAFF REPORT			
19 Montgomery Avenue, Takoma Park	Meeting Date:	3/23/2022	
Outstanding Resource Takoma Park Historic District	Report Date:	3/16/2022	
	Public Notice:	3/9/2022	
(Richard J Vitullo, Architect)	Tax Credit:	N/A	
Preliminary Consultation	Staff:	Michael Kyne	
	STAFF REPORT 19 Montgomery Avenue, Takoma Park Outstanding Resource Takoma Park Historic District Marwan Hishmeh (Richard J Vitullo, Architect)	STAFF REPORT19 Montgomery Avenue, Takoma ParkMeeting Date:Outstanding ResourceReport Date:Takoma Park Historic DistrictPublic Notice:Marwan Hishmeh (Richard J Vitullo, Architect)Tax Credit:

Preliminary Consultation

Permit Number: 984286 & 975312

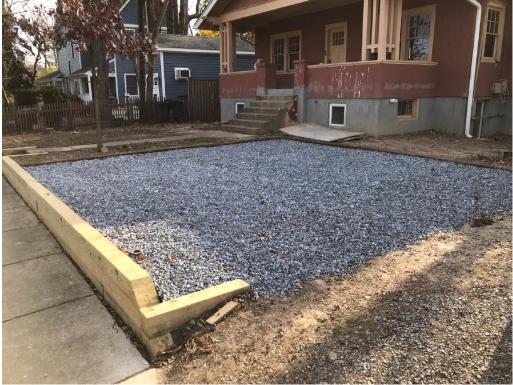
Fig. 3: Staff's December 2021 site visit photograph, with the unpermitted gravel parking pad in the foreground.

Staff notes that they would not have supported the parking pad at the front of the property, as front parking pads are incompatible with the surrounding streetscape and with the historic district as a whole.

In a March 14, 2022 email to staff, the applicant stated that other unpermitted work items at the front and right side of the property, including construction of the gravel parking pad at the front of the property and installation of the new egress window with window well at the basement level on the west/right side of the historic house, have been remediated. <u>The applicant should be prepared to present current</u> photographs and supporting documentation to demonstrate that these items have been appropriately remediated at the March 23, 2022 preliminary consultation.

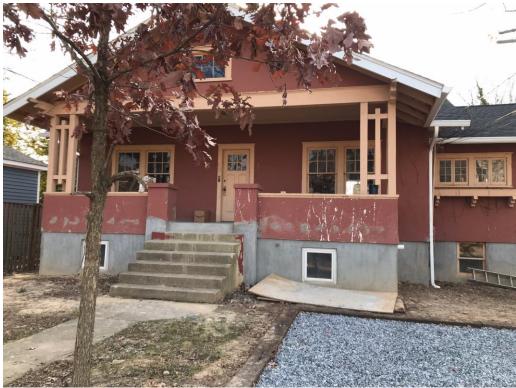
Fig. 4: Staff's December 2021 site visit photograph, showing the unpermitted windows on the basement level of the front porch.

Staff notes that they would not have supported the new basement level windows on the front porch. While the Commission typically exercises greater leniency for basement level fenestration alterations on secondary elevations, the windows in question were on the primary elevation, where they were highly visible, and they altered the original front porch, a significant character-defining feature of the subject property.

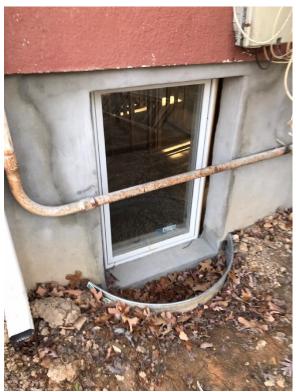
Fig. 5: Staff's December 2021 site visit photograph, showing the unpermitted basement level egress window with window well on the west/right side of the historic house.

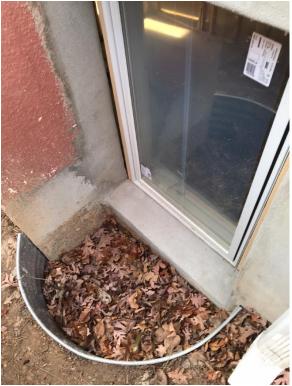
Fig. 6: Staff's December 2021 site visit photograph, showing the unpermitted basement level egress window with window well on the east/left side of the historic house.

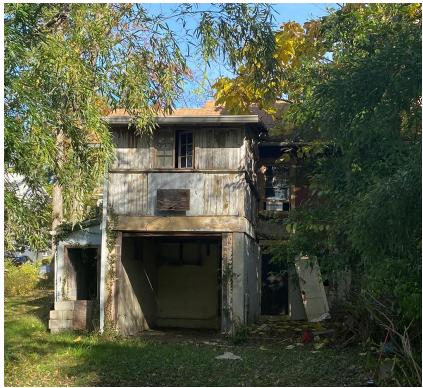
Fig. 7: Previously existing conditions at the rear of the historic house. Photograph provided by the applicant.

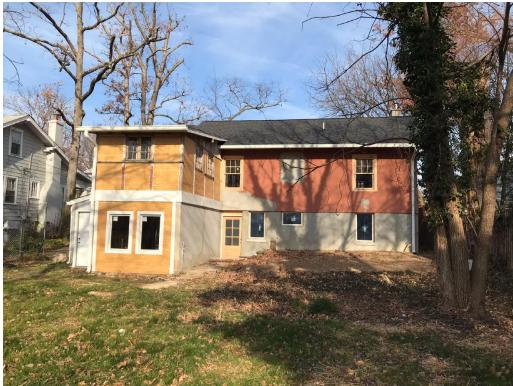
Fig. 8: Staff's December 2021 site visit photograph, showing unpermitted work at the rear of the historic house.

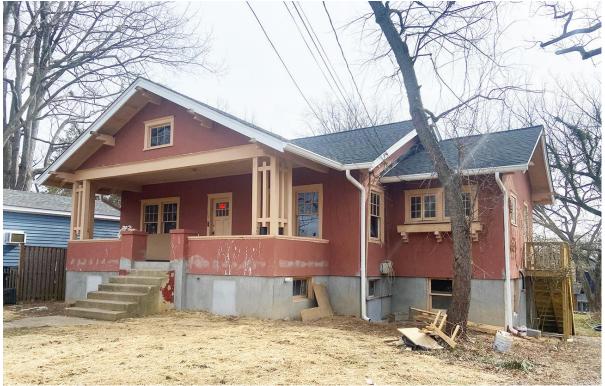
Fig. 9: Current photograph from the applicant, showing that the unpermitted basement level windows on the front porch have been removed.

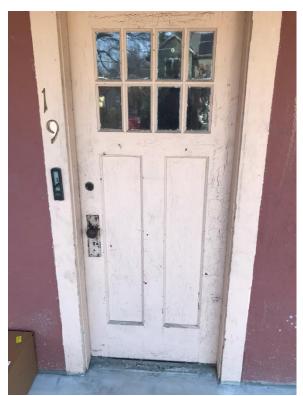
Fig. 10: Staff's December 2021 site visit photograph, showing the existing (perhaps original) front door, which is no longer proposed to be replaced.
