***EXPEDITED***  
**MONTGOMERY COUNTY HISTORIC PRESERVATION COMMISSION**  
**STAFF REPORT**

<b>Address:</b>	513 Philadelphia Ave., Takoma Park	<b>Meeting Date:</b>	4/20/2022
<b>Resource:</b>	Contributing Resource <b>Takoma Park Historic District</b>	<b>Report Date:</b>	4/13/2022
<b>Applicant:</b>	James Tate	<b>Public Notice:</b>	4/6/2022
<b>Review:</b>	HAWP	<b>Tax Credit:</b>	Partial
<b>Case No.:</b>	990356	<b>Staff:</b>	Dan Bruechert
<b>Proposal:</b>	Hardscape Alterations

# SITE AND EXTERIOR IMPROVEMENTS

21 MARCH 2022 (Rev. 07 APRIL)  
SCOPE OF WORK INDEX

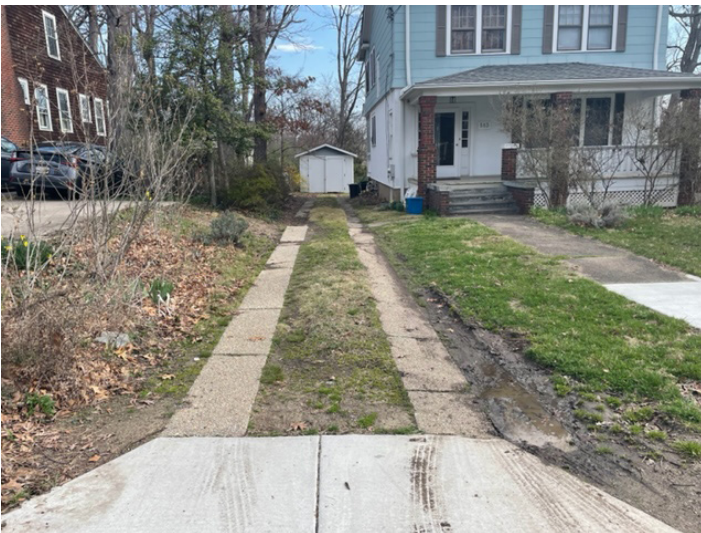
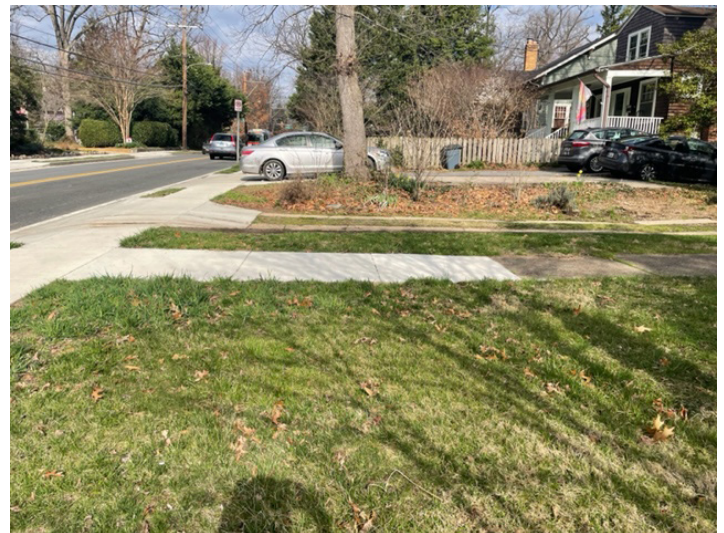
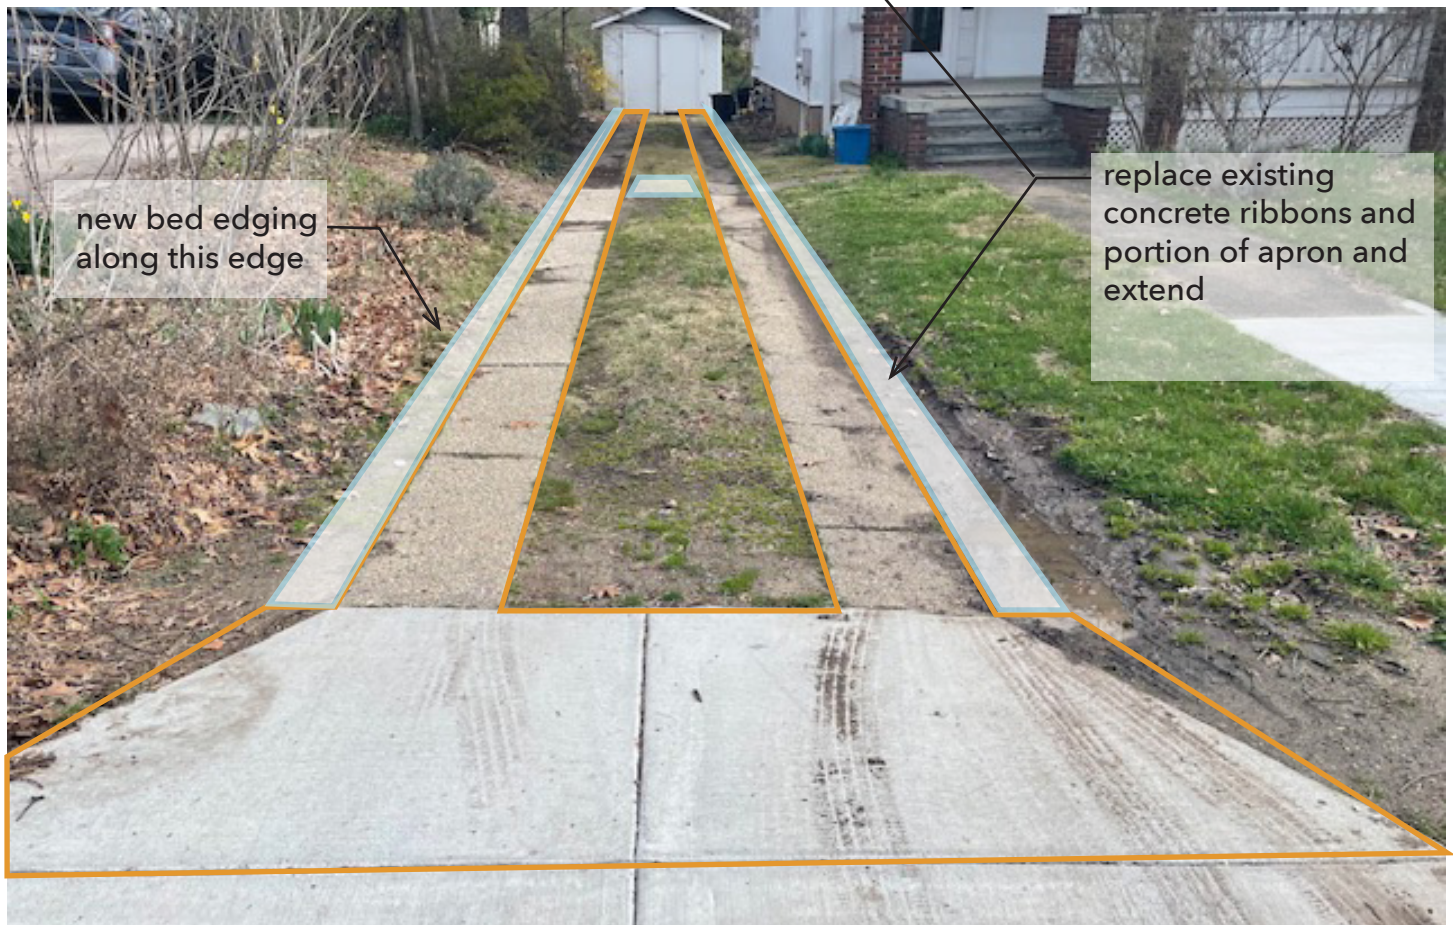
The existing concrete ribbon driveway is cracked and damaged after decades of use, tree root upheaval and uneven settling. It appears to have been repaired or replaced at some point as two different aggregates are apparent. The existing sub-surface conditions are unknown. The surrounding earth is heavily compacted with some gravel present and drainage is poor.

driveway looking east

driveway looking north

(a) Replace the entirety of the concrete ribbons in kind matching exposed aggregate finish and add a new trench drain at garage apron. Ribbons are to be extended 12" on both outside edges (each to be 32" wide). Existing material and surrounding earth are to be removed and replaced as needed to prepare a new setting bed and (b) install a new central french drain along the length of the driveway, to connect to trench drain and drain to daylight. The widening of the hard-scaped surface is to meet the specs of contemporary vehicles and eliminate damage to adjacent yard and bed.

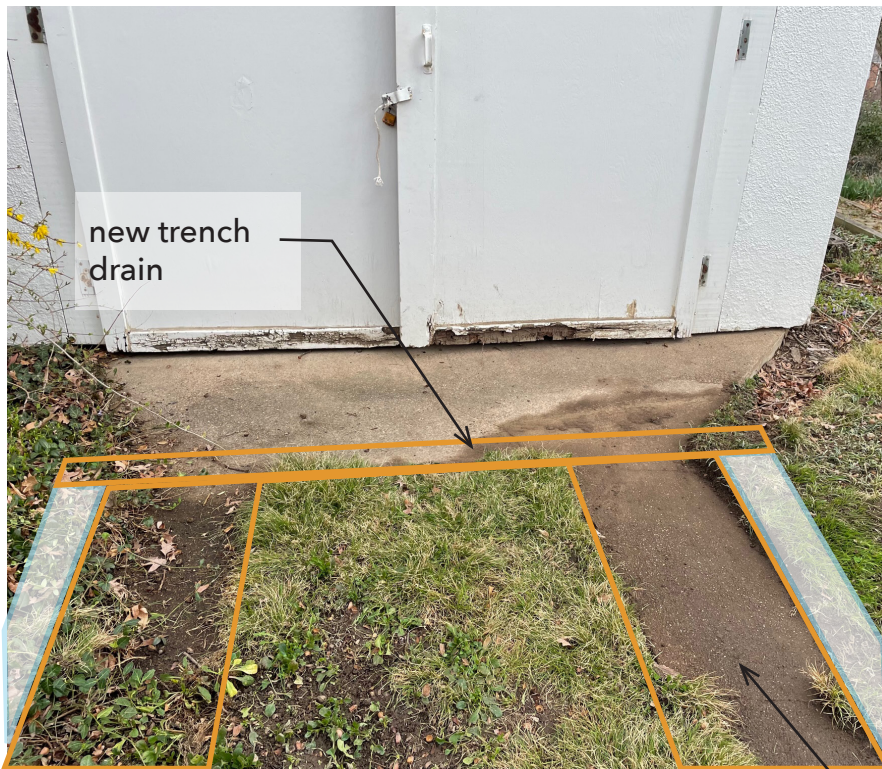
apron at garage

Overall, the grade will be adjusted to adequately meet the new existing MDOE installed concrete apron elevation, and will slope toward the rear trench drain at the garage apron. If permissible, we would like to replace a portion of the MDOE installed apron to match the width of the new ribbons; work to be approved and permitted by MDOE. (d) The garden bed to the north of the driveway will need new edging where it meets the driveway to mitigate various degrees of grade change that occur between the lot line and the driveway edge. A simple metal edging is anticipated.

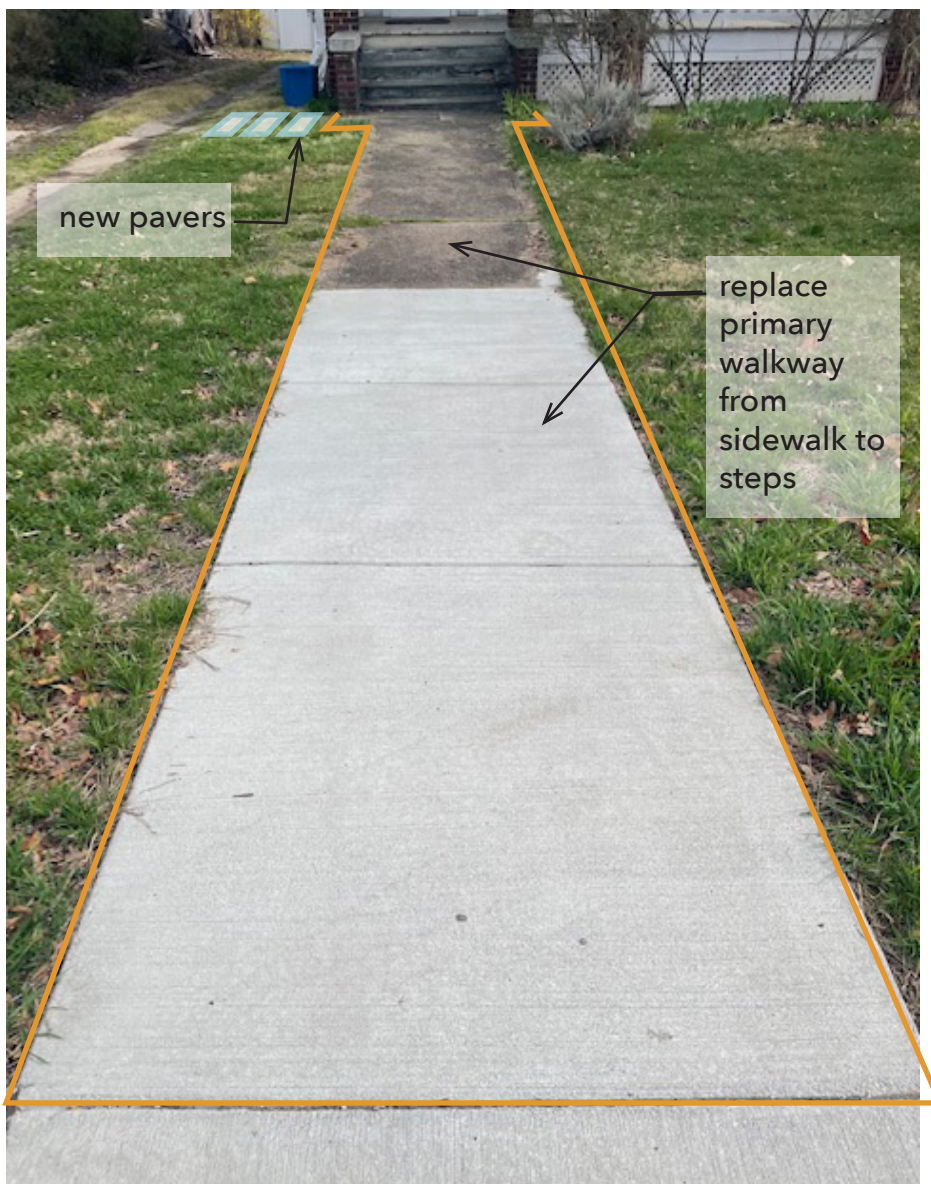
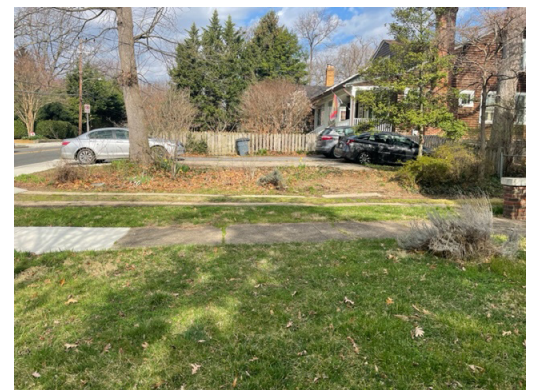
A portion of the existing concrete walkway was replaced by MDOE in 2021. The original concrete walkway is an exposed aggregate with a scored edge border and divisions every 60". Portions are cracking and uneven due to settling over time, especially near the stair.

walkway looking east

walkway looking north

The existing walkway is to be removed and the primary walkway is to be replaced in kind for the full length, restoring the original aesthetic to the sidewalk edge. The side path to the driveway will be replaced with large format pavers.

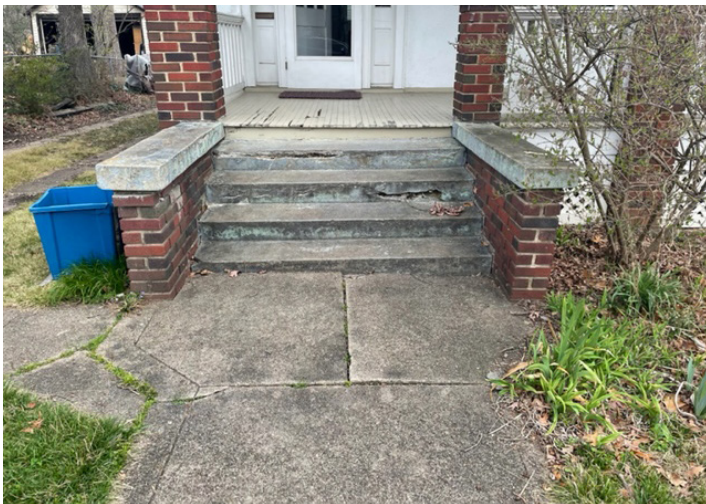
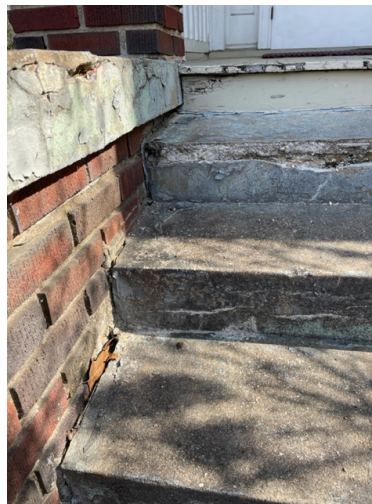
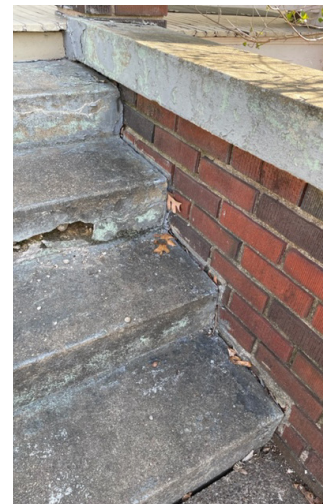
The existing concrete steps and masonry wing walls are settling, and cracking and the concrete is spalling.

stairs and wingwalls

detail views

The masonry wingwalls are to be repaired re-using the existing brick. Top courses of brick are to be carefully removed as needed until sound assembly is found. Salvaged brick are to be cleaned and prepped for re-installation. New mortar is to match existing. *These walls may require underpinning.* A new concrete stair is to be poured, matching the appearance, color and finish of the existing concrete. Stair to be re-aligned to original height and coordinated with slope of walkway; *install footing to frost line.* New concrete wingwall caps are to be installed (assuming these will be pre-cast) to match the existing in dimension, appearance, color and finish. New concrete will not be painted.

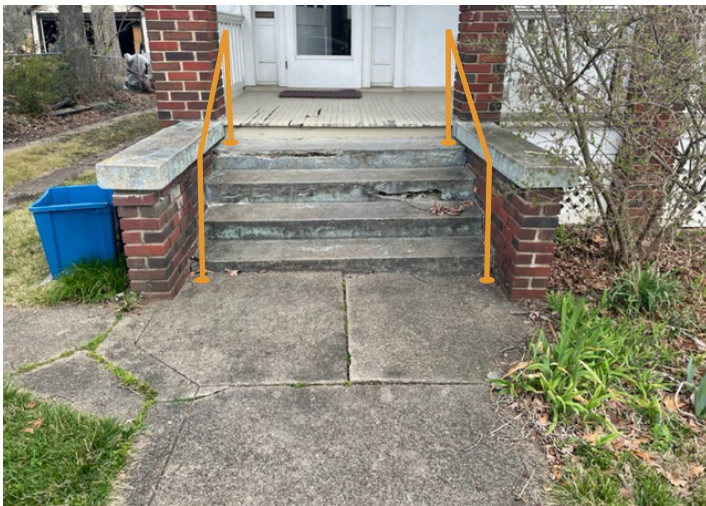
There is no existing handrail at porch stairs.

existing stairs

In coordination with item 3, install new painted single line wrought iron pipe rail 4-6" inside of wing wall. Metal work to have a smooth, architectural finish. Height to be 34min. to 36" per code.

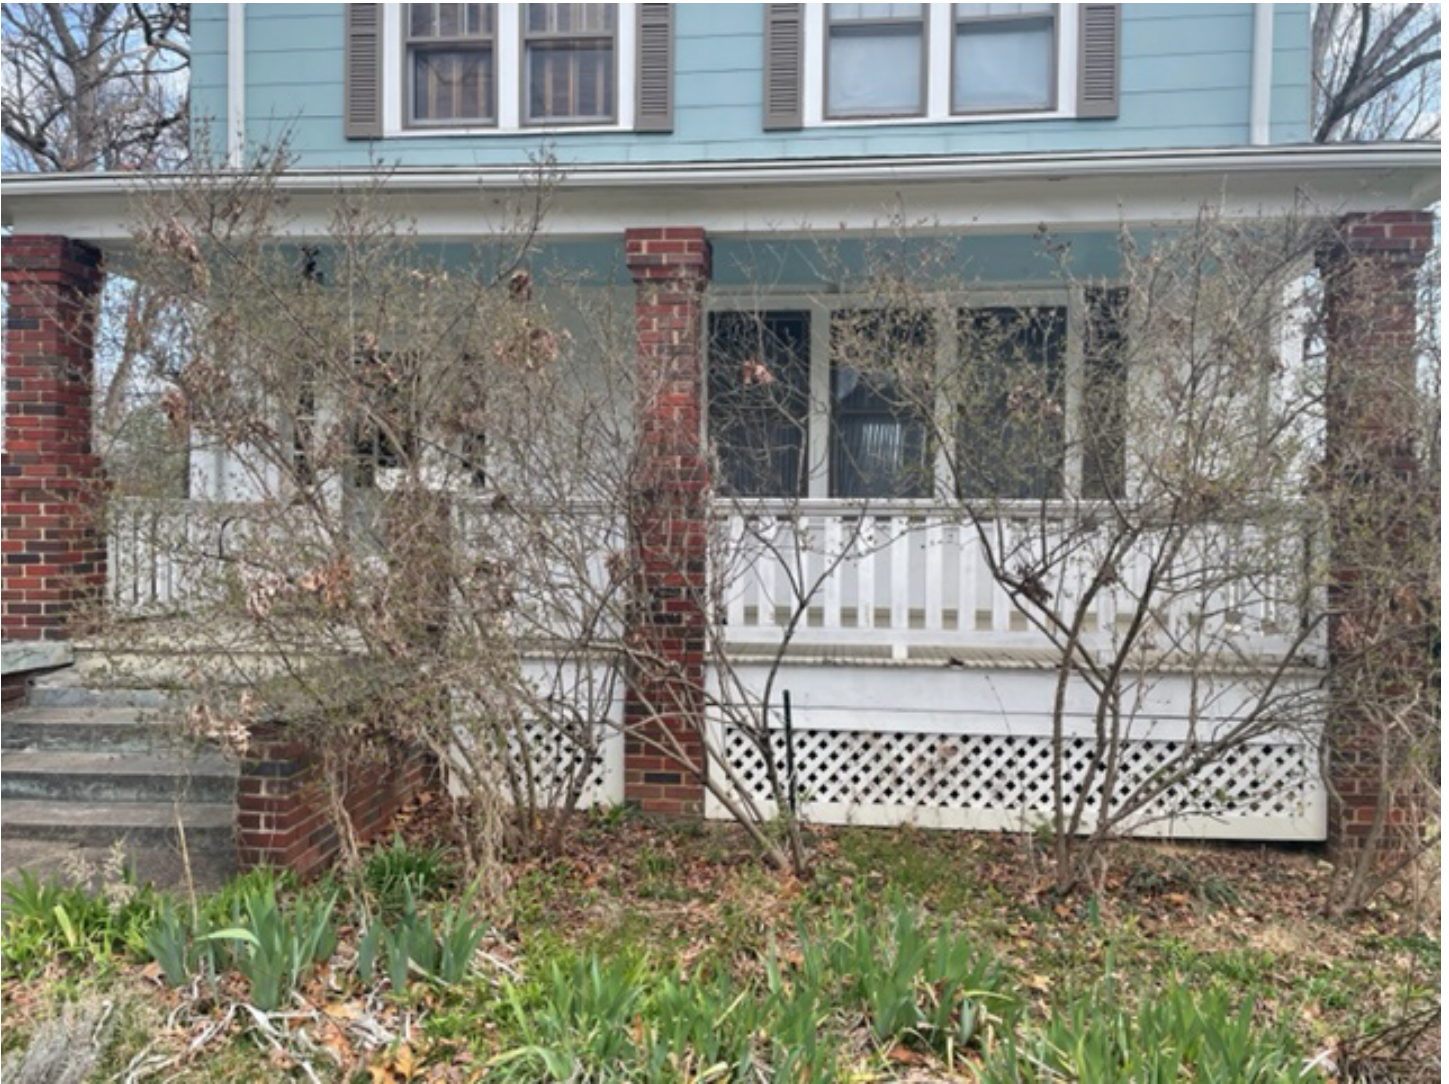
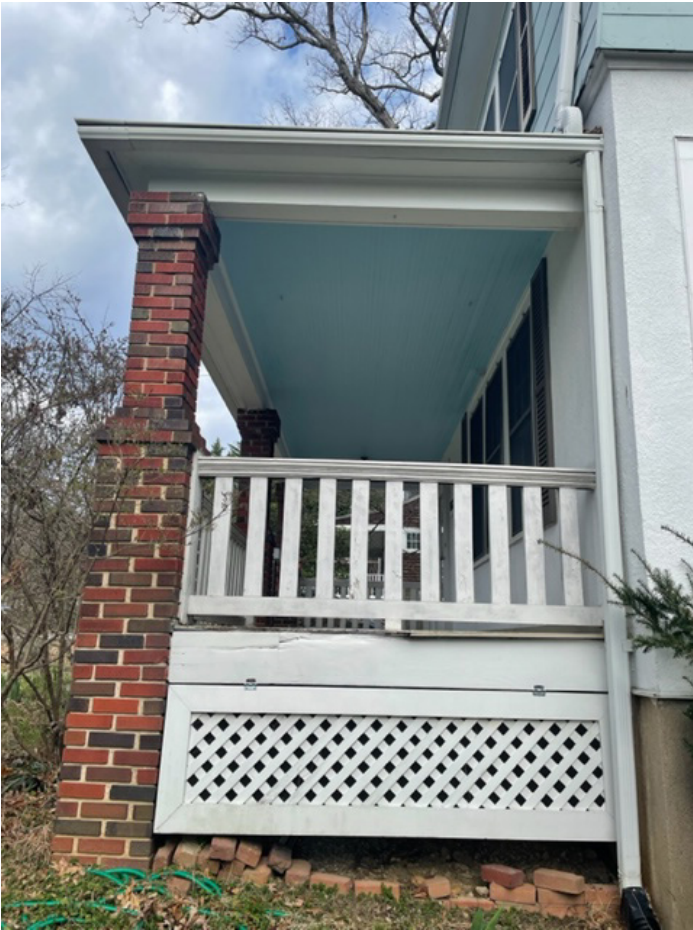
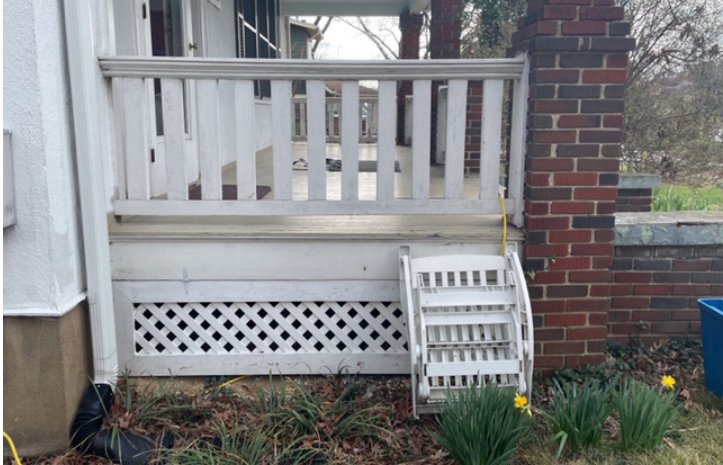
The existing front porch floor boards are failing throughout. Framing below is sagging at the entry, causing water to pool and preventing proper drainage.

west elevation of porch

south elevation of porch

north elevation of porch

Floor boards are to be replaced in entirety to match spec of original material (douglas fir, 3"x1" T&G boards). Framing below is to be adjusted to ensure proper slope and drainage, and flat porch boards. New floor boards are to be back primed and painted prior to installation. Skirt boards are to be patched or replaced in kind where compromised. Porch flooring, railings and lattice panels are to receive new paint.

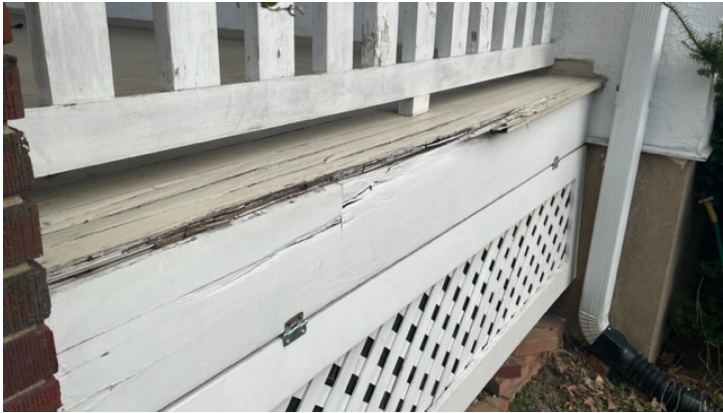
detail of damage at south end

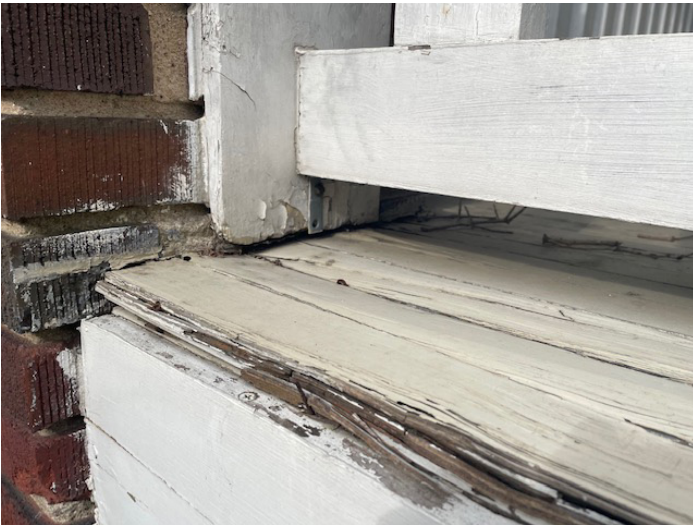
detail of damage at south end

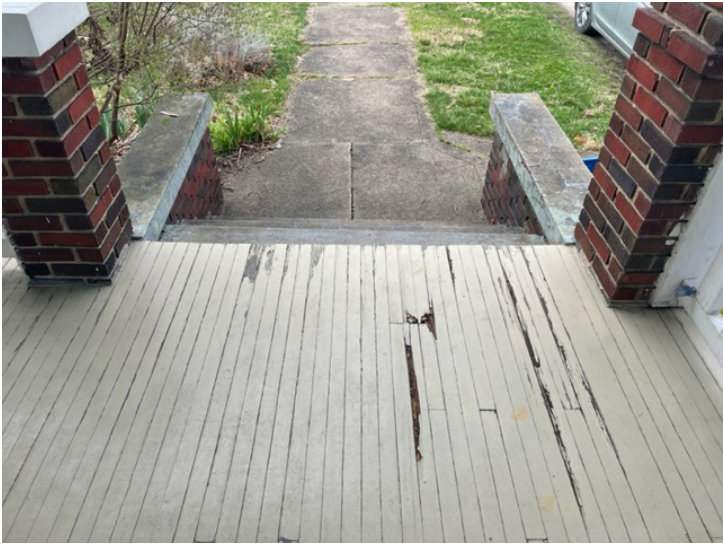
detail of damage at west edge / stair

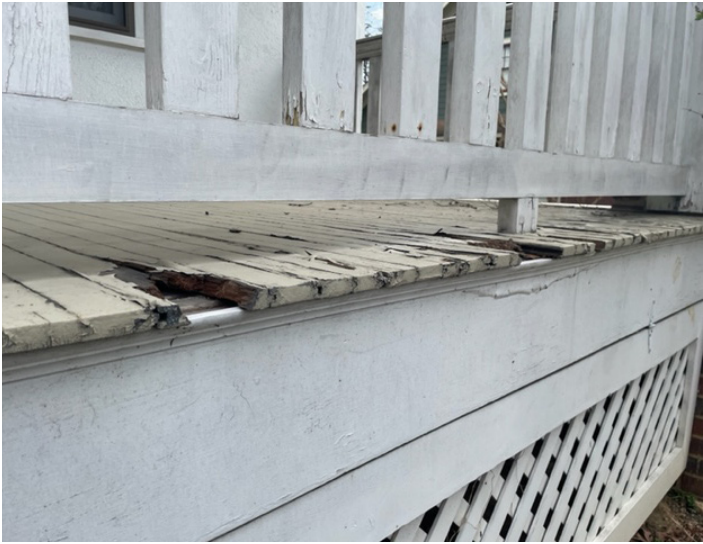
detail of damage at west edge (front)

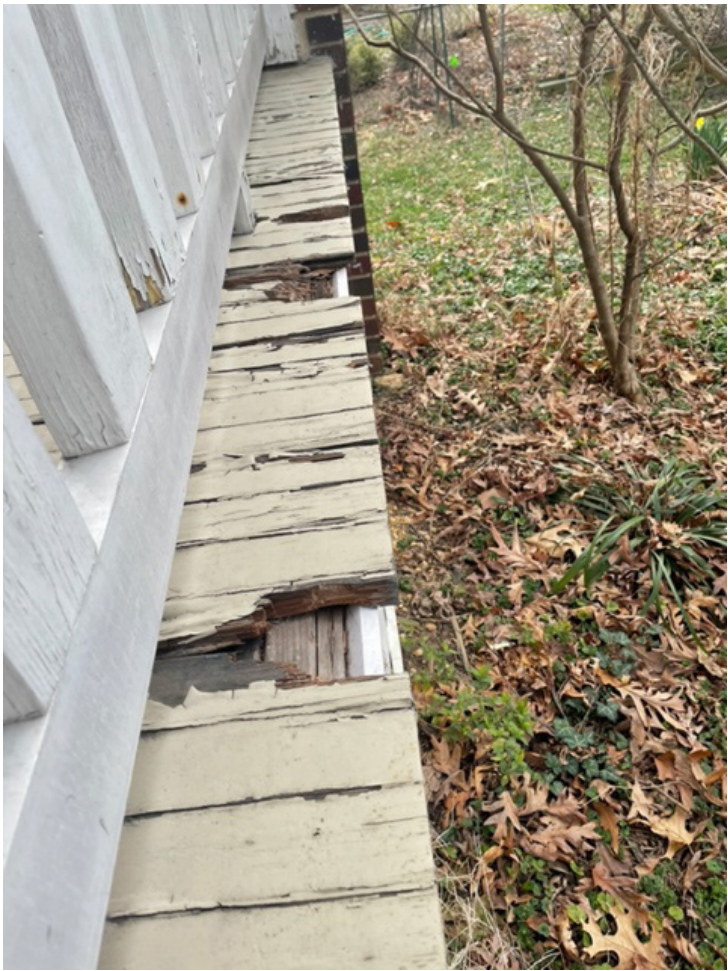
detail of damage at west edge (top)

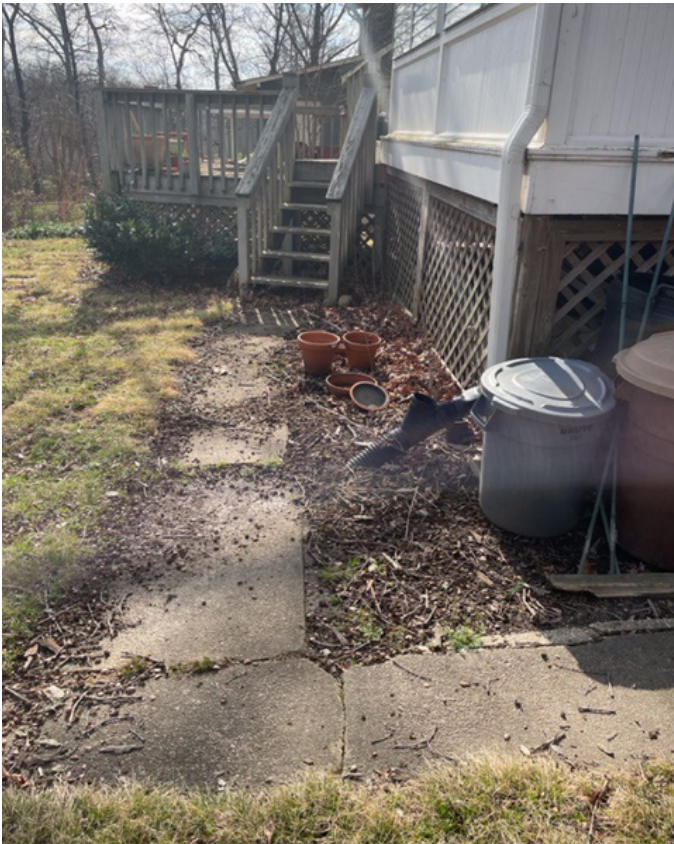
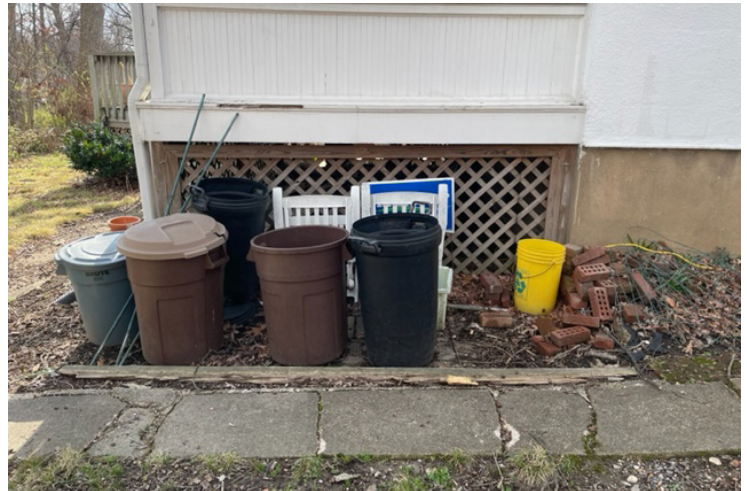
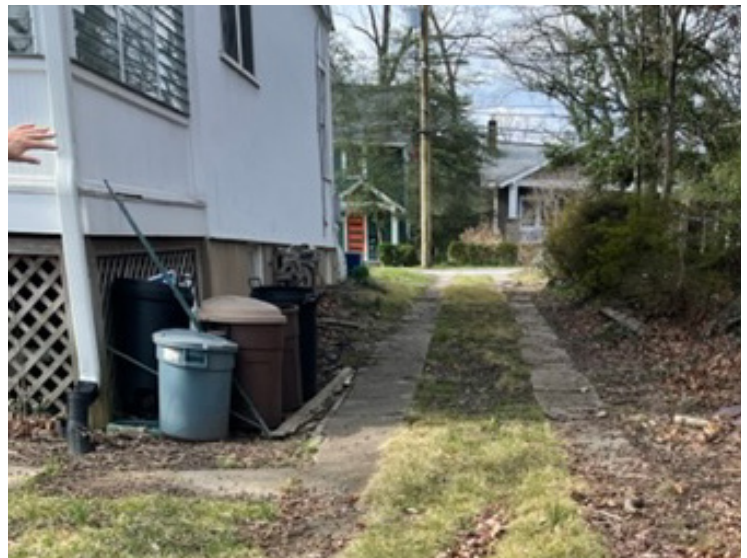
The existing rear walkway matches the original front walkway and ribbon driveway in material. There is a paved utility area for garbage and recycle bins where the walkway meets the driveway. The existing wood edging is deteriorated at this location.

walkway looking south

utility area

utility area and walkway

The walkway is to be removed and new large format pavers are to be installed. A new metal edging is to be installed at the perimeter of the planting bed next to the house. Care will need to be taken where the storm water drain runs below the sidewalk. The edging at the garbage / recycle bin area will need to be replaced in conjunction with the driveway work (item 1). New pavers may also be needed in this area, to be determined pending coordination with driveway work.

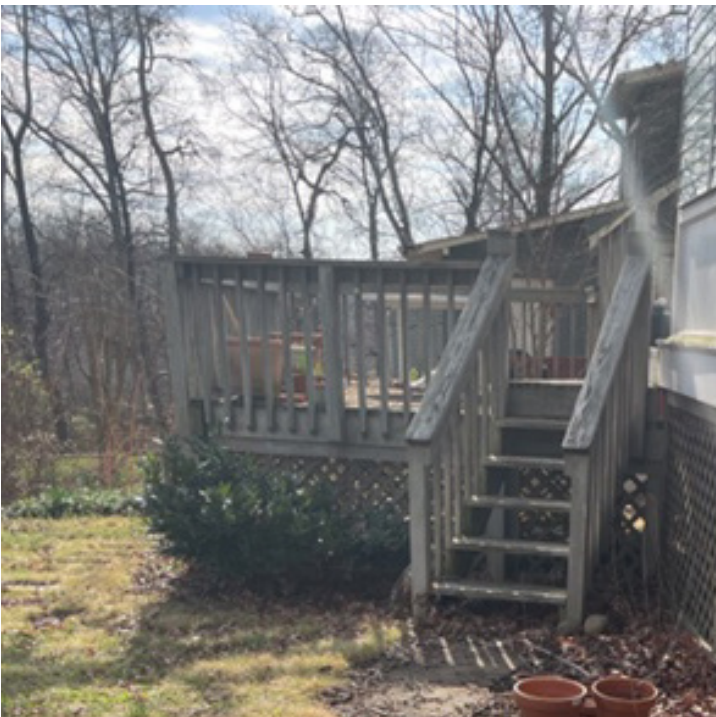
Existing Decking and top rails need to be replaced.

Verify overall structure of deck is sound prior to work. Replace deck boards, and top rails with new hardwood material (to be selected by owner). New deck boards shall be 5/4 x 4 or 6 w/ pre-grooved edges for blind fasteners (such as hulk fortress stainless steel, or similar). Deck boards shall be continuous wherever possible. New wood is to be left unfinished, to weather naturally. (Please provide pricing for Black Locust, Cypress, Garapa, Camaru, and Acetylated Radiata Pine (accoya lumber).) Stair structure to remain (this is grandfathered) and be resurfaced matching remainder of deck.
