MONTGOMERY COUNTY HISTORIC PRESERVATION COMMISSION
STAFF REPORT

Address:	7325 Carroll Avenue, Takoma Park	Meeting Date:	5/24/2023
Resource:	Contributing Resource Takoma Park Historic District	Report Date:	5/17/2023
Applicant:	Janet Hostetler & Anil Chaturvedi	Public Notice:	5/10/2023
Review:	HAWP	Tax Credit:	Yes
Permit Number:	1030069	Staff:	John Liebertz

PROPOSAL: Railing alterations, front porch repairs and rehabilitation, new storm door, and gutters.

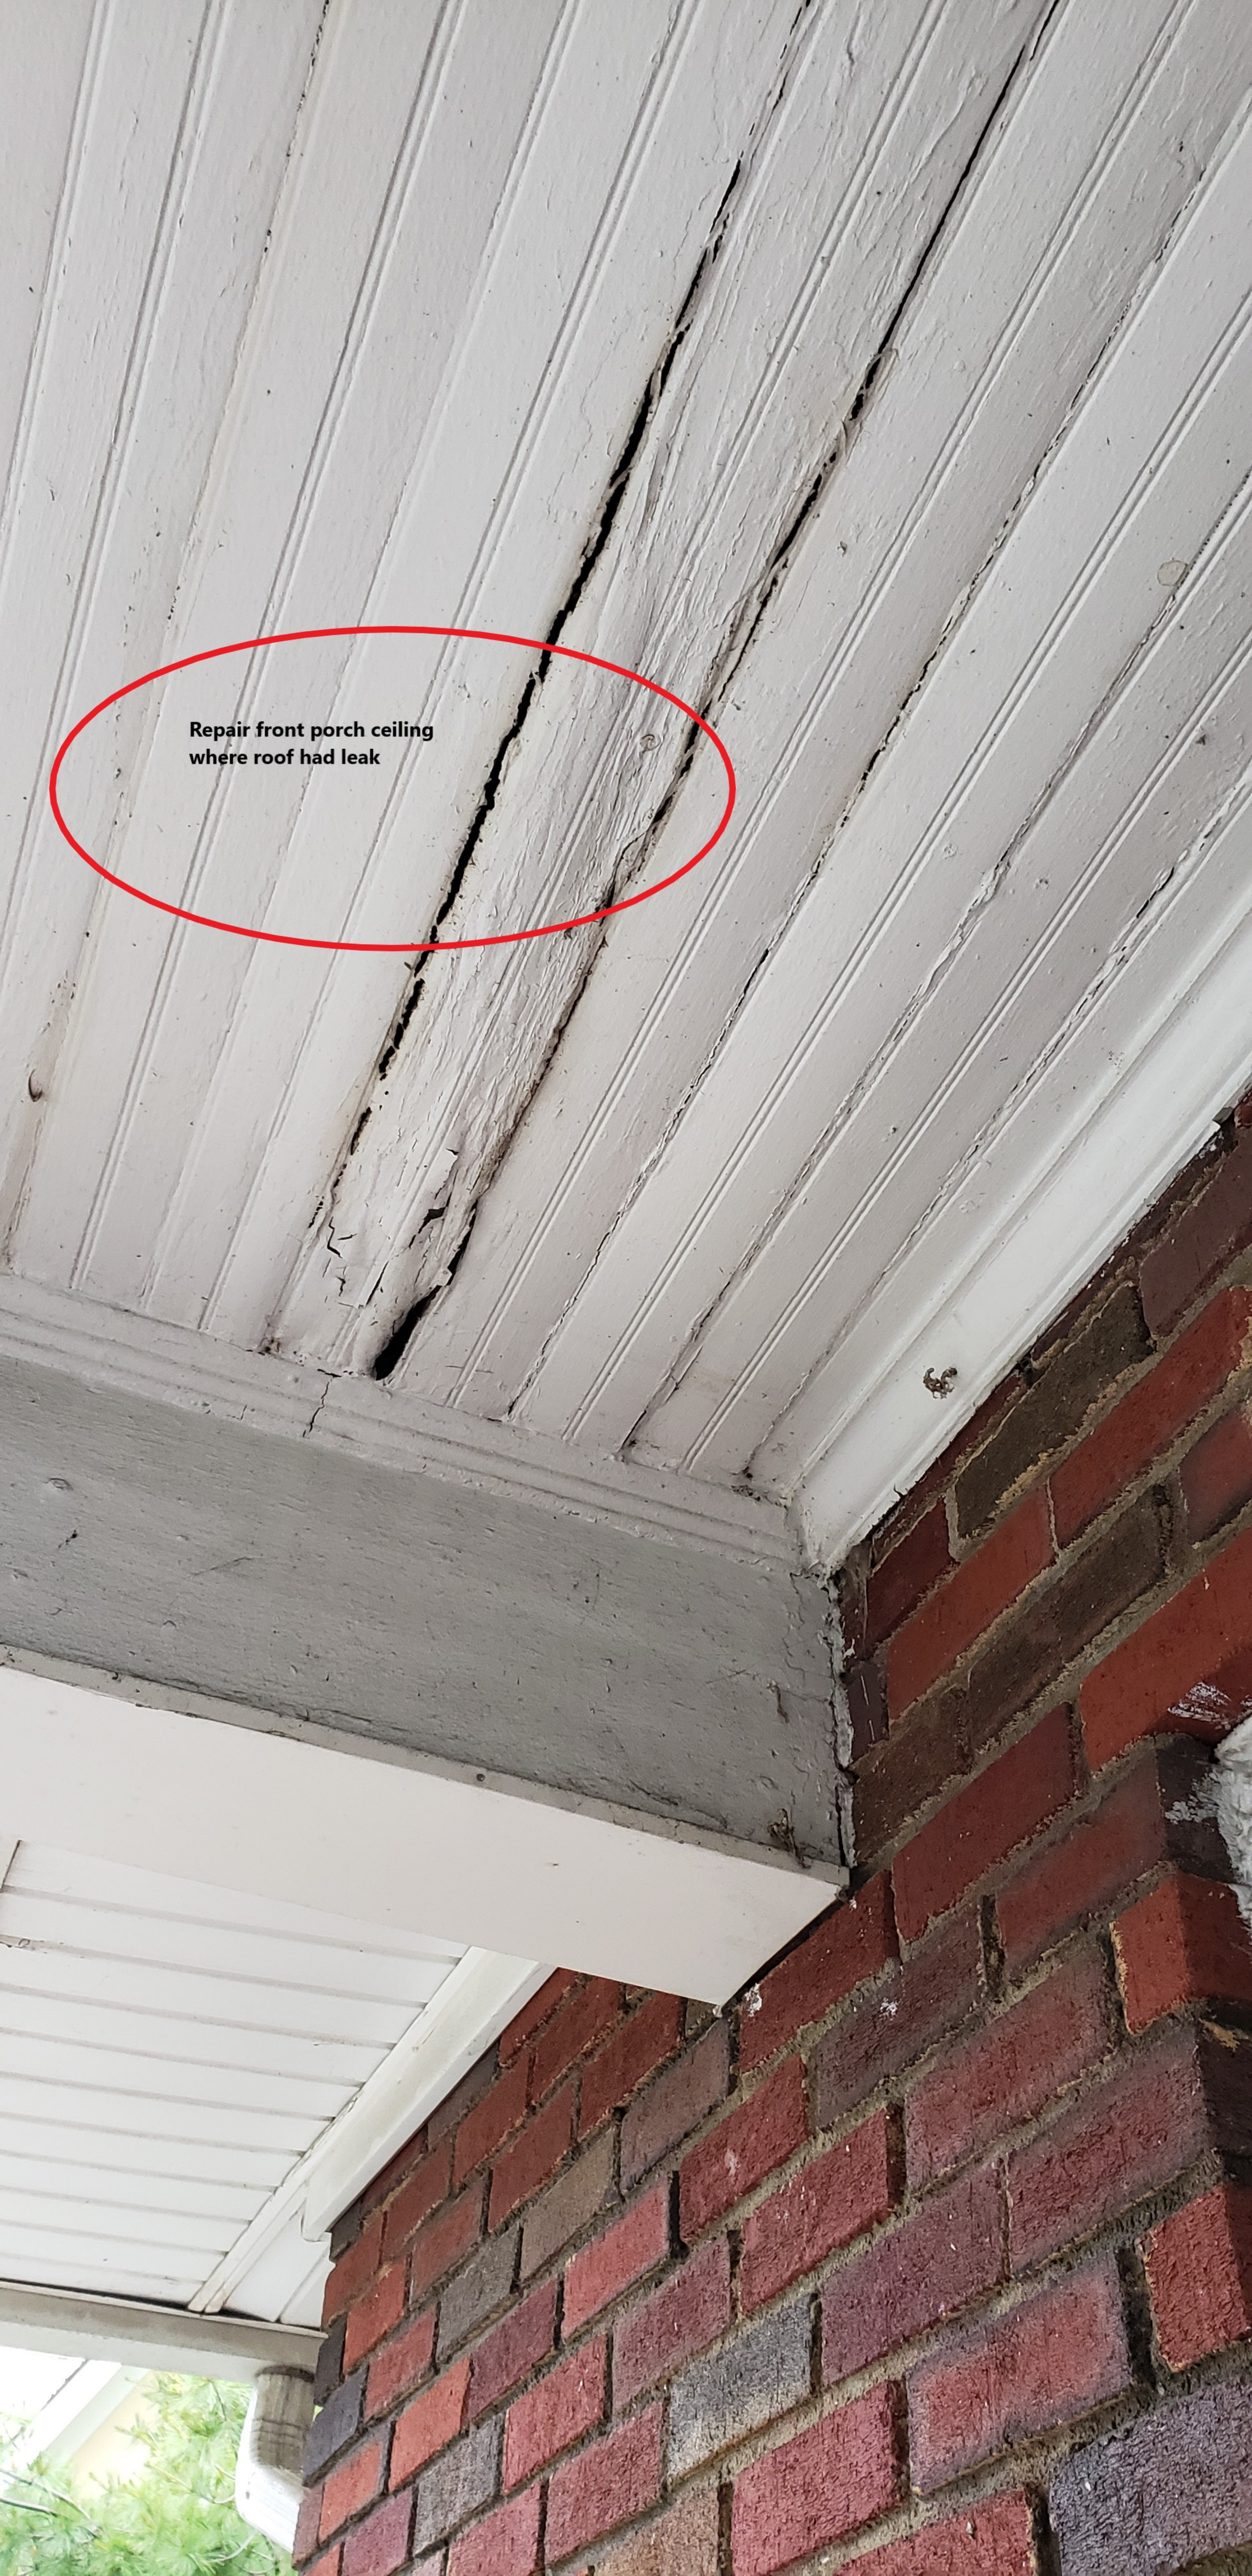
Repair front porch ceiling
where roof had leak

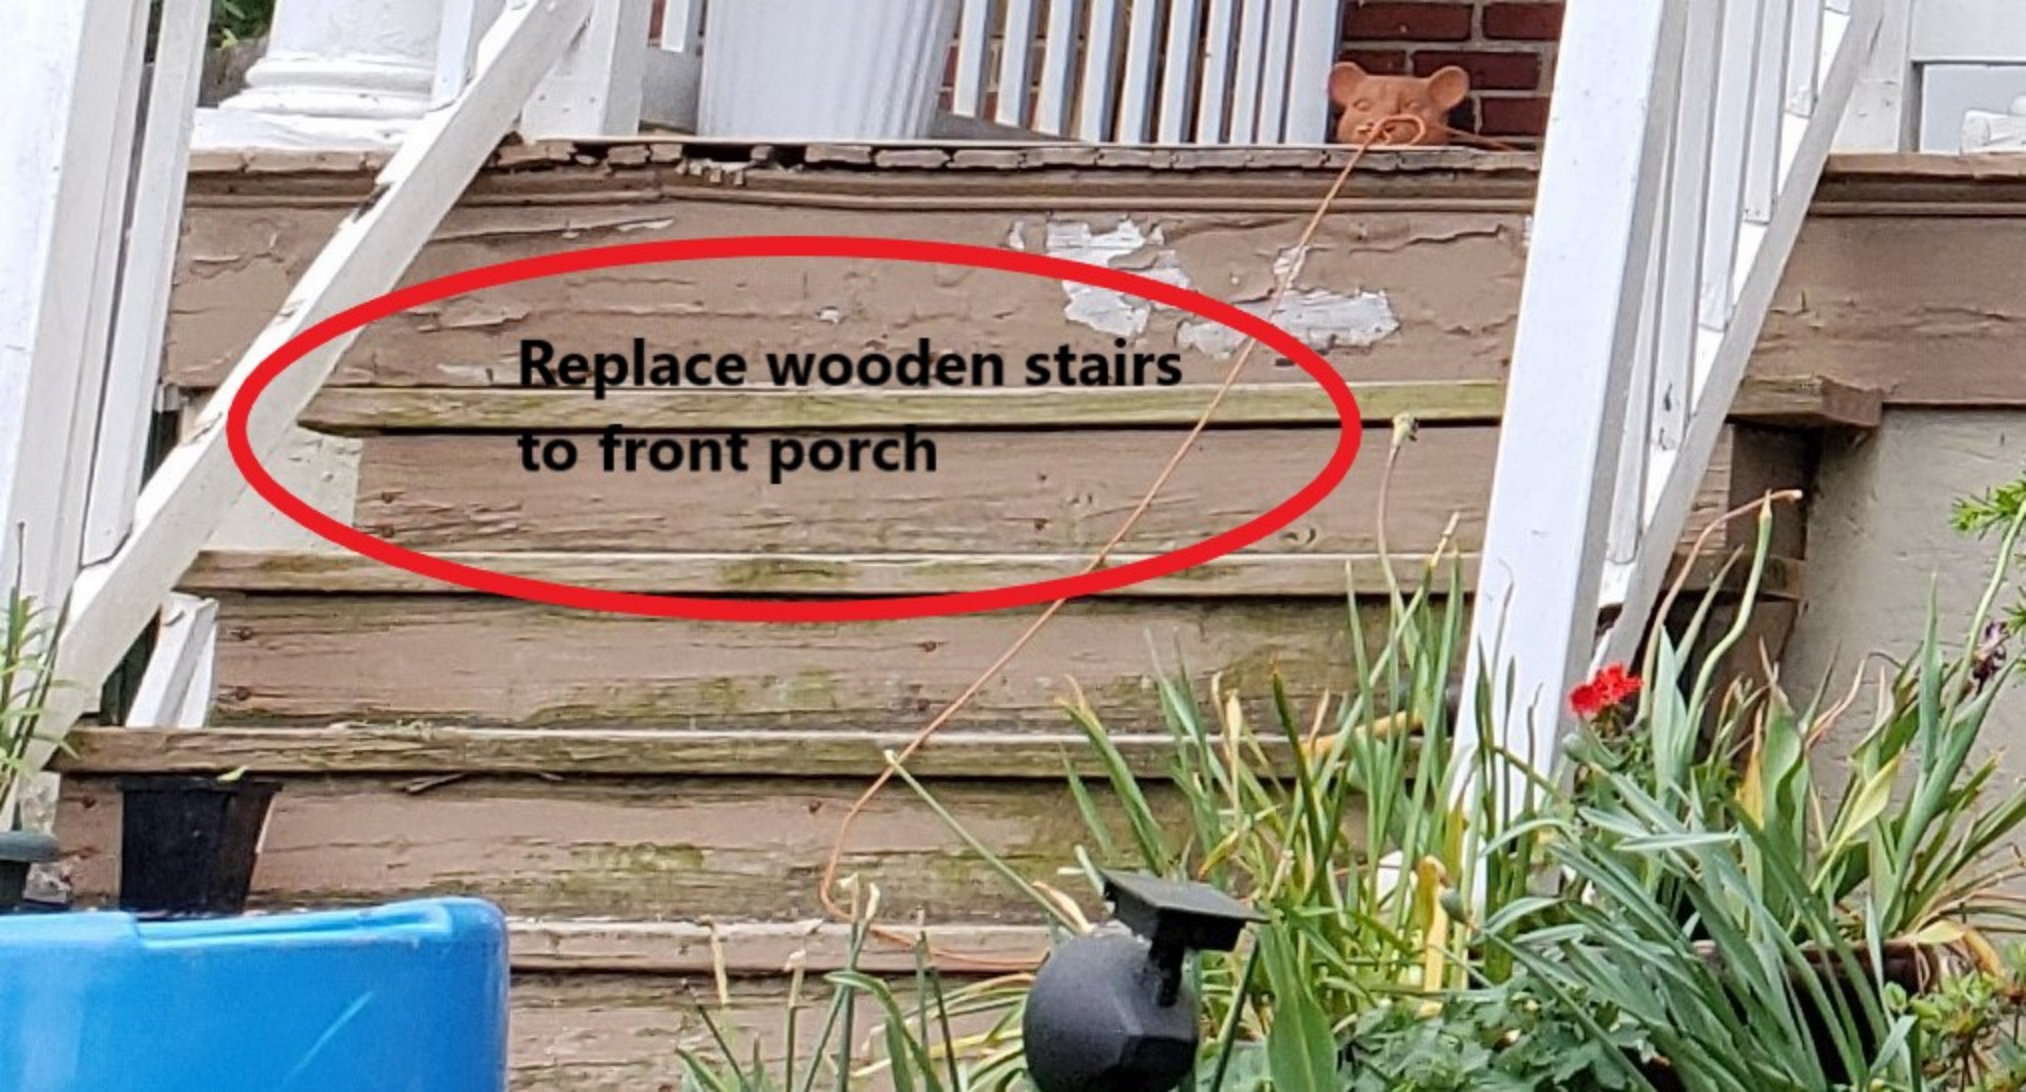
**Replace wooden stairs
to front porch**

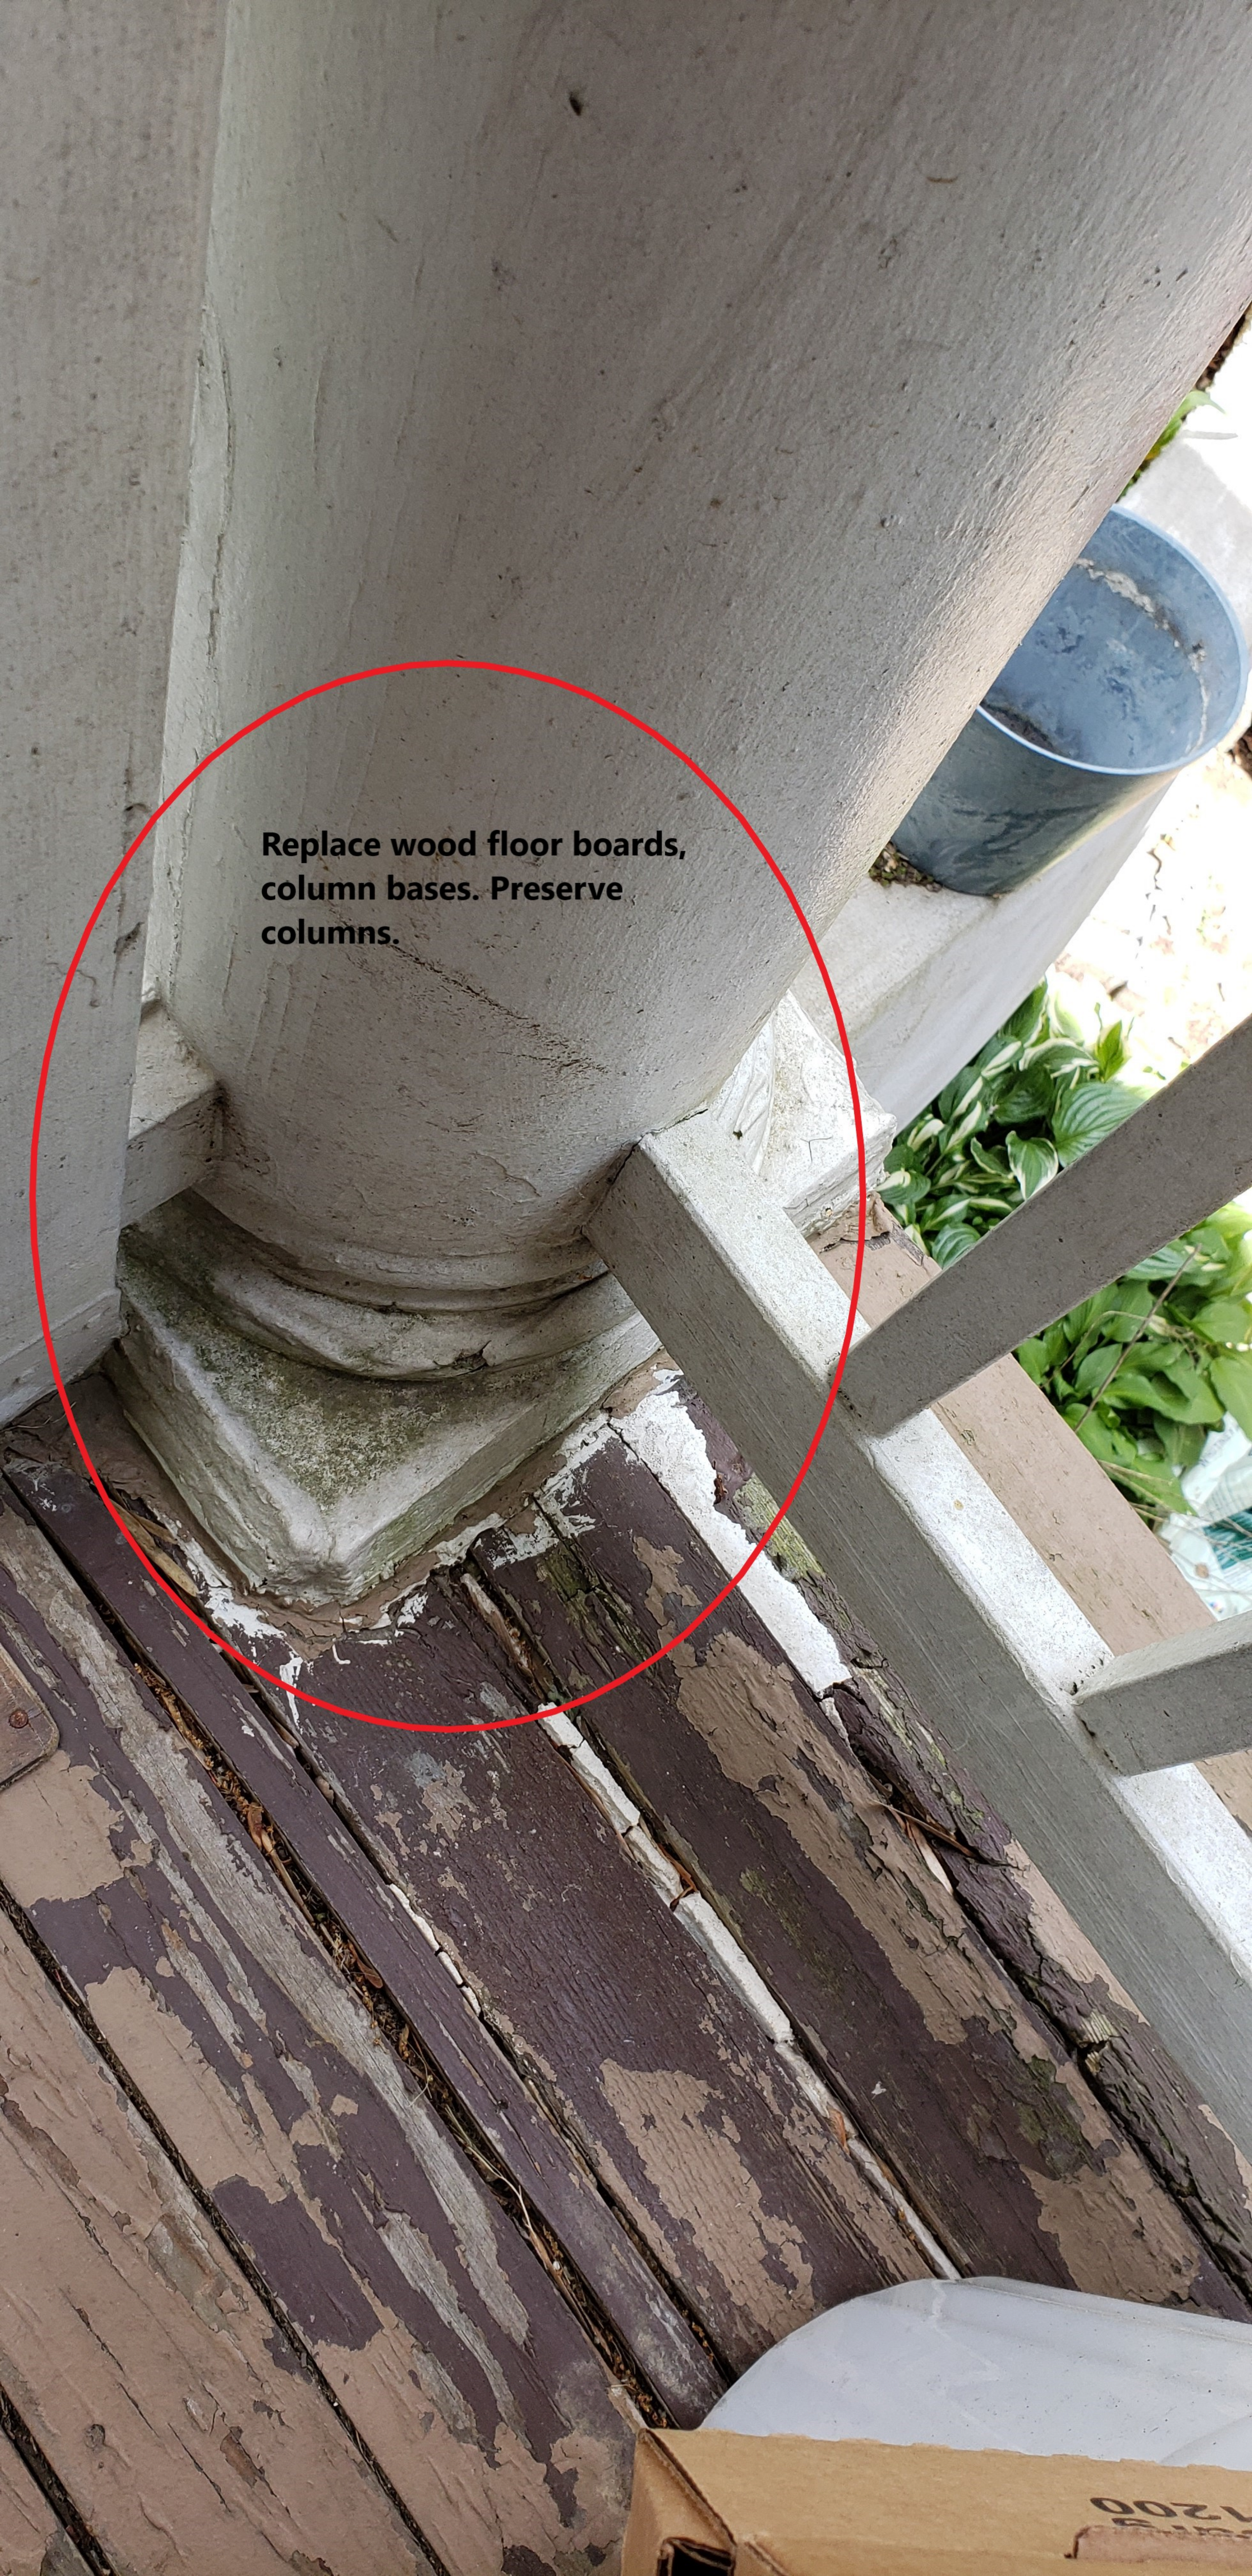
**Replace wood floor boards,
column bases. Preserve
columns.**

Replace front porch floorboards

**Replace wood
railings**

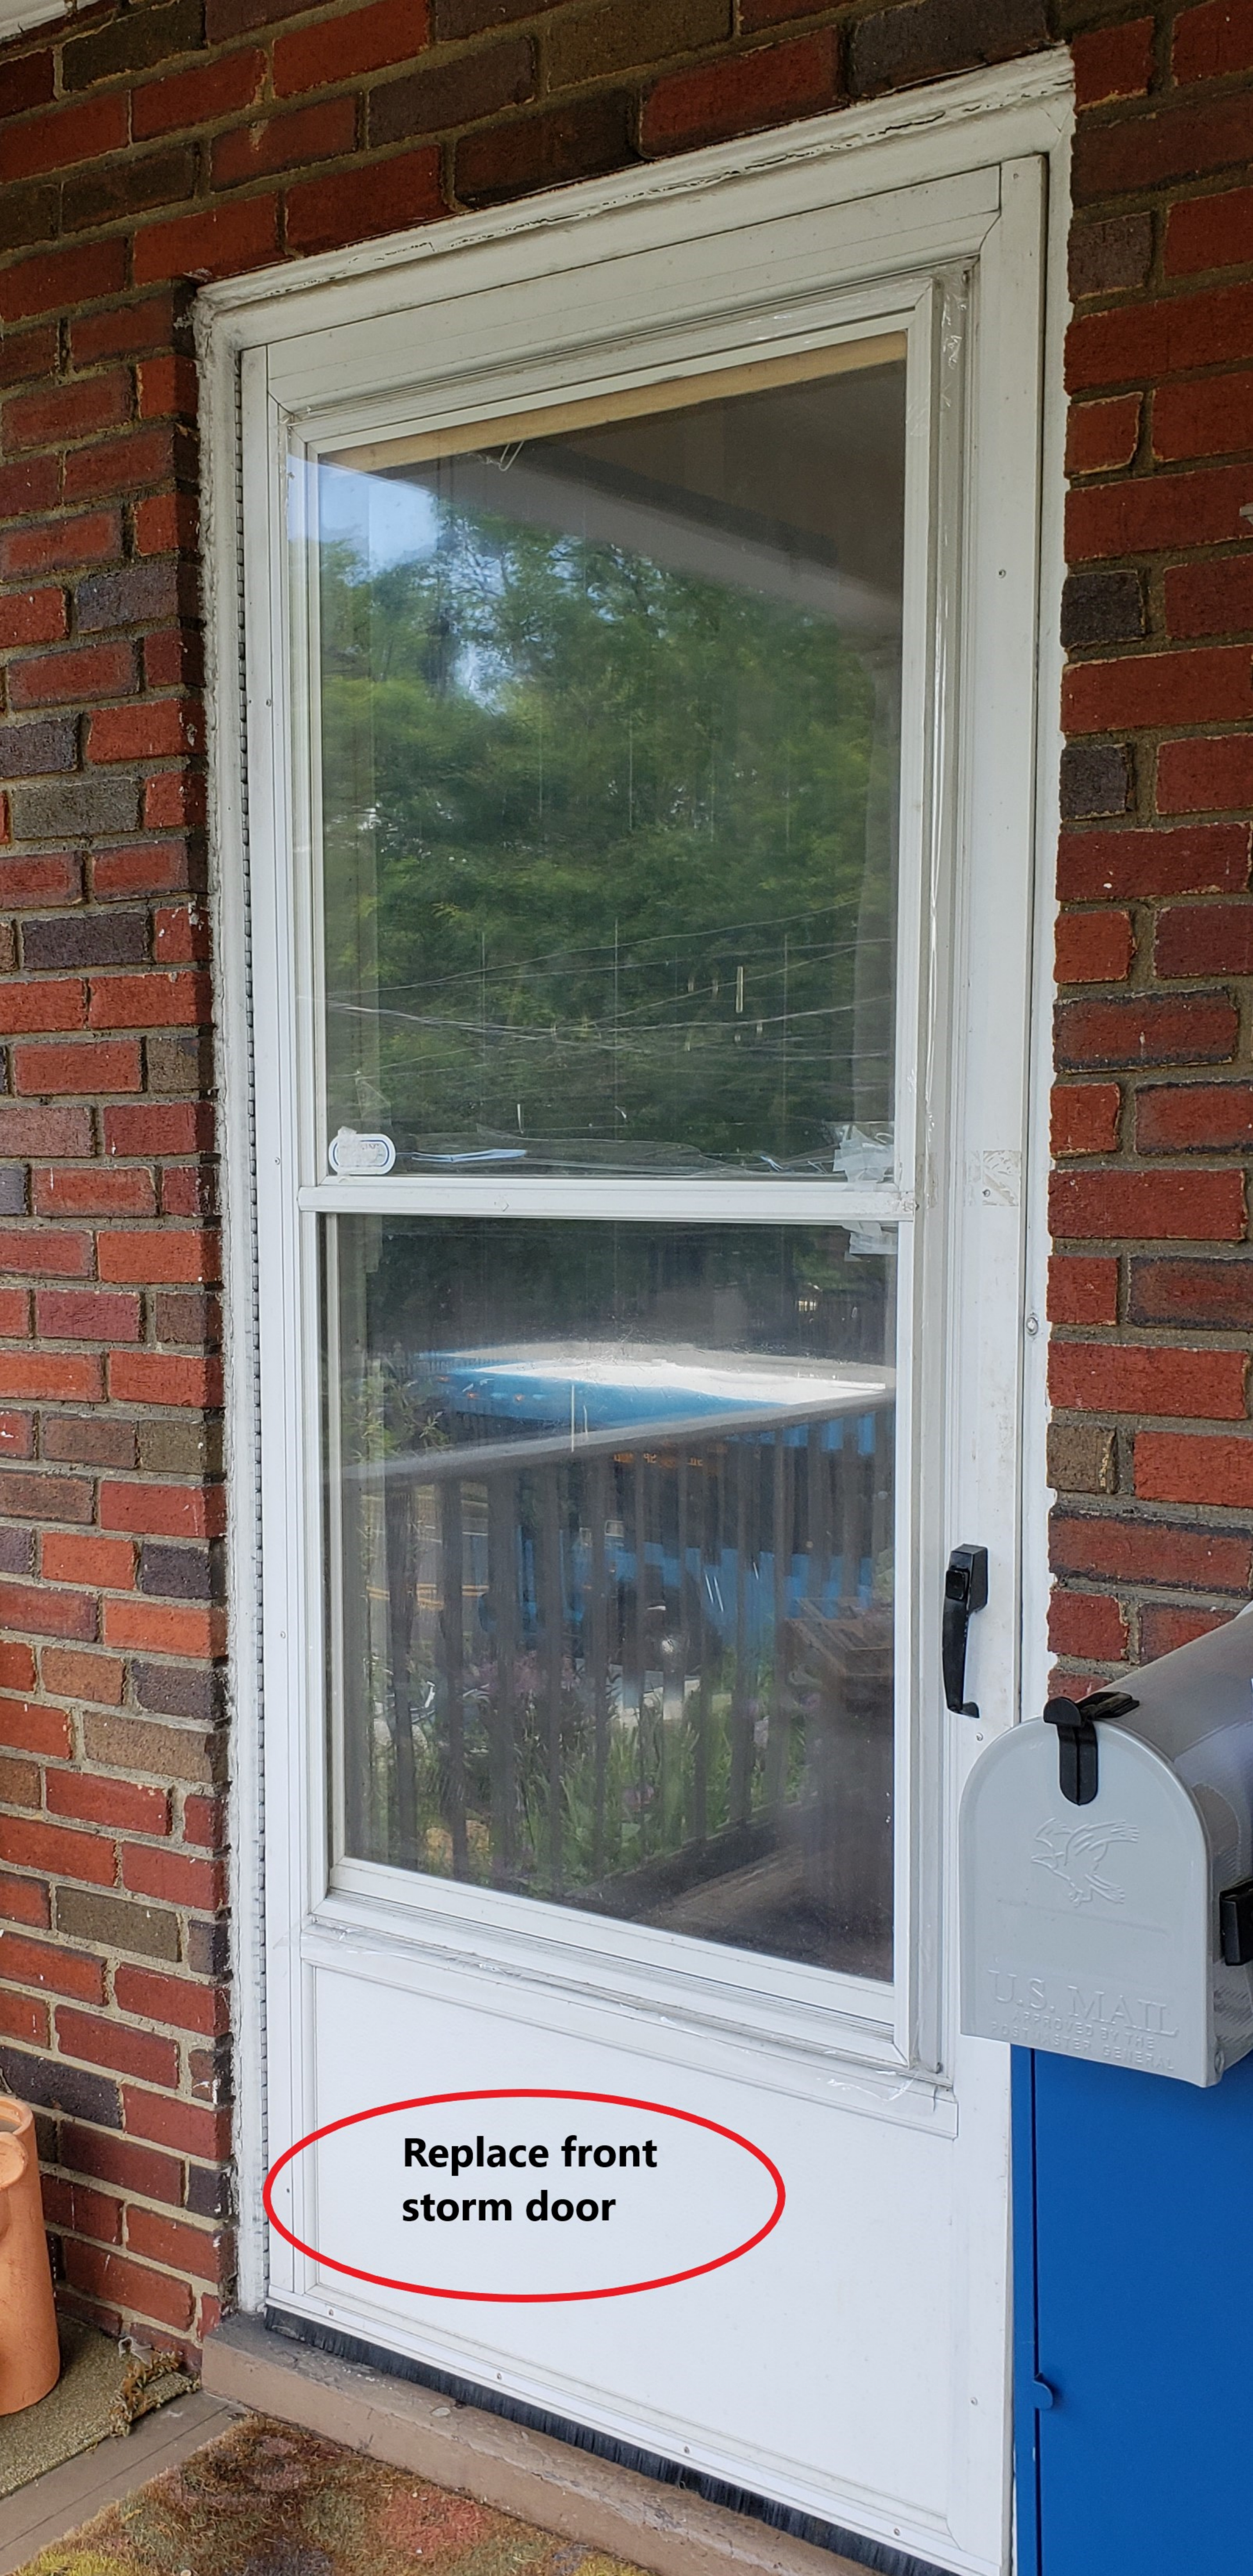
**Replace front
storm door**

**Broken front
storm door**

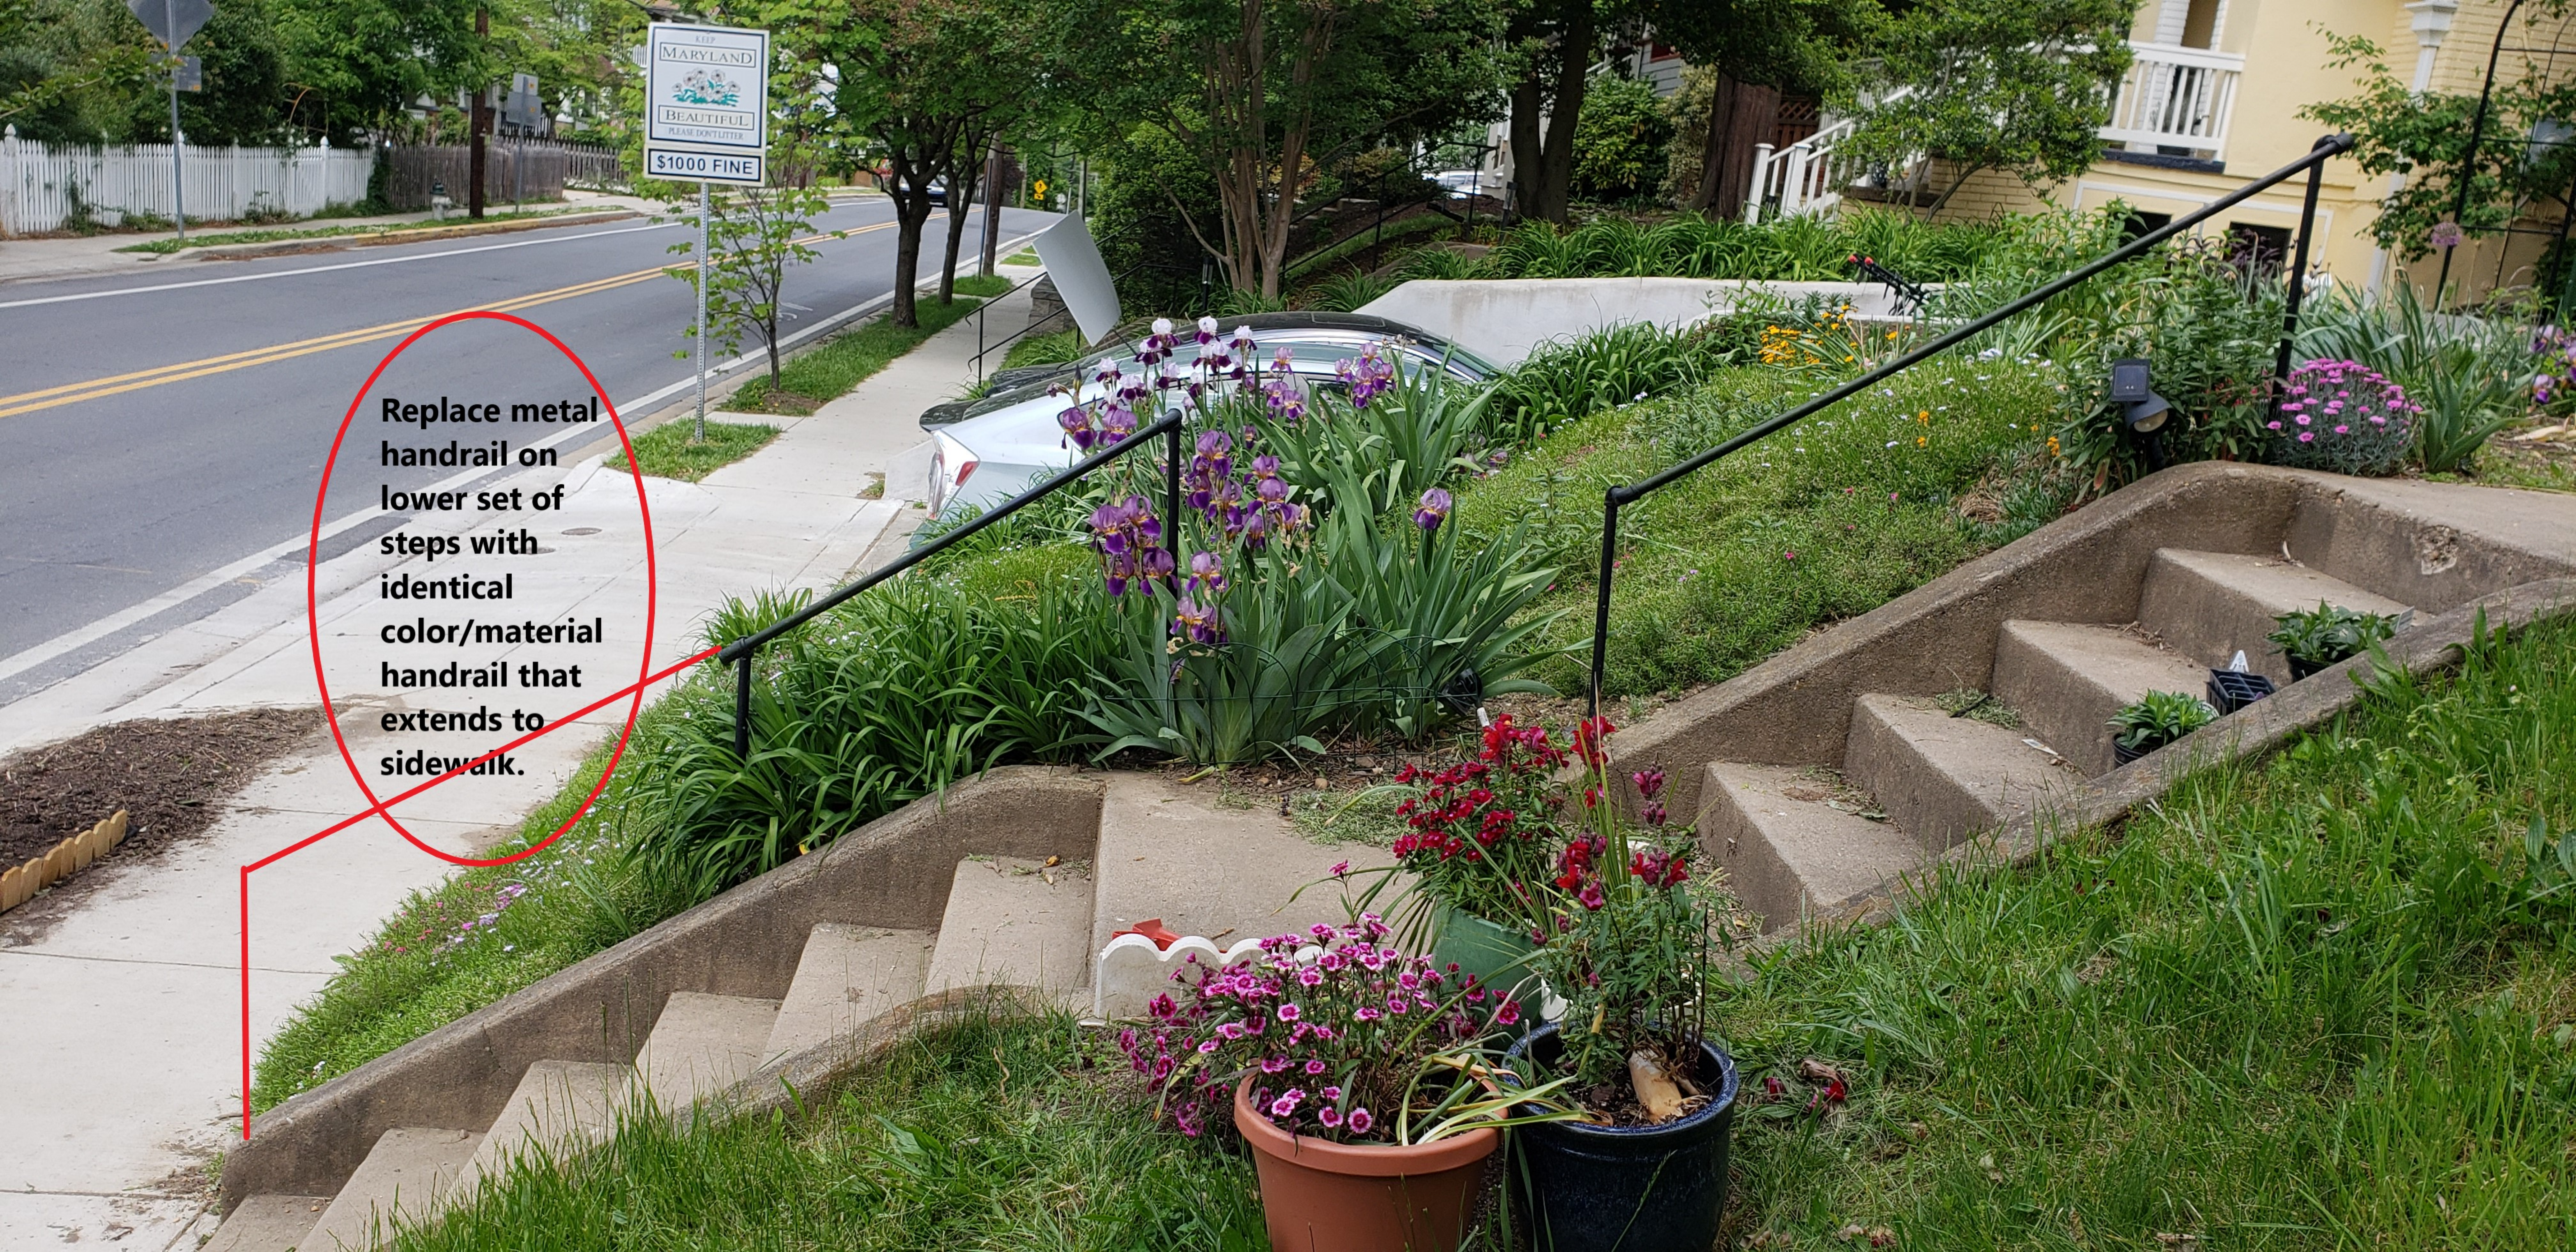
Replace gutters

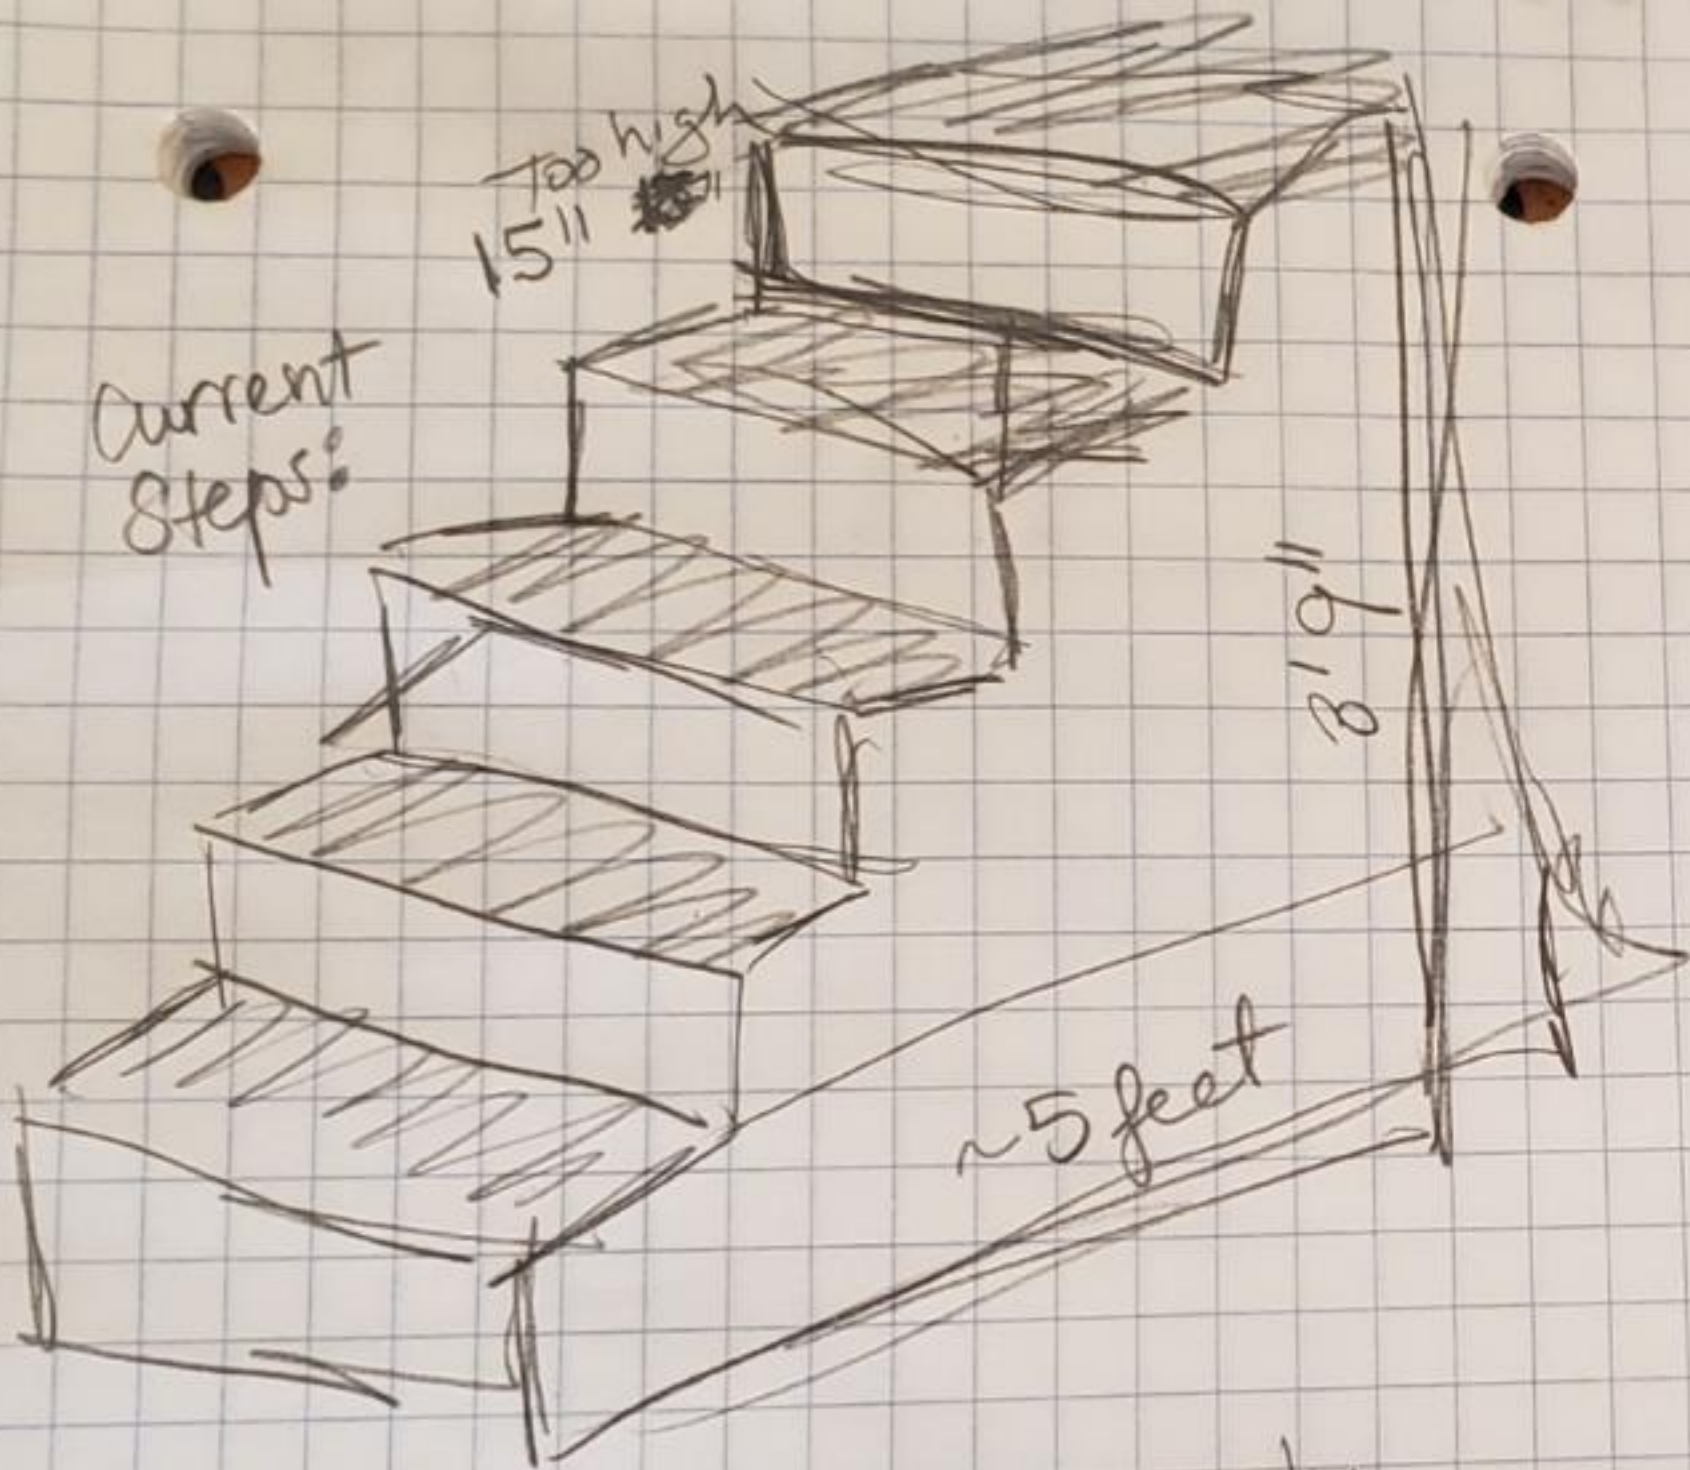
Current steps:

2.
② The current depth of the stairs is 60" (5 stairs), to bring to code on even height for each stair we plan to add another stair (6 stairs), this will increase the depth of the stairs to 72".

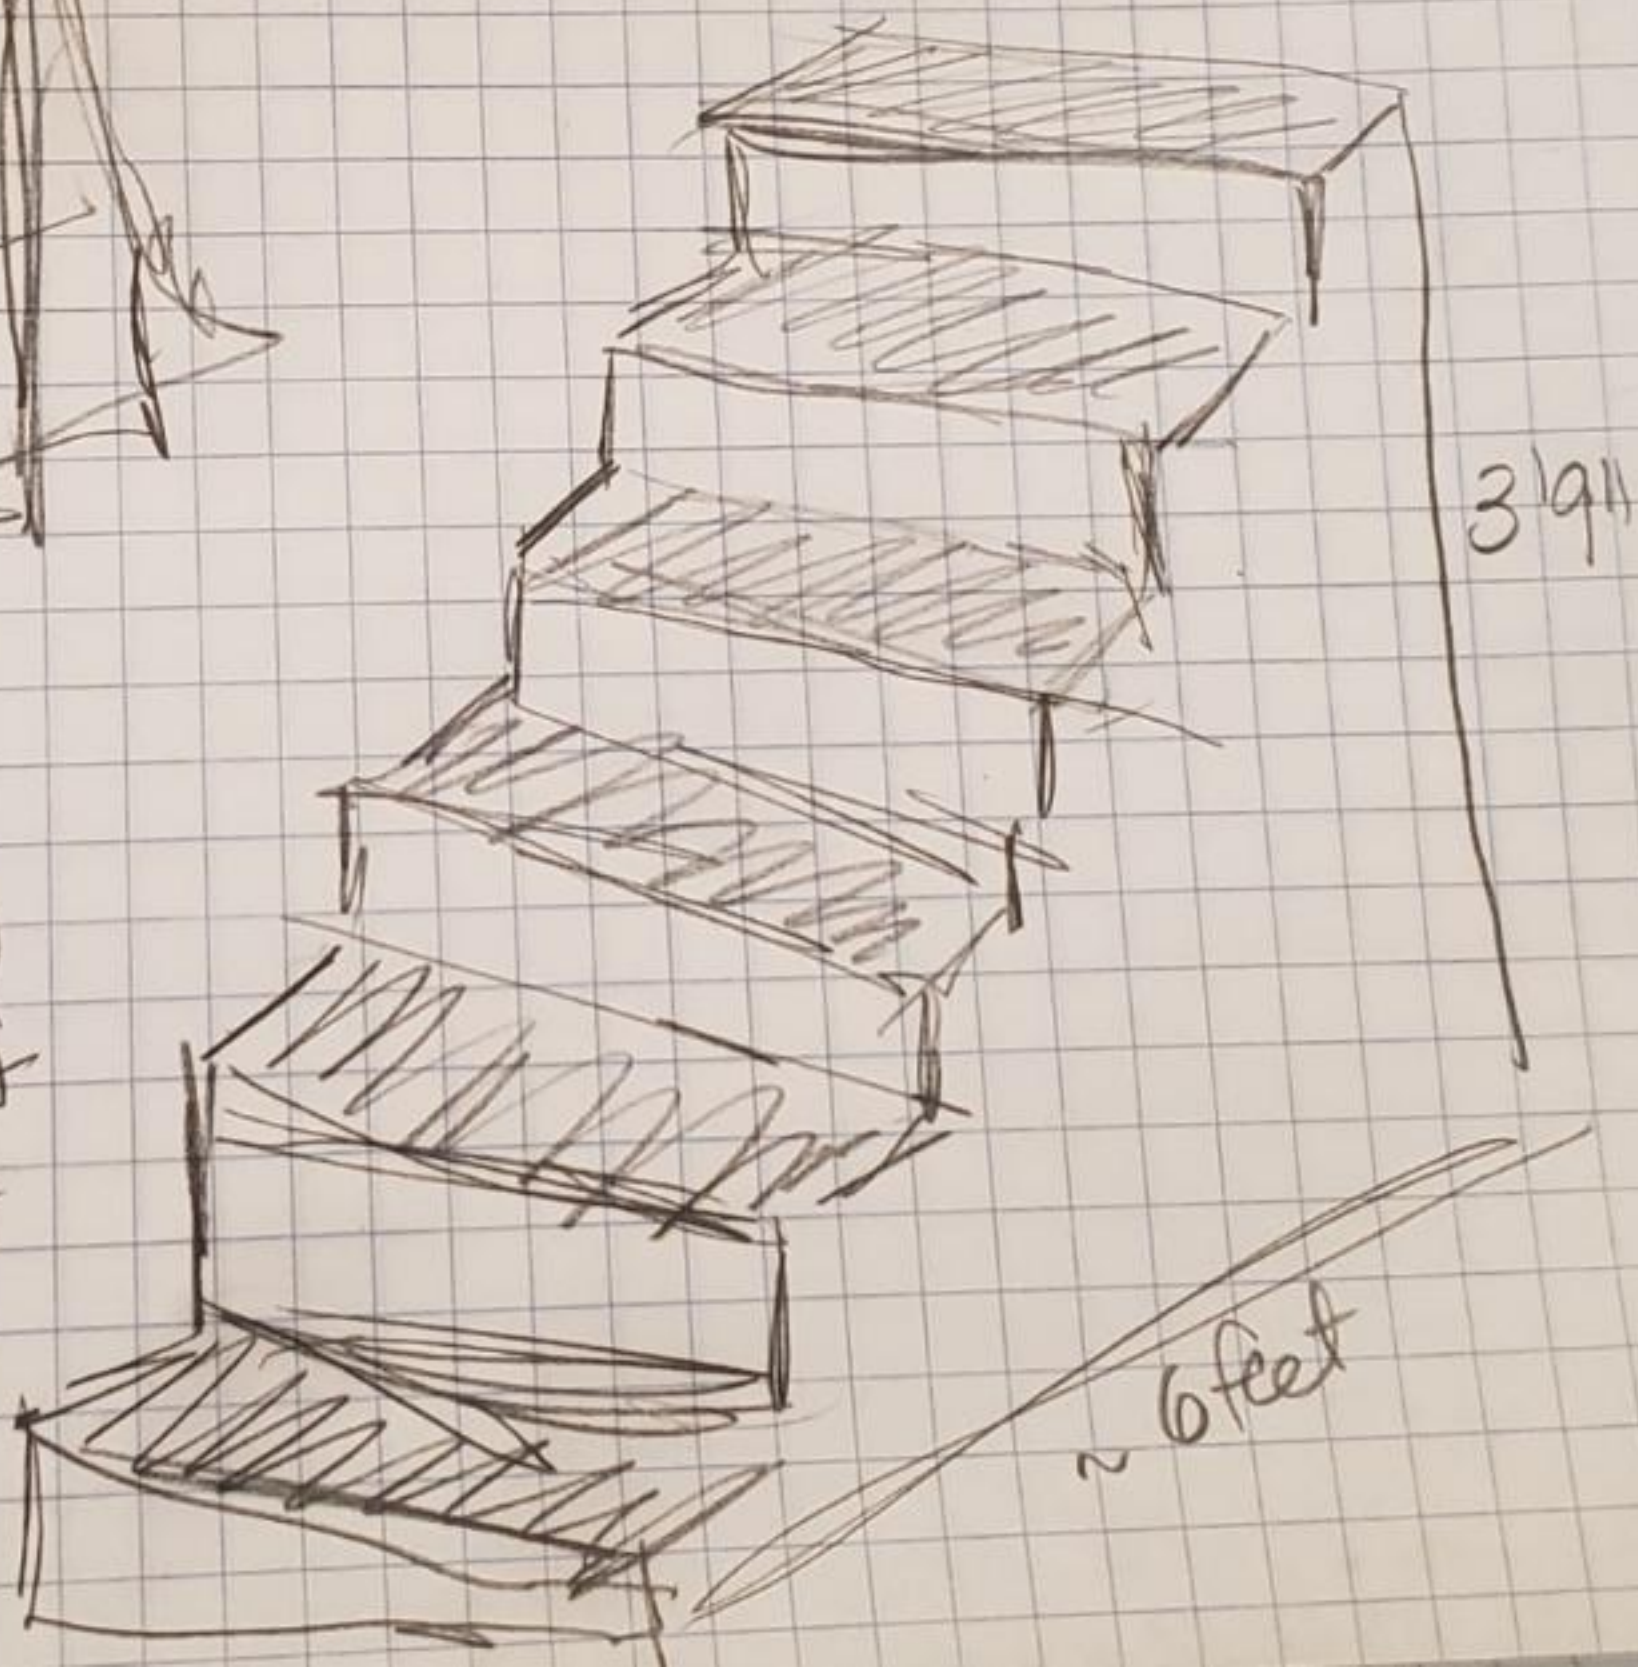
Proposed steps:

Evenly spaced treads + height to code
