Preliminary Consultation
MONTGOMERY COUNTY HISTORIC PRESERVATION COMMISSION
STAFF REPORT

Address:	9220 Damascus Hills Lane, Damascus	Meeting Date:	5/8/2024
Resource:	Master Plan Site #11/21 <i>(Rezin Bowman Farm)</i>	Report Date:	5/1/2024
Applicant:	Daniel Ferenczy	Public Notice:	4/24/2024
Review:	Preliminary Consultation	Tax Credit:	No
Case Number:	1067189 RETROACTIVE	Staff:	Chris Berger

PROPOSAL: Retroactive review of fenestration and lights replacement; window openings in the gable ends and installation of composite windows; and fence construction.

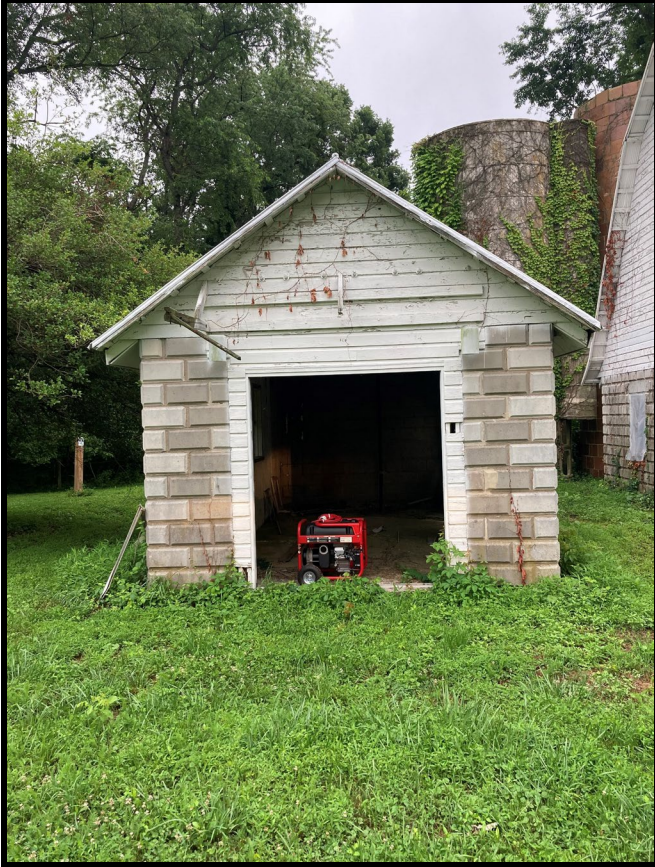
Figure 8: The applicant provided this photo taken after he took ownership in October 2021 to show the Milk House with the previous front doors removed.

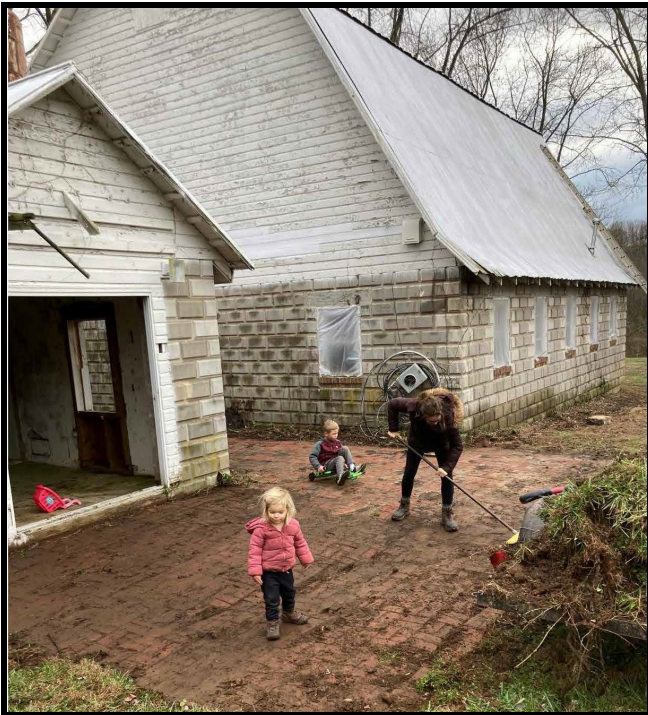
Figure 9: The applicant provided this photo taken after he took ownership in October 2021 to show the Milk House with no front door and window removed on the right-side elevation.

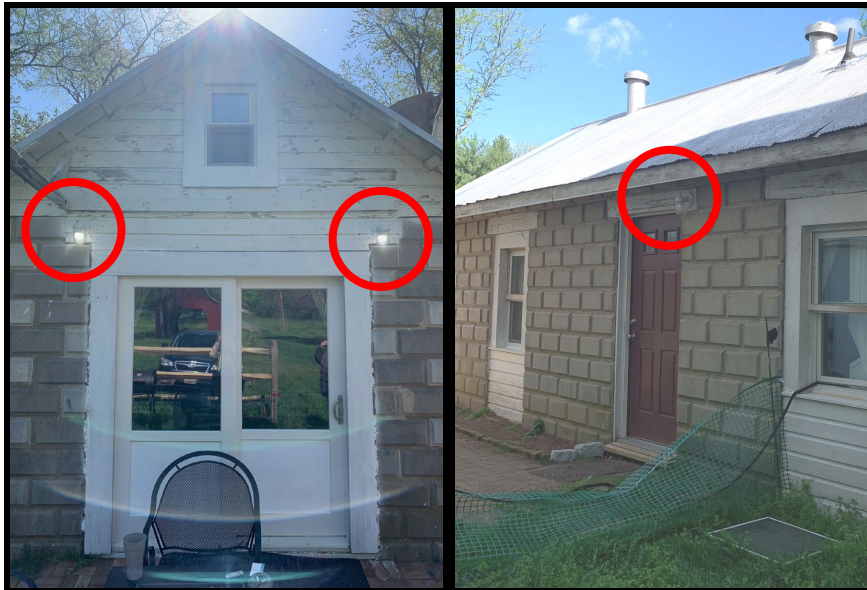
The applicant installed a composite sliding door on the front elevation (*Figures 3 and 10*). The Shaker Gliding 2/3 Lite door replaced the remnants of the double metal sliding doors on the front elevation. It is paneled with large, single lites on each of the doors. The archival photo from 1973 shown in *Figure 4* shows a window on the elevation. It is likely a sliding metal door was installed shortly thereafter when the building transitioned to a new use but prior to its historic designation in 2009. Staff supports the composite material of the door because it was placed in an opening created before the building's designation as a Master Plan Historic Site. The door is compatible to the design of the Milk House; the length and width of the lites approximate the size of the windows present on the building and is compatible with the building.

Figure 10: The sliding composite doors on the front elevation, left, and the fiberglass door on the right-side elevation. The lights are circled in red.

The applicant replaced two light fixtures on the front elevation on either side of the sliding doors, and one fixture was installed on the right-side elevation at the door (*Figure 10*). Each fixture measures approximately 8 inches long and is of a simple design that includes a clear glass shield containing an LED lightbulb and a circle-shaped housing attached to the building.

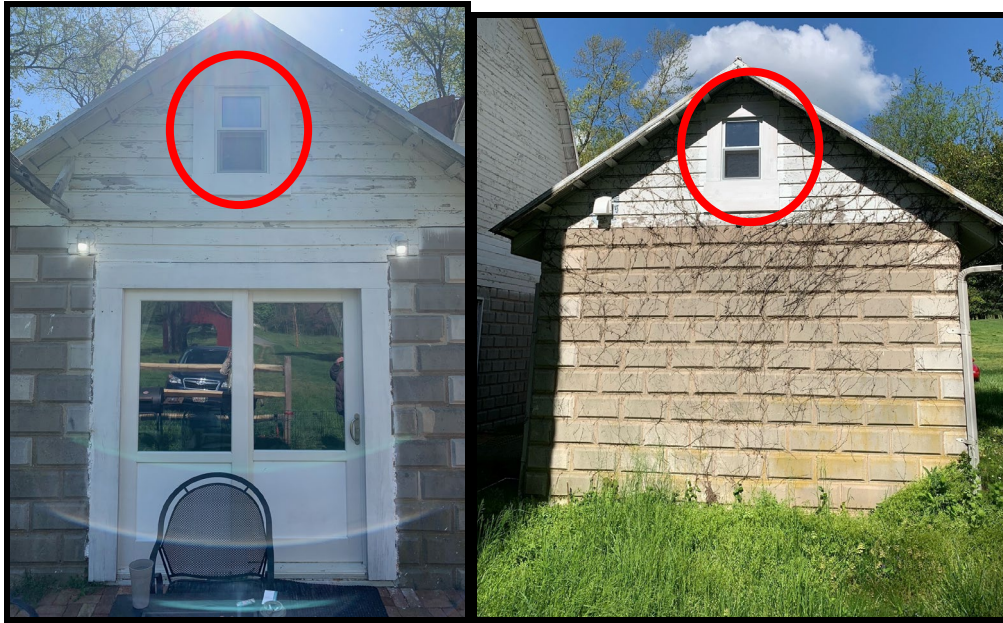
The applicant said he installed the window openings and Anderson Fibrex windows measuring 18-by-24 inches in the gable ends to provide light and ventilation to the building (*Figure 11*). The openings are centered in the gable ends, just under the roofline. While staff does not support the trim, as is detailed later in this report, staff does support the new openings and corresponding windows. Staff supports the material of the windows because they are new to the building and did not replace previously installed windows. The windows are appropriately sized for the building and were placed in the wood siding and not the historic masonry. The windows improve the functionality of the space as it is further adapted from its original, utilitarian use. Staff notes there is precedent for windows in gable ends in milk houses; staff

Figure 11: The openings and windows newly installed in the gable ends are circled.

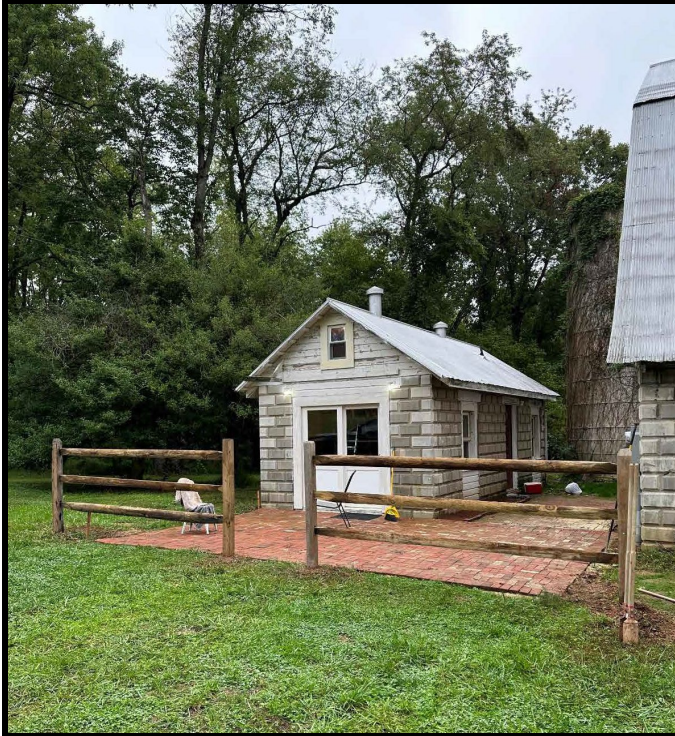
The fence consists of two sections of untreated wood posts and rails standing approximately 4 feet tall and spanning about 25 feet (*Figure 13*). It delineates the boundary of the brick patio in front of the Milk House. It is of a simple design and construction that fits the nature of the former agricultural property and can easily be removed.

Figure 13: The applicant provided this photo that shows the fence in front of the Milk House.

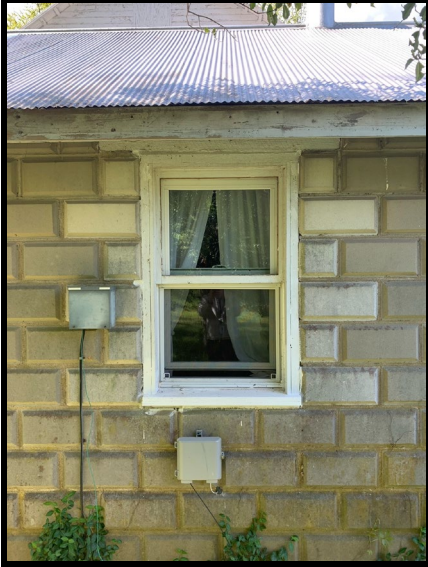
The applicant installed four new Andersen Fibrex 1/1 sash windows: two on the right-side elevation and two on the left-side elevation (*Figure 14*). According to the applicant, the wood sash windows were installed in the storm window track, and the composite windows were installed in preexisting metal window tracks. The wood upper sashes remain intact to provide guidance on remediation. Three of the wood sashes have one light, and one sash on the left-side elevation has six lites.

Figure 14: A representative photo of the one of the newly installed windows with the previous upper wood sash intact.

The building originally had wood sash windows, and wood windows are present in **Figures 5 7**. The windows on the right-side elevation were later alterations that appear to have replaced doors in those openings, but based on the clapboard siding infill material present at the bottom of the openings the windows have been present for multiple decades and predate the historic designation. The window openings on the left-side elevation appear to date to the building's construction, as evidenced by the wood lintels on top of each opening. Because the windows on the Milk House were originally wood and were wood for most of the building's approximately 90-year-old lifetime staff is of the opinion that the windows should remain wood and the change to composite should be denied. Staff recommends the applicant either install the lower wood sashes to match the existing upper sashes or install all new wood upper and lower sashes that match the lite pattern of the upper sash, either 1/1 or 6/6.

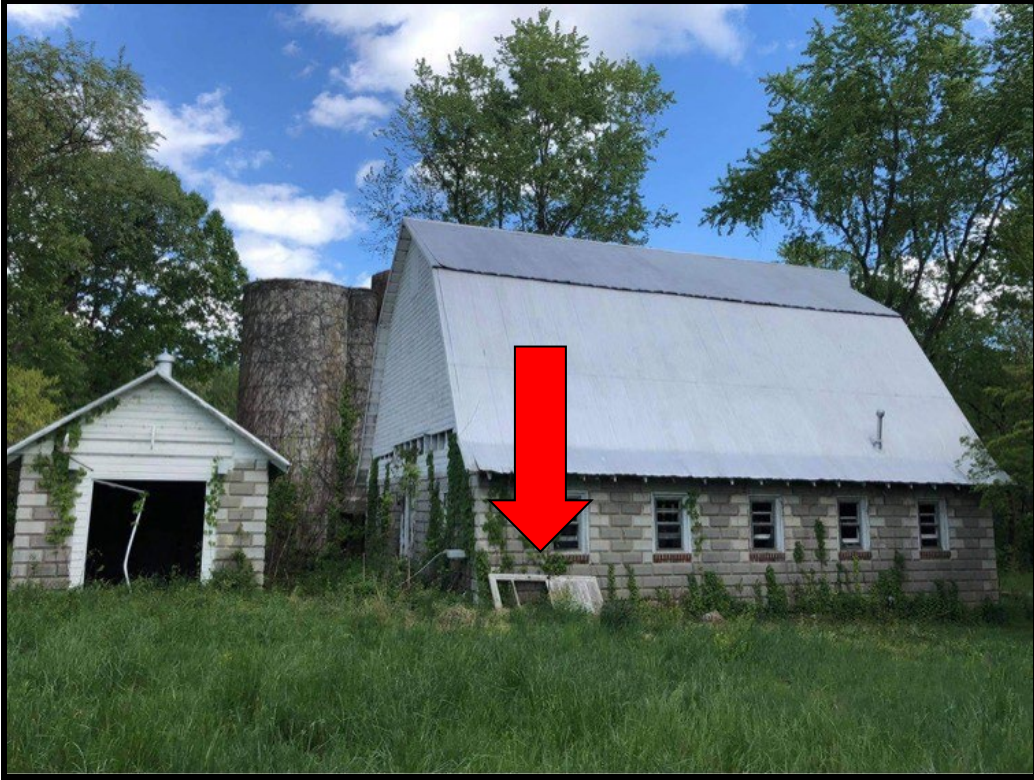
Likewise, staff does not support installation of the fiberglass door on the right-side elevation. It is a four-paneled door with two square lites at the top and is a type frequently installed on contemporary residential buildings. Staff does not find the door design and material appropriate for the historic agricultural outbuilding. Though the Milk House no longer functions in its original capacity, staff maintains the material and design of the windows and doors in its historic window and door openings should be compatible to the historic outbuilding. While no archival photos exist of the prior door, staff is confident the door was originally wood when installed in the 1930s and recommends the replacement door be constructed of the material and be appropriately designed for the building. **Figure 15** shows a wood-paneled screen door resting against the Dairy Barn in 2021. The door could have dated to the 1930s and may have originally been installed on the Milk House or Dairy Barn. Staff recommends the applicant instead install a wood door similar to the door in the image.

Figure 15: The applicant provided this circa 2021 photo of the Milk House and Dairy Barn. The arrow points to what appears to be a wood screened door that may have been installed on the Milk House or Dairy Barn.

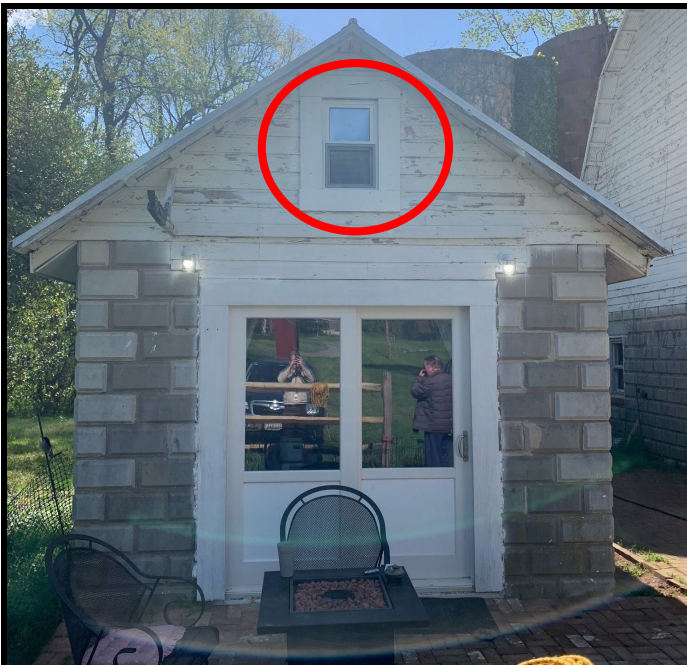
Staff does not support the size of the wood trim around the new windows in the gable ends (*Figure 16*). While staff supports the new window openings and composite windows, the approximately 6-inch wide trim around the 18-by-24-inch windows is too large and bulky for the small windows and not compatible to the small structure as it covers up much of the historic wood lap siding. Staff recommends the trim is significantly reduced in width.

Figure 16: The trim around the new front gable end opening.
