Preliminary Consultation
MONTGOMERY COUNTY HISTORIC PRESERVATION COMMISSION
STAFF REPORT

Address:	7017 Sycamore Ave., Takoma Park	Meeting Date:	7/10/2024
Resource:	Contributing Resource Takoma Park Historic District	Report Date:	7/3/2024
Applicant:	Rolf Reichle & Amy Schwenkmeyer Brian McCarthy, Architect	Public Notice:	6/26/2024
Review:	Preliminary Consultation	Staff:	Dan Bruechert
Proposal:	Alterations to front porch, partial demolition and new construction of rear deck

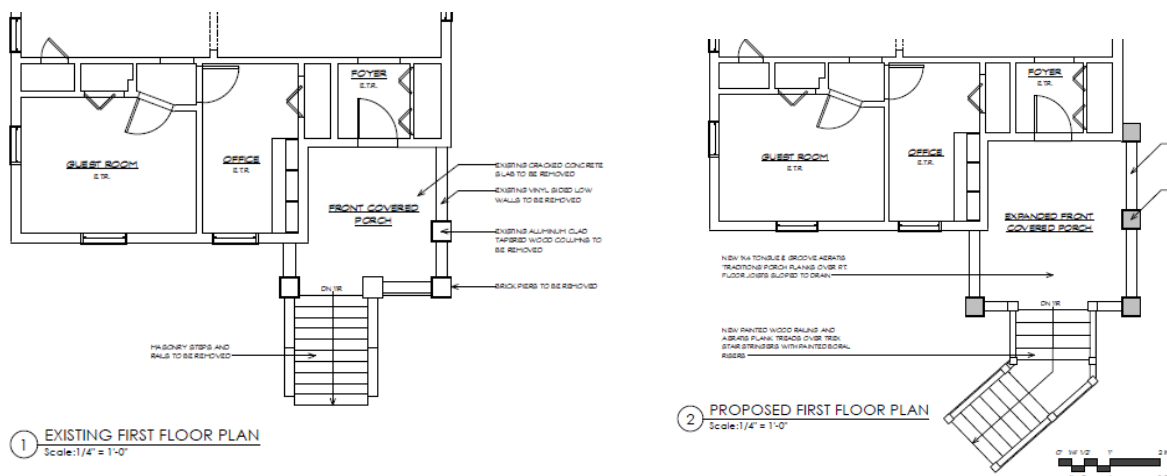
Staff has outstanding questions as to the compatibility of the run of the new front stairs (see *Figures 2 and 3*, below). Because of the location of the existing concrete path and the slope of the lot, the applicant proposes to have the stairs turn approximately 45° (forty-five degrees) to the left (west). This turn in the stairs will allow the new stairs to satisfy the code and align with the existing front walk. However, Staff finds that this type of stair run is not typical of historic Craftsman architecture and obscures much of the front porch. Staff requests feedback from the HPC regarding the appropriateness of this design.

Figure 2: Existing (left) and proposed (right) front porch configuration.

Staff's initial alternative is to have the stairs exit the porch from the left, along the house's front wall, and make a 90° (ninety-degree) turn towards the street (south). The stairs could either have a brick cheek wall or could have a lattice between the posts. Staff recognizes this would cover an existing basement window however, the basement floor plan does not indicate that access to this window is required to satisfy egress requirements.

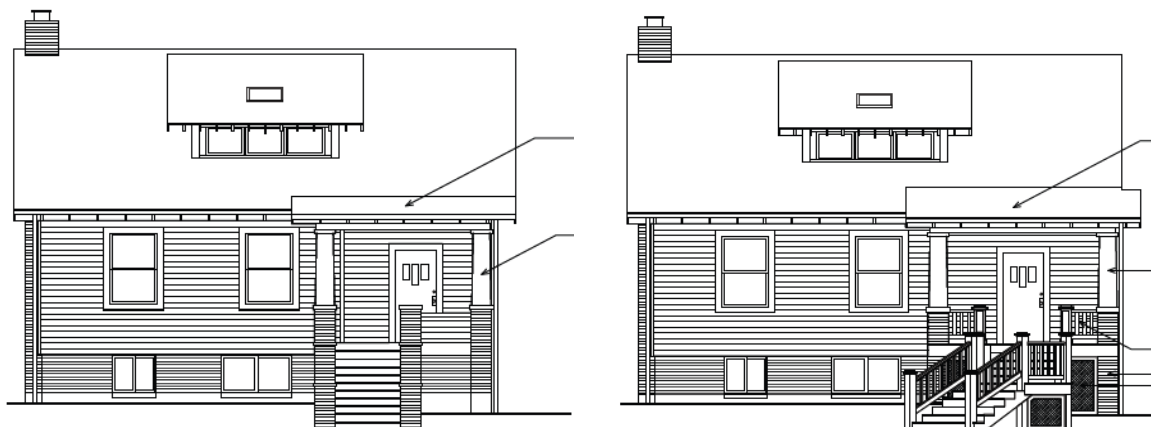
Figure 3: Existing (left) and proposed (right) front elevation showing the existing and proposed front stairs.

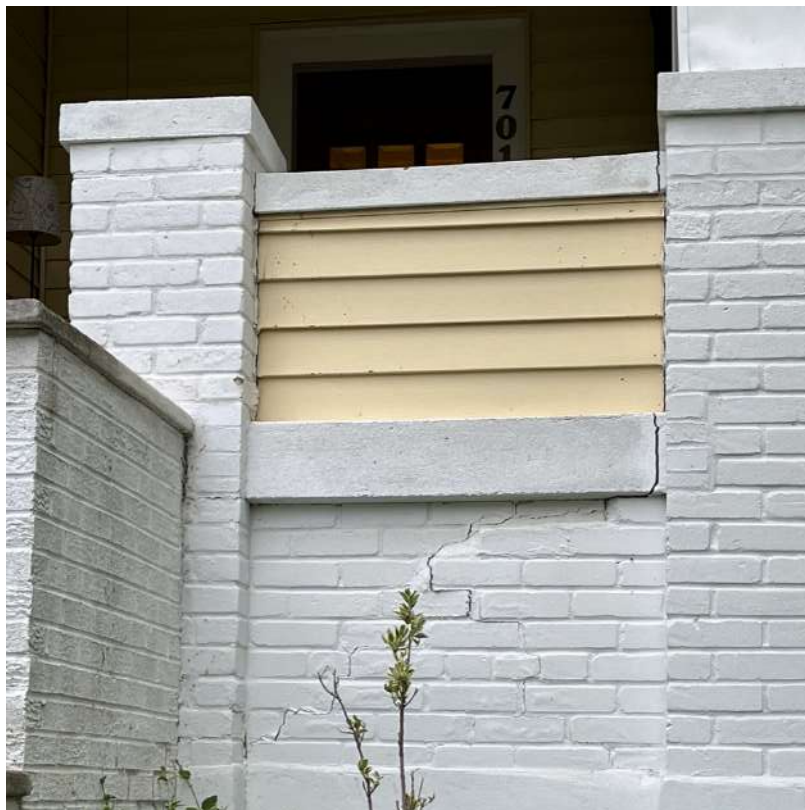
The existing front porch is in the right-front corner of the house and projects approximately 4' (four feet) in front of the front wall plane. The porch is supported by masonry piers, with aluminum-wrapped columns, and low brick walls with sections of vinyl siding between the brick column bases. The existing concrete stairs are steeper than what is allowed under the existing code. There are several cracks through

the brick walls and concrete floor. As originally constructed, the porch extended further to the rear, however, a previous owner captured much of the rear to create an entry foyer. The applicant proposes to partially demolish the front porch and construct an enlarged porch in its place. The applicant proposes to construct wood, code-compliant, front stairs.

Detail: 7017 SYCAMORE AVE. PORCH FOUNDATION CRACKS

Staff finds the existing front porch has been modified from its historic appearance. Additionally, based on Staff's observations at a site visit and the information in the application, Staff finds the structural failures are so severe that the porch has deteriorated beyond reasonable repair. Staff would recommend the HPC approve a HAWP for the partial demolition of the front porch under 24A-8(b)(2), (4), and (d).

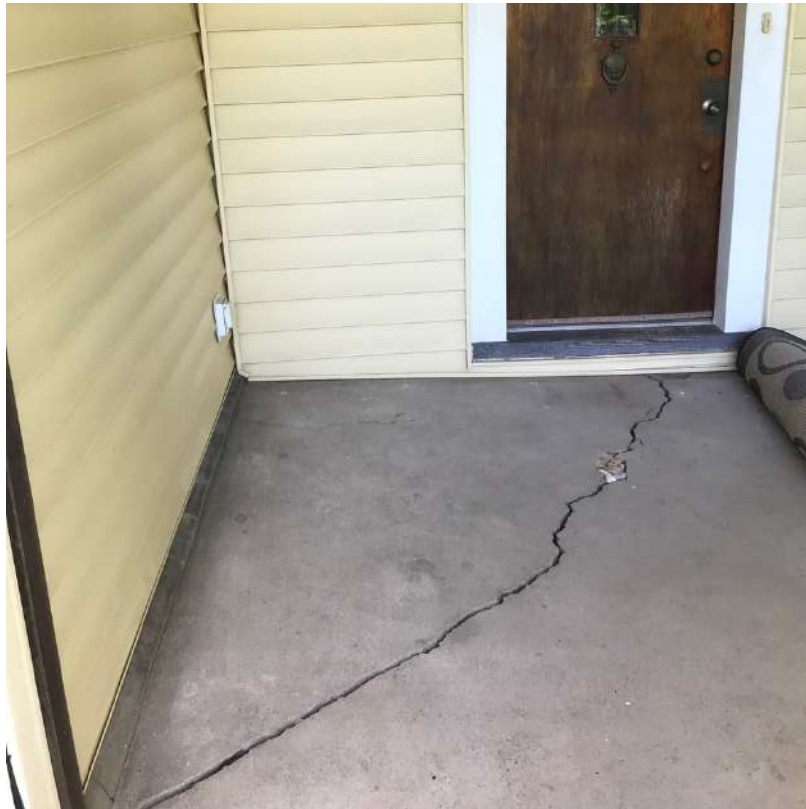
Detail: 7017 SYCAMORE AVE. CRACKED PORCH SLAB

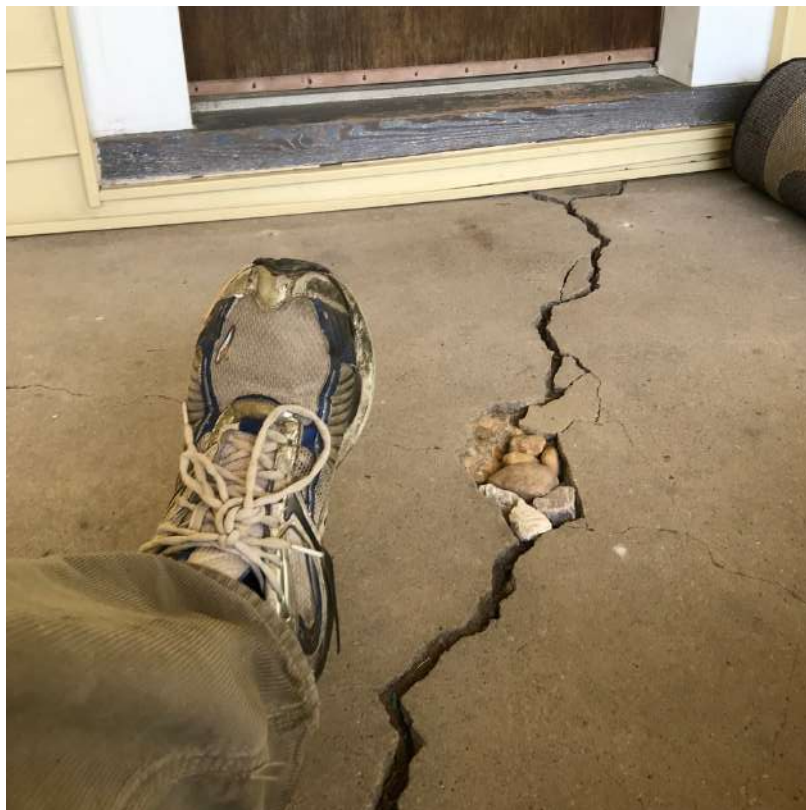
Detail: 7017 SYCAMORE AVE. CRACKED PORCH SLAB

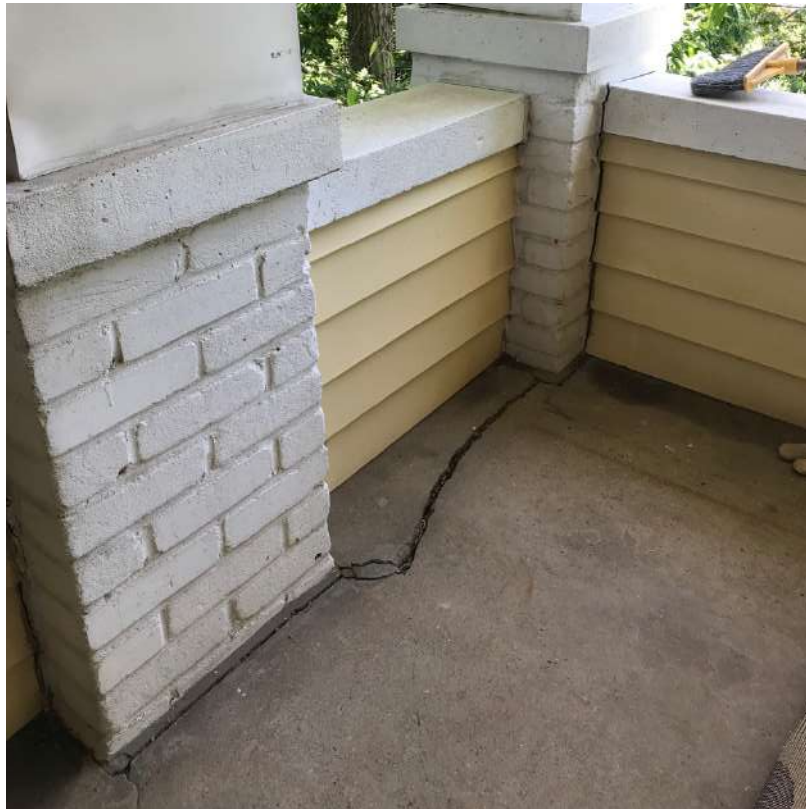
Detail: 7017 SYCAMORE AVE. CRACKED PORCH SLAB

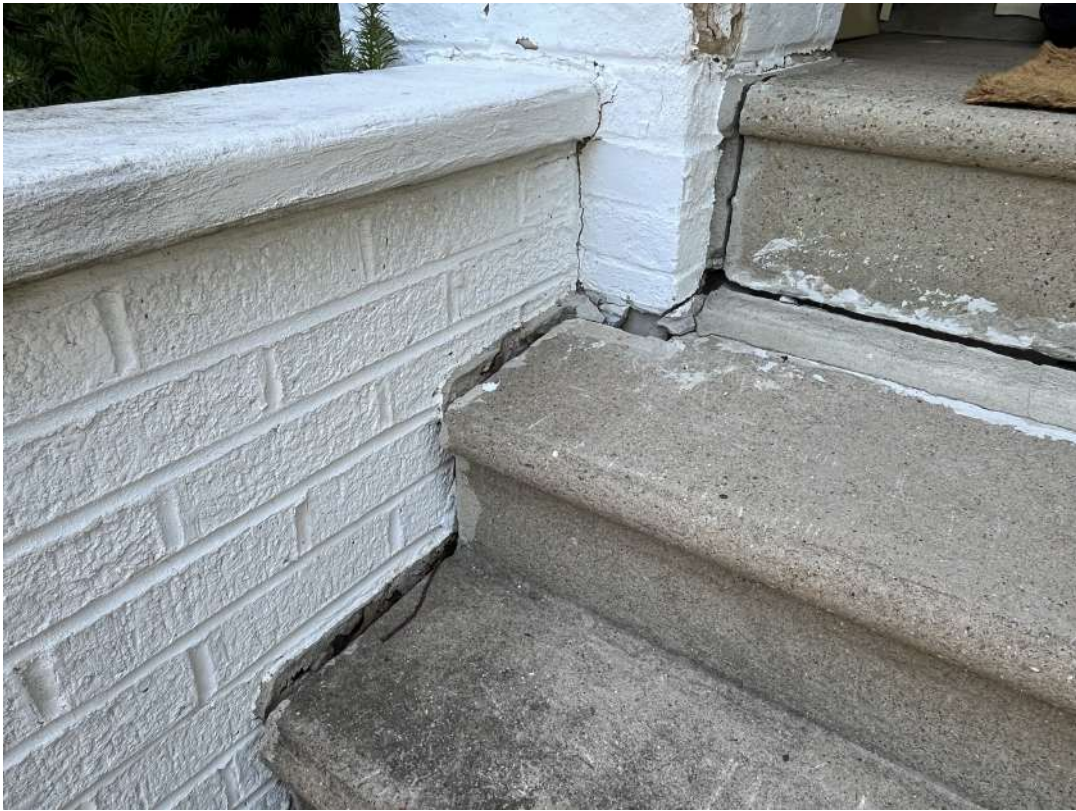
The existing front stairs are too steep to comply with the existing building code. Additionally, the brick used to construct the cheek walls does not match the brick used on the foundation and column bases, which suggests to Staff that these stairs are not historic. The applicant proposes to demolish the existing stairs and the brick cheek walls. Staff finds the demolition of these elements will not significantly alter the character of the house or the surrounding district and supports their removal under 24A-8(b)(4) and (d).

Detail: 7017 SYCAMORE AVE. CONCRETE STEPS

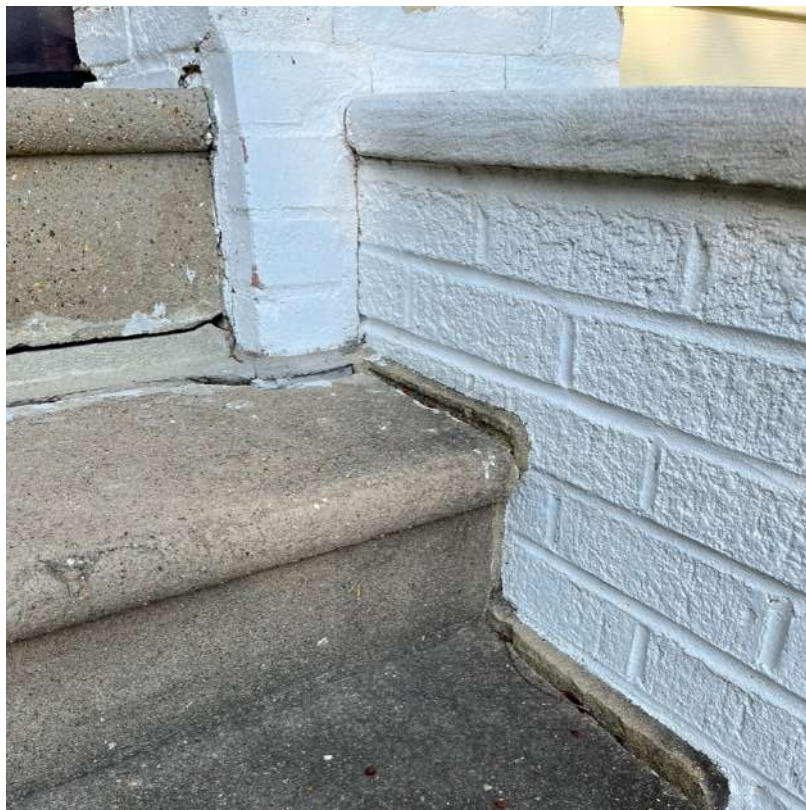
Detail: 7017 SYCAMORE AVE. CONCRETE STEPS

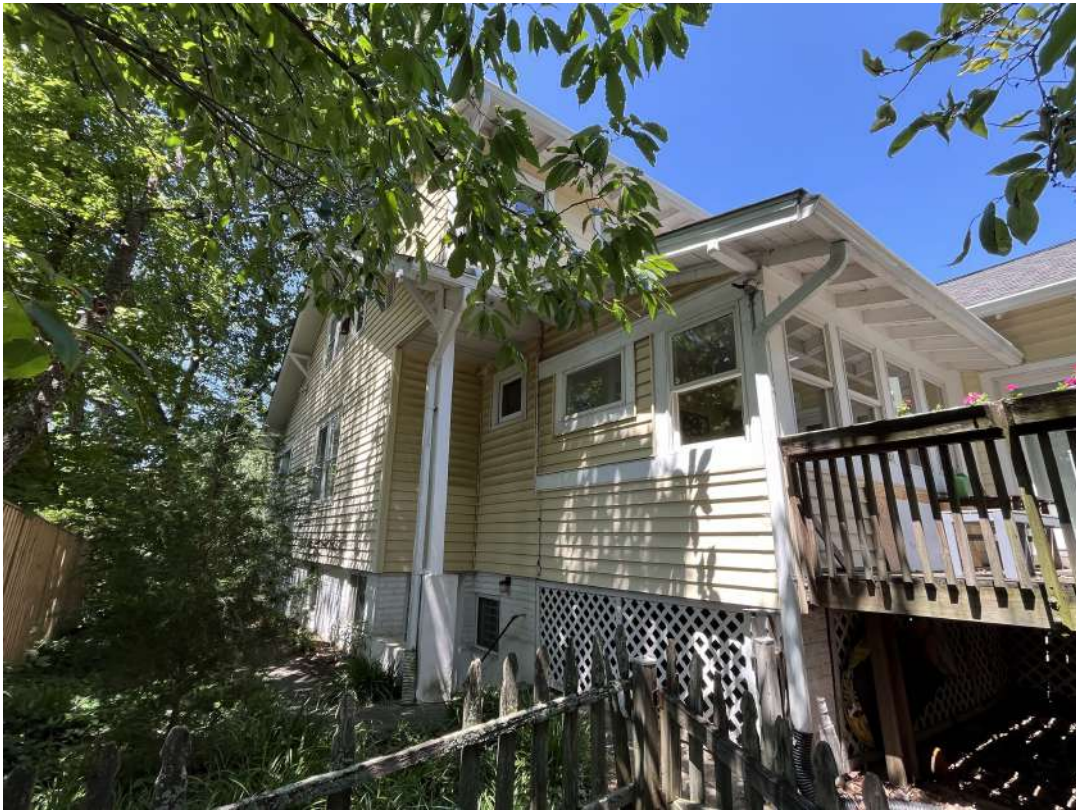
Description of Current Condition:
A pressure treated wood deck, built in the rear in the early 1990's is now in poor shape and in need of replacement.

Detail: 7017 SYCAMORE AVE. SOUTH-REAR DECK

Proposed Work:
The goal is to replace the structure in kind, though in a slightly altered configuration, and use Trex floor planks and railing systems in lieu of PT wood. The deck is not visible from the public right-of-way.
