**MONTGOMERY COUNTY HISTORIC PRESERVATION COMMISSION**  
**STAFF REPORT**

<b>Address:</b>	309 Market Street, Brookeville	<b>Meeting Date:</b>	10/09/2024
<b>Resource:</b>	Primary Resource (19 <sup>th</sup> Century) <b>Brookeville Historic District</b>	<b>Report Date:</b>	10/02/2024
<b>Applicant:</b>	Matthew Keller, Building Solutions LLC	<b>Public Notice:</b>	9/25/2024
<b>Review:</b>	Historic Area Work Permit	<b>Tax Credit:</b>	No
<b>Permit Number:</b>	1075954	<b>Staff:</b>	Rebecca Ballo
<b>PROPOSAL:</b>	Demolition of shed, stone wall, and tree removal

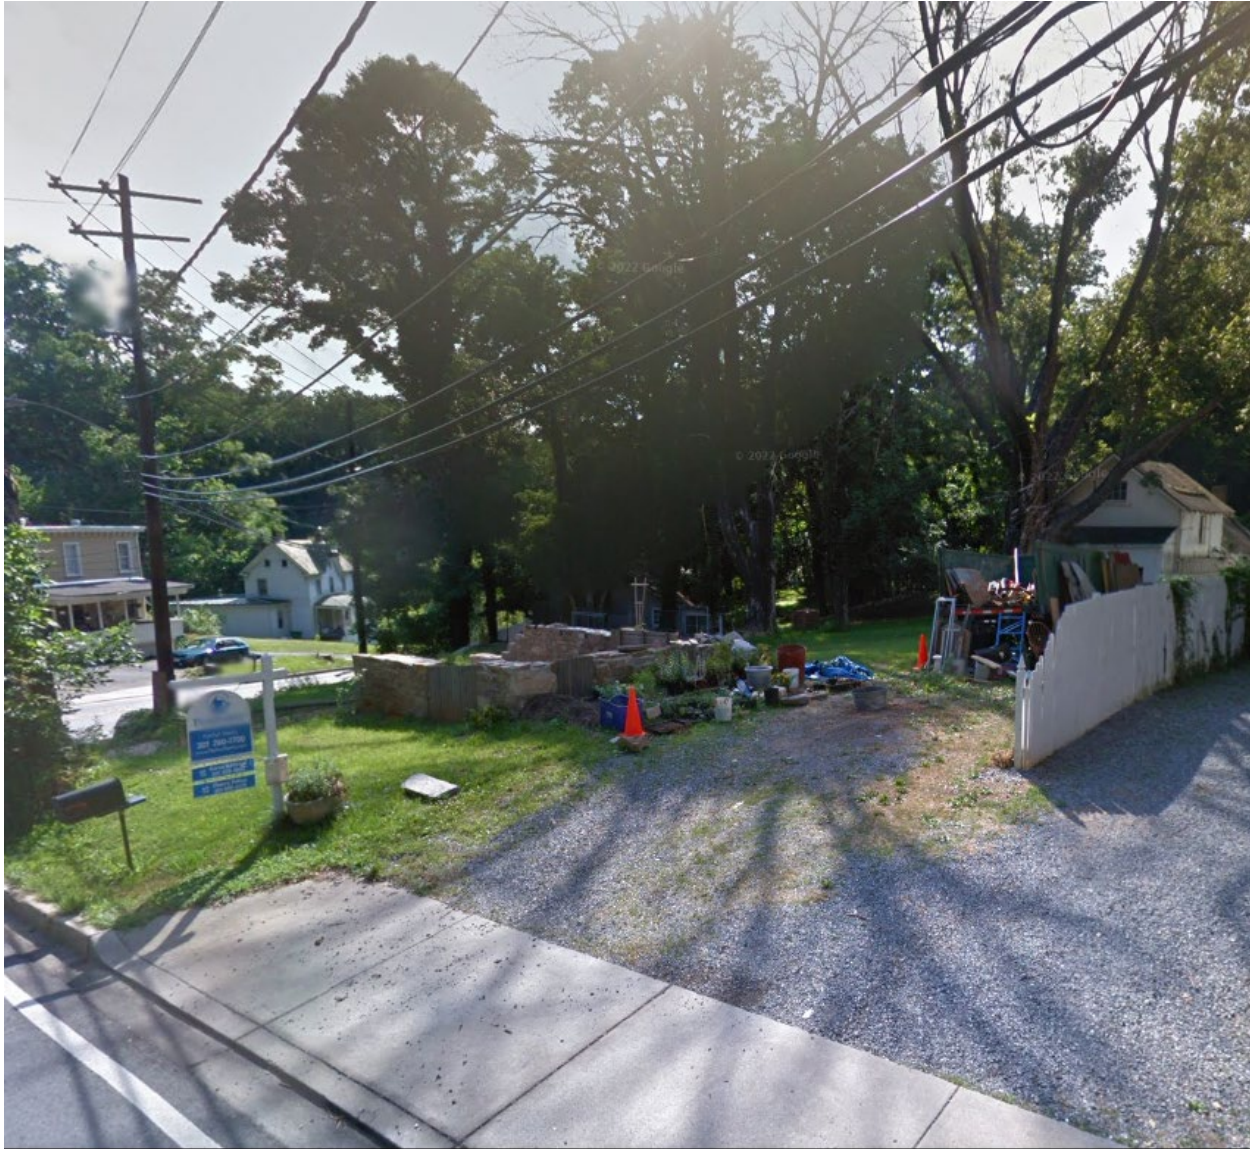
*Figure 3: Streetview image after the demolition of the main house from Market Street. The stone foundation remains extant. The shed is visible to the far right. (Google streetview from 2012)*

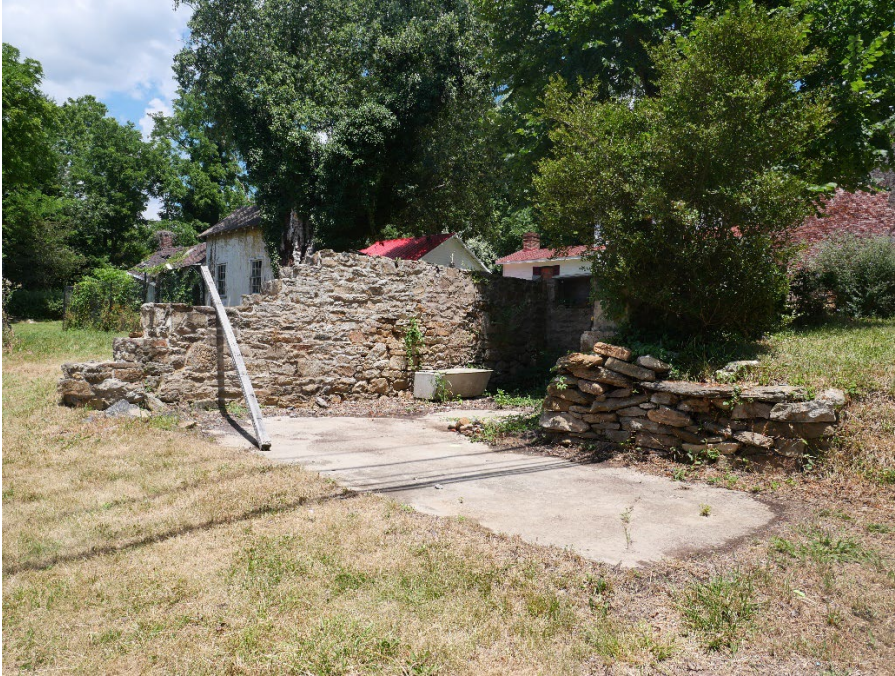
The stone wall is the only remaining extant feature of the demolished 19<sup>th</sup> century main house. The applicant is proposing to deconstruct the wall and remove it entirely from the site. The wall is variable in height from eighteen inches to approximately 36" above grade. Portions appear to be dry stacked, but this is likely due to the original lime mortar completely deteriorating in places. The remaining mortar is a lime mix with later patches presumably of a portland cement mix in small locations. The stones themselves are irregularly shaped sandstone and granite, typical of the piedmont region. The applicant states that the wall is structurally failing and requests its removal from the property.

*Figure 4: Extant basement foundation walls viewed from Market Street. (Historic Preservation Office, June 2024)*

The extant stone foundation wall is all that remains of the 19<sup>th</sup> century dwelling that had been described in the district designation. While the mortar has failed, the stones themselves remain as the last historic building material on site. These materials could be reused as part of new construction or elsewhere on site. Staff is recommending a condition that the stones be deconstructed, stacked on site, and used as part of any new building construction. That new construction will be the subject of a new HAWP application, and staff and the HPC can work with that applicant to determine an appropriate location for the stone. This condition would bring the proposal in conformance with *Standard 2* which states that ‘the removal

There is an old foundation wall which was likely part of the razing permit years ago, it's failing extensively. The mortar is beyond its useful life. The wall is tilting, and individual stones are falling out.

1. The stones from the wall may be deconstructed and stacked, but should not be removed from the property. Future plans for new construction on the property must reuse the stones as part of the new construction.

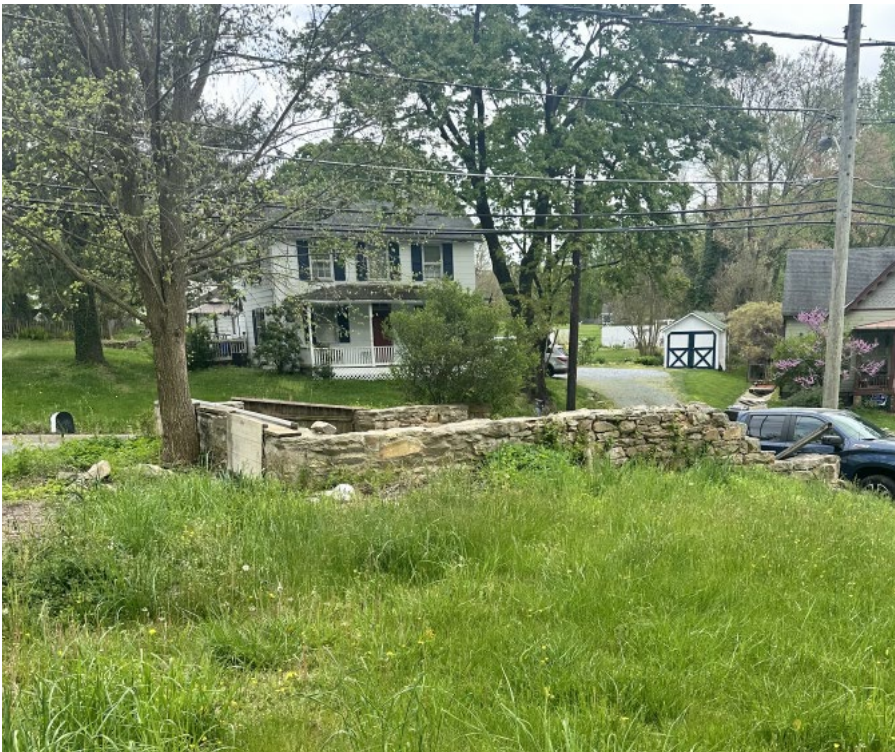
*Figure 5: Extant basement foundation walls viewed from the interior of the property looking towards Market Street. (Applicant photo)*

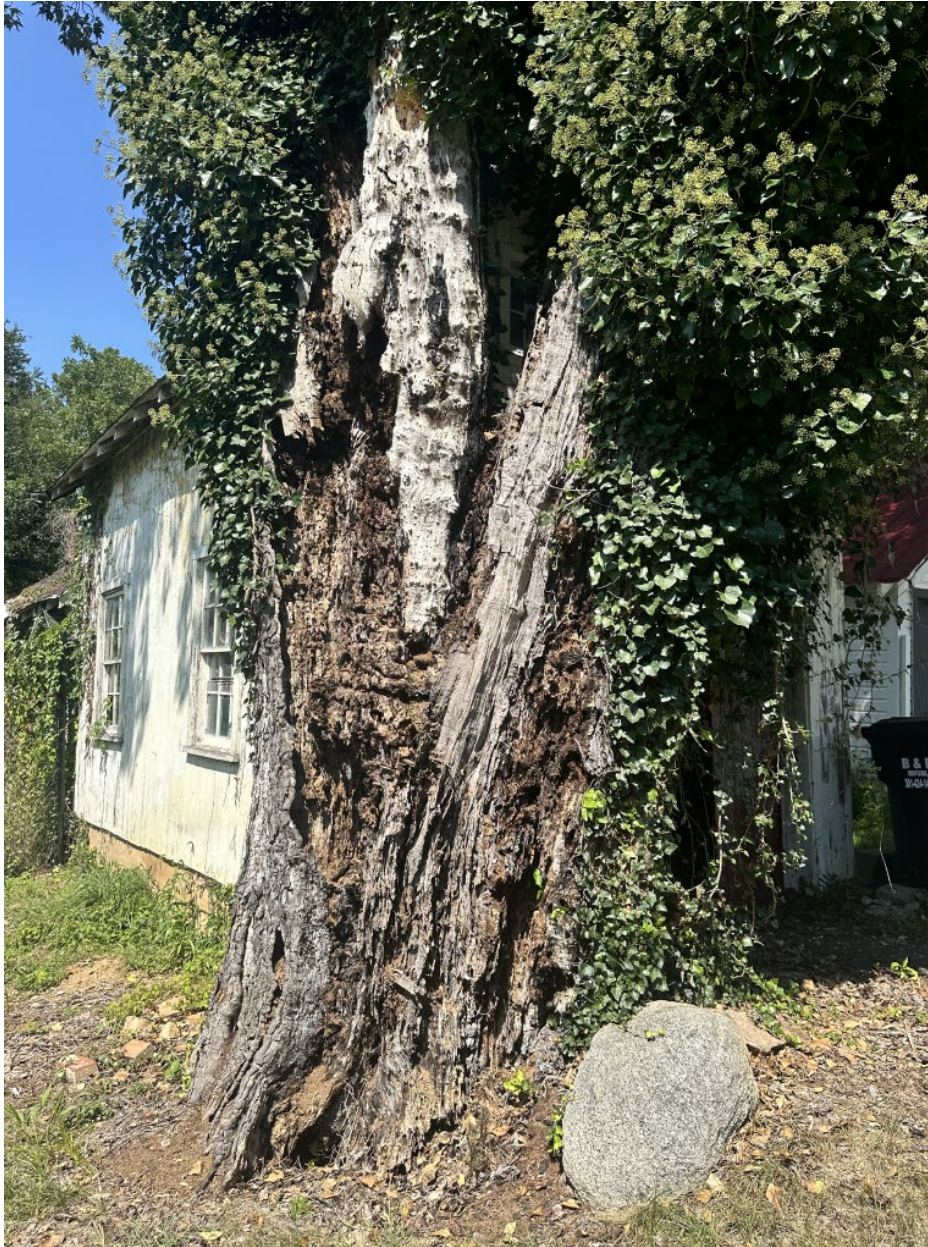
The large tree adjacent to the outbuilding is in an advanced state of decay. At the time of site visit staff observed that the the trunk is encased in porcelain berry and a large cavity at chest height was filled with

an active hornets nest. The porcelain berry extends upwards at least 20' into the canopy. There was also evidence of extensive rot from the base of the tree high into the canopy.

*Figure 6: The trunk of the tree proposed for removal. (Historic Preservation Office, June 2024)*

The tree appears to be in an advanced state of deterioration and decay. Its removal should be approved as a matter of course.

On the front left corner there is a large tree pushing against the structure. It could very well be holding the structure in its place. The tree is completely rotten and appears as if it may fall at any time.

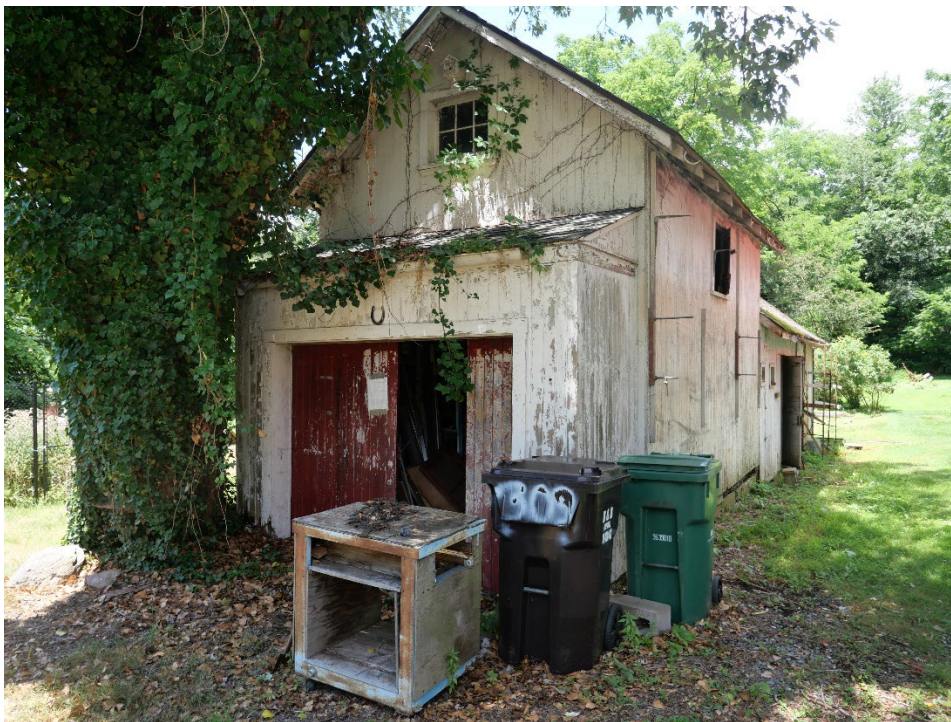
The outbuilding at the rear of the property is also proposed for removal. The one-and-a-half-story frame building rests on a concrete foundation and is clad in board and batten wood siding. The building telescopes to the rear in two distinct parts, with wood frame windows and doors, and a brick chimney flue at the rear. While the building appears to have been constructed in phases, these seem to have been done in relatively quick succession, and it is not possible to tell which portion came first. However, the concrete foundation appears to be consistent under each building section, and the exterior building materials and interior framing members that are visible all point to an early twentieth century period of construction. The framing members that are visible show machine cuts in the wood and joinery with modern nails. No peg construction or hewn construction was visible. The wood double-hung and fixed

A blight order was issued against the property in May 2024 and this notice is included in the applicant's package. The applicant has presented evidence from professionals that are skilled in historic building rehabilitation that the frame sill and portions of the walls have extensive termite damage.

*Figure 7: Front view of the outbuilding proposed for removal. (Historic Preservation Office, 2024)*

The outbuilding is also in an advanced state of deterioration having already been the subject of an abatement order from Montgomery County. While remediation of an abatement order does not automatically mean that an historic property must be demolished, staff believes that rehabilitation of this outbuilding is neither feasible nor warranted. The primary historic resource on the property, the principal dwelling, has already been removed. The outbuilding was not mentioned in the historic district designation. The outbuilding appears to be an early 20<sup>th</sup> century building, constructed with a variety of materials to serve as a storage building or workshop. While the chimneys demonstrate the building was heated at one point, and may have been occupied, there are no other signs that the building was continuously meant to be a habitable dwelling in its own right. While certainly old, it does not contribute to the historic, 18<sup>th</sup>-19<sup>th</sup> century character of this rural village historic district. In accordance with Chapter 24A-8(b)(1), the expanded deck will not substantially alter the exterior features of the historic resource within the Brookeville Historic District. Staff finds that per Chapter 24A-8(b)(2), the proposal is compatible in character and nature with the historical and architectural features of the historic district. All visible framing members are in such advanced decay, staff does not recommend salvaging any of the materials.

The structure is found to be completely deteriorated. Many sections have already collapsed, others are on the verge of collapsing. We found a lot of rot due to weather and water leaking for so many years. There is extensive termite and insect damage to the wood. The sill plate (board the structure sits on) is completely deteriorated and can give in completely. Many rafters have collapsed along with structural framing due to insects and water damage.

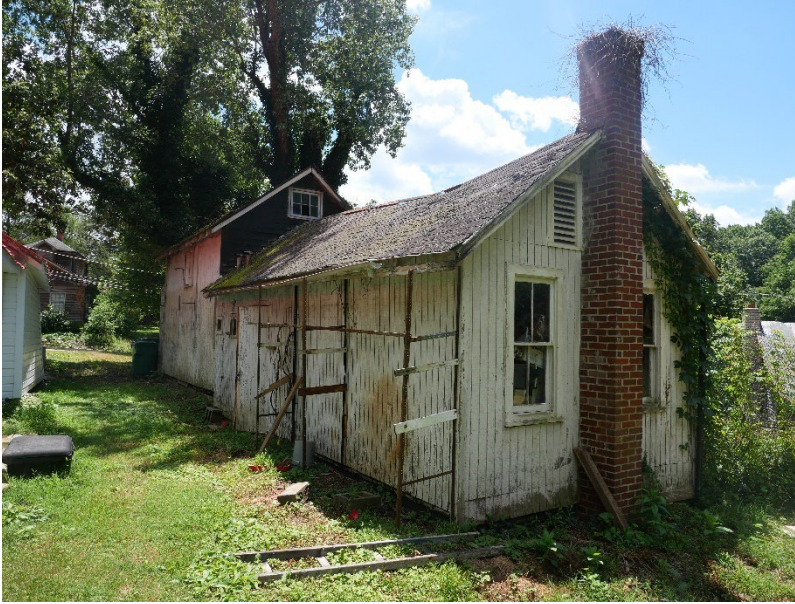
*Figure 8: Rear view of the outbuilding proposed for removal. (Historic Preservation Office, 2024)*
