MONTGOMERY COUNTY HISTORIC PRESERVATION COMMISSION
STAFF REPORT

Address:	102 East Kirke Street, Chevy Chase	Meeting Date:	5/14/2025
Resource:	Outstanding Resource Chevy Chase Village Historic District	Report Date:	5/7/2025
Project Contact:	Luke Olson, Architect	Public Notice:	4/30/2025
Review:	HAWP	Tax Credit:	n/a
Permit No.:	1067931 REVISION	Staff:	Dan Bruechert
Proposal:	Fenestration Alteration to Previously Approved HAWP

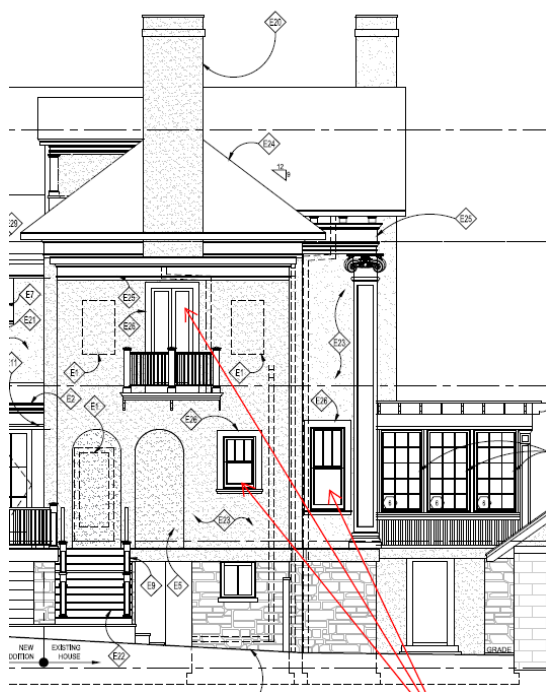
Figure 2: South elevation showing the location of the proposed window and door replacements.

The second floor French Doors (Door #3), shown in *Figure 2*, above, are wood with each door divided up into three lights. The doors show signs of warping and have allowed a significant amount of water infiltration to the point that the interior floors adjacent to the French Doors show substantial damage.

Because the existing door is not at all visible from the public right-of-way and it shows damage and deterioration, Staff finds its removal is supported under the *Design Guidelines*. Staff further finds an aluminum clad door consistent with the appearance of the approved but uninstalled clad windows on the south and east elevations is appropriate under 24A-8(b)(2) and (d) and the *Design Guidelines*. Staff recommends the HPC add a condition to the approval of this HAWP that detailed door specifications need to be submitted for review and approval before issuance of the final permit documents. Final approval authority can be delegated to Staff to verify the replacement door is consistent with the configuration and dimensions of the existing door.

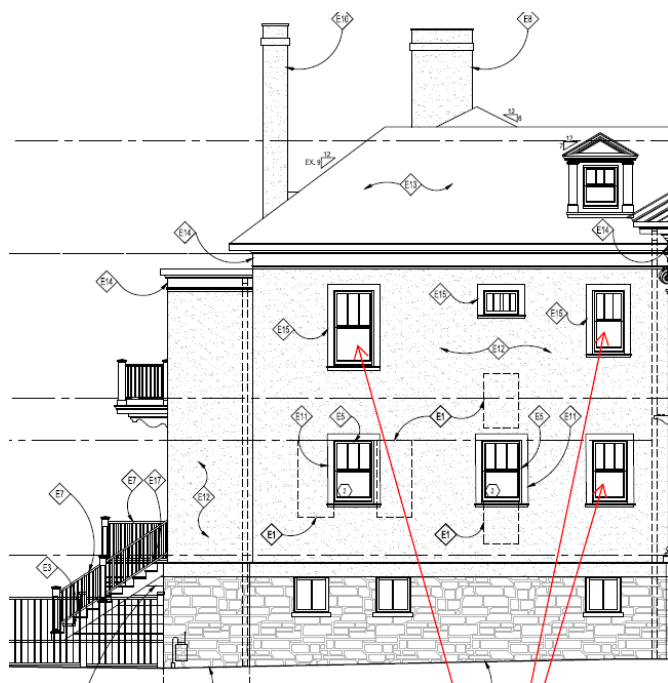
Figure 3: Eastern elevation showing the proposed replacement windows.

On the south and east elevations, the applicant proposes to remove and replace five existing wood windows (identified as windows 1, 2, 3, 7, and 8 in the application). Three windows are on the east elevation of the existing rear-L (see *Figure 3*, below). One of the windows is on the south elevation of the main house mass and the last window is on the south elevation of the rear ell (see *Figure 2*, above). These windows are not visible from the public right-of-way.

As discussed in the previous HAWP revision, the *Design Guidelines* state windows not visible from the public right-of-way, as is the case with the windows under consideration in this HAWP revision, should be reviewed under lenient scrutiny, with the exception that windows on Outstanding Resources should be reviewed under strict scrutiny. Under this analysis, windows not visible from the public right-of-way on Outstanding Resources still need to be evaluated under strict scrutiny. In the original HAWP, the Staff recommended the HPC approve the window relocation based in part on the lower level of architectural detail and design significance of the rear ell and because they were not at all visible from within the historic district. The rear ell lacks the columns, decorative modillion cornice, and detailed window trim found on the main house massing. As before, Staff supports the window removal on the east elevation and south elevation of the east ell under 24A-8(b)(2), the *Design Guidelines*, and Standard 2.

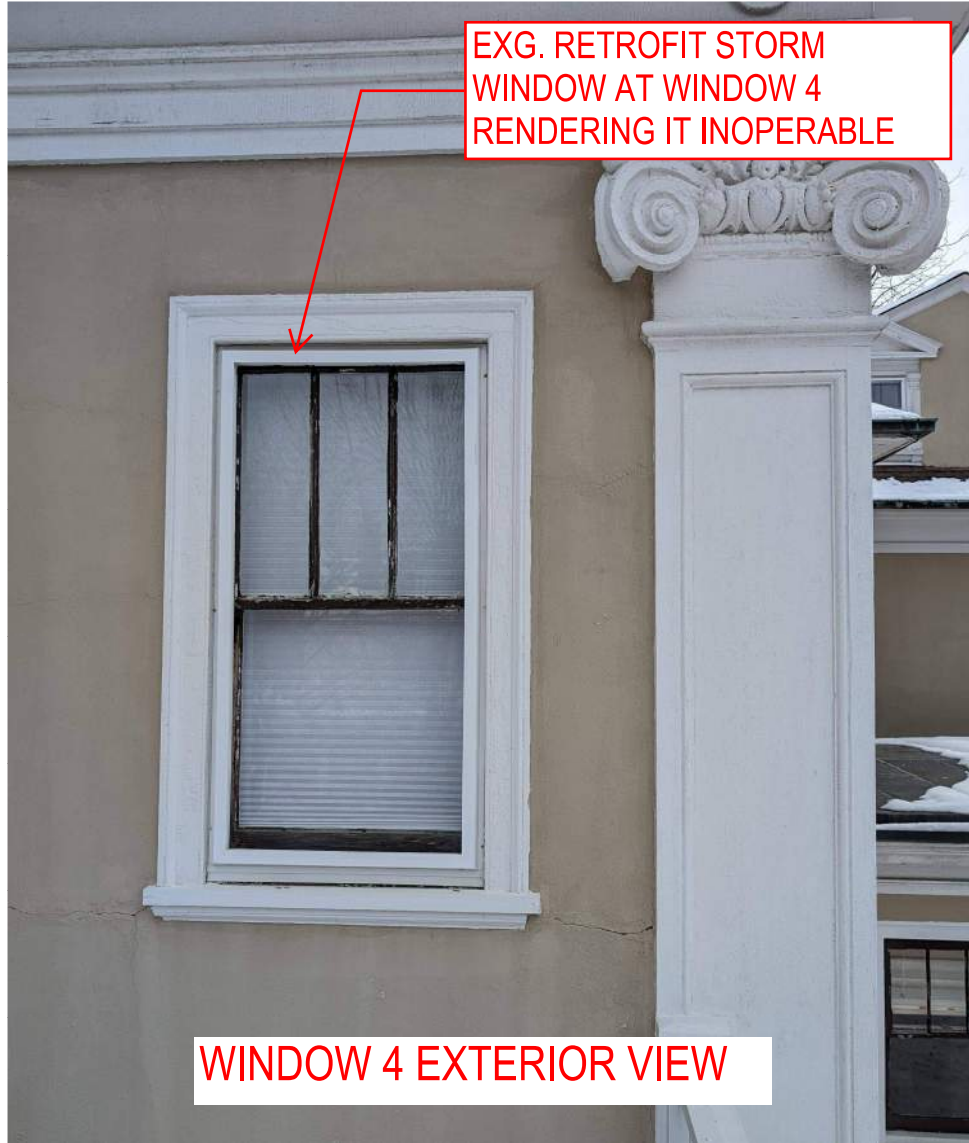
WINDOW 4 EXTERIOR VIEW

Finally, the applicant proposes to remove and replace three original wood windows and install new wood windows in the existing openings. All three of the windows are three-over-one sash windows, and they are all on the second floor of the house. One window is on the west elevation and two windows are on the east elevation. As with the doors, discussed above, the applicant proposes to remove the windows to improve the thermal performance/comfort of the house, abate traffic noise, and improve security and window operability. The application also states a desire to reduce potential lead paint hazard. Window #4 has a fixed exterior storm window that renders it inoperable

Under this heightened review standard, Staff does not find that removing the existing windows is appropriate. Nothing provided in the application indicates the windows have deteriorated beyond repair and Staff supports retaining the historic fabric to maintain the house’s material integrity. As with all HAWPs, the burden of persuasion rests with the applicant and Staff does not find that burden has satisfied here.

EXG. RETROFIT STORM WINDOW AT WINDOW 4 RENDERING IT INOPERABLE

Based on Staff’s experience, there are several ways to improve the thermal performance and mitigate some of the traffic noise. First, Staff recommends the existing wood windows be restored by a professional who specializes in this type of work. Restoring the windows will improve the window operability by stripping and repainting the windows, installing new sash cords, and cleaning the edges of

the sashes. Restoring these windows can improve the window efficiency by installing new weather stripping and replacing any cracked or broken glazing putty. Many historic wood sash windows can be routed to accommodate an insulated glass unit while largely maintain the historic exterior profiles. Additionally, interior or exterior storms can be installed to improve both the thermal performance and mitigate noise. The storms could be installed in a manner that would allow for their easy removal to allow for window operation. Staff adds that the window restoration, including installing insulated glass, and storm windows are eligible for the county's historic preservation tax credit, which would apply 25% of the cost as a credit to the owners' property tax bill.

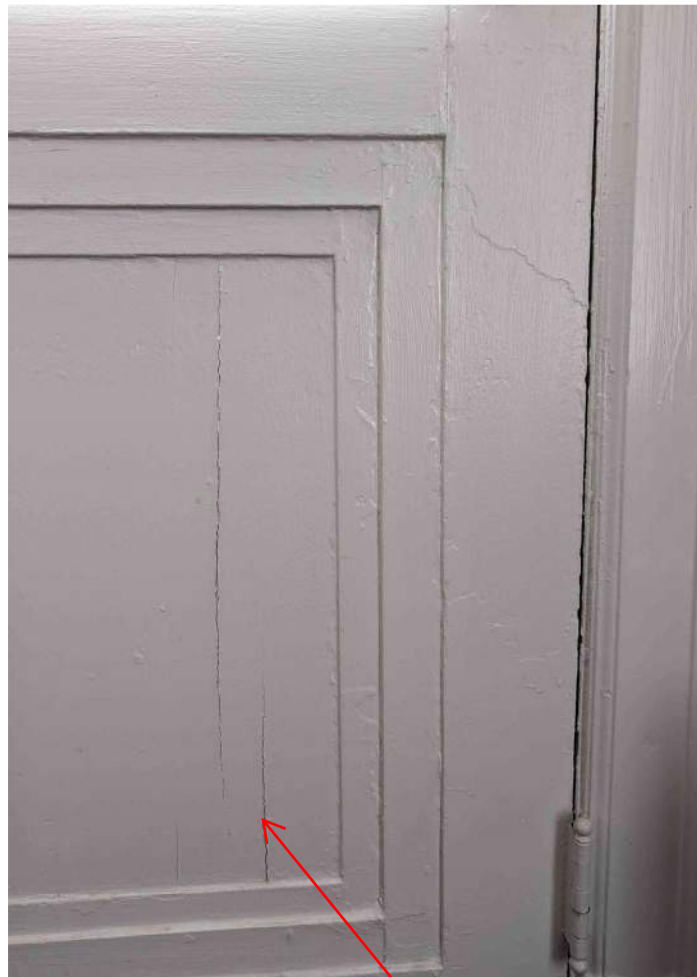
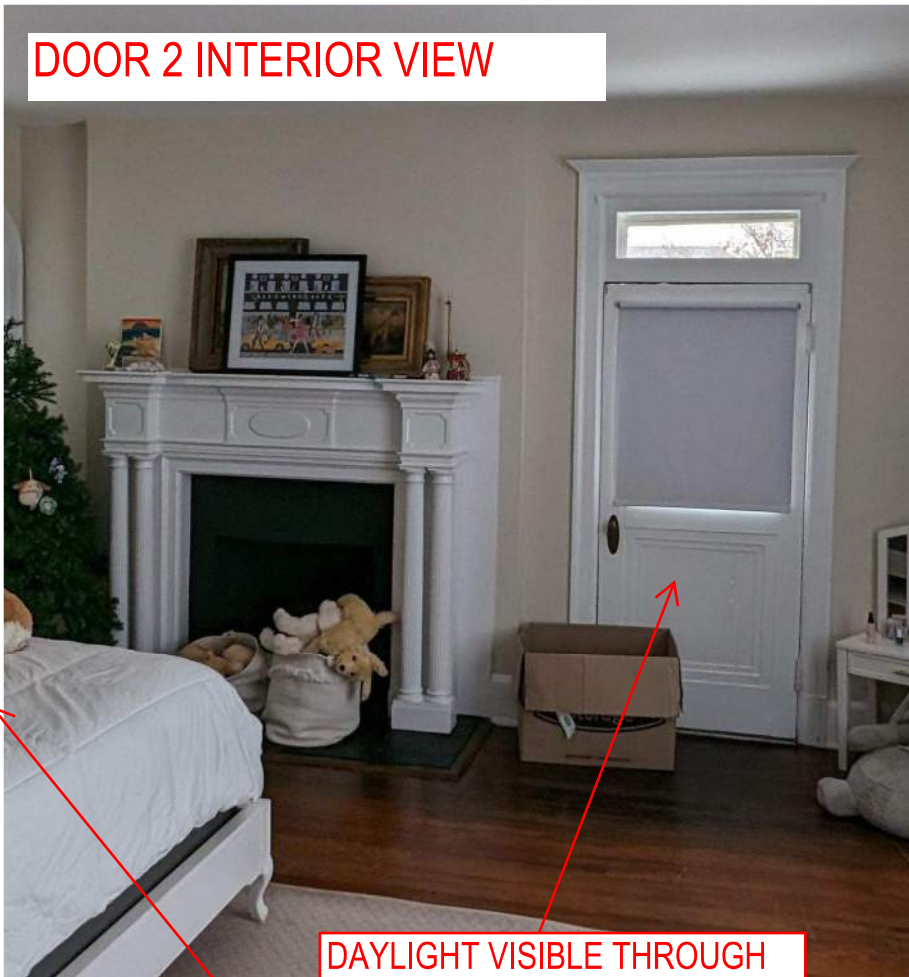
DOOR 2 INTERIOR VIEW

Door #1, on the first floor, is a full light door with a fixed transom. Door #2 is a half-light wood door with fixed transom. The submitted materials show cracks in the lower panel of door #2 on the second floor. The applicant states that the panel is too thin to be effectively repaired with new growth wood. The documentation does not identify any material or structural deficiencies in door #1; however, the accompanying narrative states a desire to improve efficiency, noise abatement, and physical security.

Based on the submitted information, Staff finds that door #2 shows damage that cannot be readily repaired and the finds that removing and replacing the door is appropriate under the *Design Guidelines* and *Standard #6*. However, the applicant has not provided detailed specifications for the proposed replacement door and Staff recommends the HPC add a condition that requires the applicant to submit detailed specifications for the wood replacement door to Staff before final approval documents can be released. Final approval authority can be delegated to Staff to verify the proposed door is consistent with the existing door.

DAYLIGHT VISIBLE THROUGH CRACKS IN PANEL OF DOOR 2

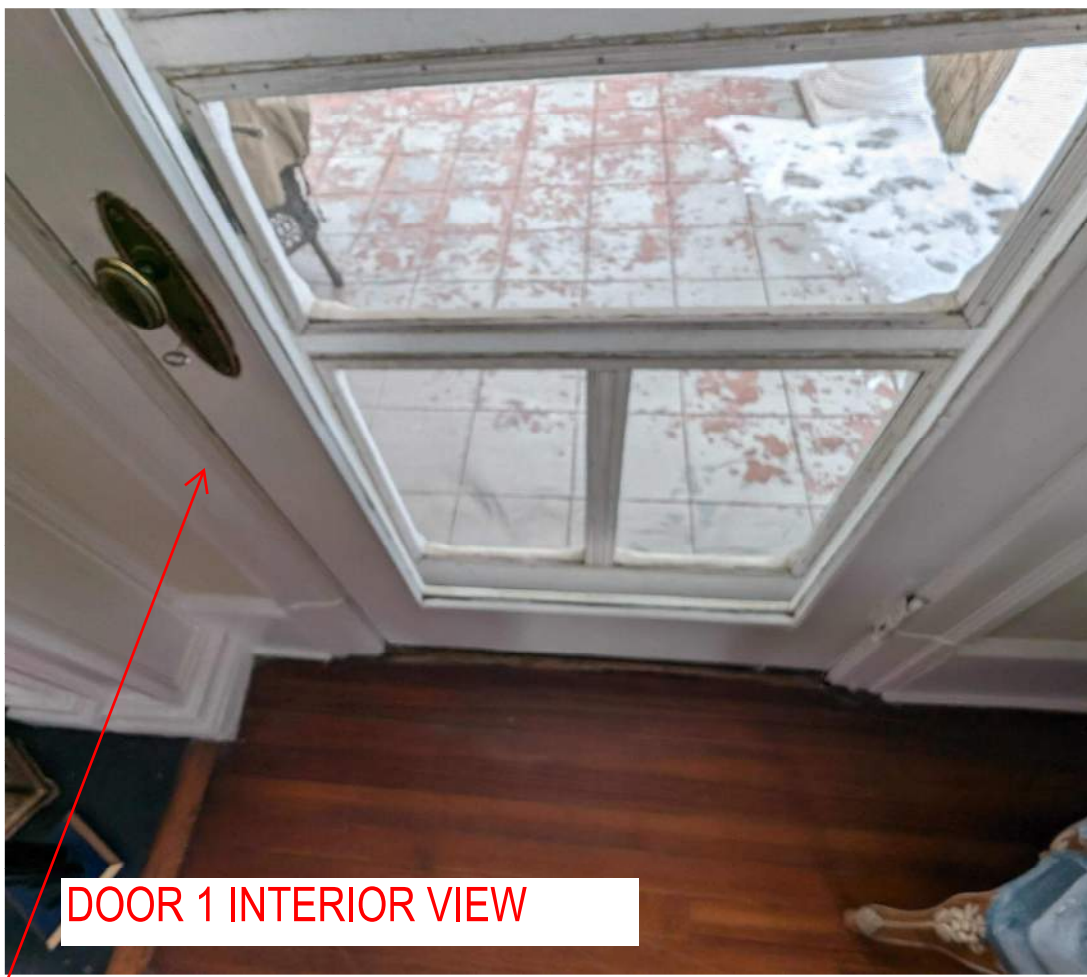
DOOR 1 INTERIOR VIEW

Staff does not find the applicant has demonstrated that the door #1 has deterioration beyond repair and notes that under moderate scrutiny the integrity of the resource is considered. If there are other concerns or mitigating factors to consider, Staff encourages the applicant to provide those to the HPC. Staff notes repainting and weather stripping the door coupled with a properly fitted storm door would improve the thermal performance and the security of the existing door. Staff does not recommend the approval of this HAWP extend to removing and replacing door #1.

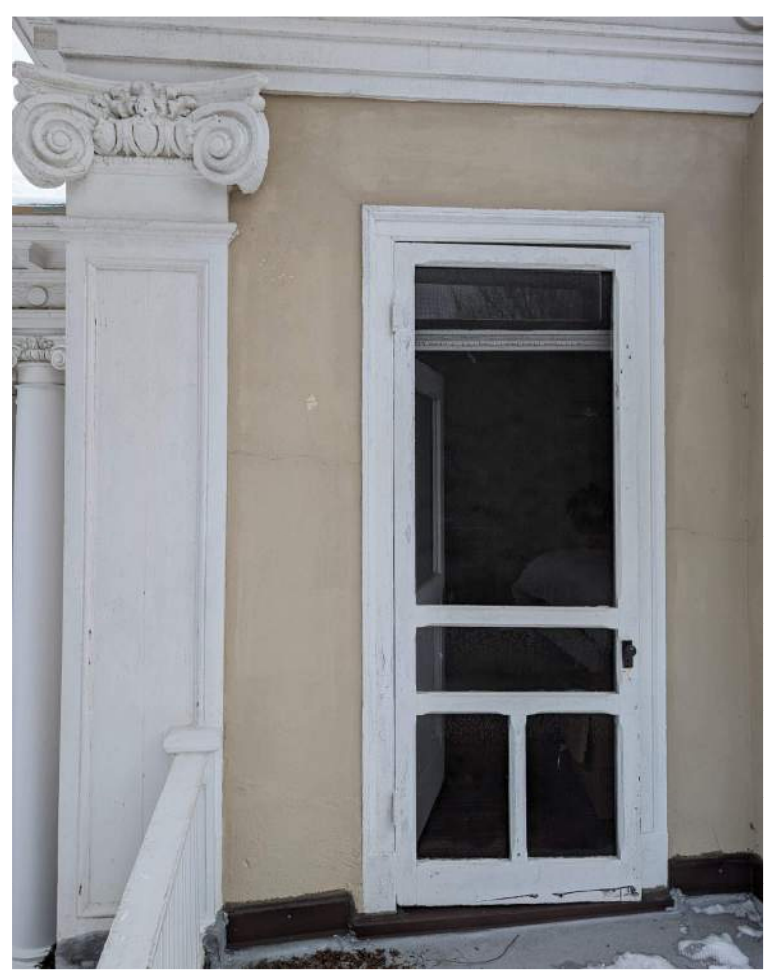
EXTERIOR VIEW OF SCREEN DOOR @ DOOR 2

Both doors have wood screen doors that show significant signs of deferred maintenance including failing paint and warping, and the screen door for door #2 appears to be out of plumb.

DOORS 1 & 2 ARE OBSCURED BY EXG. SCREEN DOORS AND NOT READILY VISIBLE, DOOR 2 HAS VISIBLE DAYLIGHT SHOWING THROUGH THE CRACKS IN THE WOOD PANEL. I DON'T BELIEVE THERE IS SUFFICIENT THICKNESS TO THAT PANEL GIVEN THE DOOR DESIGN THAT THIS ISSUE WOULD NOT REOCCUR WITH A REPLACEMENT PANEL MADE OF NEW GROWTH WOOD MORE LIKELY TO CUP/WARP/CRACK. WINDOW 4 HAS A RETROFIT CLAD OR VINLY STORM WINDOW INSTALLED ON EXTERIOR RENDERING IT INOPERABLE. WE'D LIKE TO REPLACE THESE UNITS WITH NEW ENERGY-EFFICIENT PTD. WOOD SLD UNITS THAT MATCH THE EXISTING UNITS AS CLOSELY AS POSSIBLE TO MAINTAIN THE LOOK/AESTHETICS FROM THE EXTERIOR WHILE ALSO PROVIDING A HIGHER DEGREE OF AIR/WEATHERSEALING FOR ENERGY-EFFICIENCY, FUNCTIONALITY/USEABILITY, AND COMFORT.

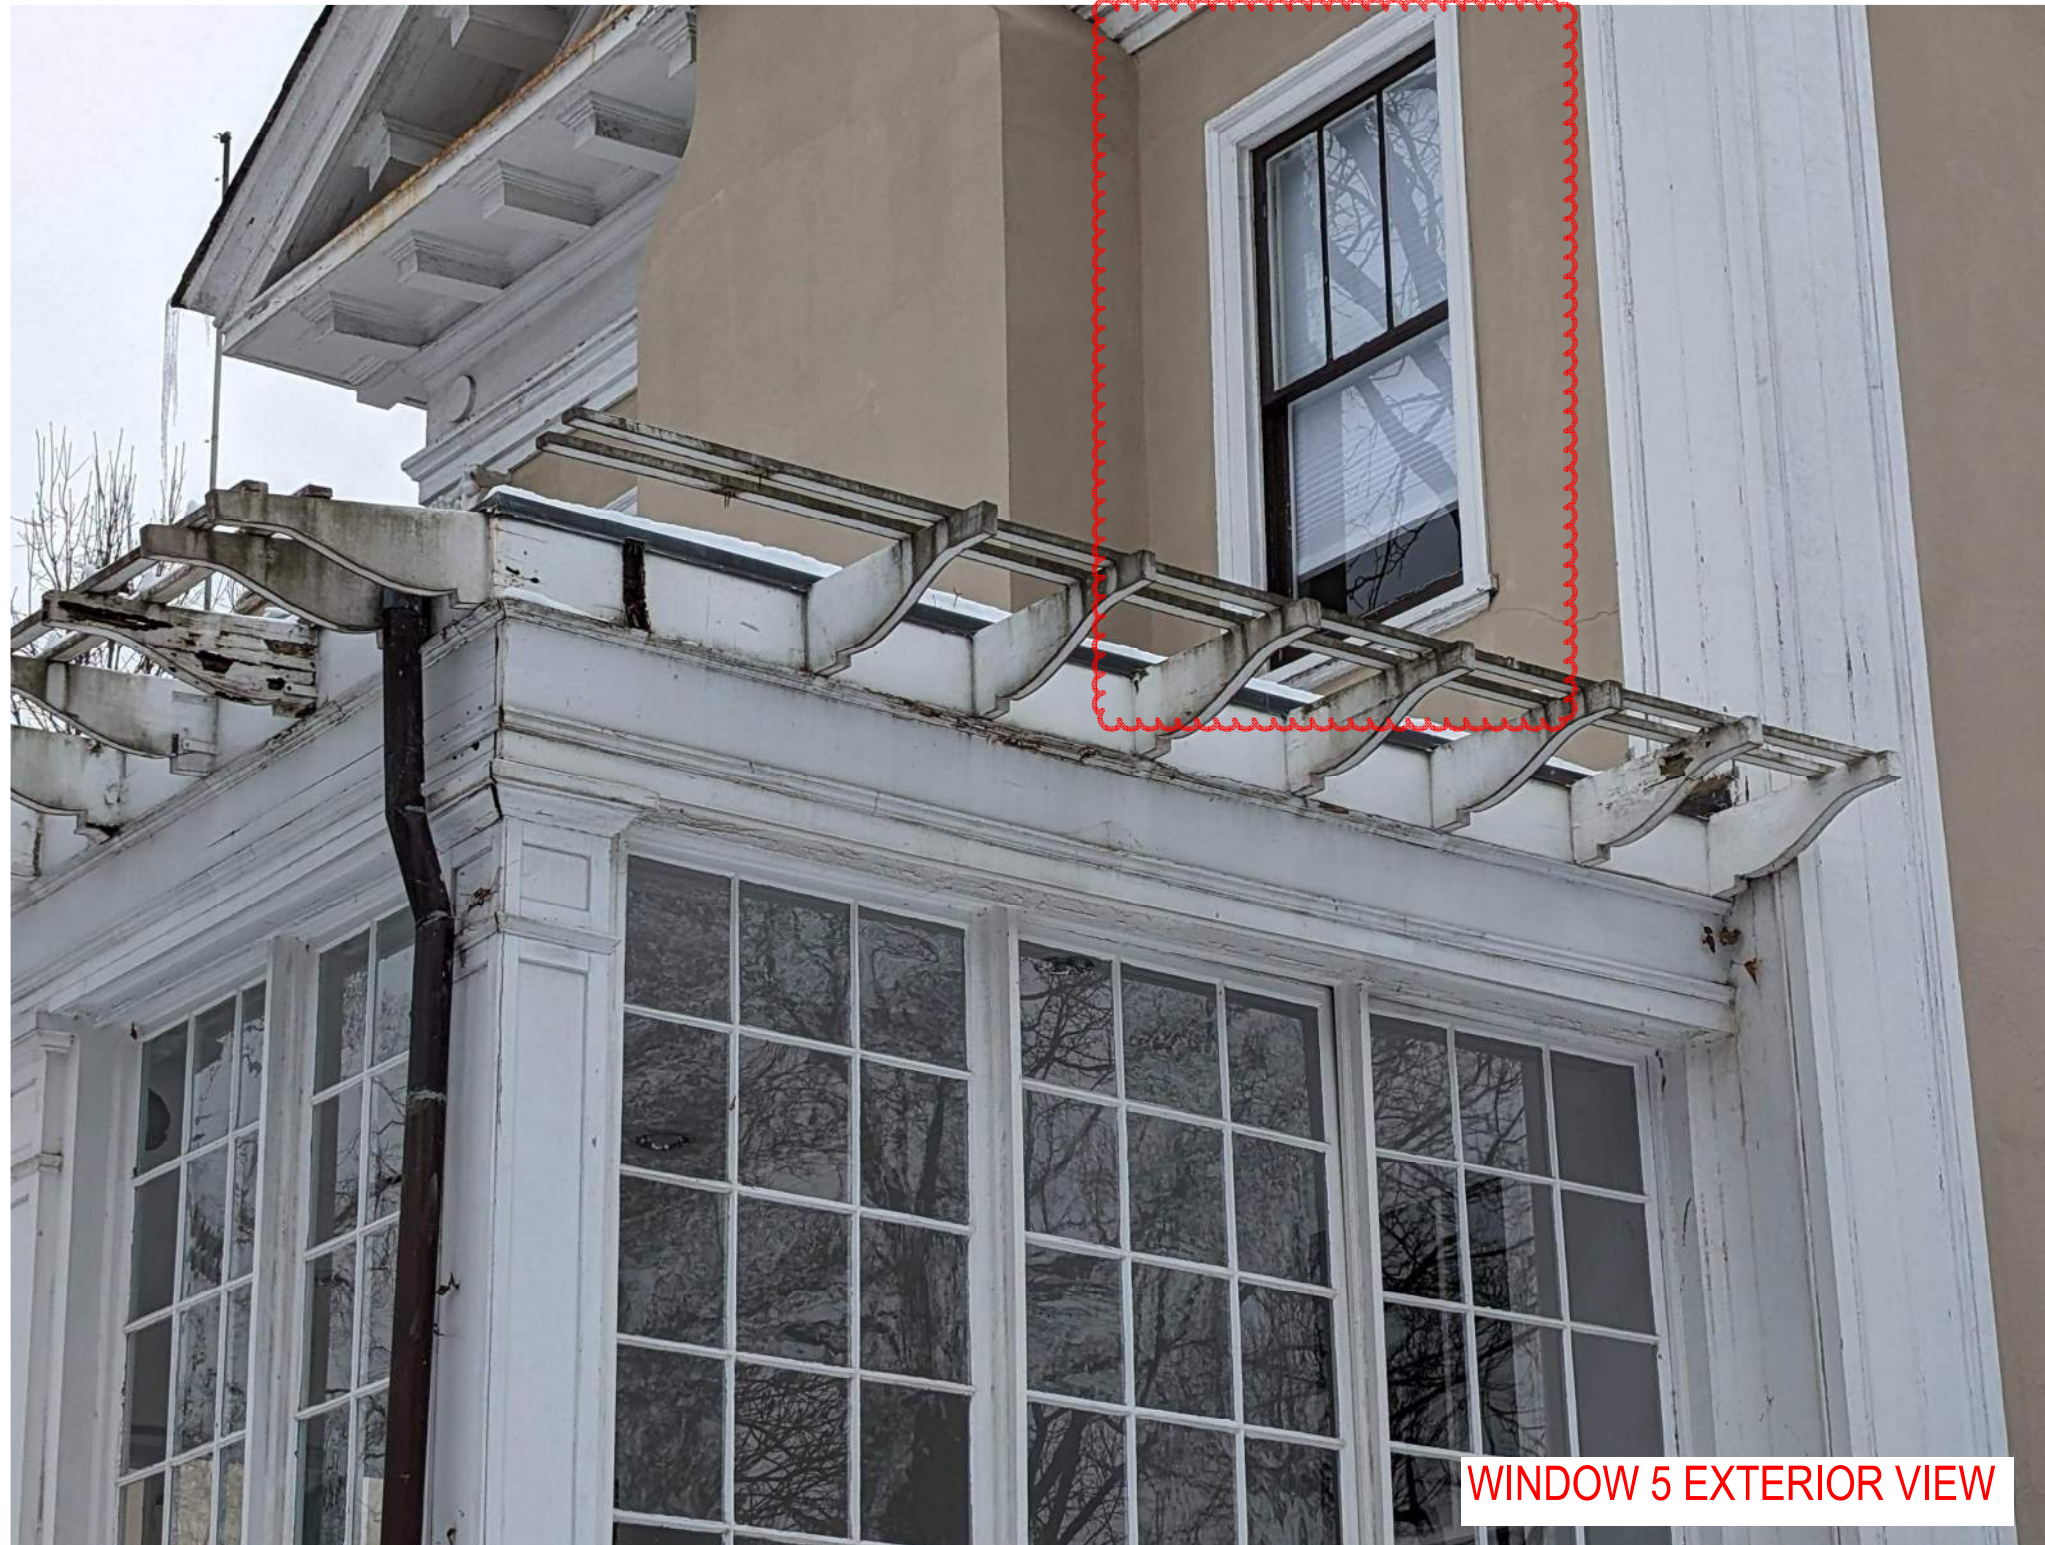
WINDOW 5 EXTERIOR VIEW

WINDOWS 5 & 6 ARE NOT READILY VISIBLE, DOOR 2 HAS VISIBLE DAYLIGHT SHOWING THROUGH THE CRACKS IN THE WOOD PANEL. WE'D LIKE TO REPLACE THESE UNITS WITH NEW ENERGY-EFFICIENT PTD. WOOD SLD UNITS THAT MATCH THE EXISTING UNITS AS CLOSELY AS POSSIBLE TO MAINTAIN THE LOOK/AESTHETICS FROM THE EXTERIOR WHILE ALSO PROVIDING A HIGHER DEGREE OF AIR/WEATHERSEALING FOR ENERGY-EFFICIENCY, FUNCTIONALITY/USEABILITY, AND COMFORT.
