MONTGOMERY COUNTY HISTORIC PRESERVATION COMMISSION
STAFF REPORT

Address:	9 Chevy Chase Circle, Chevy Chase	Meeting Date:	9/17/2025
Resource:	Master Plan Site #35/13-001A Newlands-Corby Mansion	Report Date:	9/10/2025
Applicant:	Adrienne Arsht Revocable Trust (CAS Engineering, Agent)	Public Notice:	9/3/2025
Review:	HAWP	Tax Credit:	No
Case Number:	1130413	Staff:	Laura DiPasquale
Proposal:	Tree removal and expansion of driveway apron

Tree Risk Assessment Report

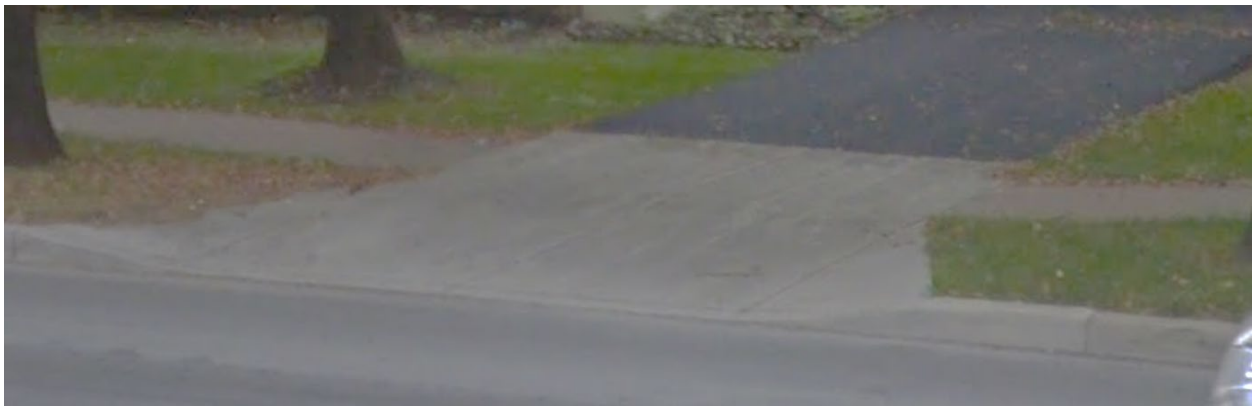
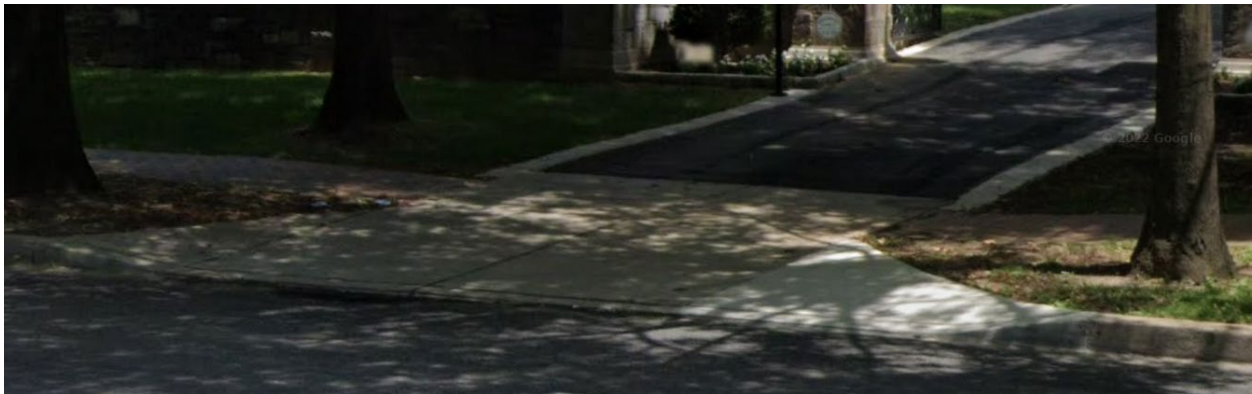
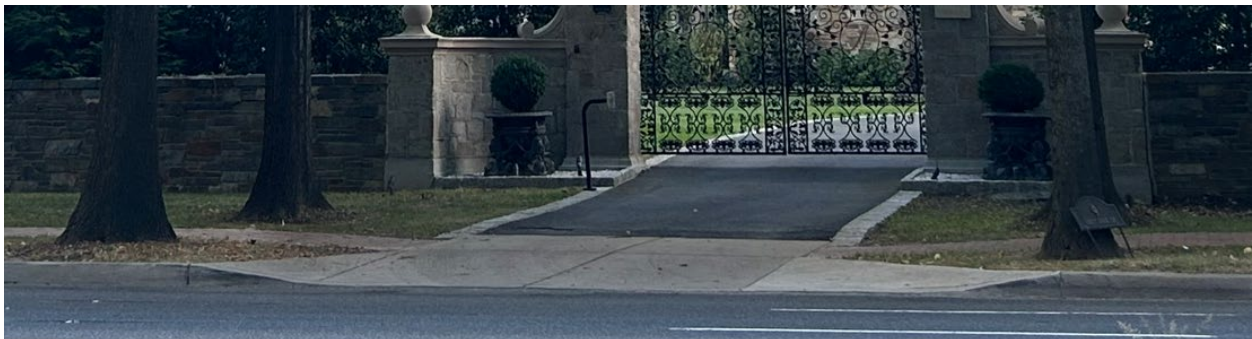
Staff supports the proposed alterations and finds that they will not substantially alter the exterior features of the historic site, per Chapter 24A-8(b)(1). The applicants argue that the current width of the driveway apron and trees proposed for removal create unsafe conditions for vehicles turning off and onto Connecticut Avenue, which is three lanes of north-running traffic wide with no shoulder at the driveway entrance, per Chapter 24A-8(b)(4). Although 20 feet is standard for residential driveway apron width, staff finds that, given the absence of other neighboring driveways along this stretch of Connecticut Avenue and the scale of the subject property, the widening of the apron will have a limited impact on the historic resource, per Chapter 24A-8(b)(1), but staff recommends that the concrete be tinted a beige or darker neutral color to minimize the visual impact of the new work and be more consistent with historic paving materials and compatible with the paving on and around the site, per Chapter 24A-8(b)(2) and *Standard 9*. Staff notes that a relatively recent extension/repair of the apron flare to the right of the driveway, which was completed between October 2019 and July 2022 in un-tinted concrete, remains conspicuous in 2025.

Figure 5: September 2017 view of the driveway apron (Google Streetview).

Figure 6: July 2022 view of the driveway apron (Google Streetview).

Figure 7: September 2025 view of the driveway apron (Historic Preservation Office).

1. The new driveway apron concrete must be tinted beige or a darker neutral, not bright white.

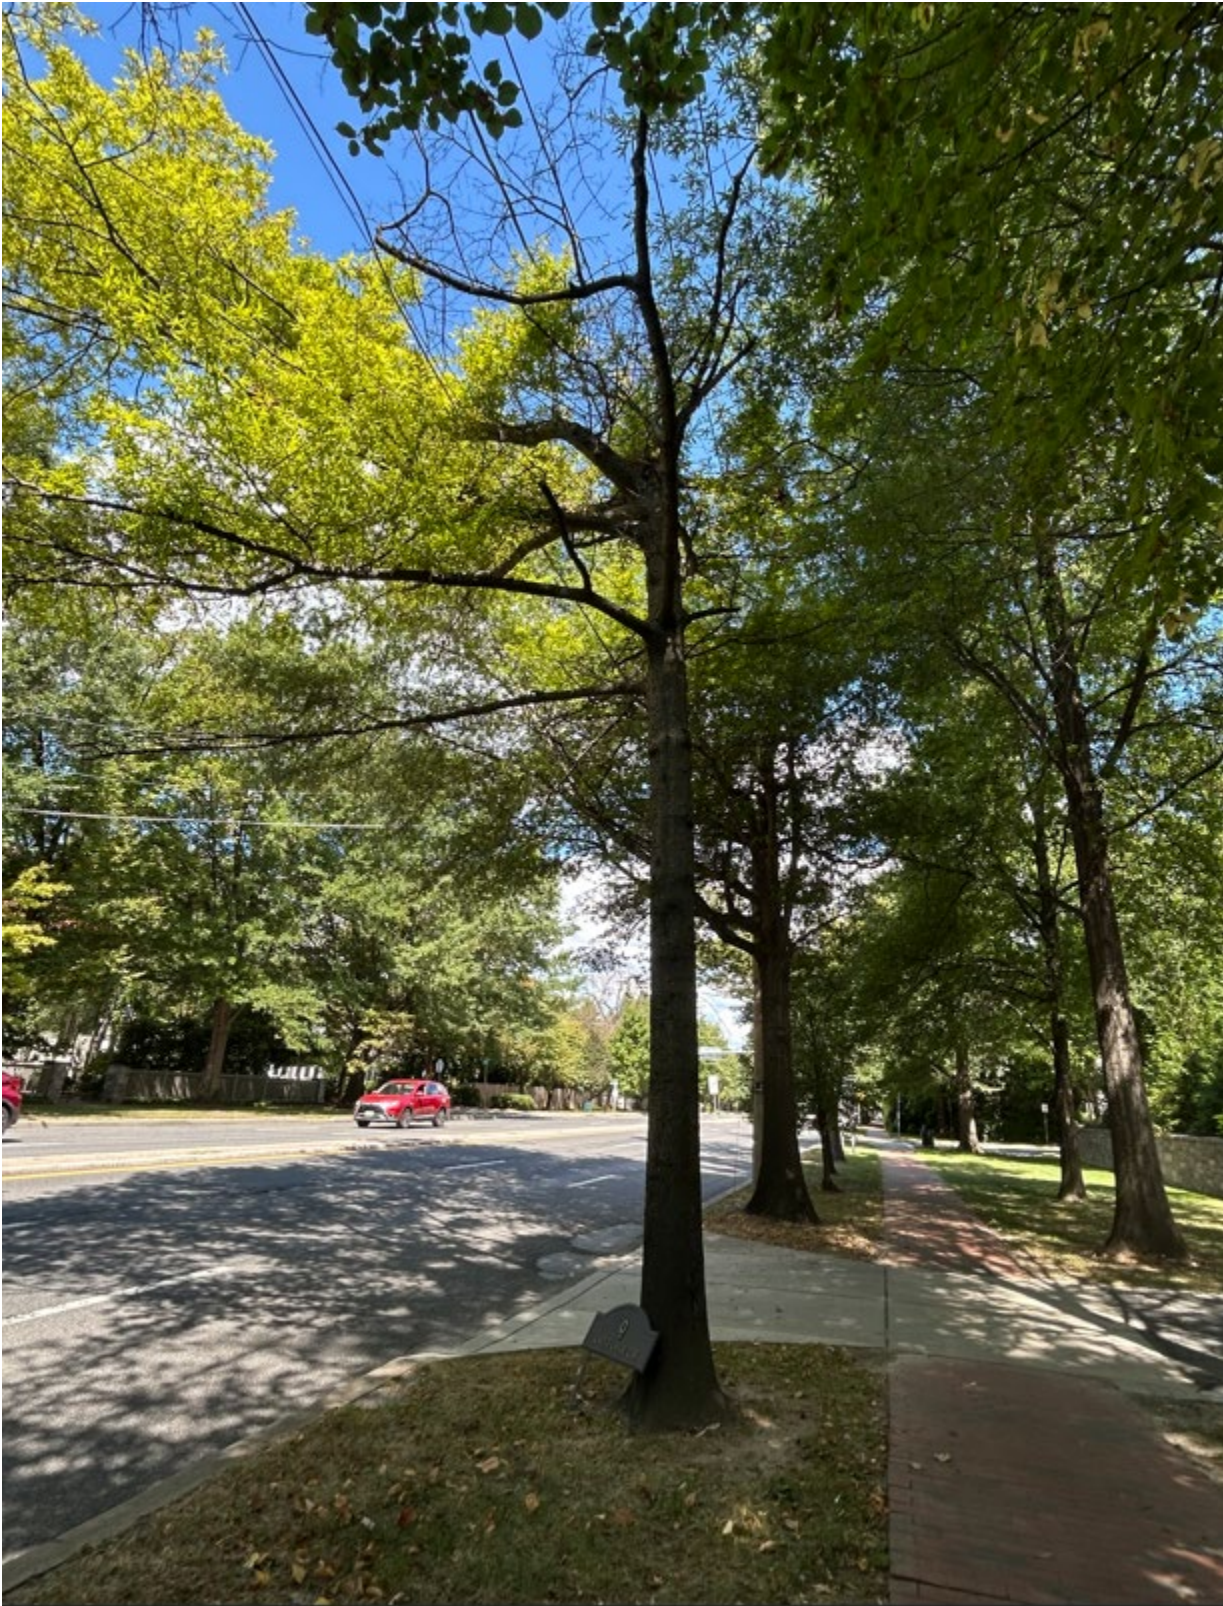
Figure 10: View north on Connecticut Avenue with Willow Oak #3 in the center foreground, and Willow Oak #1 behind (September 2025, Historic Preservation Office)

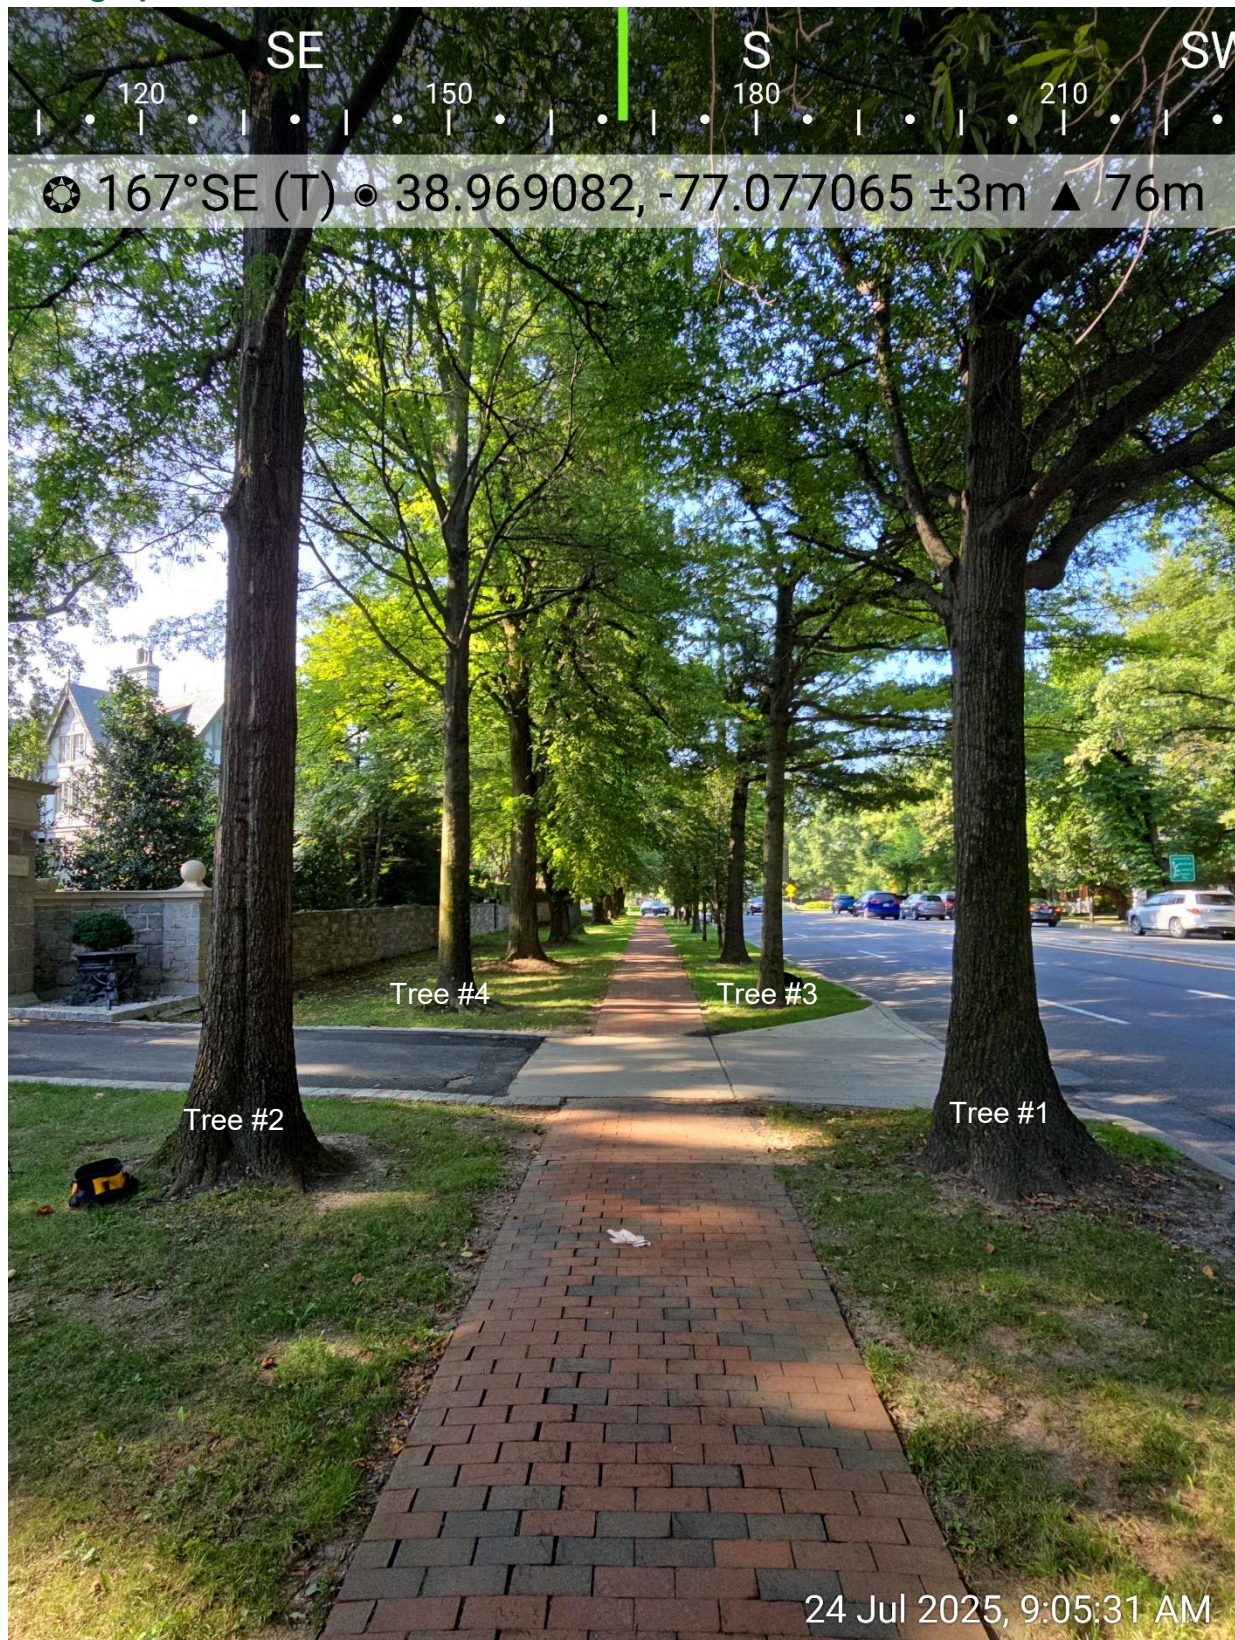
Photo 1: View of all four willow oaks, labeled.

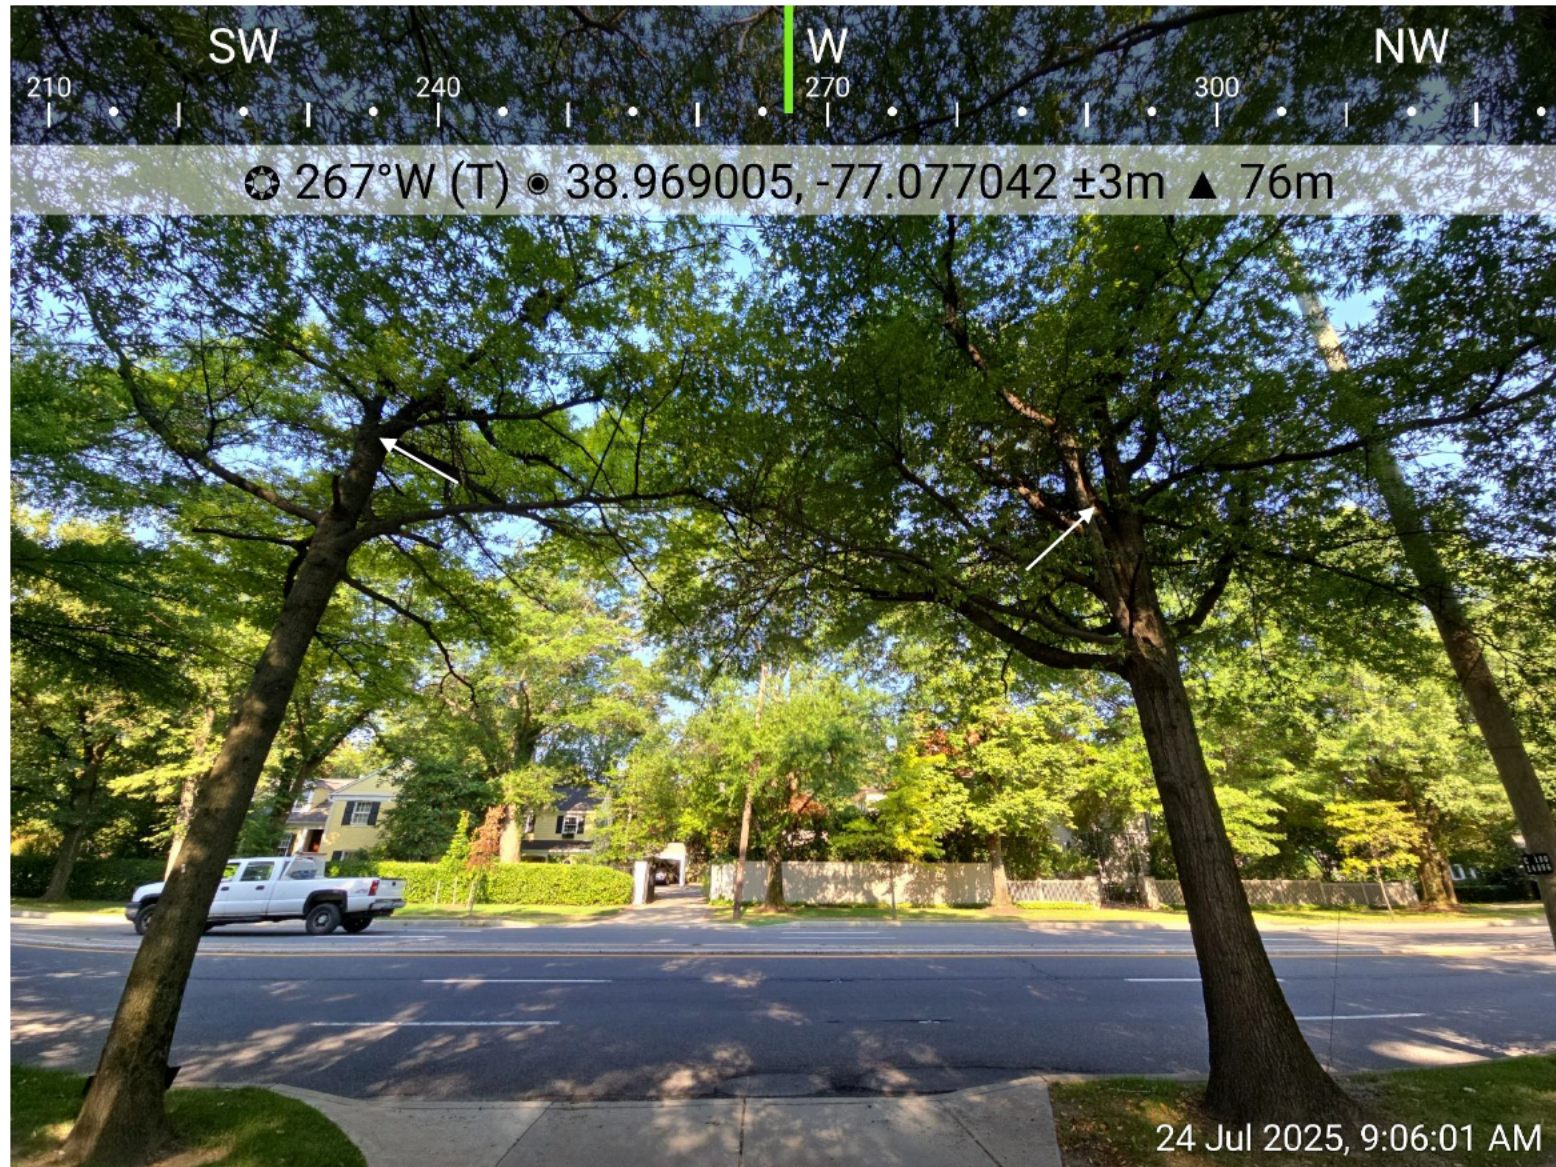
The canopy of willow oak #1 was supported by one vertical stem that was topped at approximately 25 feet above grade to provide clearance to overhead power lines. Due to the loss of apical dominance in a central stem, a majority of branches have extended west over Connecticut Avenue creating an unbalanced canopy. The stem and roots did not display any signs of loss of integrity and had solid tones when sounded. The soil was compact when tested with a probe and the root zone was confined to a small planting area between the sidewalk and road. The overall vitality of the tree was low; with diminished shoot growth and canopy density and the location and condition of this tree was poor.

Photo 2: View of oaks #1 and #3 looking south. Topping cuts are pointed out, power lines are visible within canopies.

- Option One:
I recommend removing the tree entirely to remove the risk of root, root collar, trunk, crown, and branch failure. Grind the resulting stumps and back fill the holes. There will

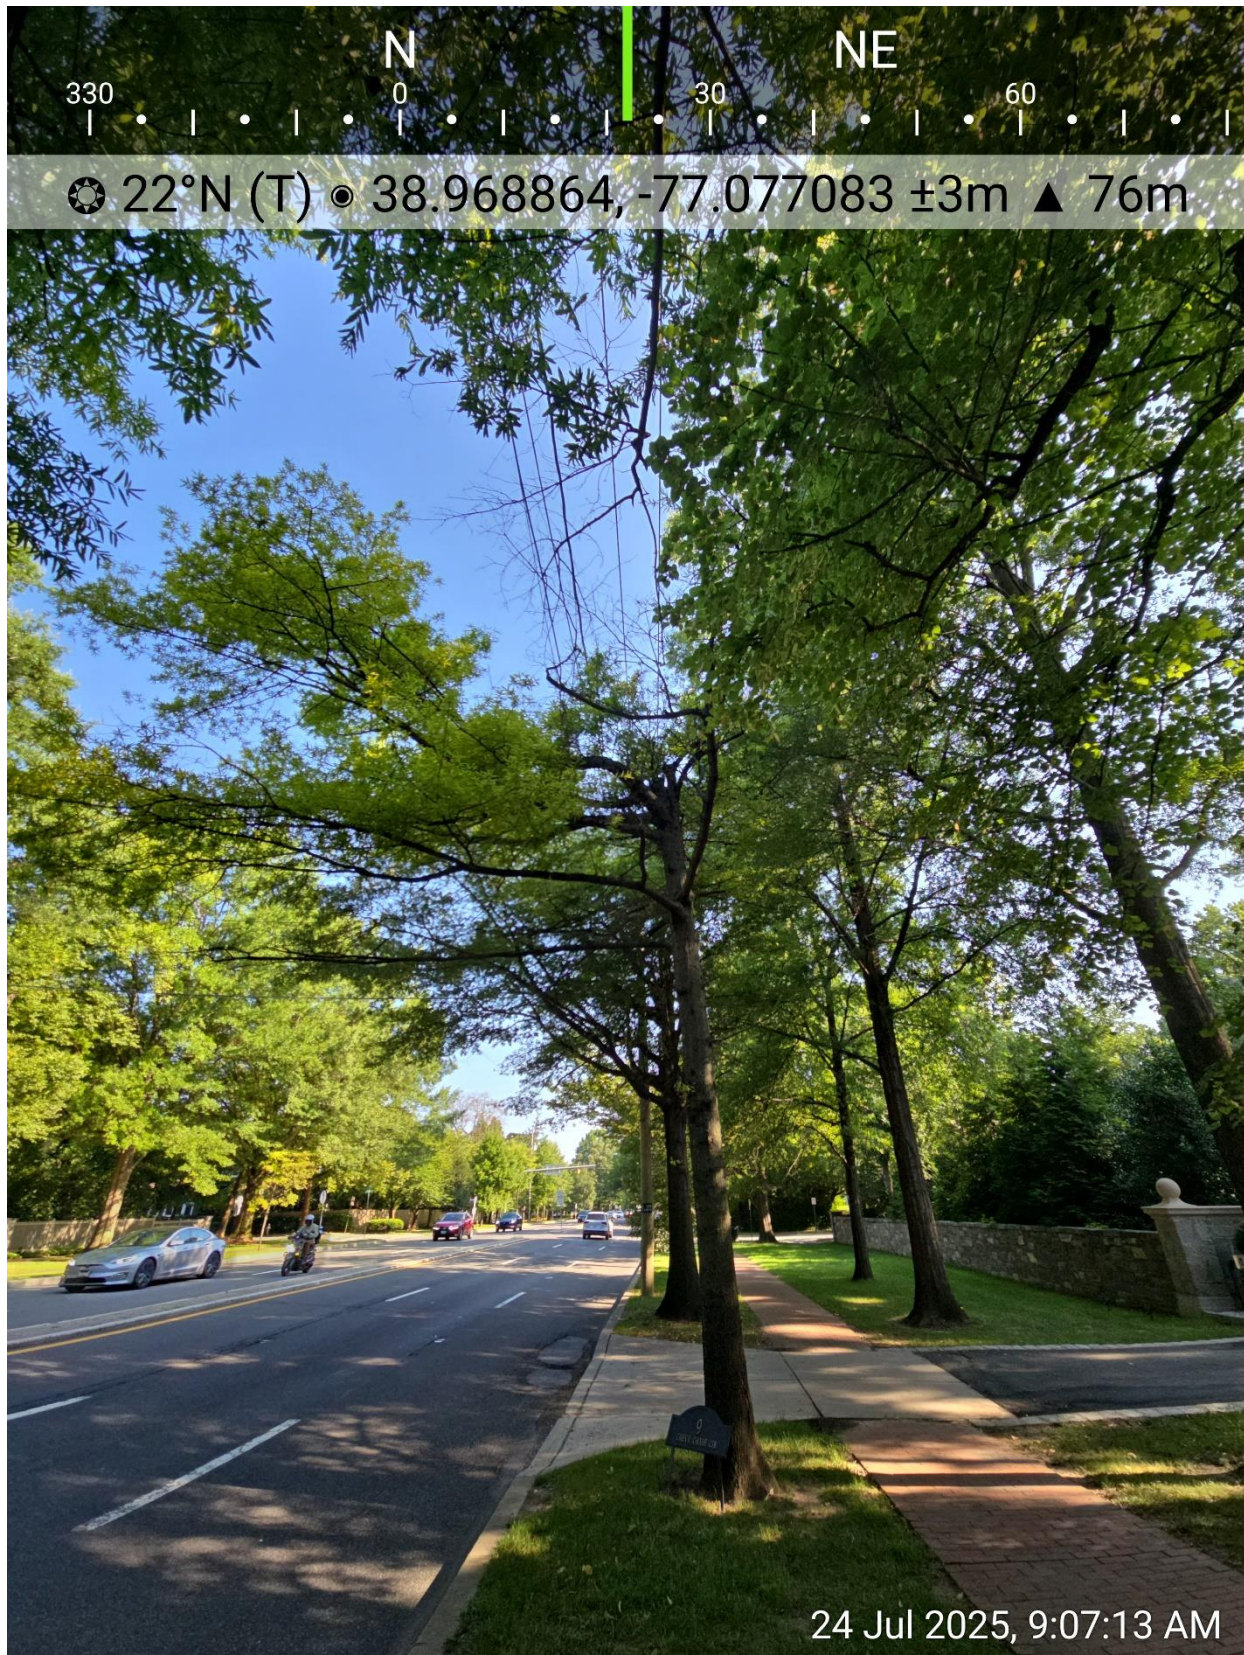
I visited the property to assess the trees on July 24, 2025. My basic assessment indicated possible branch failure in willow oaks #1 and #3 and the possible presence of a cavity in the lower trunk of willow oak #3. The likelihood of failure for root, stem, or branch failure for Willow oaks #2 and #4 were improbable. Using the methods outlined in this report and the results of the assessments of these trees, it is my professional judgment that the overall risk rating of willow oaks #1 and #3 are moderate and willow oaks #2 and #4 are low.

Photo 3: View of oaks #3 and #1, displaying topping cuts, uneven crowns, and overextend branches west towards Connecticut avenue.

- Option One:
I recommend removing the tree entirely to remove the risk of root, root collar, trunk, crown, and branch failure. Grind the resulting stumps and back fill the holes. There will be no residual risk for the trunk, crown, or branches, but there may be a tripping hazard with the remaining roots, stump, or grindings that you will need to address.
- Option Two:
If you elect not to remove the tree, I recommend mitigation pruning to remove dead branches, and to reduce the overall size of the crown will reduce the risk of branch failure to low.
- Option Three:
If you elect to not remove the tree, or prune to remove dead branches and reduce the relative size of the crown, the tree will remain a moderate risk for root collar, trunk, crown or branch failure. The tree's risk may increase in the future as a result of not performing mitigation.

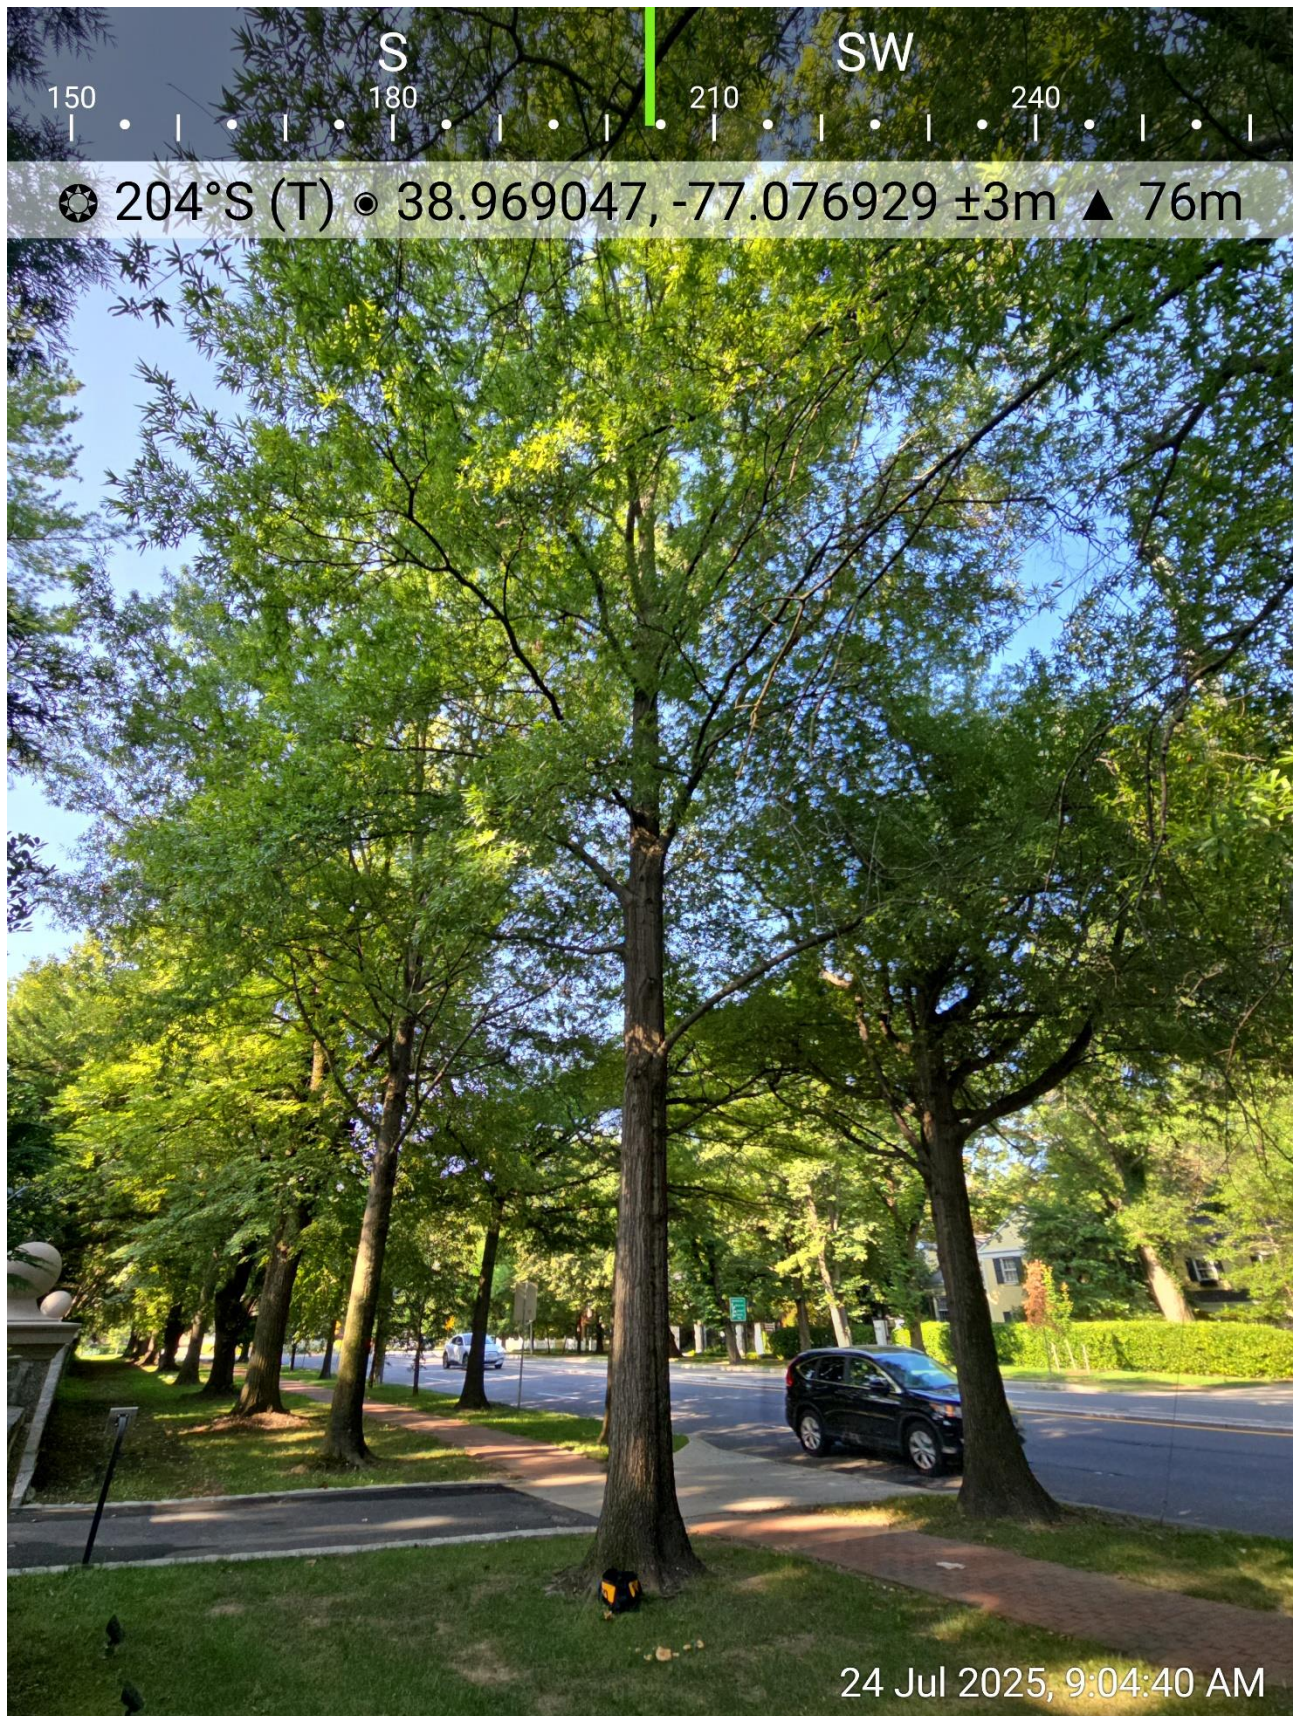
The canopy of willow oak #2 was supported by one vertical stem. The tree's form and structure were broad, open, and typical of the species. The canopy was balanced, and the overall vitality of the tree was normal. The soil around the oak was somewhat compact when probed. The location and condition of this tree were good.

Photo 4: View of oak #2.

- Option One:
I recommend performing mitigation pruning to remove dead branches, and to reduce the overall size of the crown resulting in a overall residual risk rating of low.
- Option Two:
If you elect not to remove the tree, or prune to remove dead branches and reduce the relative size of the crown, the tree will remain a *low* risk for root collar, trunk, crown or branch failure. The tree's risk may increase in the future as a result of not performing mitigation.
- Option Three:
I recommend removing the tree entirely to remove the risk of root, root collar, trunk, crown, and branch failure. Grind the resulting stumps and back fill the holes. There will be no residual risk for the trunk, crown, or branches, but there may be a tripping hazard with the remaining roots, stump, or grindings that you will need to address.

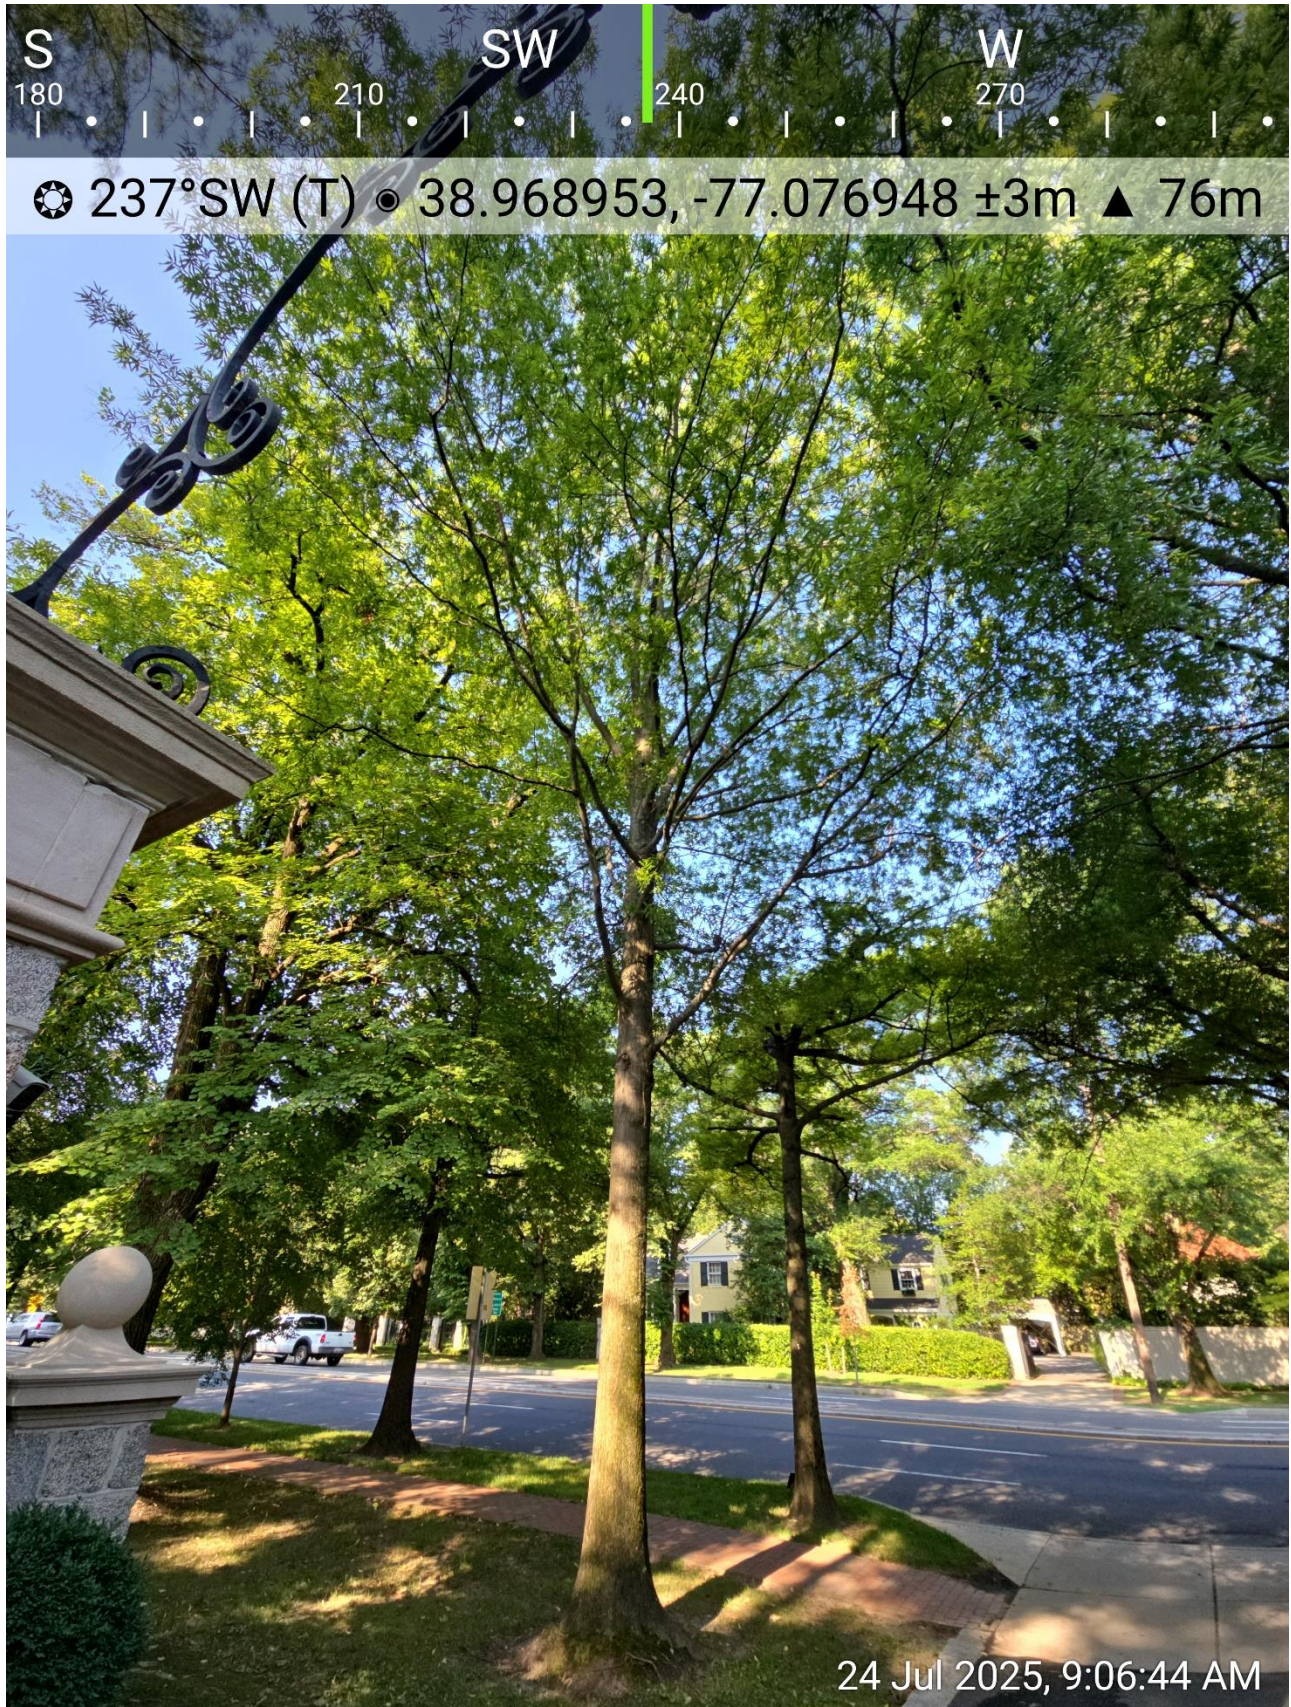
were broad, open, and typical of the species. The canopy was balanced, and the overall vitality of the tree was normal. The soil around the oak was somewhat compact when probed. The location and condition of this tree were good.

Photo 5: View of tree #4.

- Option One:
I recommend performing mitigation pruning to remove dead branches, and to reduce the overall size of the crown resulting in a overall residual risk rating of low.

- Option Two:
If you elect not to remove the tree, or prune to remove dead branches and reduce the relative size of the crown, the tree will remain a *low* risk for root collar, trunk, crown or branch failure. The tree's risk may increase in the future as a result of not performing mitigation.
- Option Three:
I recommend removing the tree entirely to remove the risk of root, root collar, trunk, crown, and branch failure. Grind the resulting stumps and back fill the holes. There will be no residual risk for the trunk, crown, or branches, but there may be a tripping hazard with the remaining roots, stump, or grindings that you will need to address.
