### MONTGOMERY COUNTY HISTORIC PRESERVATION COMMISSION STAFF REPORT

Address: 113 Elm Ave., Takoma Park Meeting Date: 7/23/2025

Case Number: 1116058 Staff: Dan Bruechert

**Proposal:** Door and Window Replacement

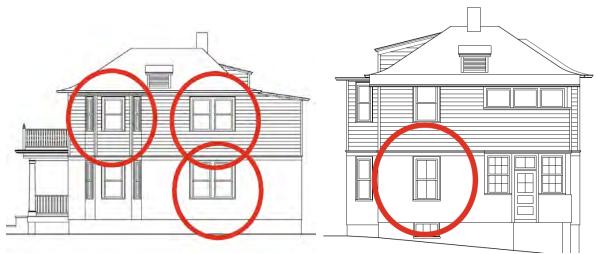
Figure 3: The applicant proposes to remove and replace eight windows.

The applicant proposes to remove and replace a total of eight windows (see *Figure 3*, below). Seven of the proposed window removals are on the left side and one is on the rear. The windows on the right elevation are one-over-one wood sashes and Staff finds their appearance and condition are consistent with the house's 1913 date of construction. The window on the rear is a two-over-two sash window that appears to have been installed when the rear was expanded, between 1927 and 1959.

Based on the information included and the application and Staff's observations at a site visit, the windows show signs of paint failure, joint failure, surface mold, and rot within the frame. Due to these issues, the sashes are no longer weathertight. Surprisingly, the sash cords in several of the windows are still present.

In place of the existing windows, the applicant proposes to install Pella Lifestyle, aluminum-clad wood windows in matching size in one-over-one configurations and to replace the trim in matching dimensions. Staff finds the profiles and proportions of the proposed windows are compatible with the existing windows. The outstanding issue is the material. The HPC has consistently approved appropriately detailed clad wood windows for additions and new construction throughout the Takoma Park Historic District. However, evaluation of a substitute material on Contributing resources has been undertaken on a case-by-case basis. The primary considerations of the use of substitute materials include, design significance of the feature, visibility from the public right-of-way, and compatibility of the substitute material's appearance. Considering these criteria, Staff finds the proposed window is not appropriate.

Having reached this conclusion, instead of denying the window replacement, Staff recommends the HPC conditionally approve the seven one-over-one wood windows that are appropriately sized to fill the historic opening, with final approval authority delegated to Staff. This will allow the applicants to continue to move the project forward without having to wait for a future HPC meeting, when the commission has already determined the appropriate requirements for this feature. If the applicants have additional questions about an appropriate window, Staff can direct the applicant to several window manufactures who produce wood windows that have been installed in the Takoma Park Historic District.

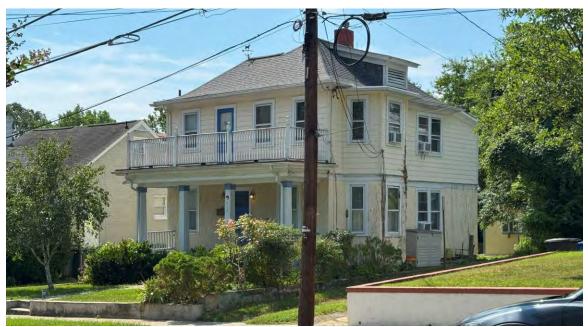
Figure 4: The subject house as viewed from the northwest.

Second, Staff finds that seven of the eight windows are visible from the public right-of-way along the right side. *Figure 4*, below shows the highly visible right elevation. A 10' (ten foot) wide dedicated alley between the houses at 113 Elm Ave. and 111 Elm Ave. will preserve the open space between the properties and maintain the open appearance of the left elevation.

For these reasons, Staff finds that wood is the only appropriate material for the proposed seven windows on the right elevation.

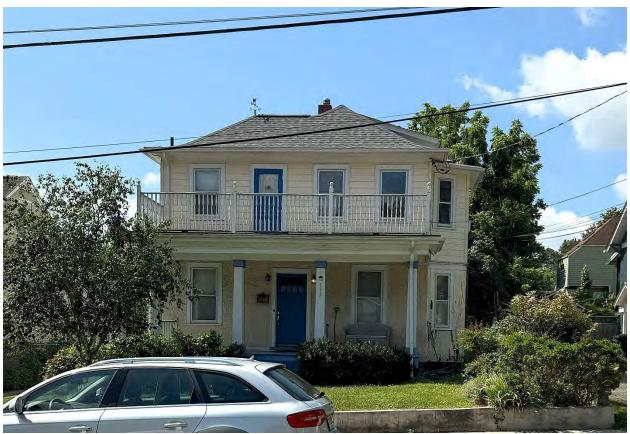
Figure 6: Front elevation of the subject property showing the second-floor door.

On the second floor of the elevation there is a half-light, three paneled, wood door. The door has suffered from significant deterioration and the applicant proposes to remove the existing door and replace it with a ProVia Legacy half-light steel door.

Staff finds the existing door shows locations of warping, rotting, and cracking on the interior and exterior. Mold is evident on the jamb on the door itself. At some point in the building's past, the door was removed and reinstalled so that it swings out. In changing the swing, the exterior door was installed nearly flush with the exterior trim in a location where backsplash off the porch's second story, a factor that likely contributed to its deterioration. Regardless of the cause of the door's deterioration, Staff finds that the door has deteriorated beyond reasonable repair and supports its removal under 24A-8(b)(4) and

For all of the reasons discussed above regarding the windows, Staff finds a wood door is appropriate here. First, a replacement door can satisfy all of the identified criteria in *Standard #6* including materials. Second, the door is one of the few decorative features on the front elevation of the house, and even though it is on the second floor, it is on the *front* elevation of the house. Third, the appearance of a metal door does not match that of a wood door. The construction and profiles in a steel door will not match those of a wood door and a steel door will not develop a patina with age.

As with the windows, Staff recommends the HPC conditionally approve a replacement wood half-light door, appropriately sized to fill the historic opening, with final approval authority delegated to Staff. This will allow the applicants to continue to move the project forward without having to wait for a future HPC meeting, when the commission has already determined the appropriate requirements for this feature. If the applicants have additional questions about an appropriate replacement door, Staff can direct the applicant to several manufactures who have produced wood doors that are compatible with the character of the house and the Takoma Park Historic District.
