### MONTGOMERY COUNTY HISTORIC PRESERVATION COMMISSION STAFF REPORT

Address: 102 East Kirke Street, Chevy Chase Meeting Date: 11/12/2025

**Permit No.:** 1067931 REVISION#4 **Staff:** Dan Bruechert

**Proposal:** Chimney Removal

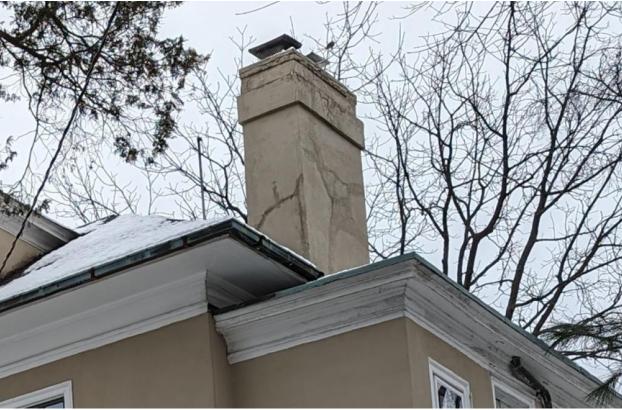
The subject property has three chimneys. There is a chimney at either gable end of the main block of the house and a chimney at the rear of the projecting-L. During construction, the applicant identified substantial damage to the rear chimney. Further investigation by a structural engineer (letter attached)

determined that chimney had deteriorated to the point it was, "unable to resist the tensile stresses at the base of the chimney." And that is considered too tall for an unreinforced chimney due to its tall, slender proportions. The applicant proposes to remove this chimney and to repair the roof.

Figure 2: Photo of the chimney showing visible cracks and previous repairs.

Staff finds that based on the analysis by the structural engineer that the existing chimney has deteriorated beyond repair and needs to be demolished. The question then is, what is the appropriate treatment for the chimney's location?

Our reasoning for the removal of the chimney was that the 20"x 48" x 14'-0" tall chimney had severe deterioration to the brick mortar that would have made the chimney unable to resist the tensile stresses at the base of the chimney. This tall and slender chimney when subjected to a 30 psf design wind loading would have induced a 58psi tensile stress at the base of unreinforced brick masonry chimney, which is considered too high for the unreinforced and deteriorated brick masonry.

1. The chimney above the roofline must be replicated to match the dimensions and appearance of the historic chimney. Documents detailing the construction of the chimney must be submitted to Staff before the issuance of the final HAWP approval documents.
