**MONTGOMERY COUNTY HISTORIC PRESERVATION COMMISSION**  
**STAFF REPORT**

| <b>Address:</b> | 19811 Darnestown Road, Beallsville | <b>Meeting Date:</b> | 11/12/2025 |
| <b>Resource:</b> | Darby House<br>Beallsville Historic District | <b>Report Date:</b> | 11/5/2025 |
| <b>Proposal:</b> | Demolition of accessory structure and construction of new shed. | | |

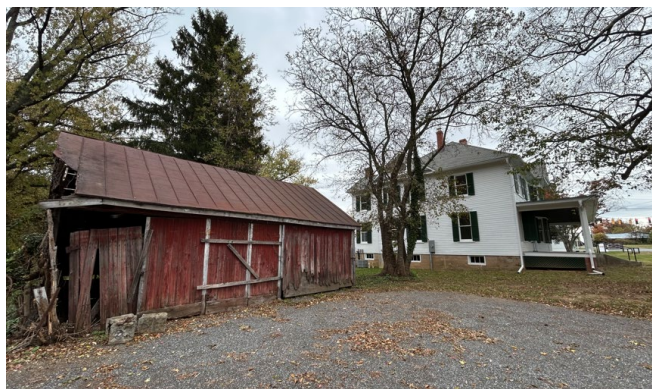
*Figure 6: The accessory structure proposed for demolition with the Darby house in the background (Left, October 2025, Historic Preservation office), and proposed shed (right).*

The north bay is severely structurally compromised. The sill plate, set on ground, has rotted, as have corner posts and stud bottoms, as well as siding, facia, and other elements. The bay doors have been secured shut, but they would be inoperable because of deterioration to most components. The man door providing access to this bay has also deteriorated and is inoperable (and open to the weather). A window ventilating the gable end is missing, so the building is open to the weather and a vulture was present inside the bay during the most recent site visit.

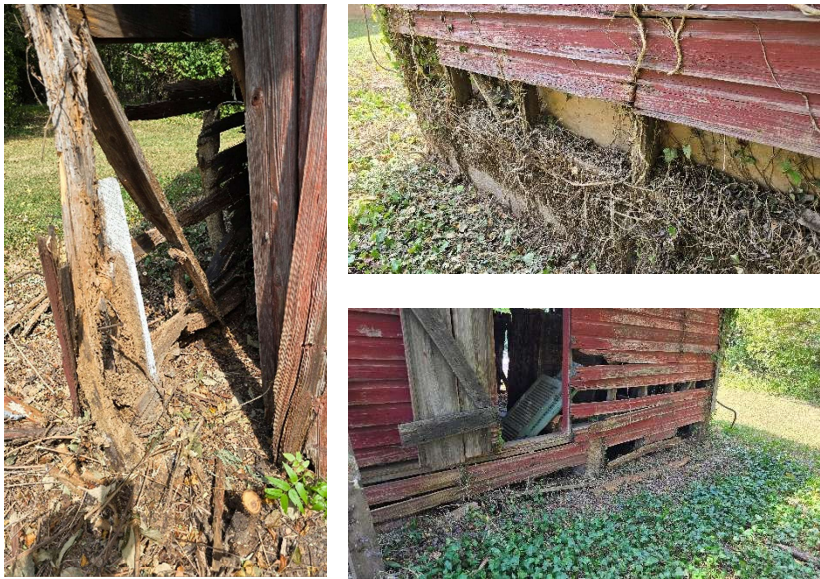
The shed structure has sustained significant deterioration over time due to termite activity and prolonged moisture exposure. The wall studs along all exterior walls exhibit advanced rot, particularly at their connections to the footing. The bottom plates of the walls are extensively decayed and have lost their structural integrity.

Figure 2 – Rotten wood at the base of the walls

Based on my observations, the shed structure is beyond repair in its current condition. After digging test pits to verify the width and depth, the footing is the only component that may be retained if a new, similar structure is to be constructed at the same location. All other wooden elements, including the walls and roof framing, have deteriorated to the point where complete replacement is necessary.
