Preliminary Consultation
MONTGOMERY COUNTY HISTORIC PRESERVATION COMMISSION
STAFF REPORT

Address:	20 Grafton Street, Chevy Chase	Meeting Date:	4/8/2026
Resource:	Contributing Resource Chevy Chase Village Historic District	Report Date:	4/1/2026
Applicant:	Scott and Meredith Raney (Eric Zuckerman, Agent)	Public Notice:	3/25/2026
Review:	HAWP	Tax Credit:	No
Permit No.:	1151195	Staff:	Laura DiPasquale
Proposal:	Replacement of slate roof with synthetic slate

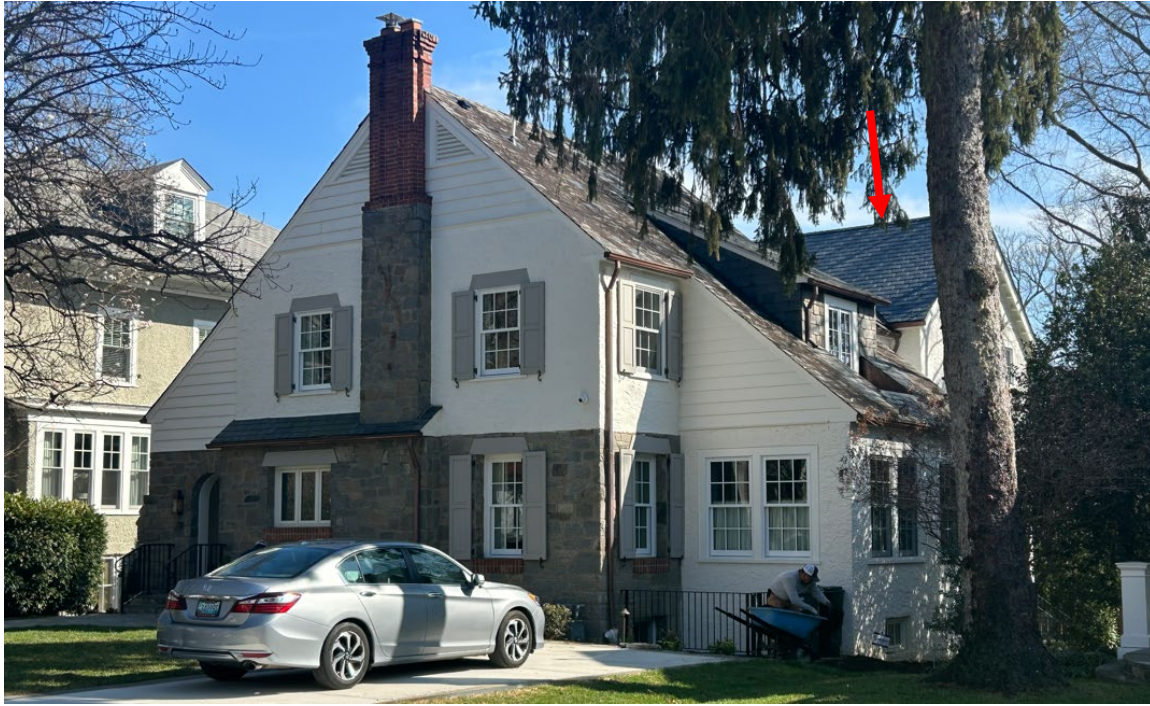
Figure 2: Front and partial west side elevation (March 2026, Historic Preservation Division). The existing slate on the main block would be replaced with synthetic slate to match that of the rear addition (shown with a red arrow).

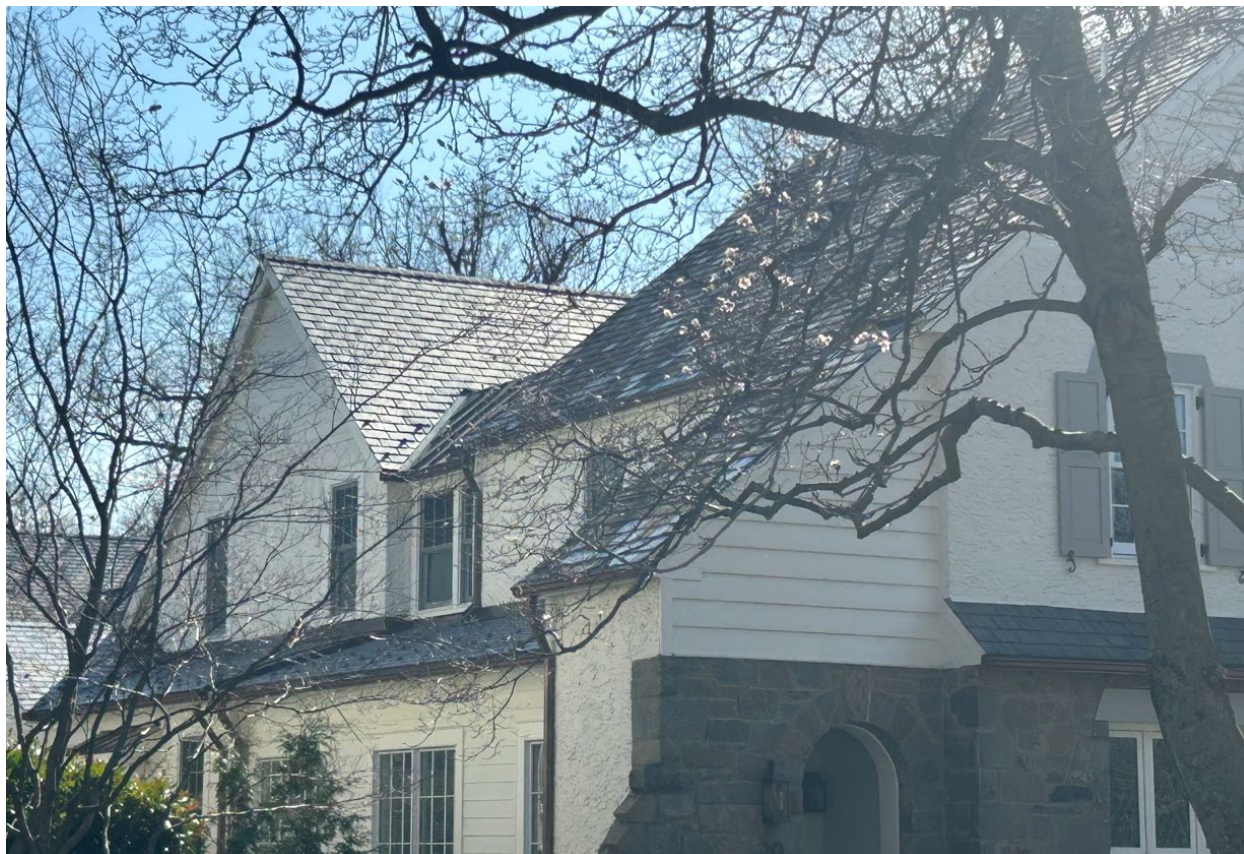
Figure 4: View of the juncture between the historic slate on the main block and the EcoStar Majestic synthetic slate on the non-historic rear addition (March 2026, Historic Preservation Division).

Staff also has concerns with this application about having the proposed synthetic slate on the historic main block matching the slate on the non-historic addition, find that the compatibility but differentiation between the new and old is important under *Standard 9*. Staff notes that the proposed synthetic slate has a more rectangular shape than the existing slate, which has a more square exposure. However, should the HPC be open to allowing for replacement of the existing slate with EcoStar Majestic synthetic slate, staff recommends that applicants provide for review and match the dimensions of the existing slate exposure and color, regardless of the dimensions and color of the existing rear addition.

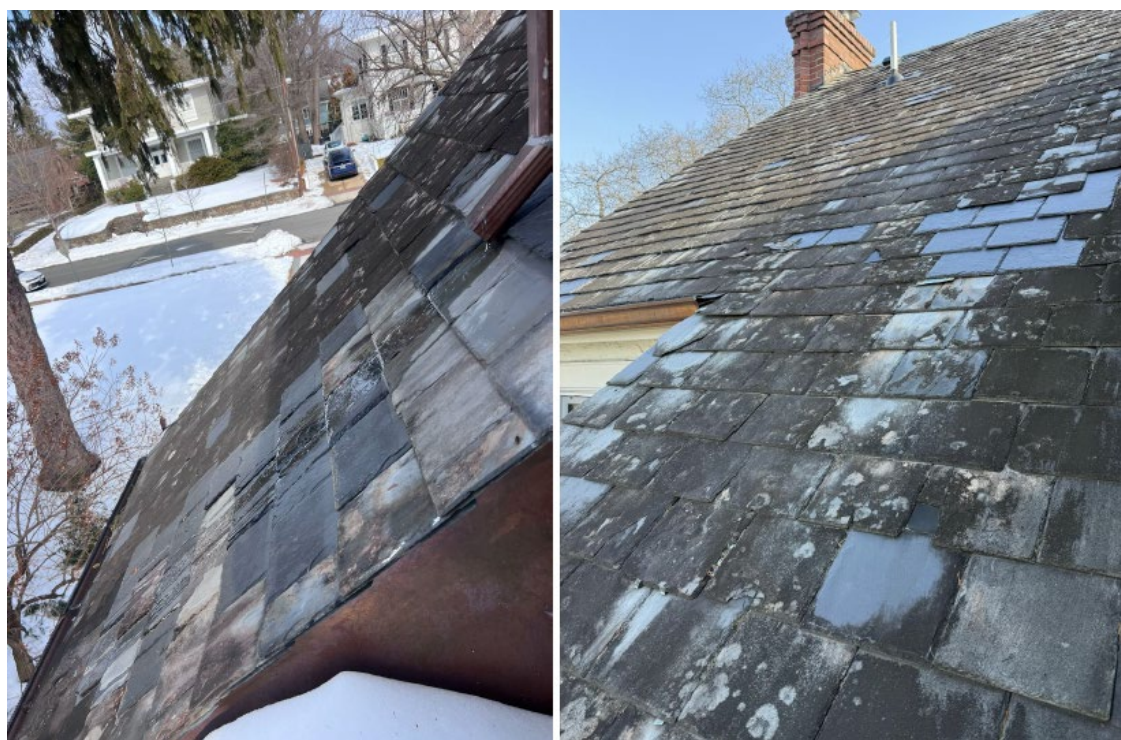
Prior to allowing for replacement, staff finds that the applicants must demonstrate that the historic roofing is beyond repair. Per *Standard 6*, “where the severity of deterioration requires replacement of a distinctive feature, the new feature will match the old in design, color, texture, and where possible, materials.” Staff finds that the existing slate roof is in poor condition and that there is evidence that repairs that have been made to the roof are insufficient in preventing further interior damage. Staff notes that historic slate roofing typically has a service life of 75-125+ years, and finds that at approximately 100 years old, the slate roof on 20 Grafton Street is within a normal range of replacement.

Figure 5: Detail of the existing slate roof showing the historic shape and color and areas of patching.

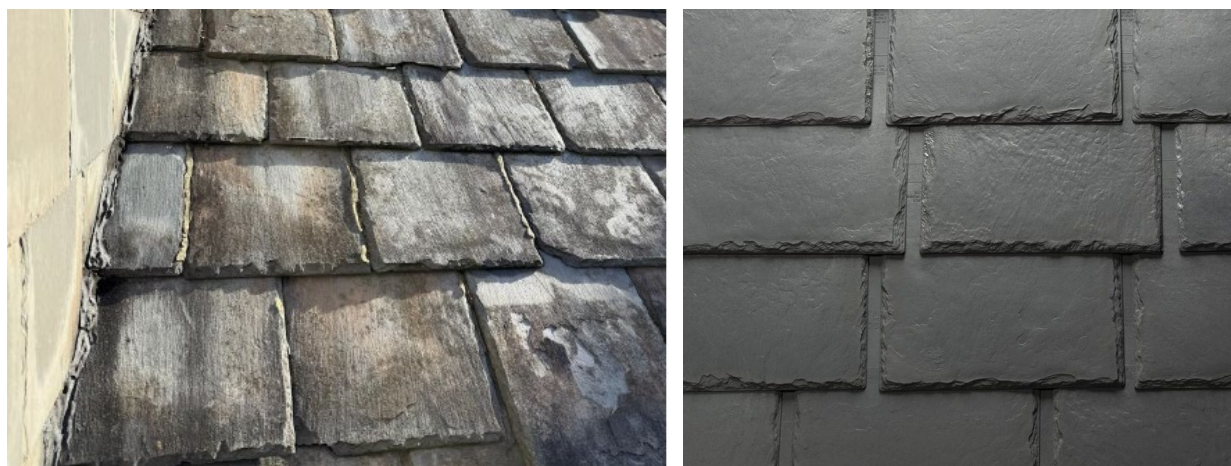
As submitted, the applicants propose to replace the existing slate with EcoStar Majestic synthetic slate to match that of the rear addition. Staff finds that the EcoStar Majestic synthetic slate more closely resembles slate than do other alternative materials, such as asphalt shingles, and that unlike other synthetic slate materials staff has seen, does not have an overly shiny or plasticky appearance on site. Staff notes that EcoStar Majestic synthetic slate comes in several different sizes, shapes, and colors and would be capable of replicating patterned slate designs. Staff would support the use of EcoStar Majestic synthetic slate in lieu of asphalt shingles where the original slate was absent, but has concerns about the precedent created by allowing replacement of existing slate with a synthetic material. Staff finds that, while the synthetic slate may be capable of approximating the appearance of new natural slate, it will not have the same subtle natural variance and will not weather the same way as natural slate, whose patina is one of its character-defining features.

Figure 6: Detail of the existing slate roofing (left) and stock image of the EcoStar Majestic synthetic slate roofing (right).

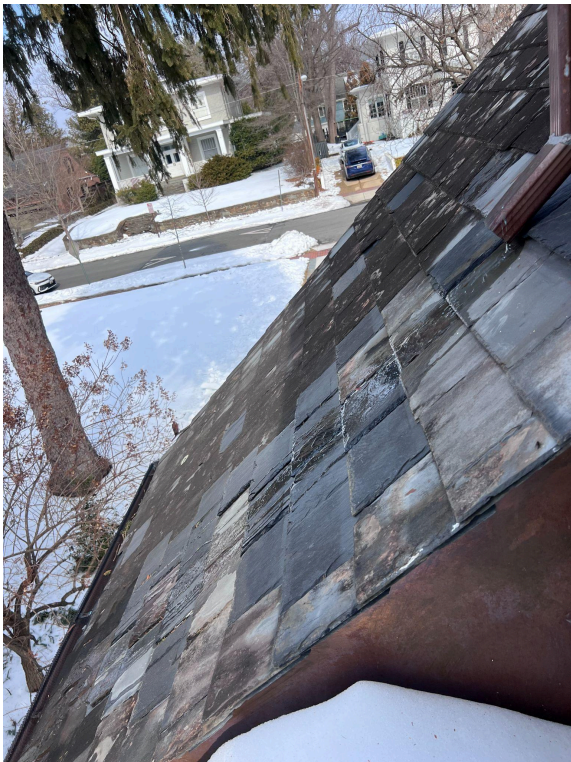
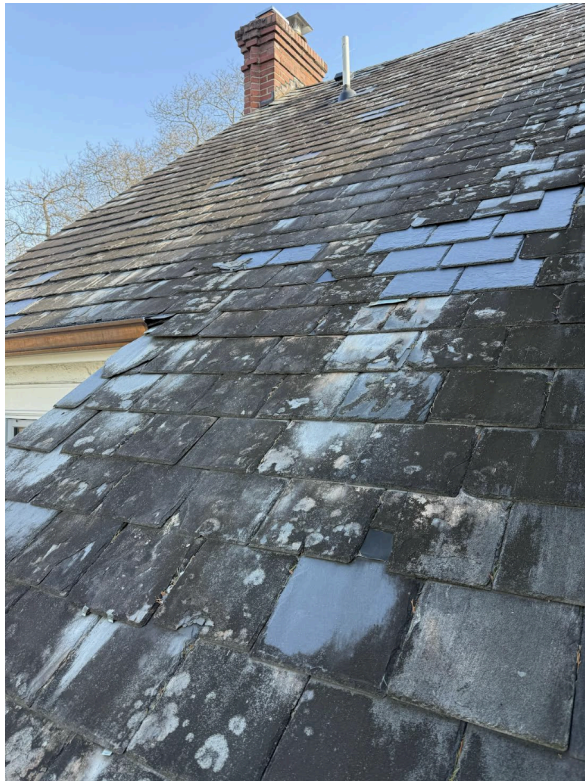
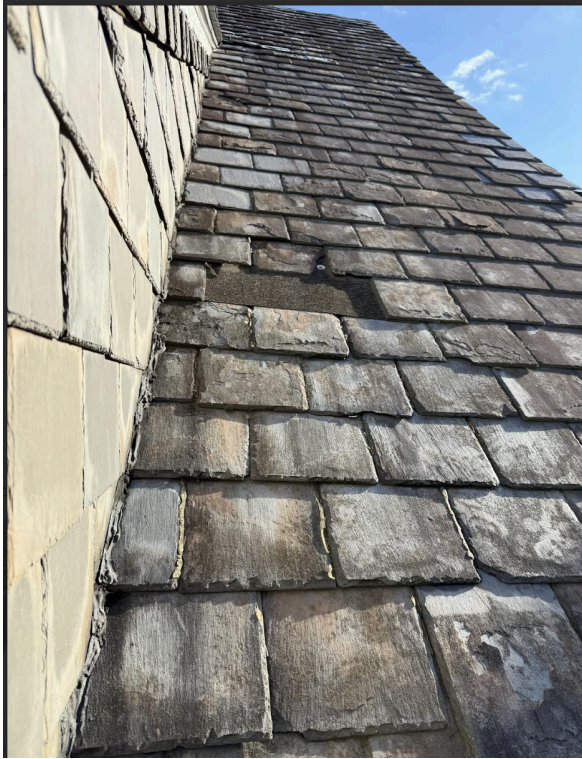
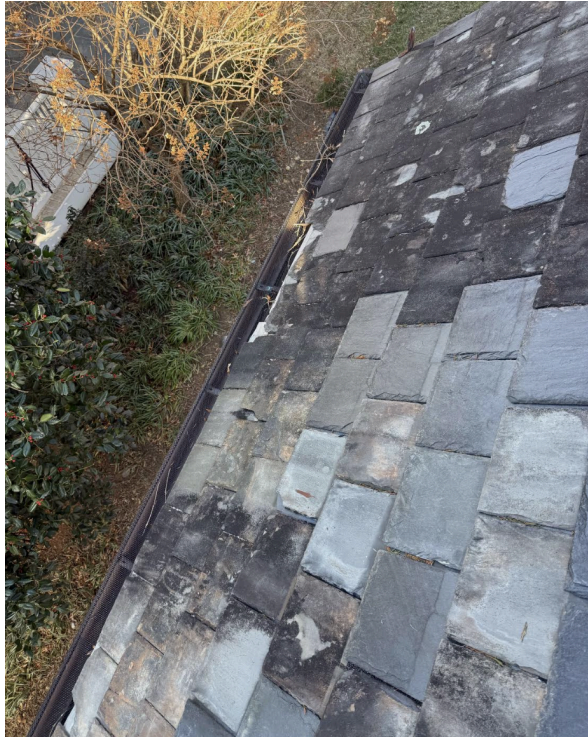
Proposal is to replace the existing slate roof on the front of the house (the original to the historic section of the home) with the roof material that was approved and used for the rear two story addition by MCHPC on 4/20/22 for HAWP #987802) The approved material matches the existing roof on the historic section of the house and is much more effective and long-lasting while fully in keeping with the look of the historic roof material. Per HAWP #987802 (and subsequent building permits), the material is "synthetic slate shingles, ecostar majestic or eq., matching existing slate roofing color & style". The roof needs to be fully replaced based on professional assessments because it is showing signs of serious wear and tear and water intrusion issues need to be avoided through replacement as soon as possible.

Existing slate roof on front part of house (entire roof needs to be replaced):
