# Montgomery County Historic Preservation

## Staff Report

<p><b>ADDRESS:</b> 9 Primrose St., Chevy Chase</p> <p><b>RESOURCE:</b> Chevy Chase Village Historic District</p> <p><b>APPLICANT:</b> Alice Keating</p> <p><b>REVIEW:</b> HAWP <u>Revision 2</u></p> <p><b>CASE NO.:</b> 1146371</p> <p><b>PROPOSAL:</b> Porch Railing Replacement</p>	<p><b>MEETING DATE:</b> 5/13/2026</p> <p><b>REPORT DATE:</b> 5/6/2026</p> <p><b>PUBLIC NOTICE:</b> 4/29/2026</p> <p><b>TAX CREDIT ELIGIBLE:</b> Yes</p> <p><b>STAFF:</b> Dan Bruechert</p>
--	--

## KEATING RESIDENCE

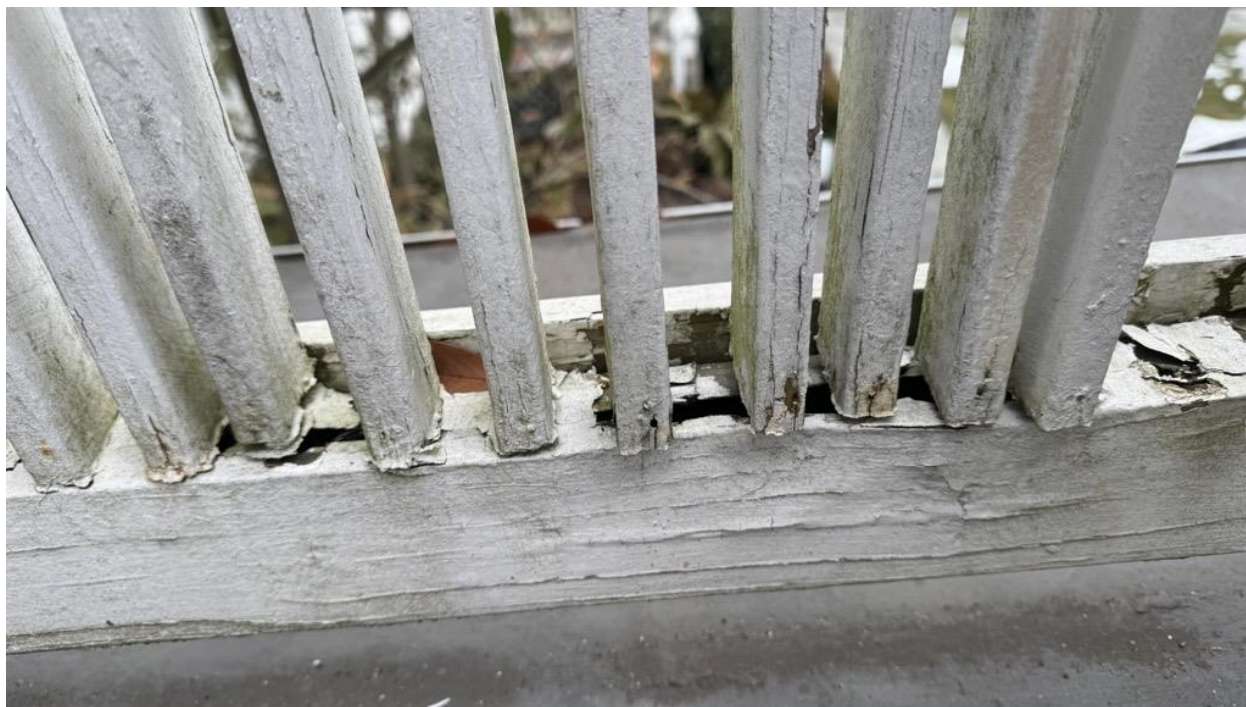
The second-floor porch railing has been modified from its original configuration. At some point the posts were covered in PVC, which would have required, at a minimum, shortening the railing to account for the narrower space between the posts. The existing railing shows extensive rot and select areas of repair (see *Figure 2*, below). At some point a 1" × 4" (one by four inch) strip of wood was applied to the face of the

bottom rail which created a dam that allowed water to collect at the railing. There are also areas where the narrow balusters have warped and bowed. Based on Staff's observations on site and the provided photographic documentation, Staff finds the railing has deteriorated to the point it will likely fall apart when it is removed for the new roof, and the railing has deteriorated beyond repair and must be replaced. Staff supports the railing removal under 24A-8(b)(2) and (d) and *Standard #6*.

Figure 2: Detail of the existing second-floor railing condition.

The applicant proposes to replace the existing second floor railing with a new mahogany railing. Baluster dimensions and spacing for the new railing will match the measurements on the first-floor railing. The new railing will be taller than the railing on the first floor, so that it satisfies the 36" (thirty-six inch) code compliant height.

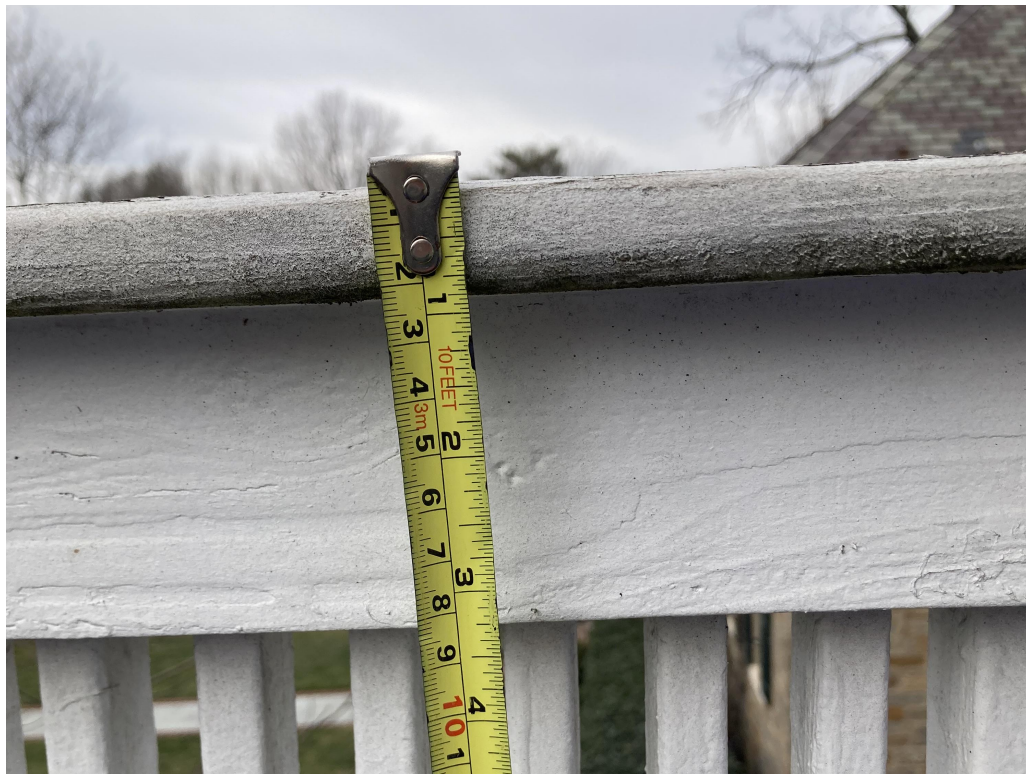
1 Exist. Top Rail Dtl., Porch Roof

The existing railing at the perimeter of the existing front porch roof is primarily painted mahogany. The bottom rail appears to be assembled from painted 1x pine trim. The railings do not appear to be the original construction and have been replaced within the last twenty years. The existing posts are constructed of plywood boxes wrapped in 1x PVC trim, also likely replaced within the last twenty years.

The existing painted pine and mahogany railing at the perimeter of the existing front porch roof will be replaced with a new 36-inch tall painted mahogany railing, custom milled to match the existing railing profile at the first floor covered porch below. The existing railing at the first floor covered porch is presumed to be the original design.

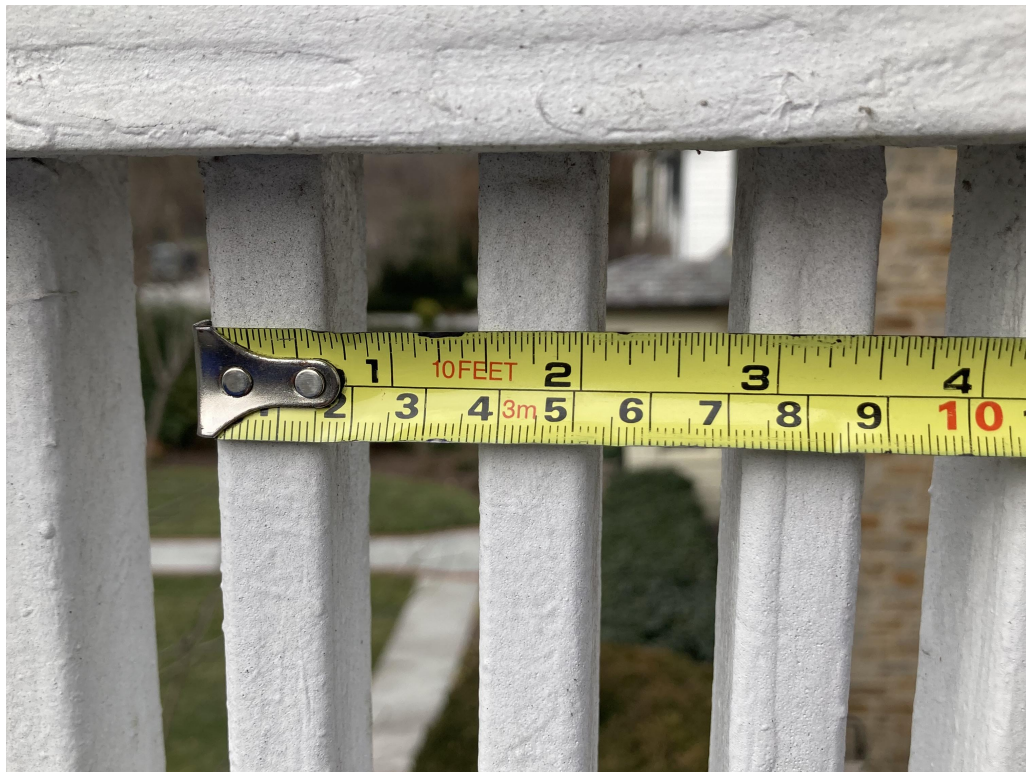
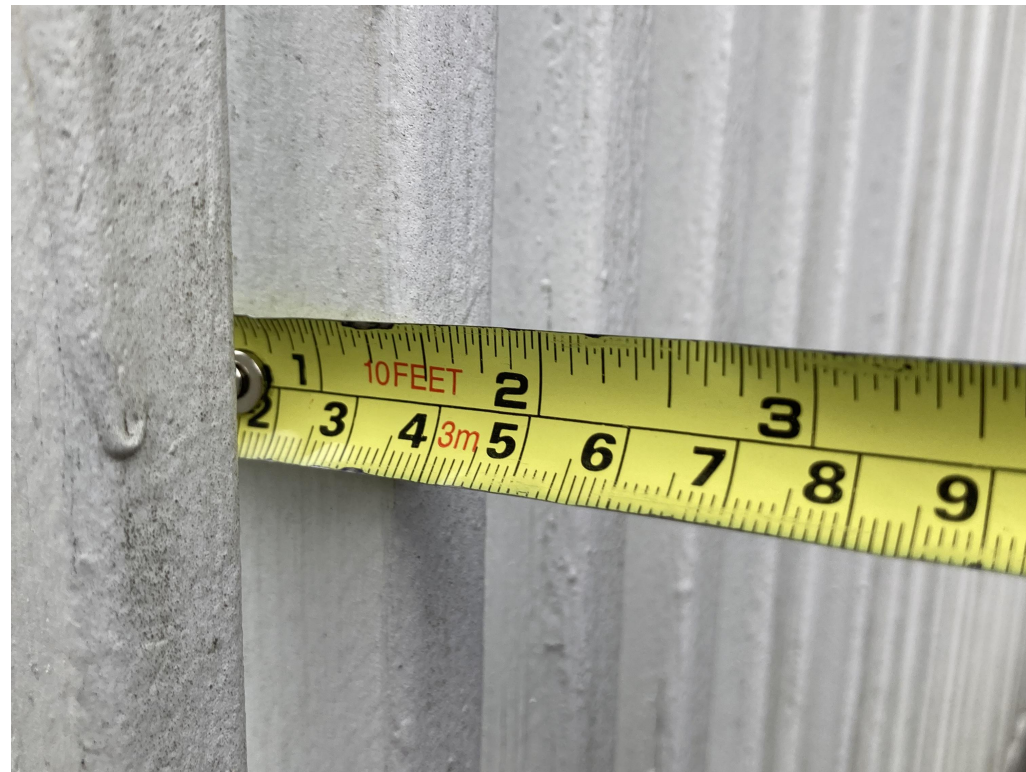
1 Exist. Baluster Dtl., Porch Roof

The existing porch roof railing balusters are 5/8" wide x 1-3/8" deep, with a 3/4" space between. This varies from the original first floor porch below, where the balusters are 7/8" x 1-3/4", with 1" space between. The railing fabricator does not recommend matching the 5/8" balusters as they will bow and eventually fail again. We propose using 1" x 1-3/4" balusters at the upper railing and will match the baluster spacing at the first floor front porch below. Our approach will unify the upper and lower porch railings for a more consistent and improved appearance and will ensure the longevity of the architectural millwork over time.
